CONDITION REPORT

Report No:  
2017305114  
DATE  
30/09/2026

| Manufacturer | TOYOTA | Registration Number | HHD351L |
| Model | COROLLA QUEST 1.8 PLUS CVT [2022-2025] | Register Number | |

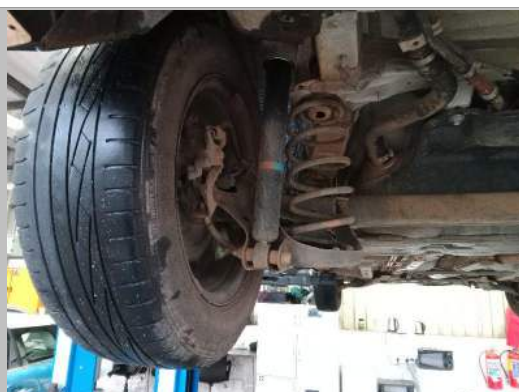
LR TYRE TREAD

| | Size | Load/Speed Index | Manufacture | Model | Type* | Production Date | Tread Depth (mm) |
|---|---|---|---|---|---|---|---|
| Rear Left | 195/65 R15 | 91H | Goodyear | Excellence | V | 4422 | 1 mm |

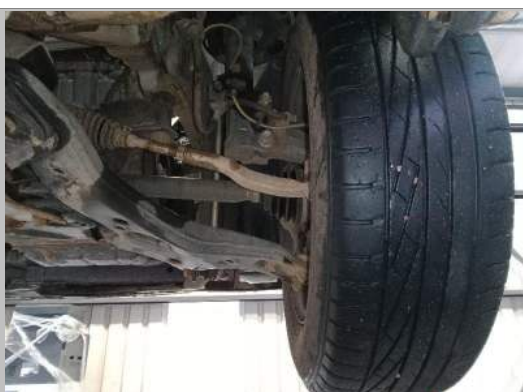
RF TYRE TREAD

| | Size | Load/Speed Index | Manufacture | Model | Type* | Production Date | Tread Depth (mm) |
|---|---|---|---|---|---|---|---|
| Front Right | 195/65 R15 | 91H | Goodyear | Excellence | V | 0323 | 3 mm |

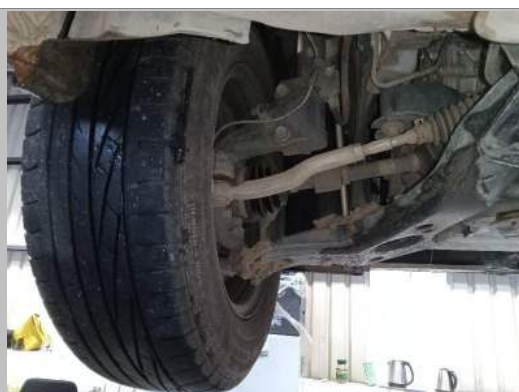
LF TYRE TREAD

| | Size | Load/Speed Index | Manufacture | Model | Type* | Production Date | Tread Depth (mm) |
|---|---|---|---|---|---|---|---|
| Front Left | 195/65 R15 | 91H | Goodyear | Excellence | V | 0323 | 3 mm |

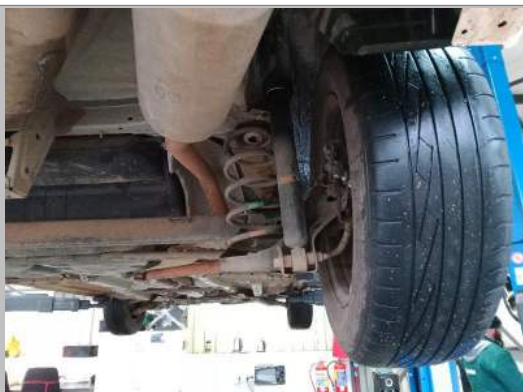
RR TYRE TREAD

| | Size | Load/Speed Index | Manufacture | Model | Type* | Production Date | Tread Depth (mm) |
|---|---|---|---|---|---|---|---|
| Rear Right | 195/65 R15 | 91H | Goodyear | Excellence | V | 4822 | 2 mm |

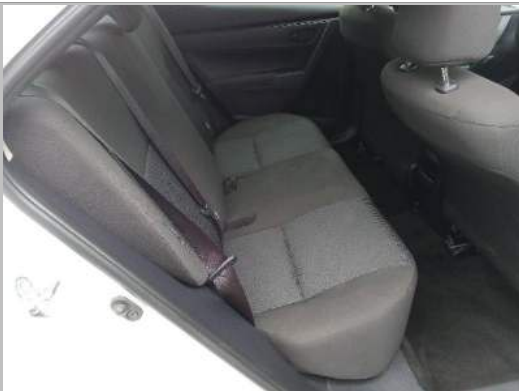
| Seat Rear Dirty | Repair |

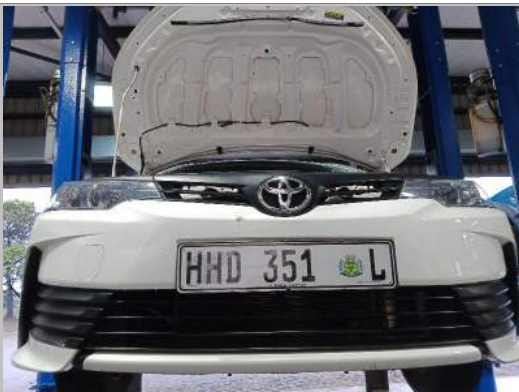
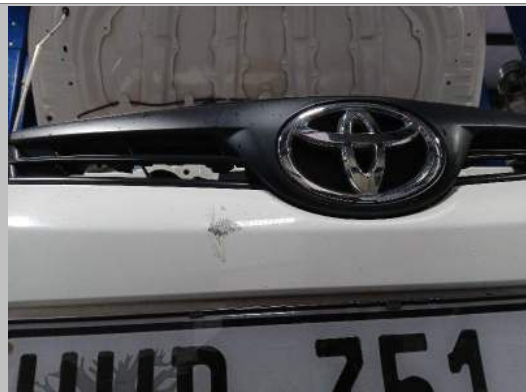
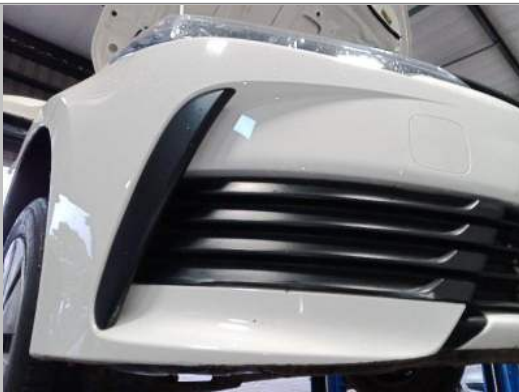
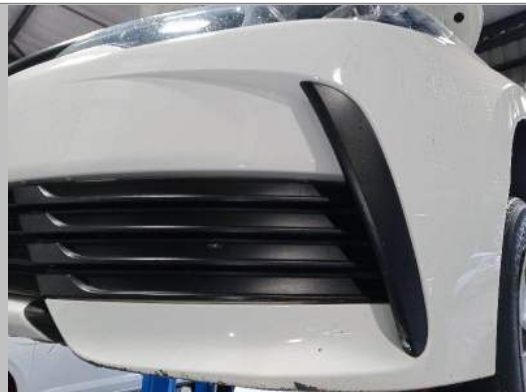
| Front Bumper Paintwork • Scratched | Repair |

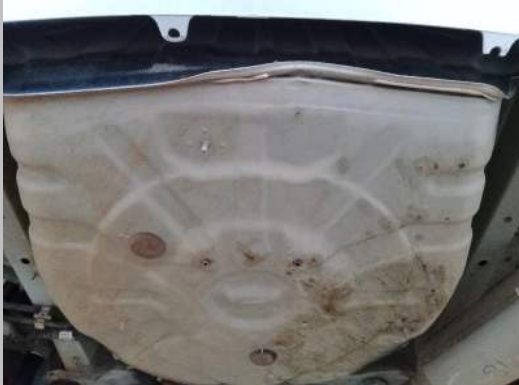
| Inner Boot Floor Pan and Spare Wheel Well Damaged | Repair |

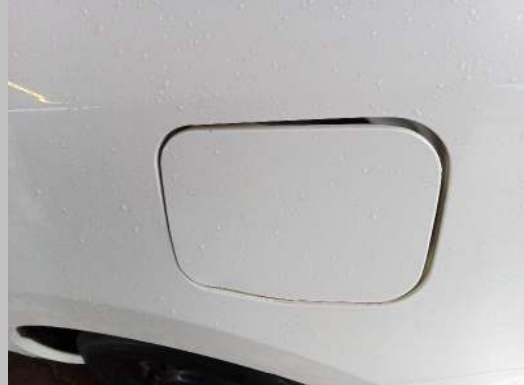
| Fuel Flap Dented | Repair |

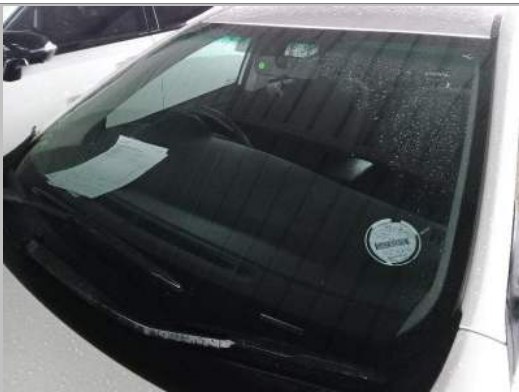
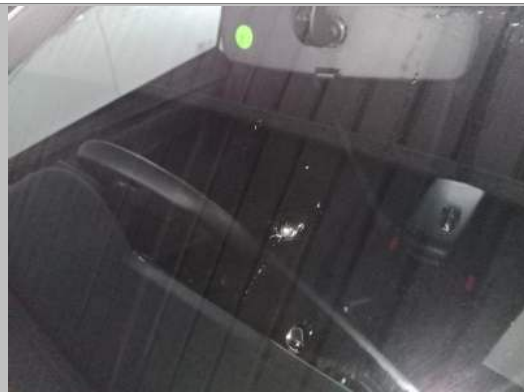
| Windscreen Chipped | Repair |
