## CONDITION REPORT

2017305777

| Manufacturer | TOYOTA | Registration Number | KD33CLGP |
| Model | COROLLA QUEST 1.8 PLUS [2021-2022] | Register Number | |

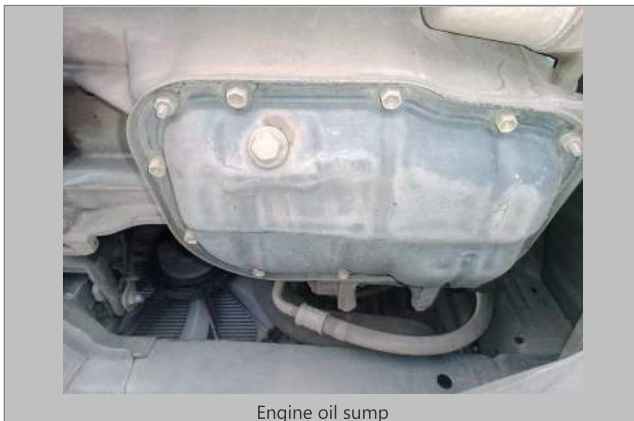
| Damage | Repair Way |
|---|---|
| Engine oil sump damaged | Replace |

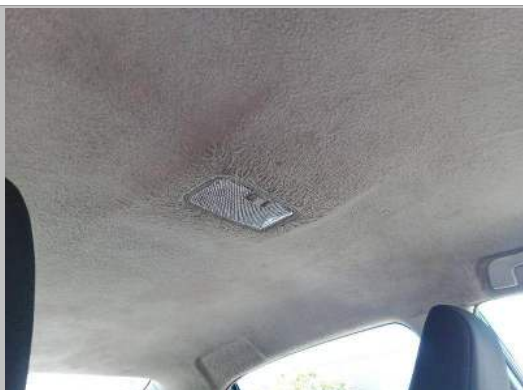
| Damage | Repair Way |
|---|---|
| Hood Lining Excessive Wear & Tear | Repair |

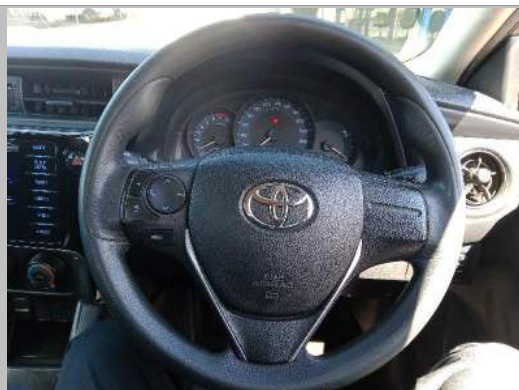
## Steering Wheel Trim

| Damage | Repair Way |
|---|---|
| Steering Wheel Trim Excessive Wear & Tear | Repair |

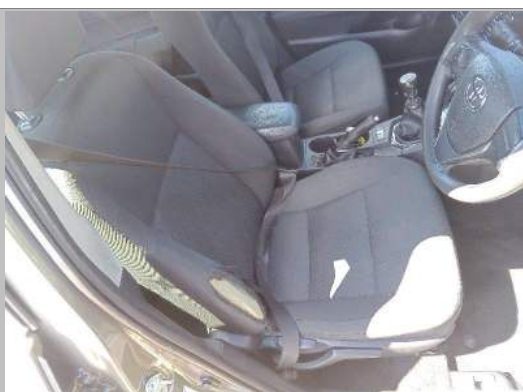
| Damage | Repair Way |
|---|---|
| Seat Front Right Damaged | Repair |

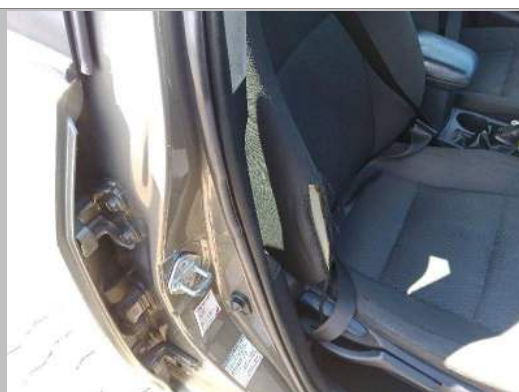
| Damage | Repair Way |
|---|---|
| Door Sealing Rubber Front Right Damaged | Replace |

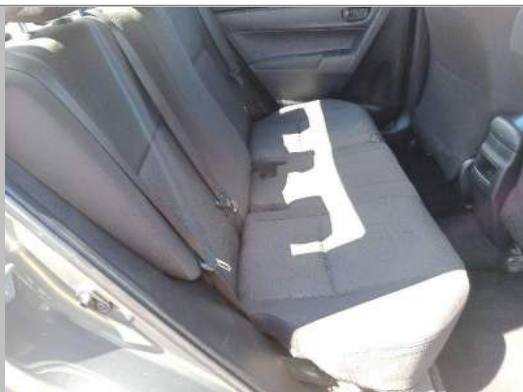
| Damage | Repair Way |
|---|---|
| Seat Rear Damaged | Repair |

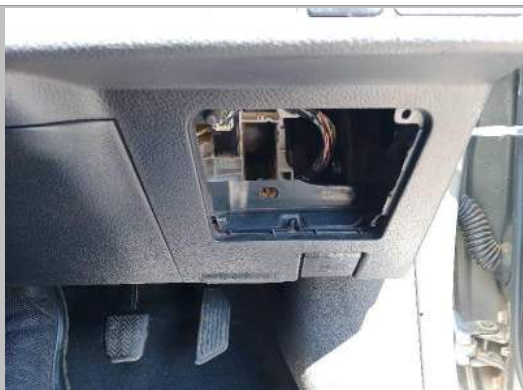
| Damage | Repair Way |
|---|---|
| Center Console / Cubbyhole + Lid Missing | Replace |

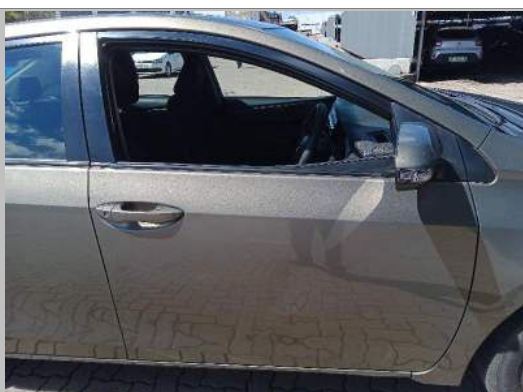
| Damage | Repair Way |
|---|---|
| Door Front Right Damaged | Repair |

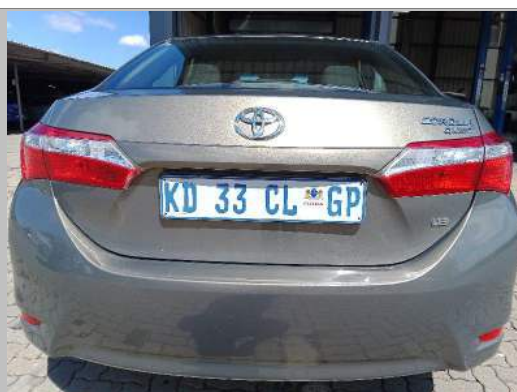
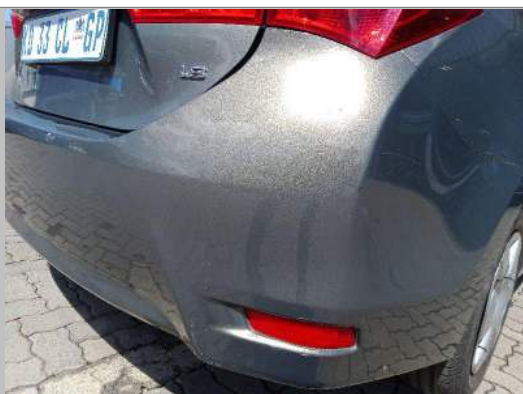
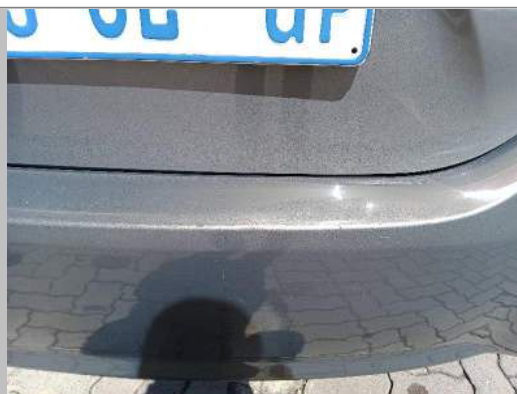
| Damage | Repair Way |
|---|---|
| Rear bumper Damaged | Repair |

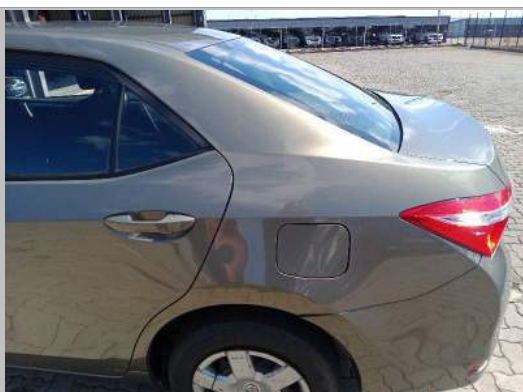
| Damage | Repair Way |
|---|---|
| Rear Fender Left Dented | Repair |

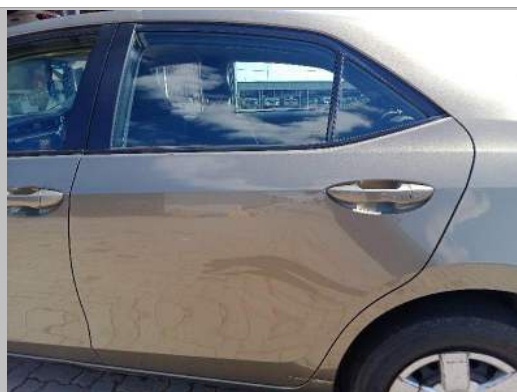
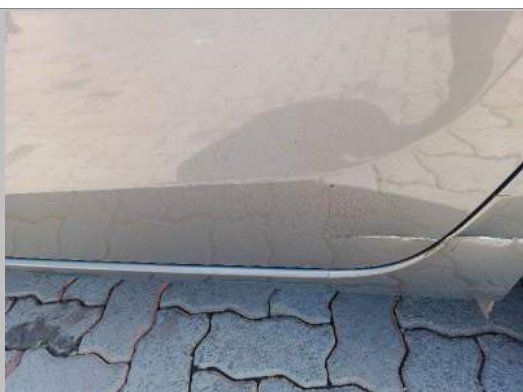
| Damage | Repair Way |
|---|---|
| Door Rear Left Paintwork • Scratched | Repair |

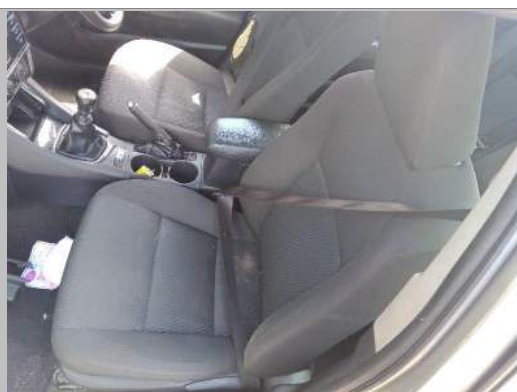
| Damage | Repair Way |
|---|---|
| Seat Front Left Dirty | Repair |

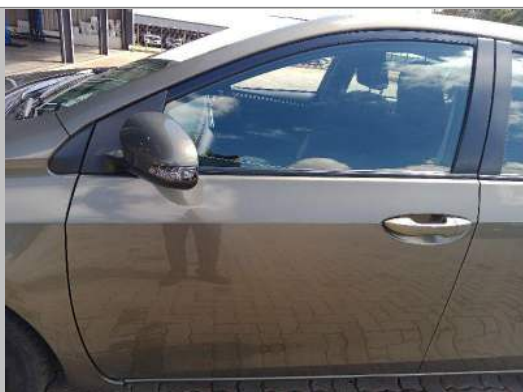
| Damage | Repair Way |
|---|---|
| Door Front Left Residual Traces of Repair | Repair |

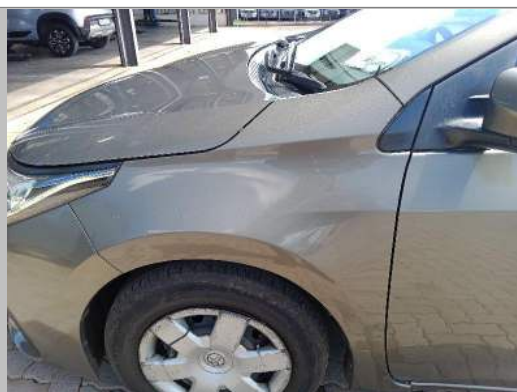
| Damage | Repair Way |
|---|---|
| Front Fender Left Damaged | Repair |

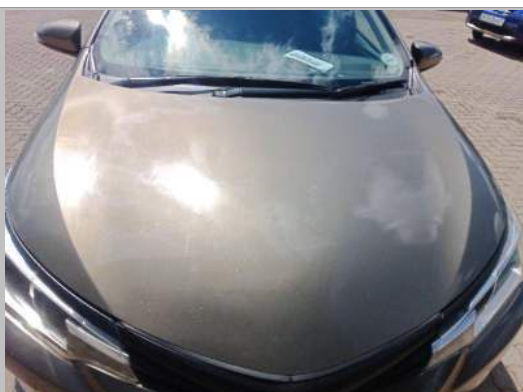
| Damage | Repair Way |
|---|---|
| Bonnet Damaged | Repair |

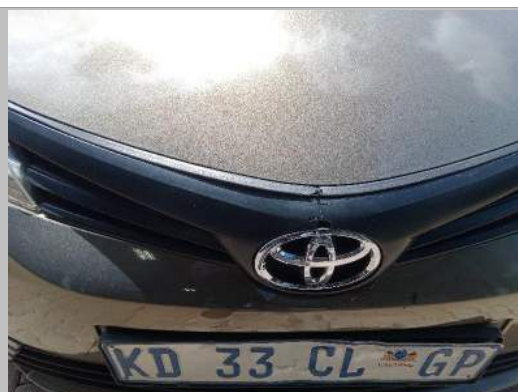
| Damage | Repair Way |
|---|---|
| Grill Damaged | Replace |

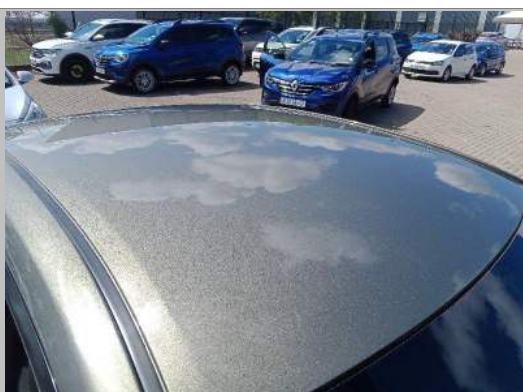
| Damage | Repair Way |
|---|---|
| Roof Dented | Repair |

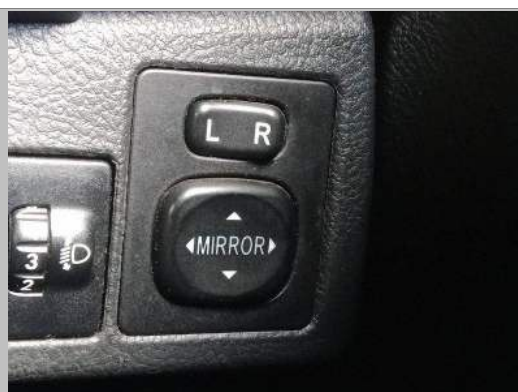
## Mirror Adjusters

| Damage | Repair Way |
|---|---|
| Mirror Adjusters Malfunction | Replace |

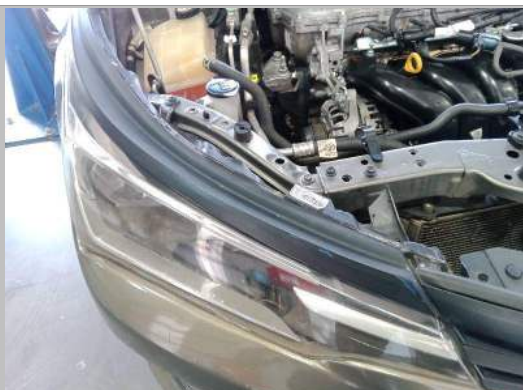
| Damage | Repair Way |
|---|---|
| Headlight Right Damaged | Replace |

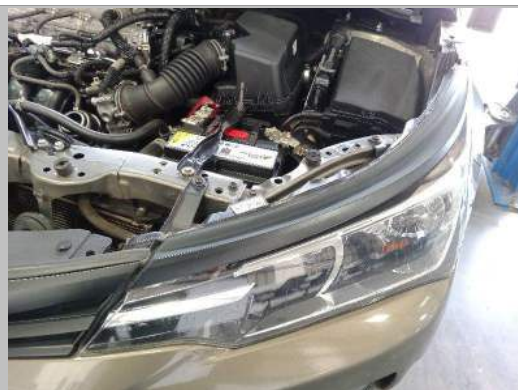
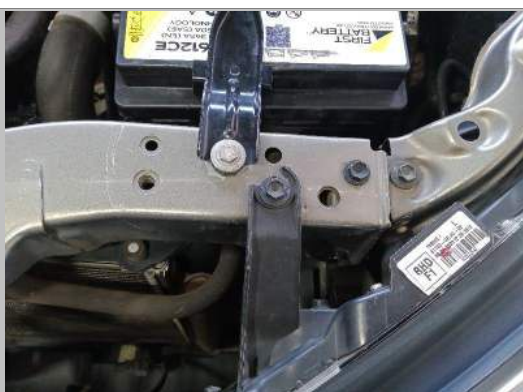
| Damage | Repair Way |
|---|---|
| Headlight Left Damaged | Replace |

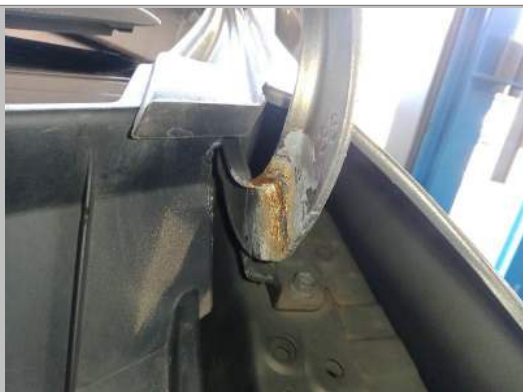
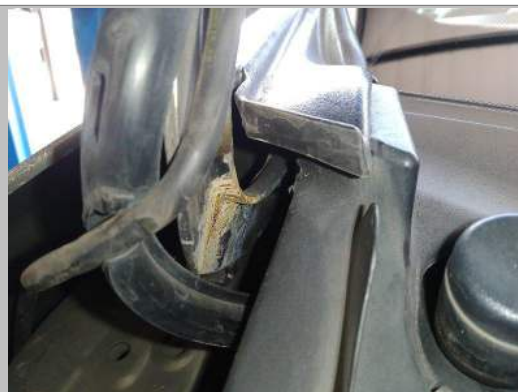
### Bonnet hinges

| Damage | Repair Way |
|---|---|
| Bonnet hinges Damaged | Replace |

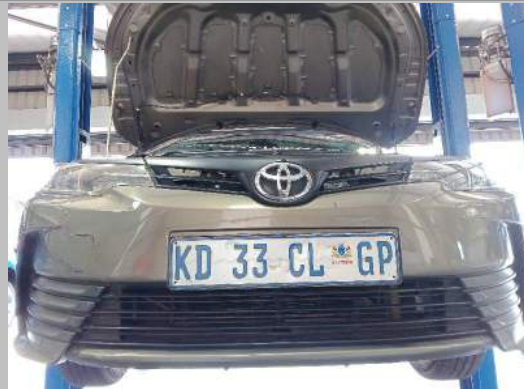
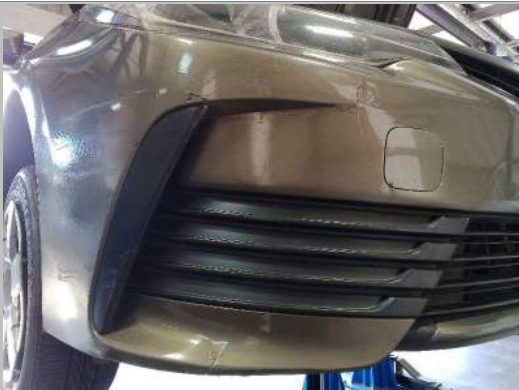
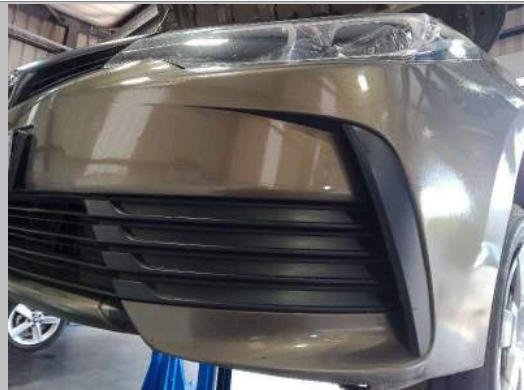
| Damage | Repair Way |
|---|---|
| Front Bumper Damaged | Replace |

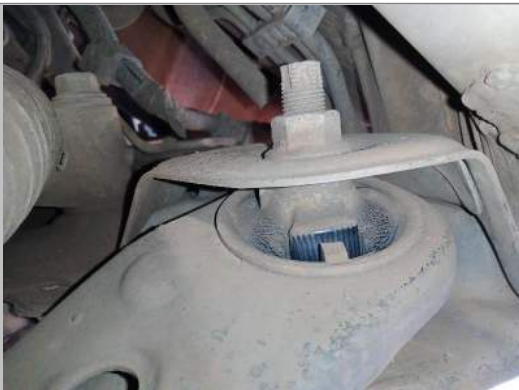
| Damage | Repair Way |
|---|---|
| Control Arm Bush(es) Front Axle Left Cracked | Replace |

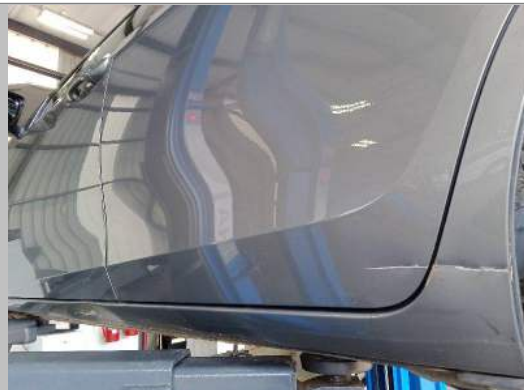
| Damage | Repair Way |
|---|---|
| Sill Panel Left Damaged | Repair |

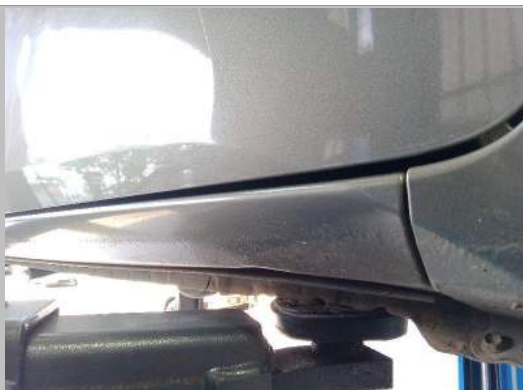
| Damage | Repair Way |
|---|---|
| Sill Panel Right Dented | Repair |

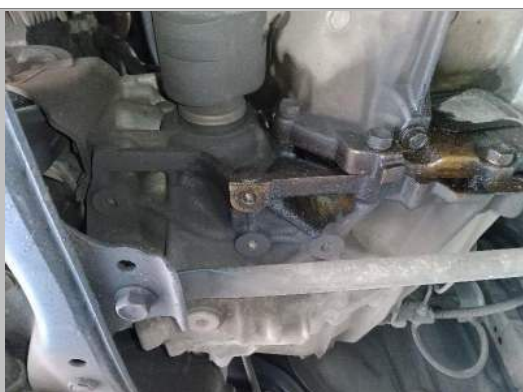
| Damage | Repair Way |
|---|---|
| Gearbox Oil Leak | Repair |

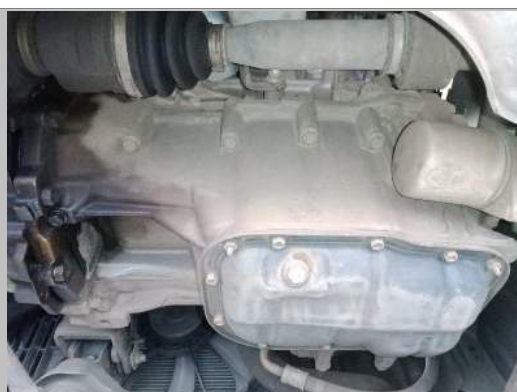
| Damage | Repair Way |
|---|---|
| Engine Oil Leak | Repair |

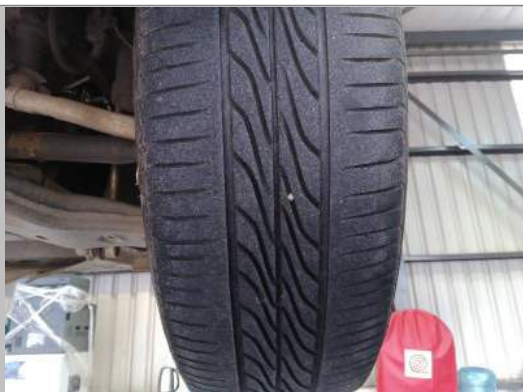
| Damage | Repair Way |
|---|---|
| Tyre Front Right Damaged | Replace |
| Front right and rear left tyres regrooved | Replace |

| | Size | Load/Speed Index | Manufacture | Model | Type* | Production Date | Tread Depth (mm) |
|---|---|---|---|---|---|---|---|
| Front Right | 185/65 R15 | 88H | Bridgestone | B250 | V | 0319 | 0 mm |

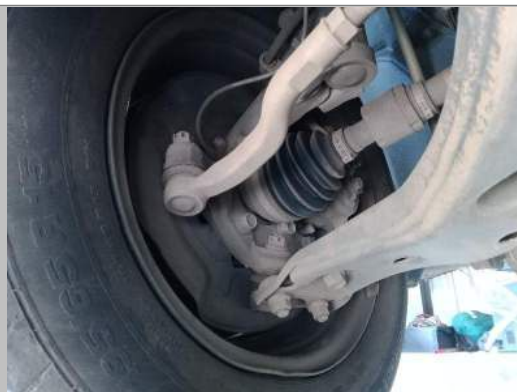
| Damage | Repair Way |
|---|---|
| Rim Front Left Dented | Repair |

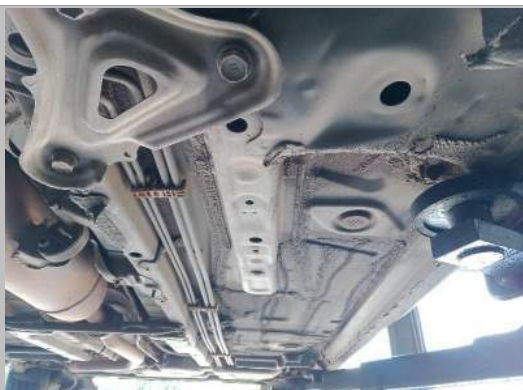
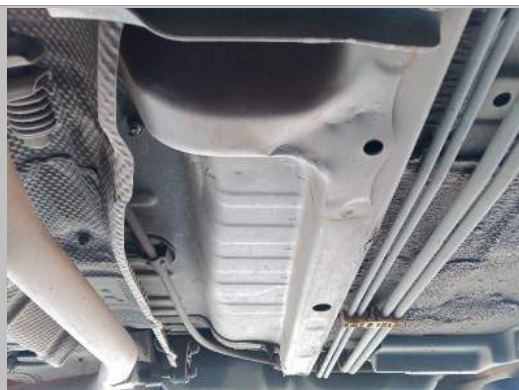
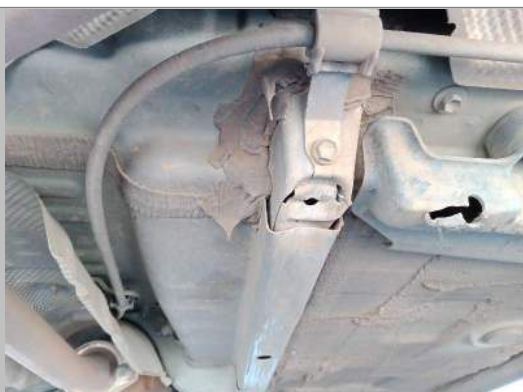
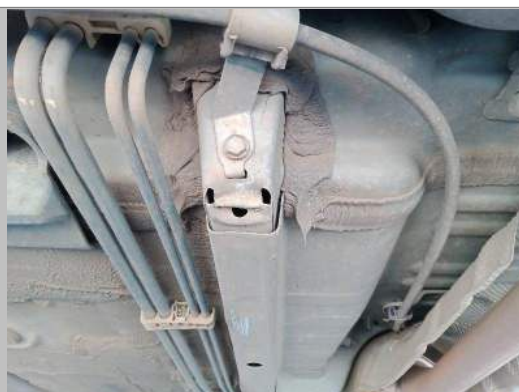
| Damage | Repair Way |
|---|---|
| Chassis Damaged | Repair |

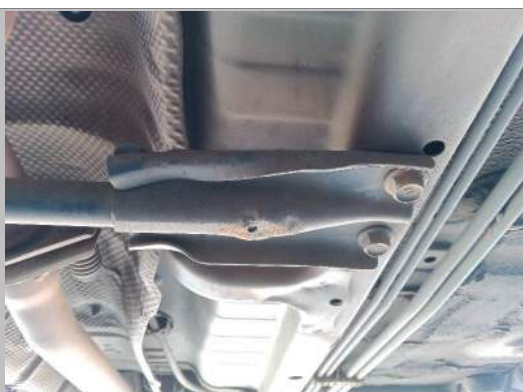
| Damage | Repair Way |
|---|---|
| Cross Member Rear Left Damaged | Repair |

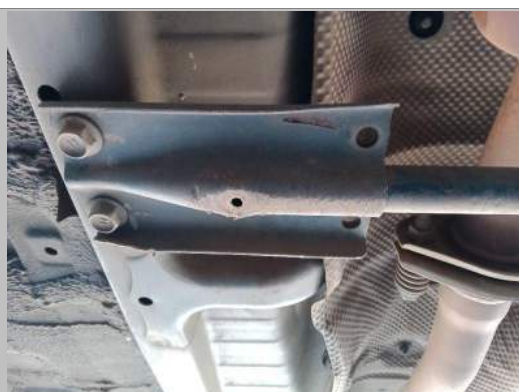
| Damage | Repair Way |
|---|---|
| Cross Member Rear Right Damaged | Repair |

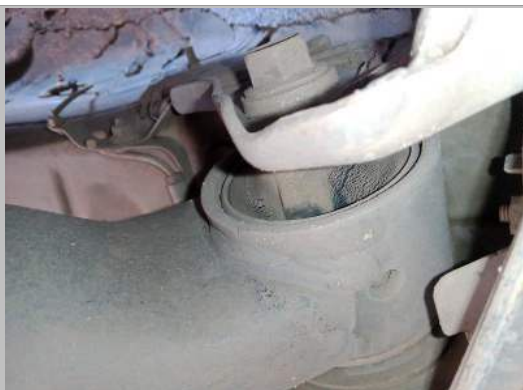
| Damage | Repair Way |
|---|---|
| Mounting Rubber(s) Rear Axle Right Cracked | Replace |

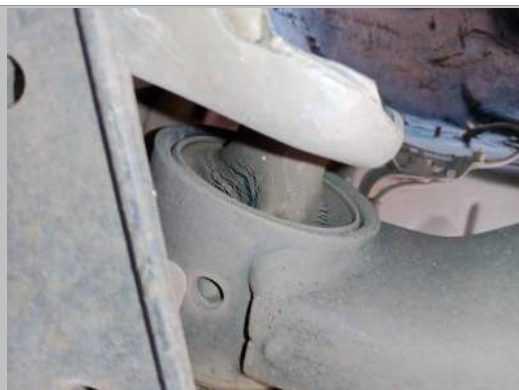
| Damage | Repair Way |
|---|---|
| Mounting Rubber(s) Rear Axle Left Cracked | Replace |

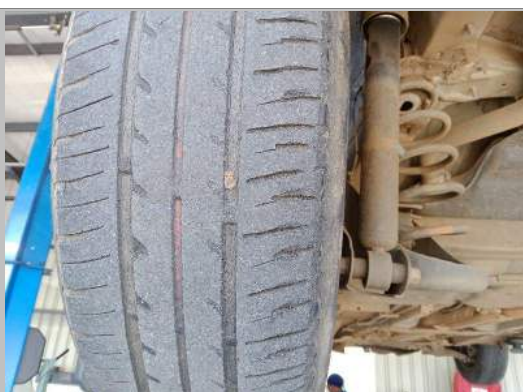
| Damage | Repair Way |
|---|---|
| Tyre Rear Left Damaged | Replace |

| | Size | Load/Speed Index | Manufacture | Model | Type* | Production Date | Tread Depth (mm) |
|---|---|---|---|---|---|---|---|
| Rear Left | 195/65 R15 | 91H | Firestone | Touring | V | 4917 | 0 mm |

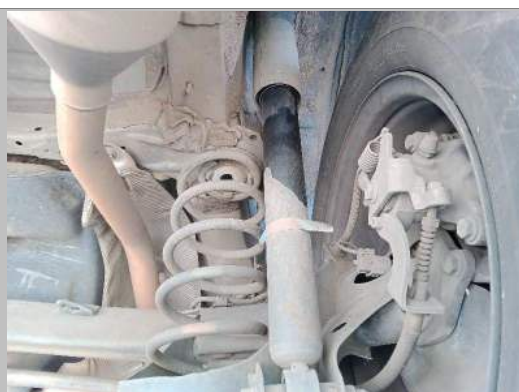
| Damage | Repair Way |
|---|---|
| Shock Absorber Rear Right Leak | Replace |

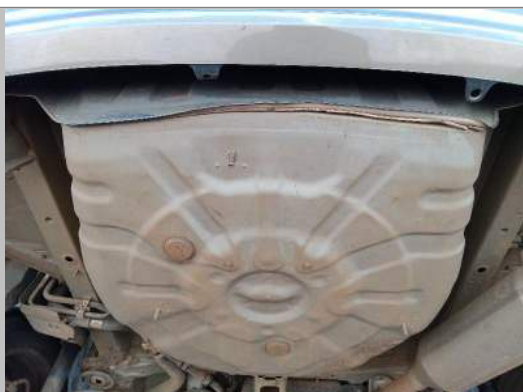
| Damage | Repair Way |
|---|---|
| Inner Boot Floor Pan and Spare Wheel Well Damaged | Repair |

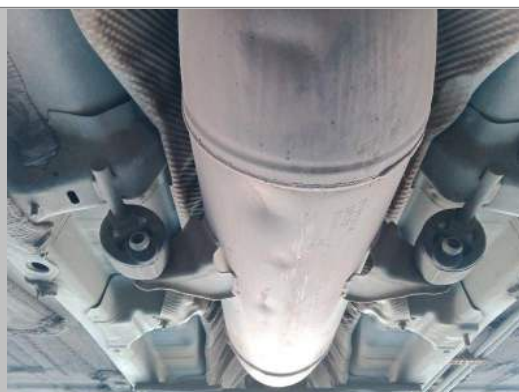
| Damage | Repair Way |
|---|---|
| Silencer Damaged | Repair |

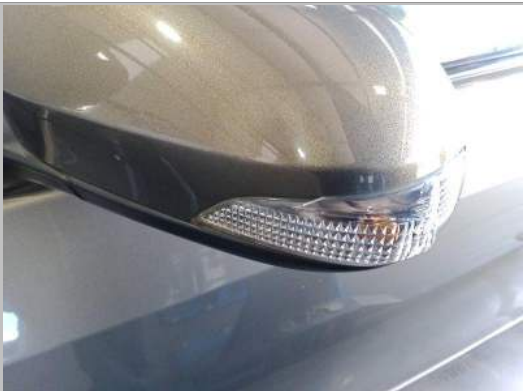
| Damage | Repair Way |
|---|---|
| Indicator Light Front Left Cracked | Replace |
