CONDITION REPORT

Report No:  
2017297912  
DATE  
11/09/2026

| Manufacturer | TOYOTA | Registration Number | MD92JFGP |
| Model | COROLLA QUEST 1.8 PLUS [2022-2025] | Register Number | |

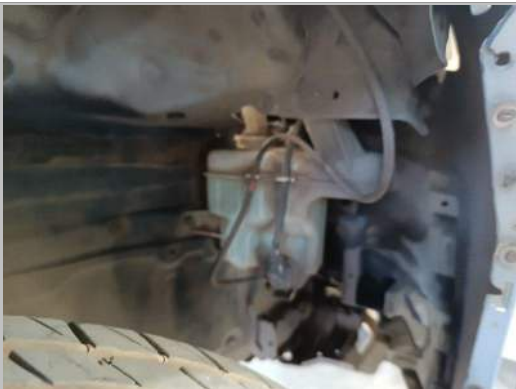
R/F fender liner missing

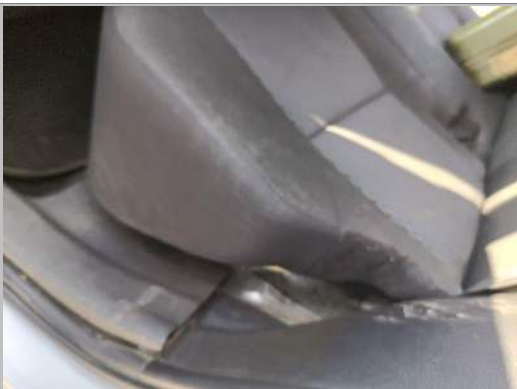
| Seat Rear Damaged | Repair |

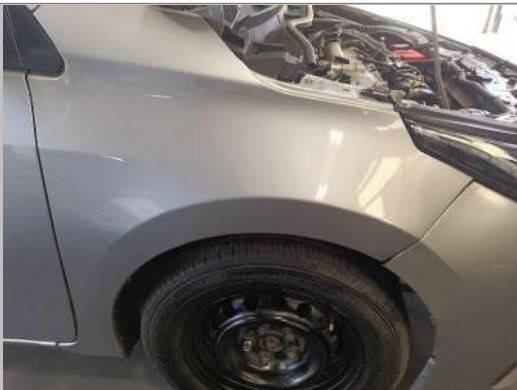
| Front Fender Right Residual Traces of Repair | Repair |

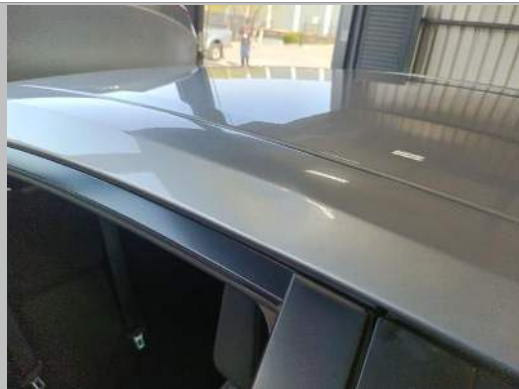
| A • Pillar Right Dented | Repair |

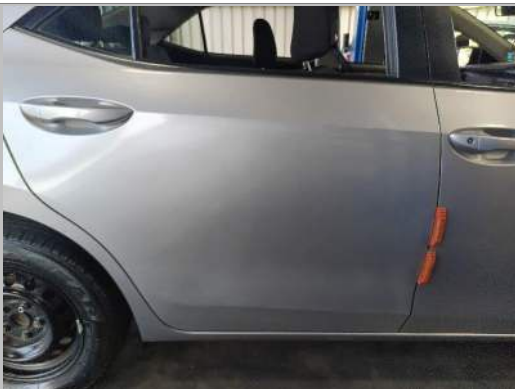
| Door Rear Right Residual Traces of Repair | Repair |

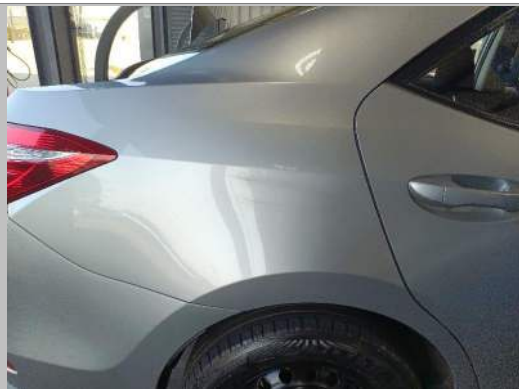
| Rear Fender Right Paintwork • Scratched | Repair |

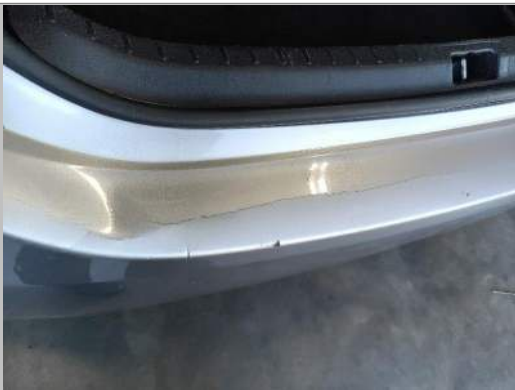
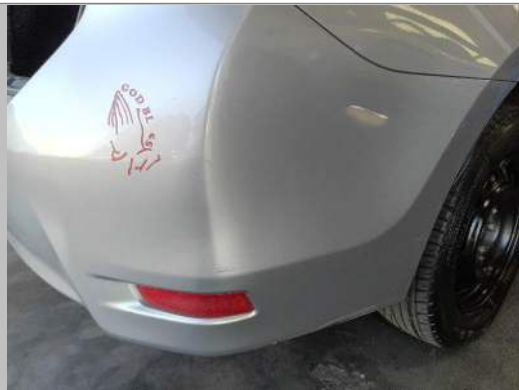
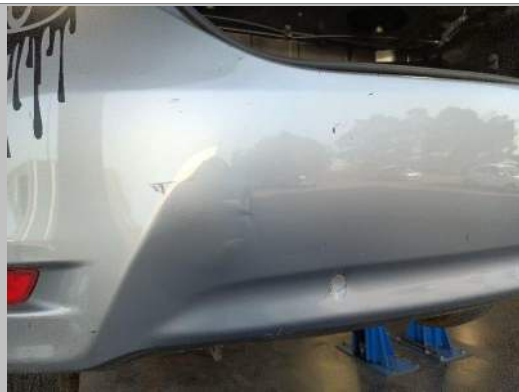
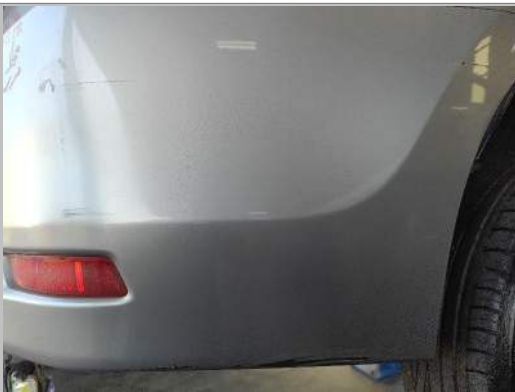
| Rear bumper Damaged | Repair |

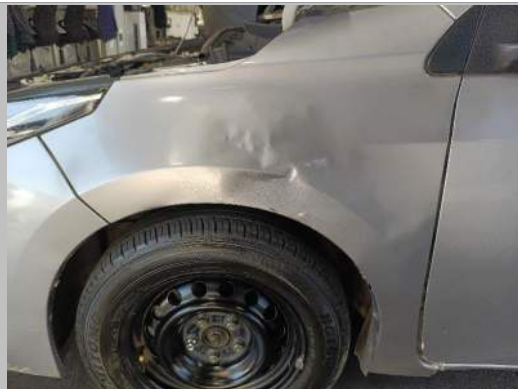
| Front Fender Left Damaged | Repair |

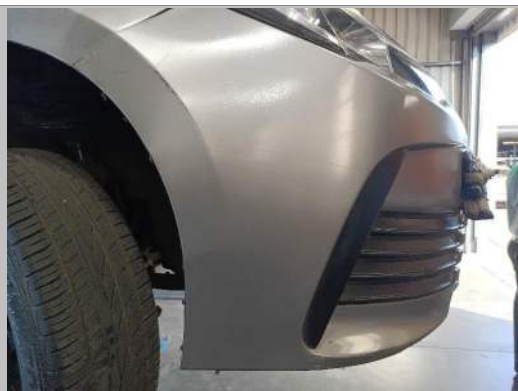
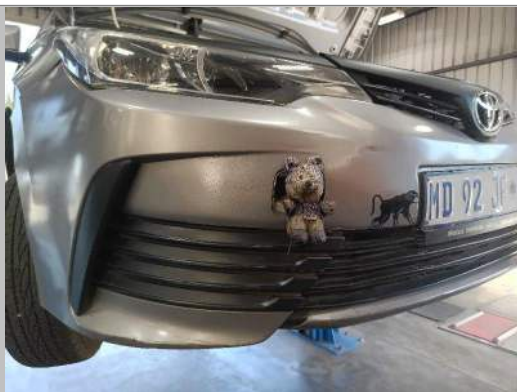
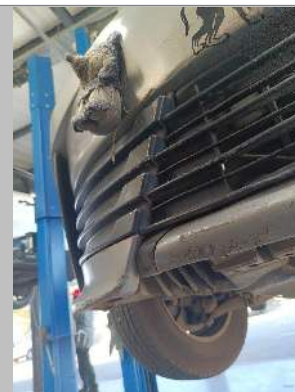
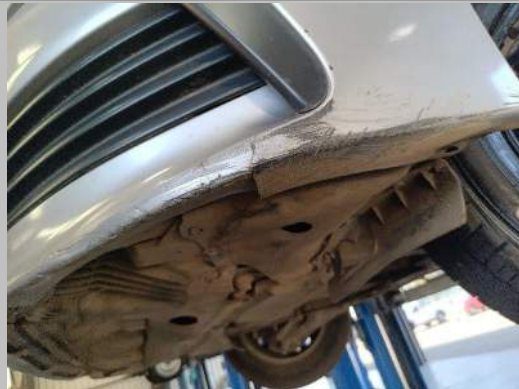
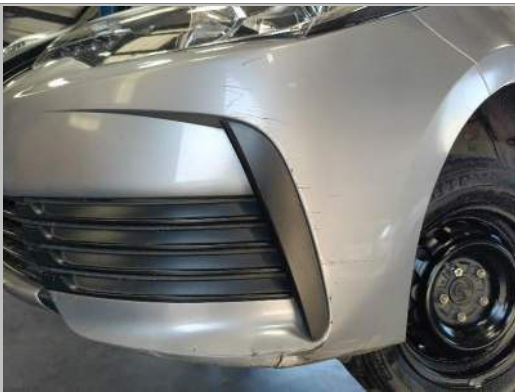
| Front Bumper Residual Traces of Repair | Repair |

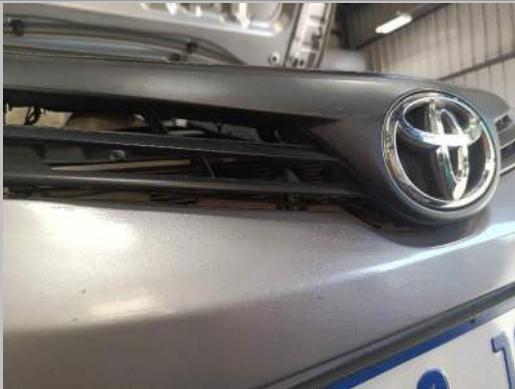
| Grill Damaged | Repair |

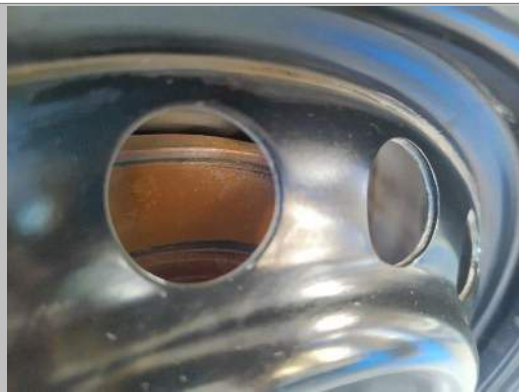
| Brake disc 2. Axle right Corrosion | Replace |

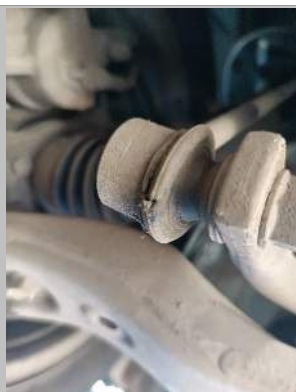
| Stabilizer Mounting Front Right Damaged | Replace |

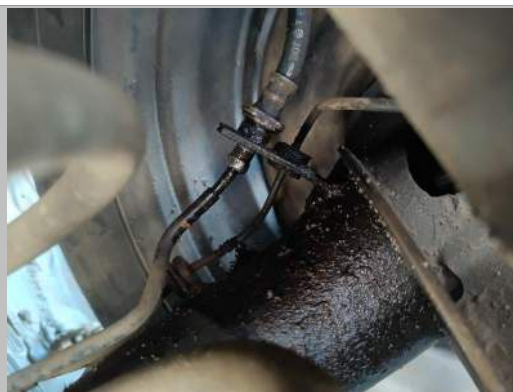
| Brake Piping Leak | Repair |

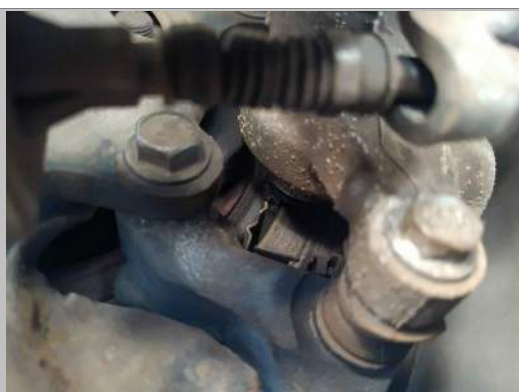
| Brake Pad/Shoe 2. Axle right Damaged | Replace |

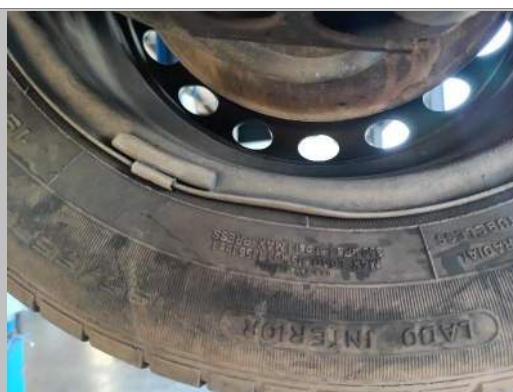
| Rim Rear Right Deformed | Repair |

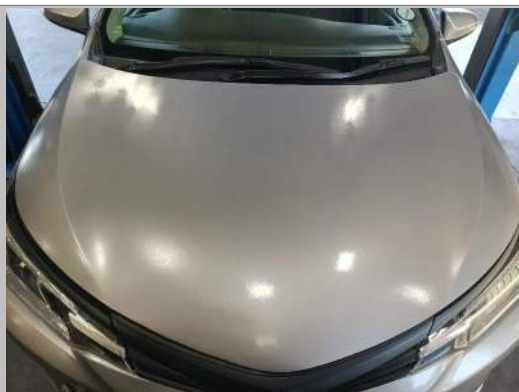
| Bonnet Residual Traces of Repair | Repair |
