CONDITION REPORT

Report No:
2016945342
DATE
14/07/2025

| Manufacturer | TOYOTA | Registration Number | FTM730L |
| Model | HILUX 2.0 VVTI S A/C PU [2020-2022] | Register Number | |

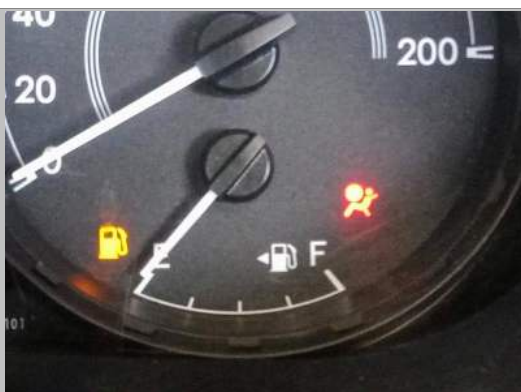
| No | System | Code | Description | Status |
|---|---|---|---|---|
| 1 | AIRBAG | C1241 | DRIVER SQUIB CIRCUIT SHORT TO BATTERY | |

Airbag warning lights illumina

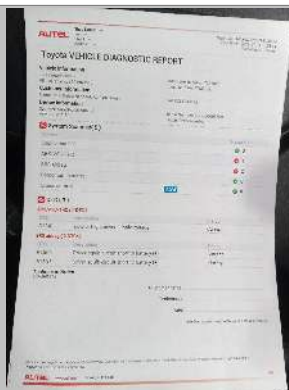
Diagnostic test

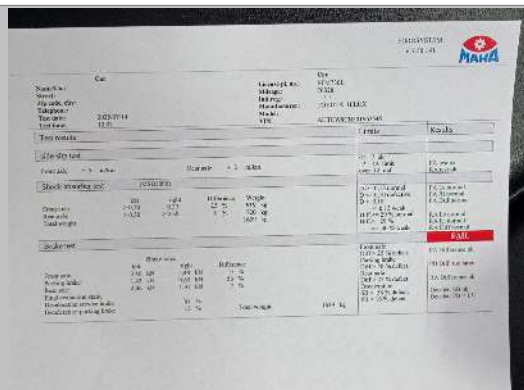
Shock and brake report

| Damage | Repair Way |
|--|--|
| Parking Brake Performance Left / Right Difference out of legal range | Repair |

| Brake test | | | | |
|---|---|---|---|---|
| Parking brake | 1,43 kN | 0,63 kN | 56 % | |

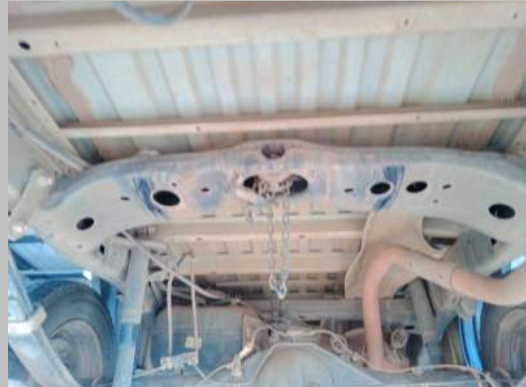
No sparewheel

| Damage | Repair Way |
|--|--|
| Spare wheel Missing | Replace |

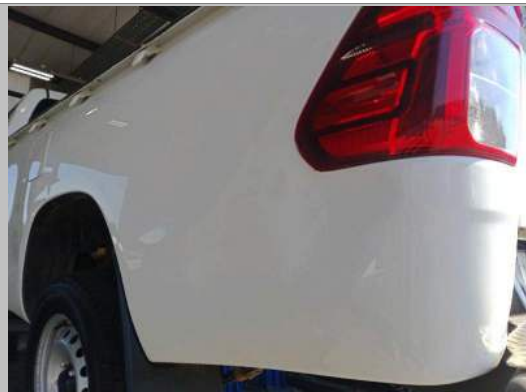
| Damage | Repair Way |
|--|--|
| Load Body Damaged | Repair |

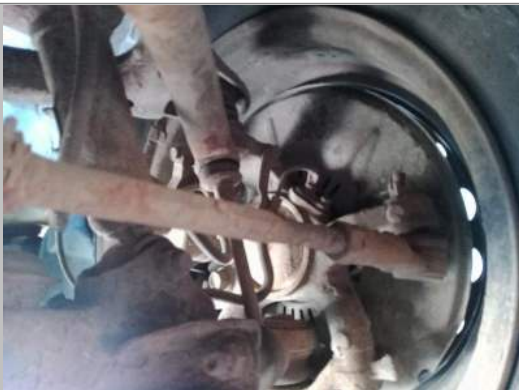
| Damage | Repair Way |
|--|--|
| Tie Rod End left Loose / Excessive Play | Replace |

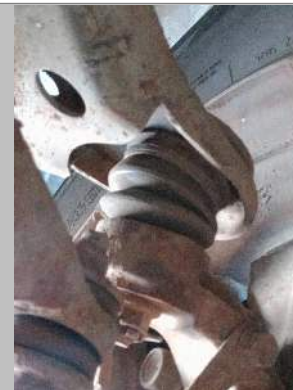
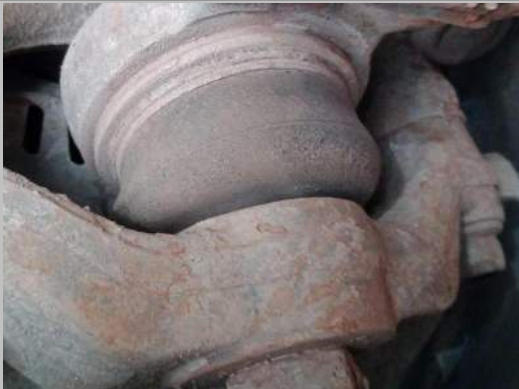
| Damage | Repair Way |
|--|--|
| Ball Joint(s) Front Axle Left Loose / Excessive Play | Replace |

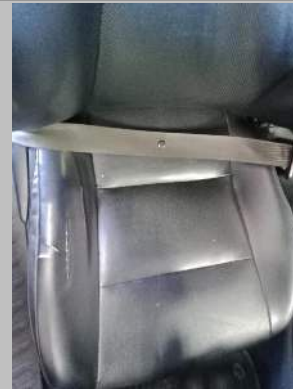
| Damage | Repair Way |
|--|--|
| Seat Front Right Torn / Cut | Repair |
