## CONDITION REPORT

Report No:  
2016962809  
DATE  
30/07/2025

| Manufacturer | TOYOTA | Registration Number | KPC870MP |
| Model | HILUX 2.0 VVT-I PU AC [2018-2020] | Register Number | |

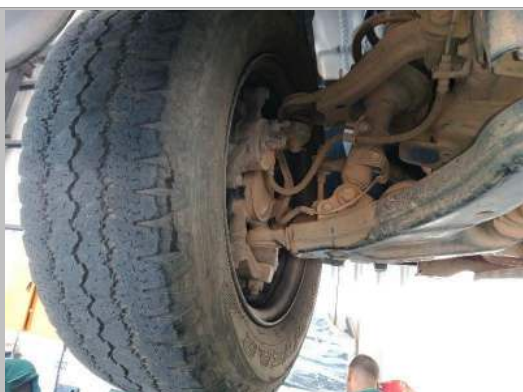
LF TYRE TREAD

| | Size | Load/Speed Index | Manufacture | Model | Type* | Production Date | Tread Depth (mm) |
|---|---|---|---|---|---|---|---|
| Front Left | 205/70R15 | 100T | Goodyear | Wrangler | V | 2321 | 2 mm |

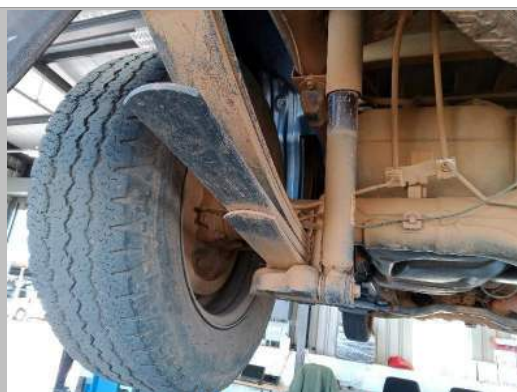
LR TYRE TREAD

| | Size | Load/Speed Index | Manufacture | Model | Type* | Production Date | Tread Depth (mm) |
|---|---|---|---|---|---|---|---|
| Rear Left | 205/70R15 | 100T | Goodyear | Wrangler | V | 0122 | 2 mm |

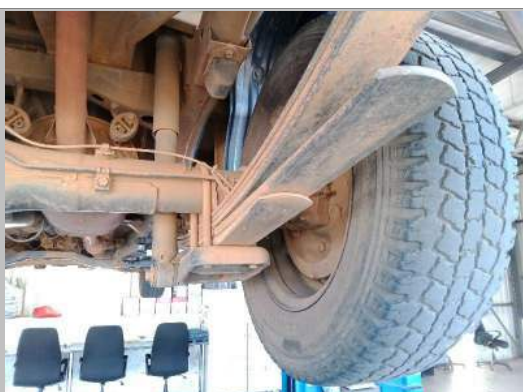
RR TYRE TREAD

| | Size | Load/Speed Index | Manufacture | Model | Type* | Production Date | Tread Depth (mm) |
|---|---|---|---|---|---|---|---|
| Rear Right | 205/70R15C | 106/104S | Continental | WorldContact | V | 4819 | 2 mm |

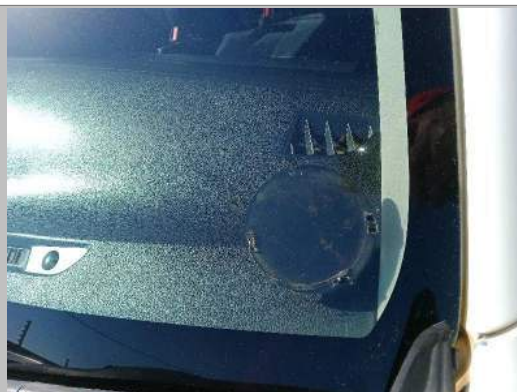
No license disc

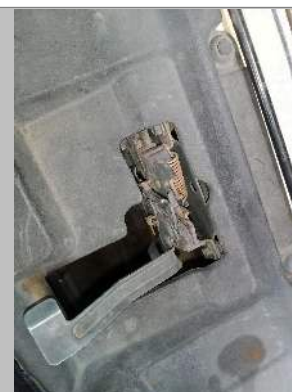
| Damage | Repair Way |
|---|---|
| Bonnet latch defective | Repair |

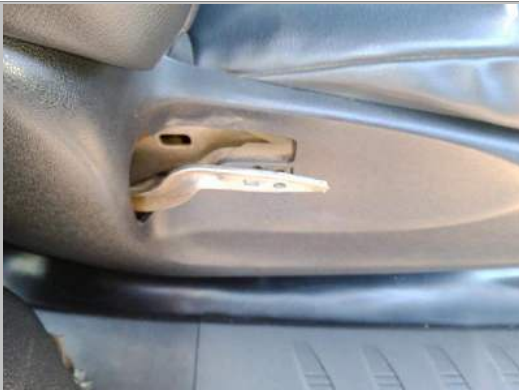
| Damage | Repair Way |
|---|---|
| RF Seat backrest lever cover missing | Replace |

RF seat backrest lever cover m

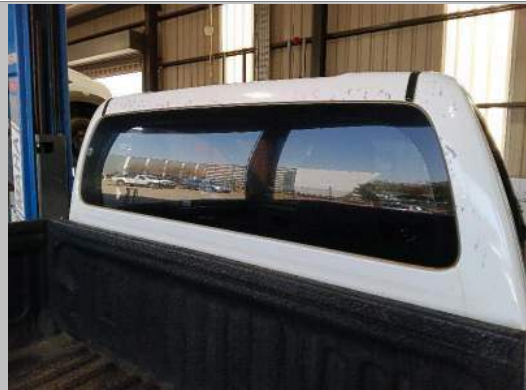
| Damage | Repair Way |
|---|---|
| Rear cab body scratched | Repair |

Rear cab body scratched

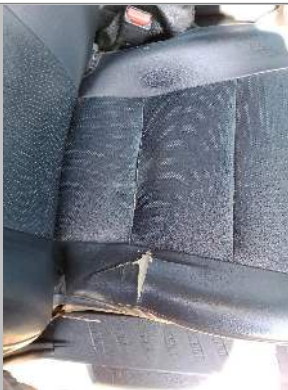
| Damage | Repair Way |
|---|---|
| Seat Front Right Torn / Cut | Repair |

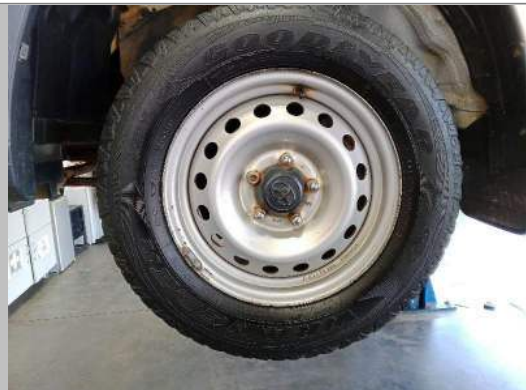
| Damage | Repair Way |
|---|---|
| Wheel bearing Front Left Loose / Excessive Play | Replace |

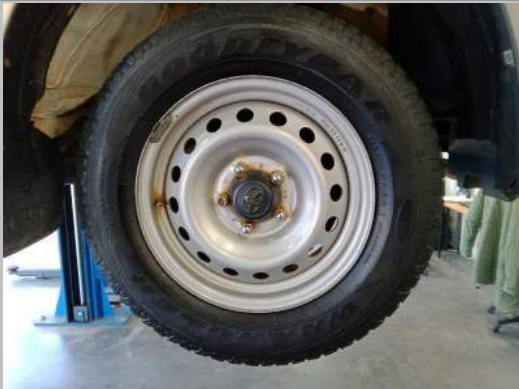
| Damage | Repair Way |
|---|---|
| Wheel bearing Front Right Loose / Excessive Play | Replace |

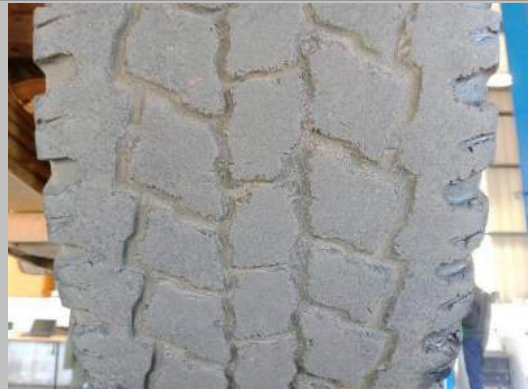
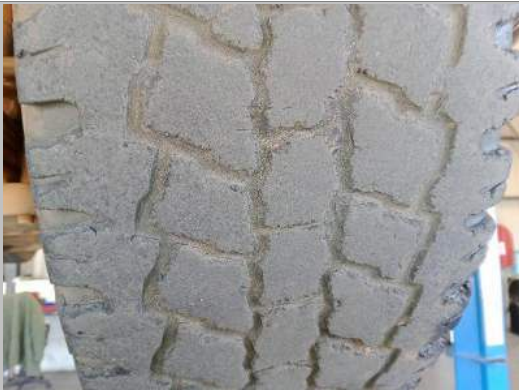
| Damage | Repair Way |
|---|---|
| Tyre Rear Right Excessive Wear & Tear | Replace |

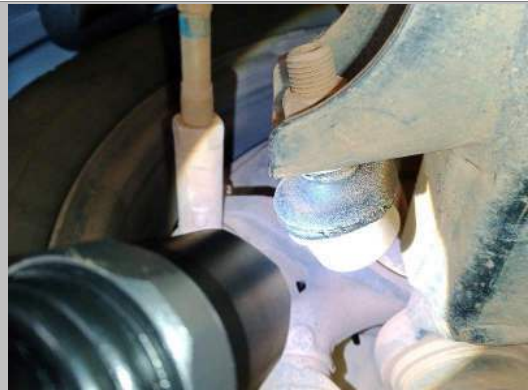
| Damage | Repair Way |
|---|---|
| Stabilizer Front Defective | Replace |

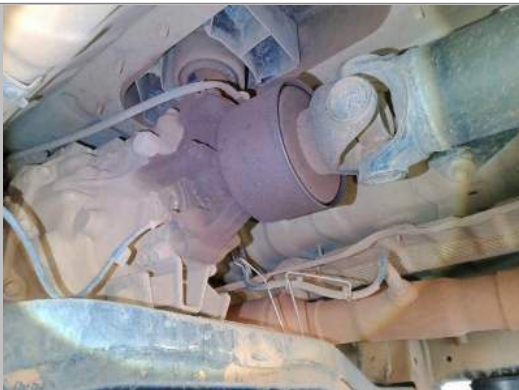
| Damage | Repair Way |
|---|---|
| Gearbox Oil Sweat | Repair |

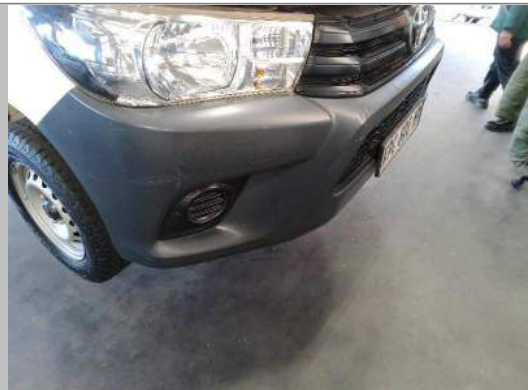
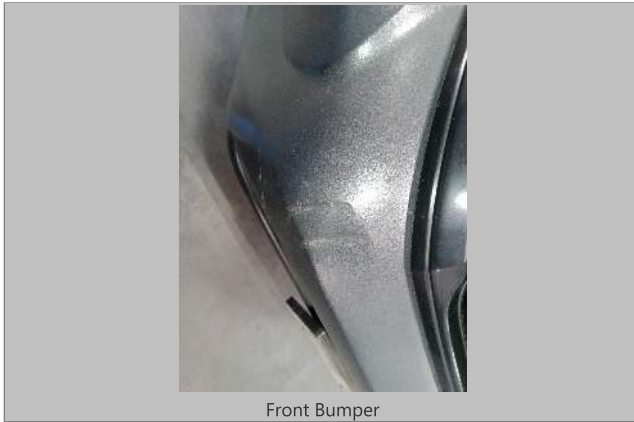
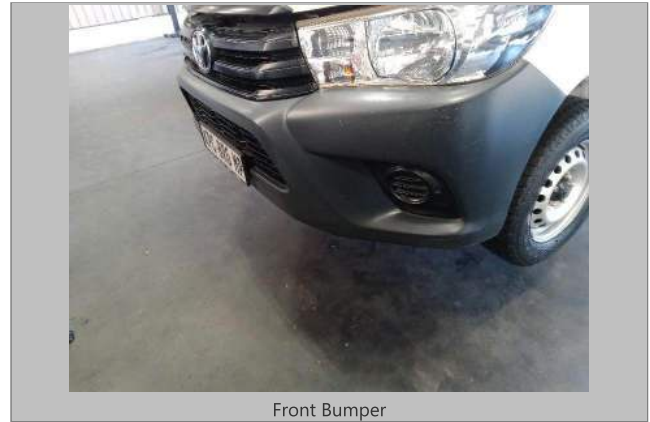
| Damage | Repair Way |
|---|---|
| Front Bumper Deformed | |

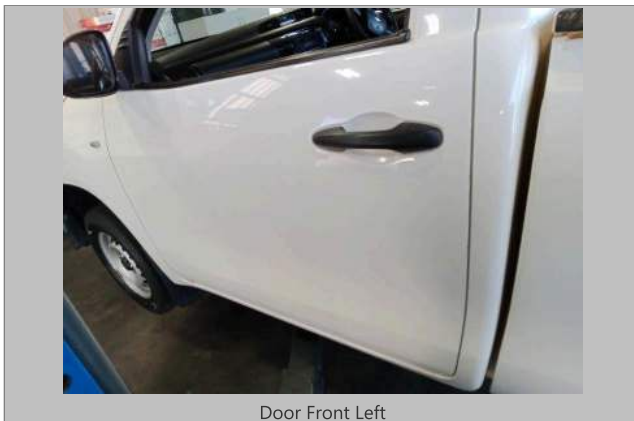
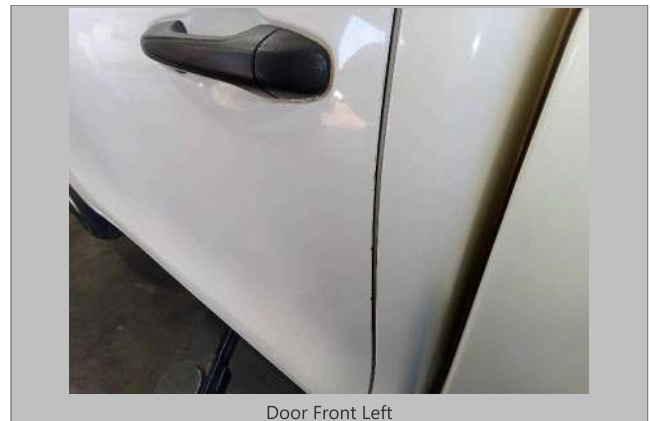
| Damage | Repair Way |
|---|---|
| Door Front Left Paintwork • Chipmarks | |

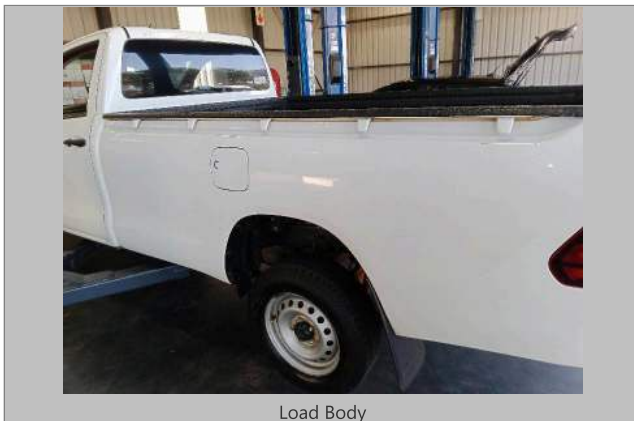
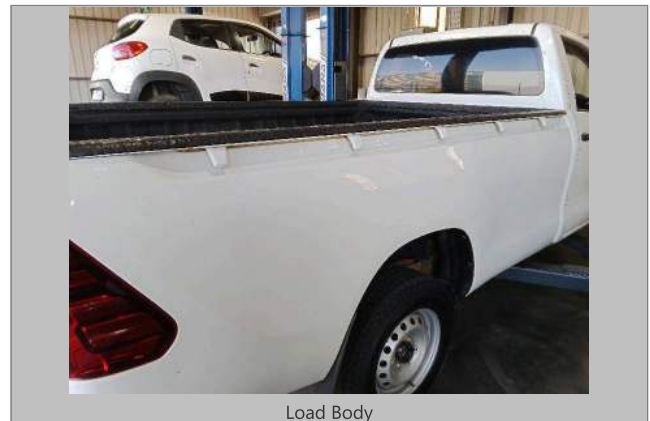
| Damage | Repair Way |
|---|---|
| Load Body Dented | Repair |

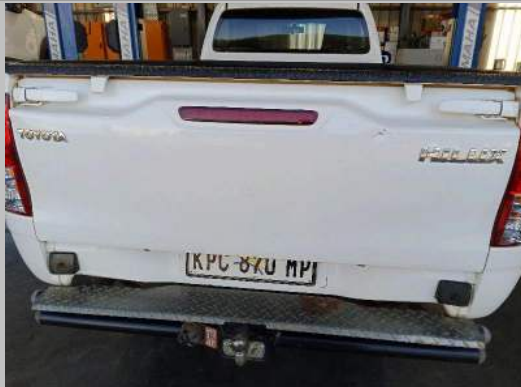
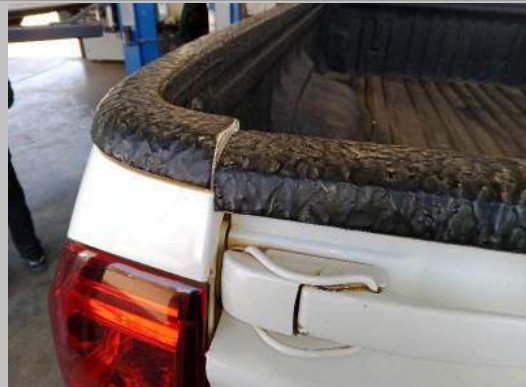
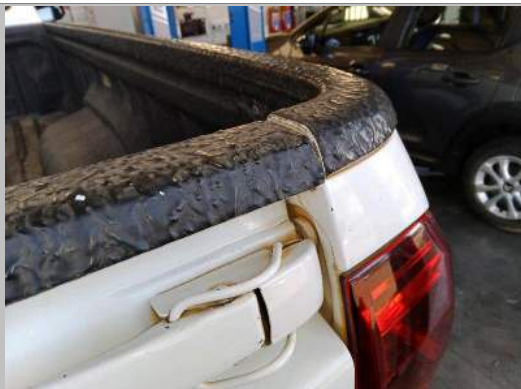
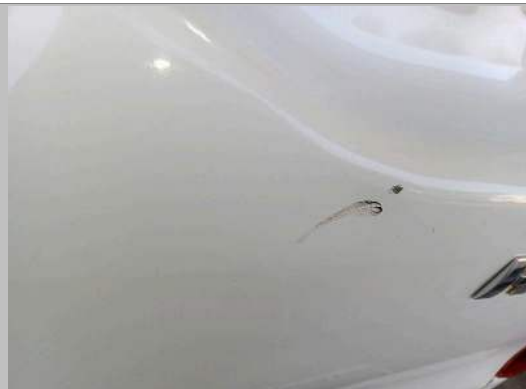
| Damage | Repair Way |
|---|---|
| Tailgate Dented | Repair |

General Comments: ACCORDING TO THE AGE AND MILEAGE OF THE VEHICLE, NORMAL WEAR AND TEAR MARKS ARE VISIBLE ON THE INTERIOR, EXTERIOR, ELECTRICAL AND MECHANICAL PARTS. Body • Exterior: Minor dents, scratches and chip marks on various body panels. Tailgate alignment.

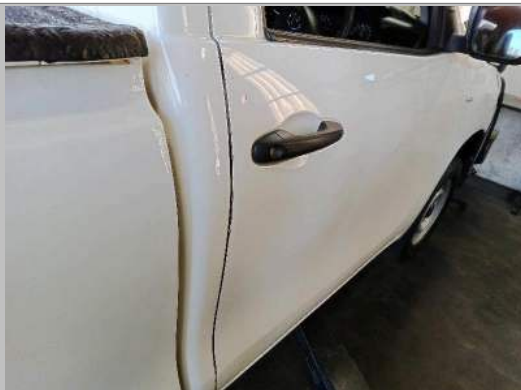
| Damage | Repair Way |
|---|---|
| Door Front Right Paintwork • Chipmarks | Repair |

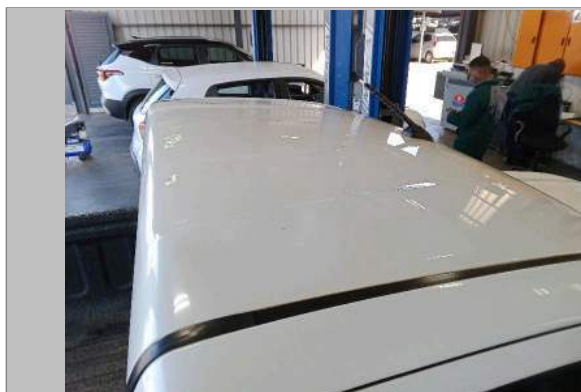
| Damage | Repair Way |
|---|---|
| Roof Dented | Repair |

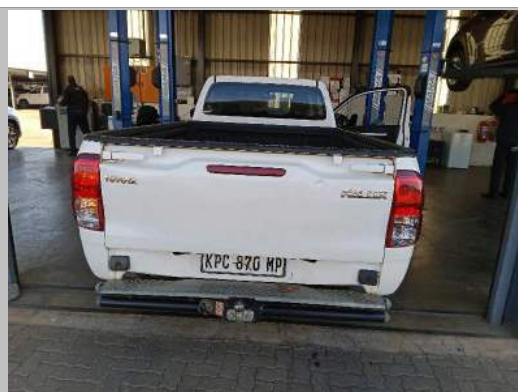
| Damage | Repair Way |
|---|---|
| Park Light Rear Right Defective | Repair |
