## CONDITION REPORT

Report No:  
2017303410  
DATE  
25/09/2026

| Manufacturer | TOYOTA | Registration Number | LV21VCGP |
| Model | HILUX 2.4 GD-6 RB RAIDER D-CAB DSL PU [2021-2023] | Register Number | |

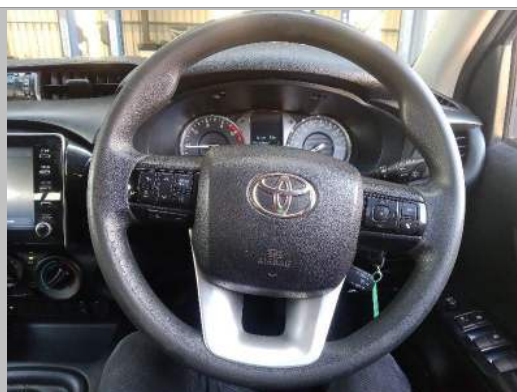
| Steering Wheel Trim Excessive Wear & Tear | Repair |

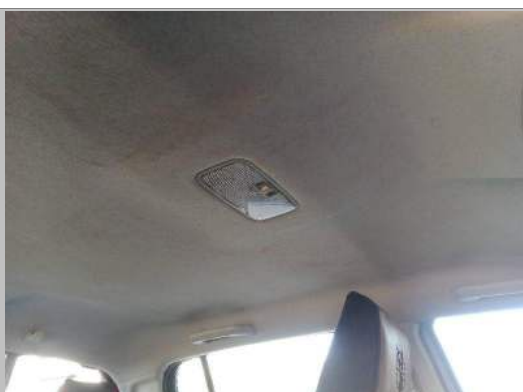
| Hood Lining Dirty | Repair |

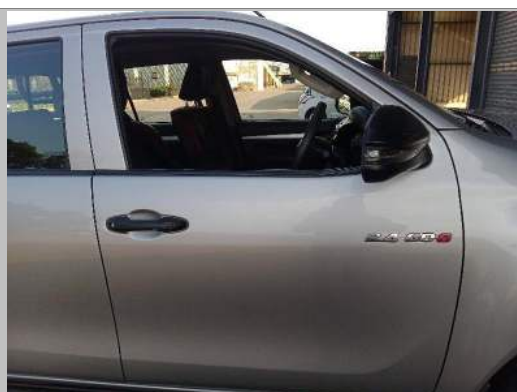
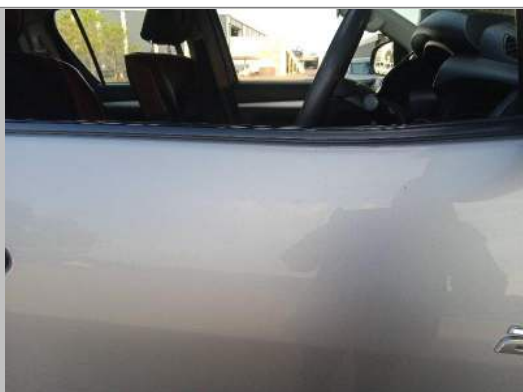
| Door Front Right Paintwork • Scratched | Repair |

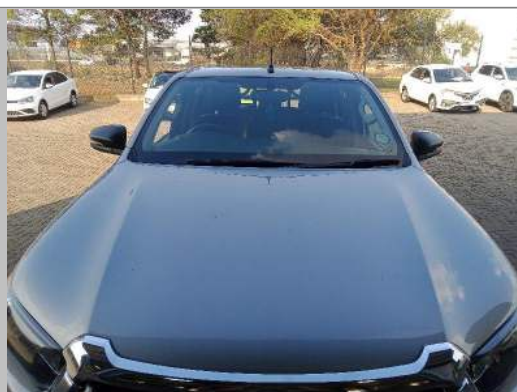
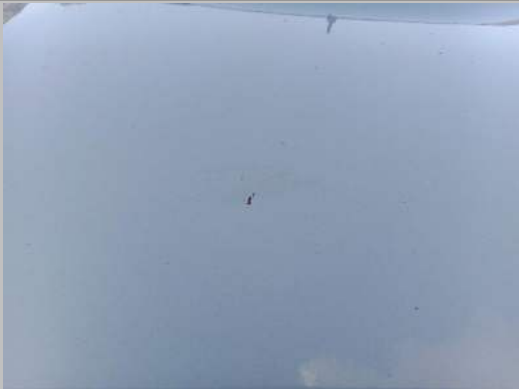
| Bonnet Paintwork • Scratched | Repair |

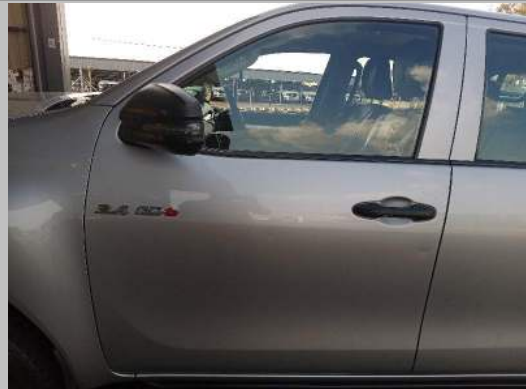
| Door Front Left Dented | Repair |

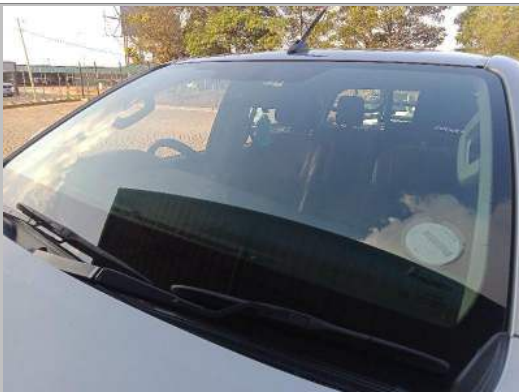
| Windscreen Chipped | Repair |

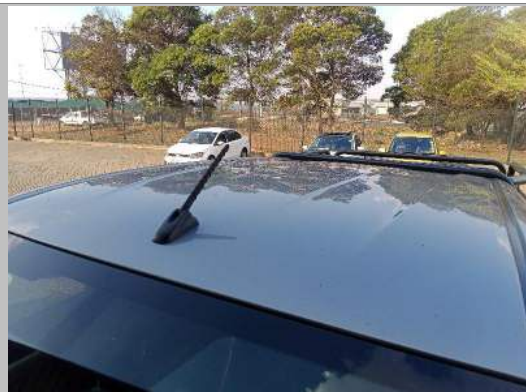
| Roof Paintwork • Chipmarks | Repair |

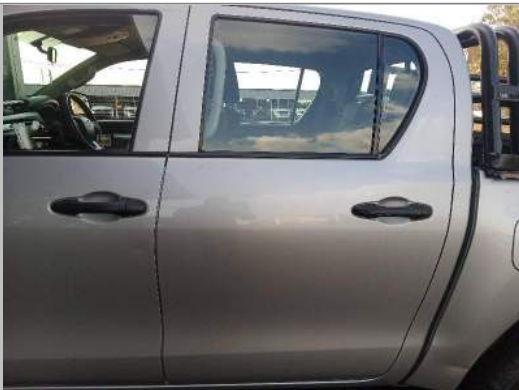
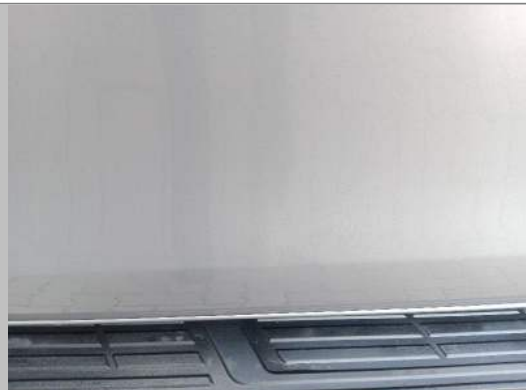
| Door Rear Left Paintwork • Scratched | Repair |

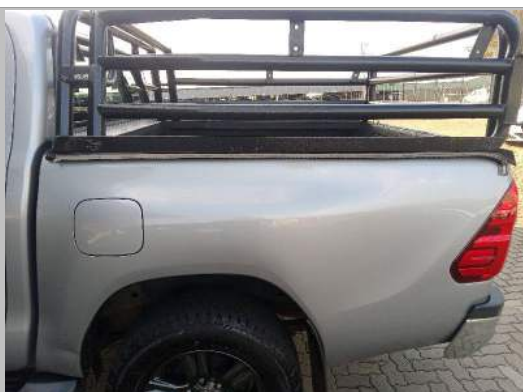
| Rear Fender Left Damaged | Repair |

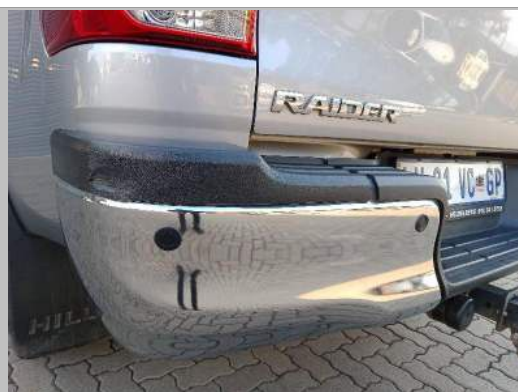
| Rear bumper Damaged | Repair |

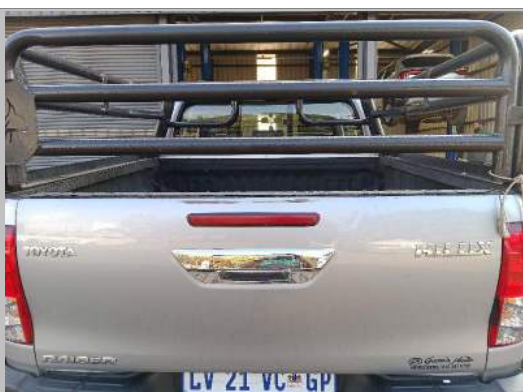
| Tailgate Paintwork • Scratched | Repair |

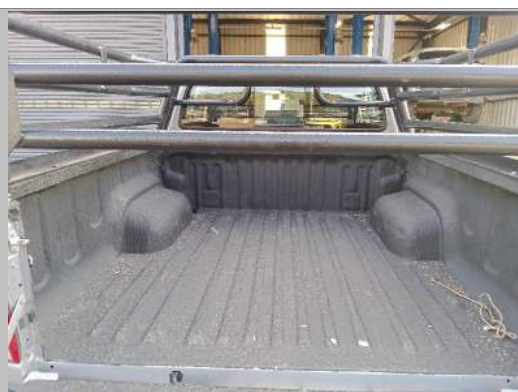
| Load Body Dented | Repair |

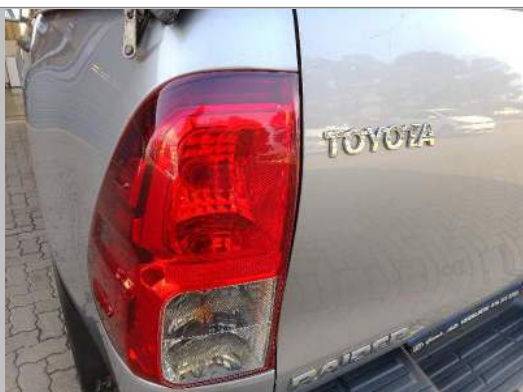
| Tail Light Left Cracked | Replace |

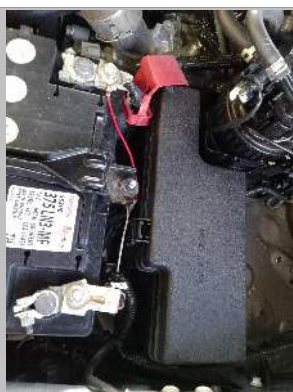
| Engine Wiring Defective | Repair |

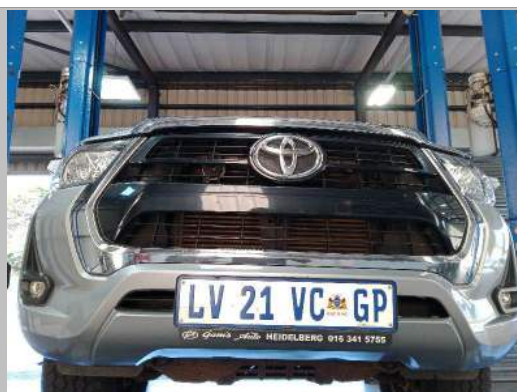
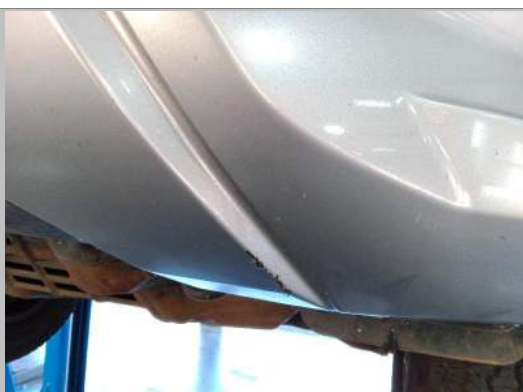
| Front Bumper Paintwork • Scratched | Repair |

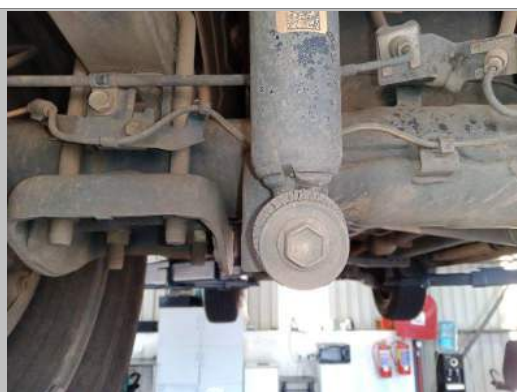
| Shock Absorber Mounting Rear Left Cracked | Replace |

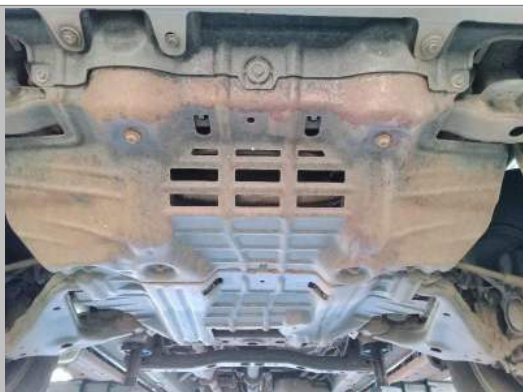
| Belly plates Damaged | Repair |

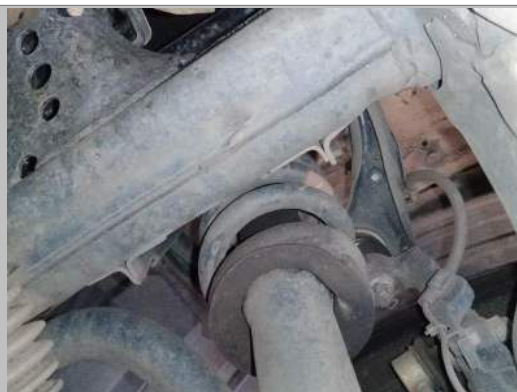
| Shock Absorber Front Right Sweat | Replace |
| Front right and rear right shock absorbers weak | Replace |
