CONDITION REPORT

Report No:  
2017297957  
DATE  
14/09/2026

| Manufacturer | TOYOTA | Registration Number | MH51SDGP |
| Model | HILUX 2.7 VVTI RB S D-CAB PU [2023-2024] | Register Number | |

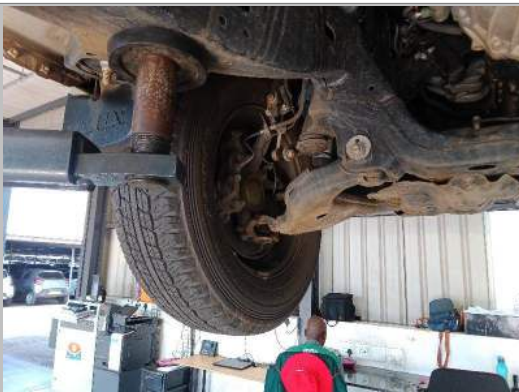
LF TYRE TREAD

| | Size | Load/Speed Index | Manufacture | Model | Type* | Production Date | Tread Depth (mm) |
|---|---|---|---|---|---|---|---|
| Front Left | 225/70R17 | 108/106S | Dunlop | Grandtrek | V | 0623 | 4 mm |

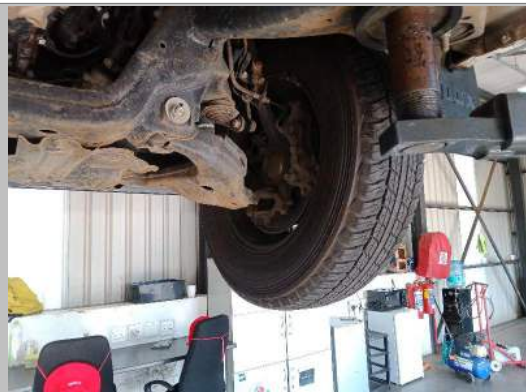
RF TYRE TREAD

| | Size | Load/Speed Index | Manufacture | Model | Type* | Production Date | Tread Depth (mm) |
|---|---|---|---|---|---|---|---|
| Front Right | 225/70R17 | 108/106S | Dunlop | Grandtrek | V | 0623 | 4 mm |

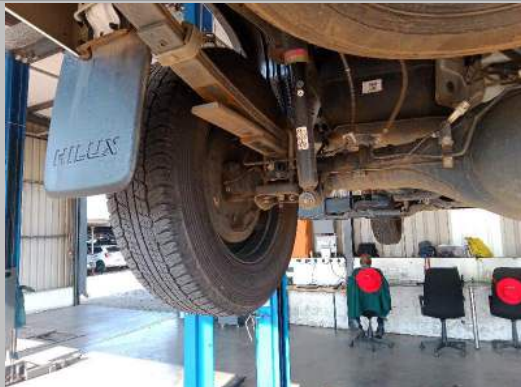
LR TYRE TREAD

| | Size | Load/Speed Index | Manufacture | Model | Type* | Production Date | Tread Depth (mm) |
|---|---|---|---|---|---|---|---|
| Rear Left | 225/70R17 | 108/106S | Dunlop | Grandtrek | V | 0623 | 4 mm |

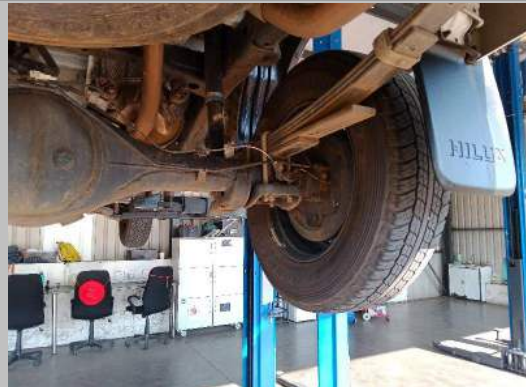
RR TYRE TREAD

| | Size | Load/Speed Index | Manufacture | Model | Type* | Production Date | Tread Depth (mm) |
|---|---|---|---|---|---|---|---|
| Rear Right | 225/70R17 | 108/106S | Grandtrek | Dunlop | V | 0723 | 4 mm |

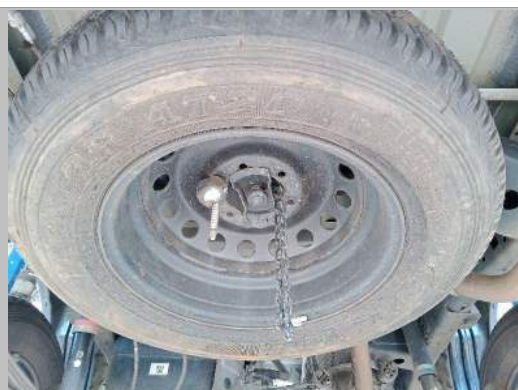
SPARE WHEEL

| | Size | Load/Speed Index | Manufacture | Model | Type* | Production Date | Tread Depth (mm) |
|---|---|---|---|---|---|---|---|
| Spare | 225/70R17 | 108/106S | Dunlop | Grandtrek | V | 0000 | 6 mm |

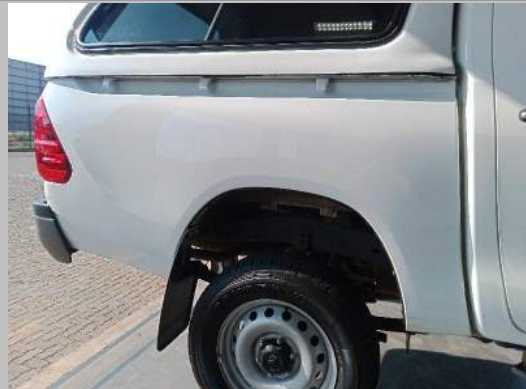
| Damage | Repair Way |
|---|---|
| Rear Fender Right Dented | Repair |

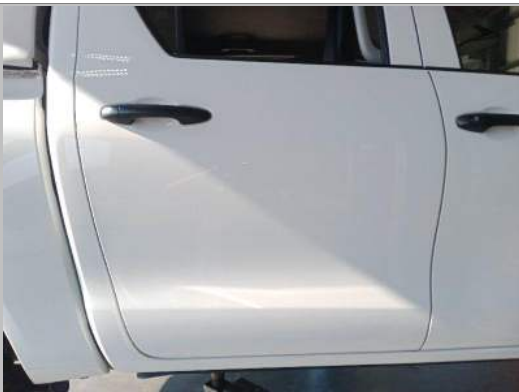
| Damage | Repair Way |
|---|---|
| Door Rear Right Paintwork • Scratched | Repair |

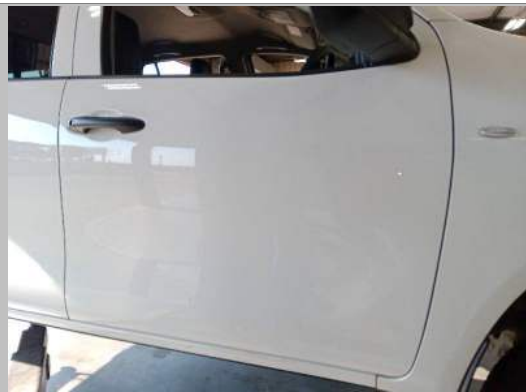
| Damage | Repair Way |
|---|---|
| Door Front Right Paintwork • Scratched | Repair |

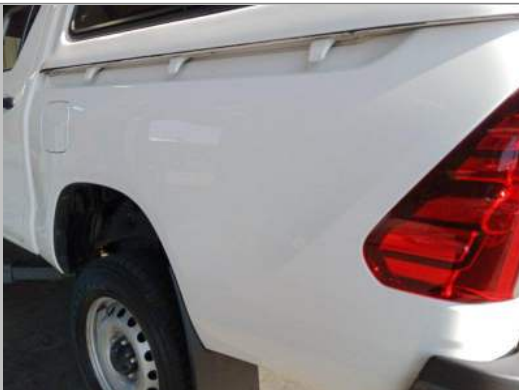
| Damage | Repair Way |
|---|---|
| Rear Fender Left Paintwork • Scratched | Repair |
