MFC Auction House  
M57 Pretoria Rd, Glenmarais, KEMPTON PARK  
Gauteng

DEKRA MFC  
M57 Pretoria Rd - 1619  
KEMPTON PARK - GT  
08610 33572

Vehicle Type	LIGHT LOAD VEHICLE	Registered Owner	
Manufacturer	TOYOTA	Registration Number	JZ46MFGP
Model	HILUX 2.4 GD-6 SRX 4X4 DSL PU [2016-2018]	Register Number	
VIN	AHTKB8CBX02852202	Date Of First Licensing	
Engine Number		Last COR	
Doors	2	License Expiry Date	30/04/2025
Color	WHITE	Power / Displacement	
Year Model	2017	Paint Finish	C - COMMON
Km Reading	411,372 KM	Fuel	DIESEL
Cab / Body Type	SINGLE CAB	Transmission	MANUAL

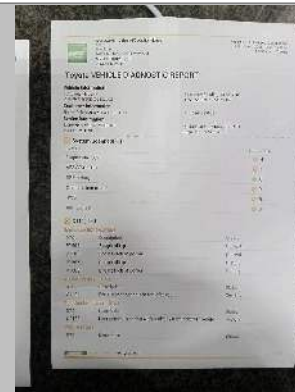
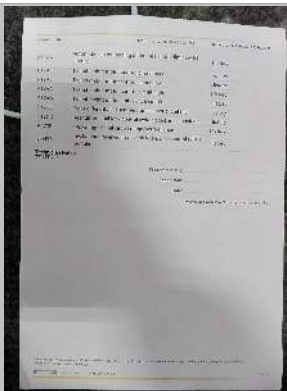
Diagnostic test

No	System	Code	Description	Status
1	ENGINE AND ECT	P1605	ROUGH IDLING

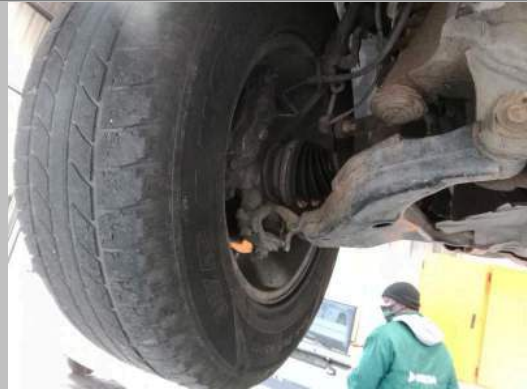
LF TYRE TREAD

Size	Load/Speed Index	Manufacture	Model	Type*	Production Date	Tread Depth (mm)
Front Left	265/65R17	112H	Goodyear	Wrangler	V	0722	2 mm
Front Right	265/65R17	112H	Goodyear	Wrangler	V	0722	2 mm
Rear Left	265/65R17	112H	Goodyear	Wrangler	V	0722	4 mm
Rear Right	265/65R17	112H	Goodyear	Wrangler	V	1921	3 mm
Spare	265/65R17	112S	Bridgestone	Dueler	V	0000	3 mm

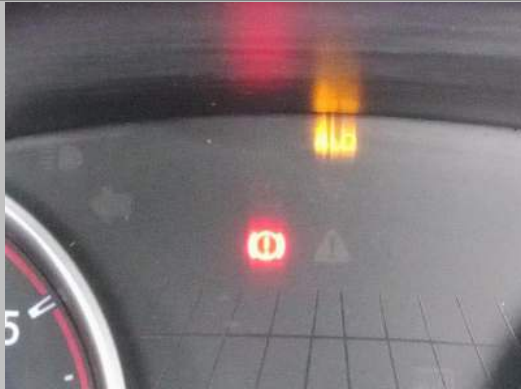
Damage	Repair Way
Power Steering Pump / Electronic Unit Defective	Repair
Wiring connections Defective	Repair
Seat Front Right Torn / Cut	Repair
Front Bumper Residual Traces of Repair	Repair
Bonnet Dented	Repair
Front Fender Right Paintwork • Chipmarks	Repair
Brake Drum 2. Axle left Excessive Wear & Tear	Repair
Steering Rack Boot Left Missing	Replace
Steering Rack Boot Right Missing	Replace
Alignment Left / Right Difference out of legal range	Repair
Differential Oil Leak	Repair
Low and High Range Selection Insufficient	Repair
4x4 selection not working	Repair
Body exterior	Signs of spray work done on some body panels
Engine	Bottom of engine is fully covered
Multiple warning lights illuminated	Repair

Warning lights illuminated

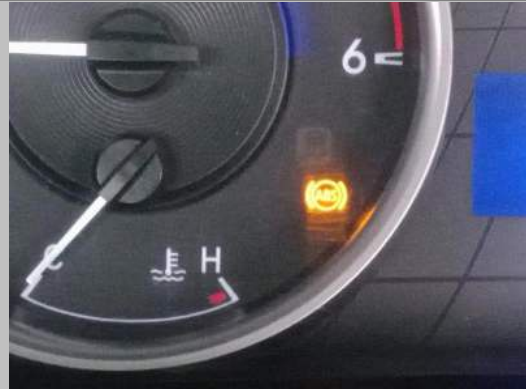
ABS warning lights illuminated

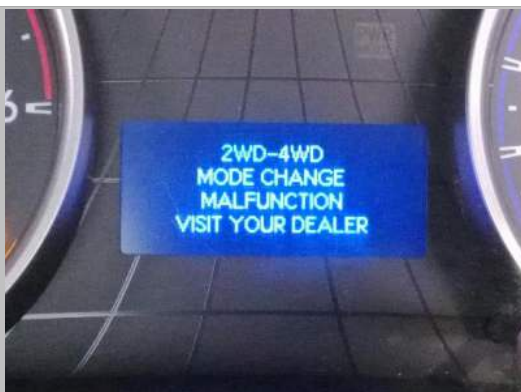
4x4 selection warning lights i
