CONDITION REPORT

Report No:
2016918984
DATE
20/06/2025

MFC Auction House
M57 Pretoria Rd, Glenmarais, KEMPTON PARK
Gauteng

Vehicle Type	LIGHT LOAD VEHICLE	Registered Owner	MFC AUCTION HOUSE
Manufacturer	TOYOTA	Registration Number	MF09PPGP
Model	HILUX 2.4 GD-6 SRX 4X4 D-CAB DSL PU [2016-2017]	Register Number	
		Date Of First Licensing	
VIN	AHTKB8CD602961130	Last COR	
Engine Number		License Expiry Date	
Doors	4	Power / Displacement	
Color	WHITE	Paint Finish	C - COMMON
Year Model	2016	Fuel	DIESEL
Km Reading	415,219 KM	Transmission	MANUAL
Cab / Body Type	DOUBLE CAB

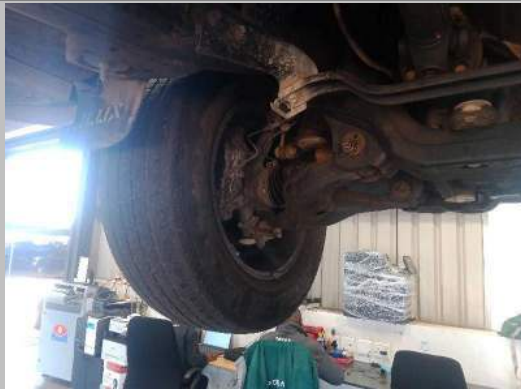
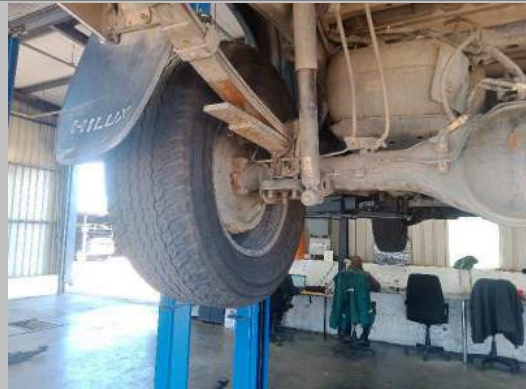
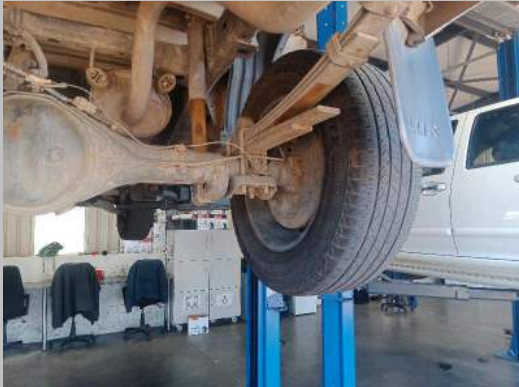
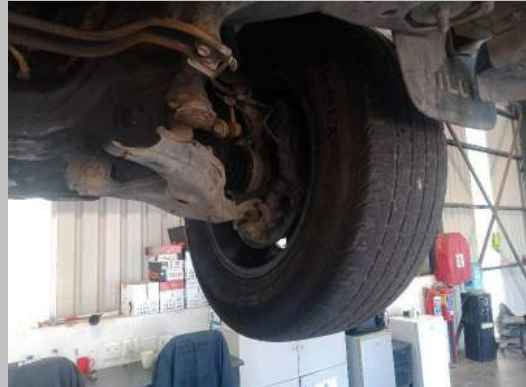
Size	Load/Speed Index	Manufacture	Model	Type*	Production Date	Tread Depth (mm)
Front Left	265/60R18	110T	Continental	Contact	V	3019	3 mm
Front Right	265/60R18	110T	Continental	Contact	V	1422	3 mm
Rear Left	285/60R18	116V	Dunlop	Grandtrek	V	1420	3 mm
Rear Right	265/60R18	110H	Nexen	Roadian	V	4820	3 mm

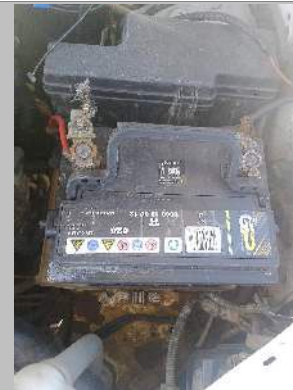
Battery loose

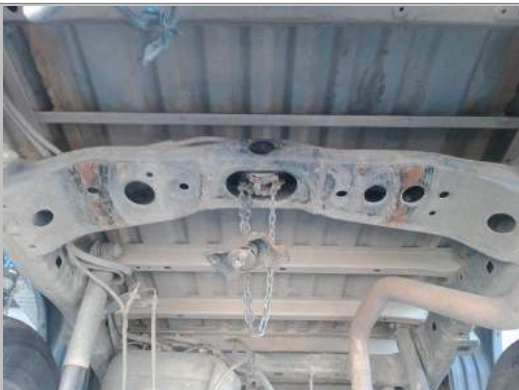
No spare wheel

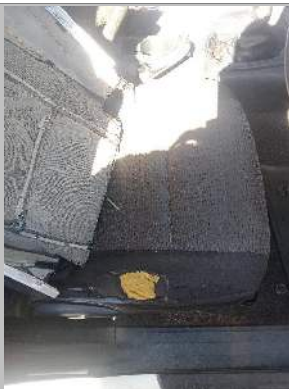
Damage	Repair Way
Engine Oil Leak	Repair
Fog Light Front Left Missing	Replace
Fog Light Front Right Missing	Replace
Seat Front Right Damaged	Repair
Front Bumper Paintwork • Scratched	Repair
Grill Damaged	Repair
Bonnet Dented	Repair
Bonnet slam plate (Shock tower/ Inner tray) Residual	Repair
Traces of Repair	Repair
Front Fender Left Paintwork • Scratched	Repair
Front Fender Right Paintwork • Scratched	Repair
Rear Fender Left Paintwork • Scratched	Repair
Rear Fender Right Dented	Repair
Door Front Left Dented	Repair
Door Front Right Paintwork • Scratched	Repair
Door Rear Left Paintwork • Scratched	Repair
Door Rear Right Paintwork • Scratched	Repair
Tailgate Paintwork • Scratched	Repair
Rear bumper Damaged	Repair
Rocker Panel Right Damaged	Repair
Windscreen Chipped	Repair
Shock Absorber Mounting Rear Left Damaged	Replace
Shock Absorber Mounting Rear Right Damaged	Replace
Stabilizer Mounting Front Left Defective	Replace

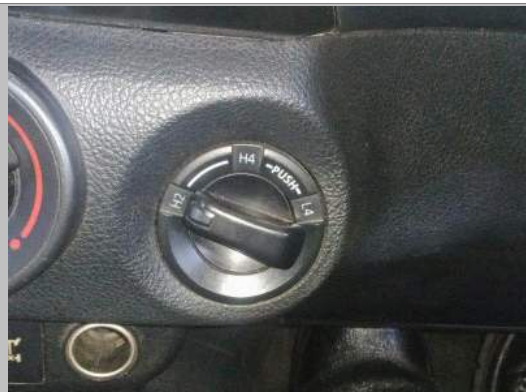
Stabilizer Mounting Front Right Defective	Repair
Bolt(s) / Nut(s) Front Wheel Left Missing	Replace
Bolt(s) / Nut(s) Front Wheel Right Missing	Replace
Bolt(s) / Nut(s) Rear Wheel Left Missing	Replace
Bolt(s) / Nut(s) Rear Wheel Right Missing	Replace
Gearbox Oil Leak	Repair
4x4 Differential Lock Malfunction	Repair
Battery loose	Repair
ABS and brake light on	Repair
