CONDITION REPORT

Report No: 201620776

MFC Auction House
M57 Pretoria Rd, Glenmarais, KEMPTON PARK
Gauteng

Vehicle Type	PASSENGER VEHICLE	Registered Owner	MFC
Manufacturer	TOYOTA	Registration Number	KRS924NW
Model	COROLLA CROSS	Register Number	
VIN	AHTKFAAG400607708	Date Of First Licensing	
Engine Number		Last COR	
Doors	5	License Expiry Date	29/02/2024
Color	WHITE	Power / Displacement	
Year Model		Paint Finish	C - COMMON
Km Reading	40,323 KM	Fuel	PETROL
Cab / Body Type	STATION WAGON	Transmission	AUTOMATIC

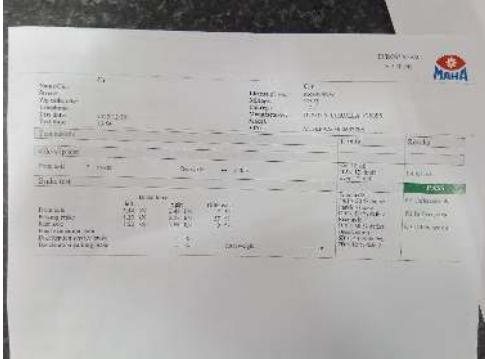
Shock and brake

Axe and Suspension: Shock test not performed.

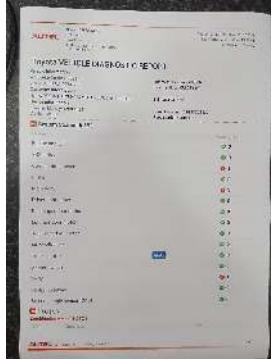
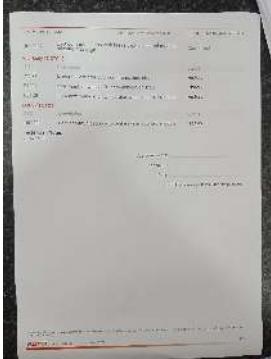
Diagnostic test

During the diagnostic no active error messages were detected. (See also attached Diagnostic Report. For more information regarding the Fault Codes (DTC) and the recommended rectifications please contact the workshops of the vehicle manufacturer).

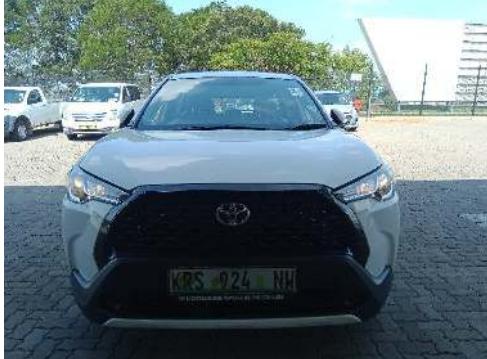
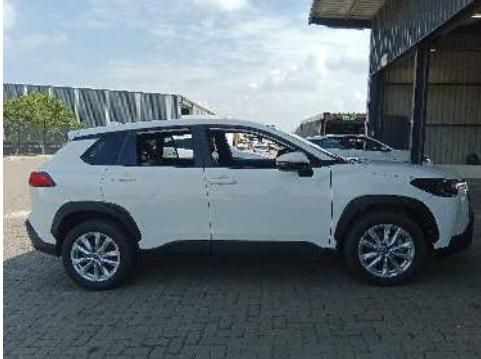
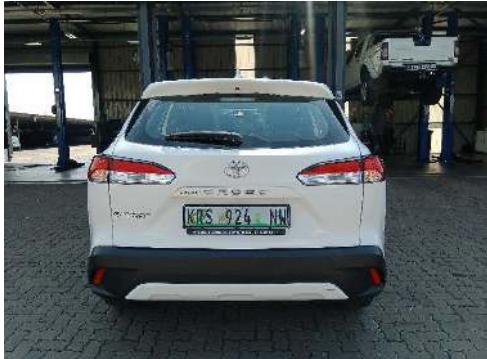
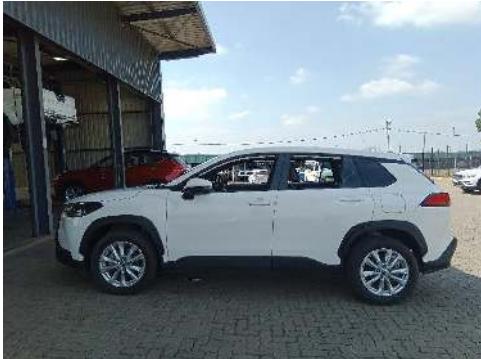
Body • Exterior: Minor dents scratches and stone chips on some body panels. Signs of spray work done on some body panels.

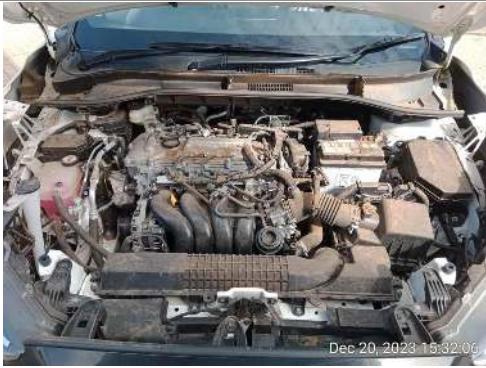
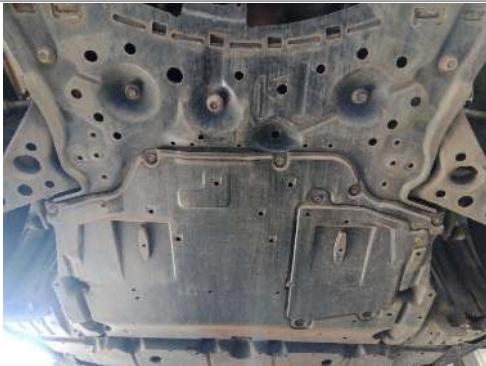
ENGINE 1

Engine Compartment: Bottom of engine is fully covered.
