## CONDITION REPORT

Report No: 201688601

| Manufacturer | TOYOTA | Registration Number | KL86ZHGP |
| Model | COROLLA QUEST 1.6 [2016-2021] | Register Number | |

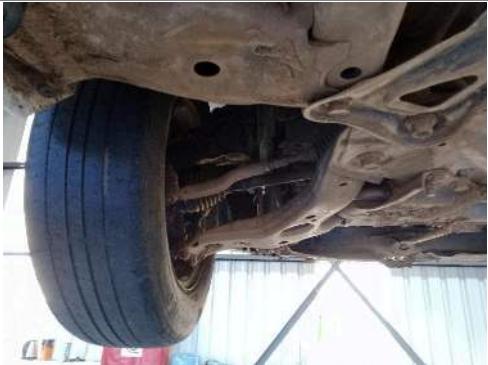
LF TYRE TREAD

| Damage | Repair Way |
|---|---|
| Tyre Front Left Worn | Replace |

| | Size | Load/Speed Index | Manufacture | Model | Type* | Production Date | Tread Depth (mm) |
|---|---|---|---|---|---|---|---|
| Front Left | 195/65R15 | 91H | Annaite | Radial | V | 4723 | 0 mm |

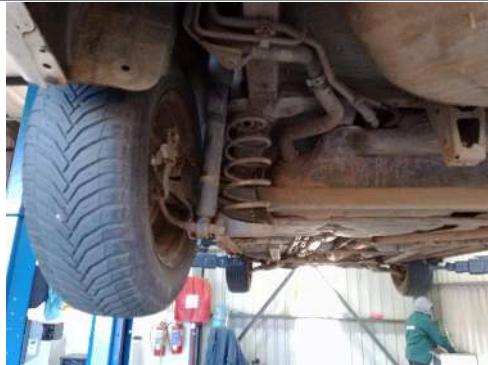
LR TYRE TREAD

| | Size | Load/Speed Index | Manufacture | Model | Type* | Production Date | Tread Depth (mm) |
|---|---|---|---|---|---|---|---|
| Rear Left | 195/65R15 | 95V | Michelin | Radial | V | 0223 | 2 mm |

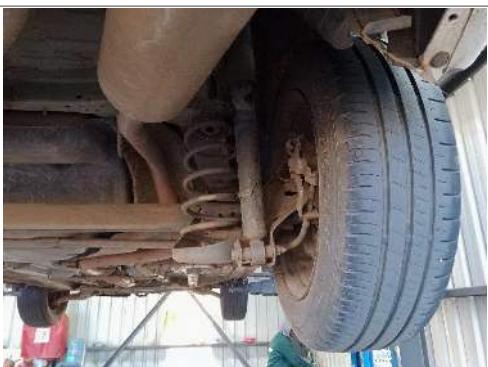
RR TYRE TREAD

| | Size | Load/Speed Index | Manufacture | Model | Type* | Production Date | Tread Depth (mm) |
|---|---|---|---|---|---|---|---|
| Rear Right | 185/60R15 | 84H | Dunlop | Sp | V | 1524 | 2 mm |

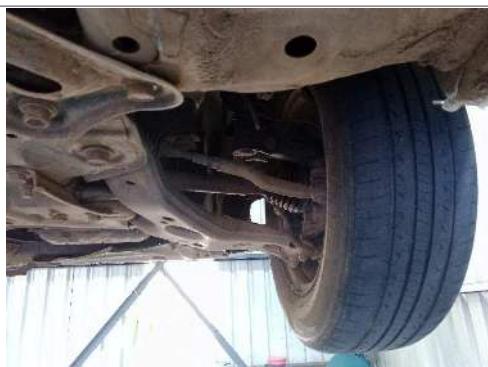
RF TYRE TREAD

| Damage | Repair Way |
|---|---|
| Tyre Front Right Worn | Replace |

| | Size | Load/Speed Index | Manufacture | Model | Type* | Production Date | Tread Depth (mm) |
|---|---|---|---|---|---|---|---|
| Front Right | 195/65R15 | 91H | Annaite | Radial | V | 4723 | 0 mm |

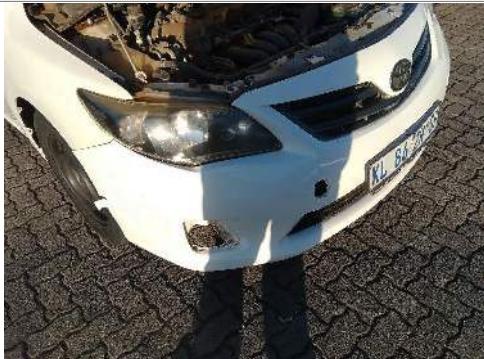
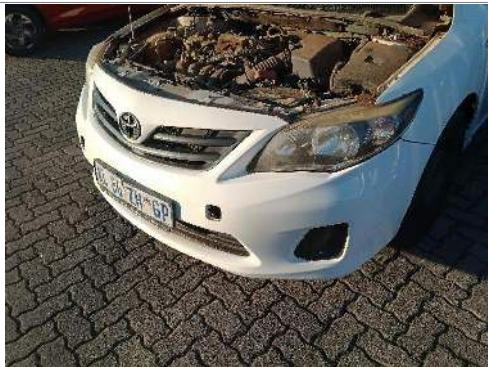
| Damage | Repair Way |
|--|---|
| Front Bumper Damaged | Repair |

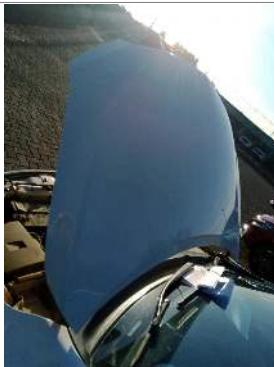
| Damage | Repair Way |
|--|---|
| Bonnet Damaged | Repair |

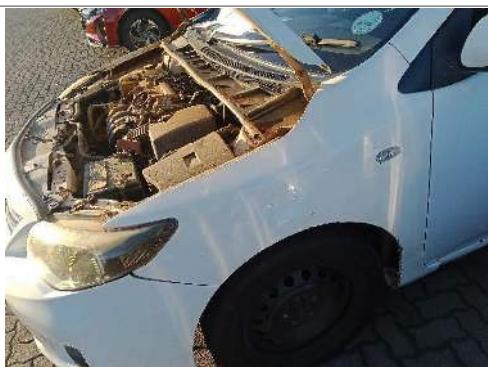
| Damage | Repair Way |
|--|---|
| Front Fender Left Damaged | Repair |

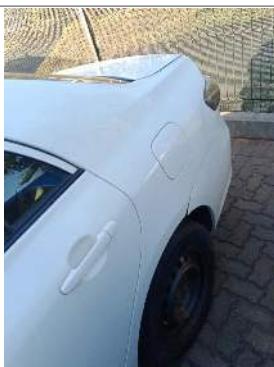
| Damage | Repair Way |
|--|---|
| Rear Fender Left Damaged | Repair |

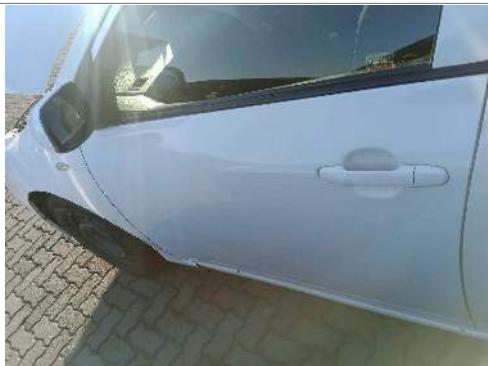
| Damage | Repair Way |
|--|---|
| Door Front Left Damaged | Repair |

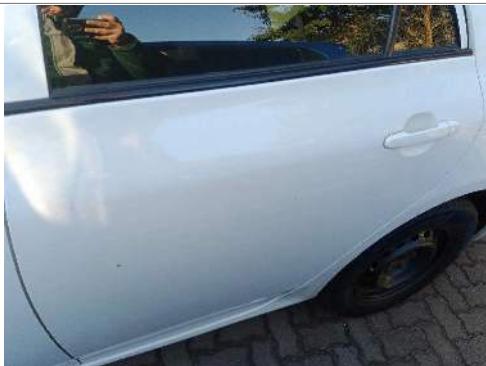
| Damage | Repair Way |
|--|---|
| Door Rear Left Damaged | Repair |

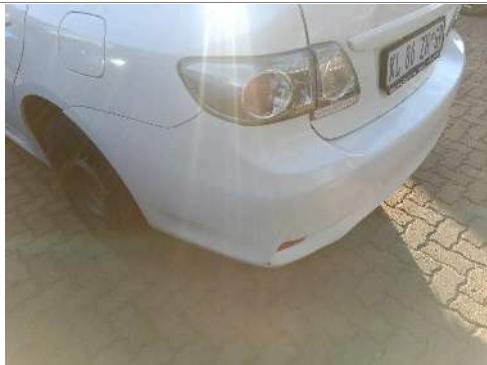
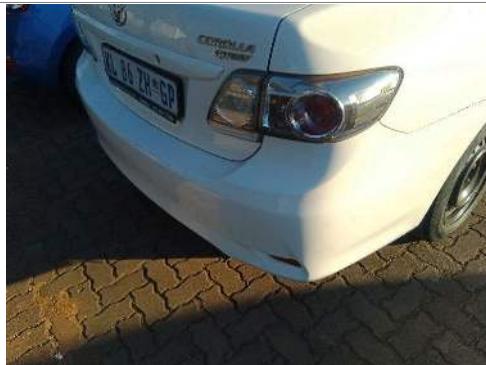
| Damage | Repair Way |
|--|---|
| Rear bumper Damaged | Repair |

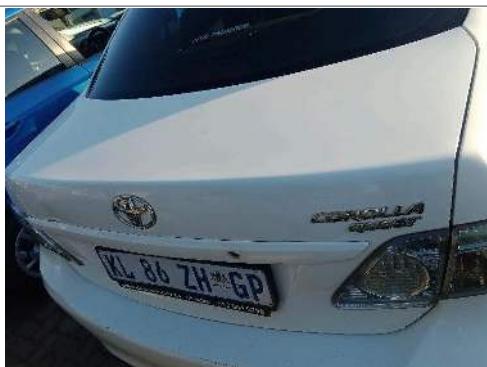
| Damage | Repair Way |
|--|---|
| Boot Lid / Hatch door Damaged | Repair |

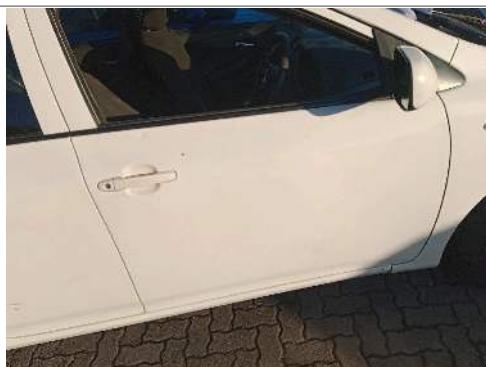
| Damage | Repair Way |
|--|---|
| Door Front Right Damaged | Repair |

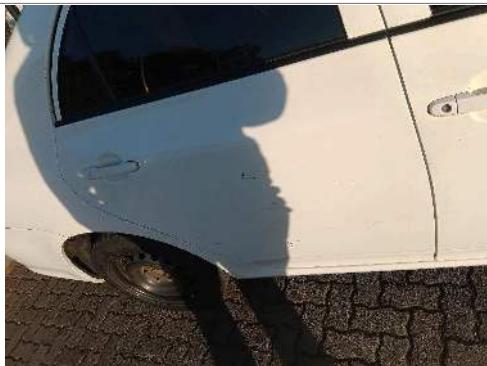
| Damage | Repair Way |
|--|---|
| Door Rear Right Damaged | Repair |

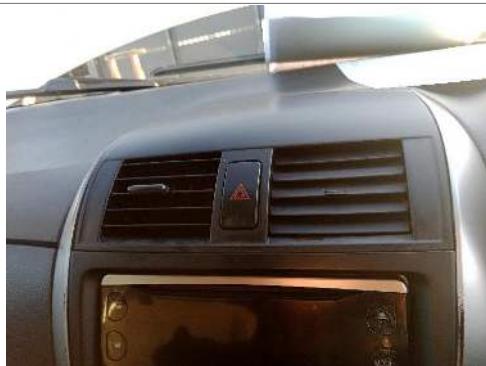
| Damage | Repair Way |
|--|---|
| Central Air Vent Damaged | Repair |

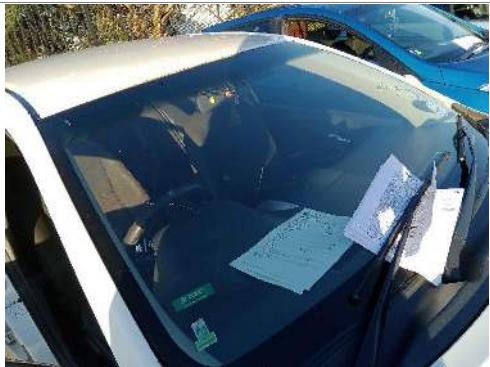
| Damage | Repair Way |
|--|---|
| Windscreen Damaged | Replace |

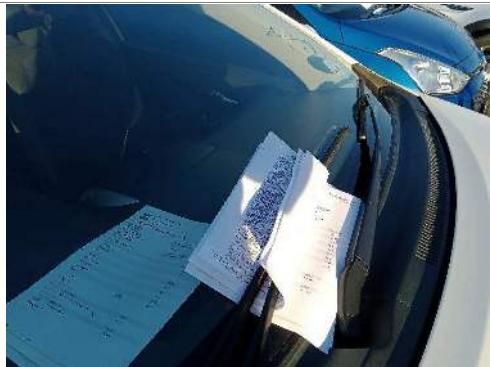
| Damage | Repair Way |
|--|---|
| Windscreen Wiper Damaged | Replace |

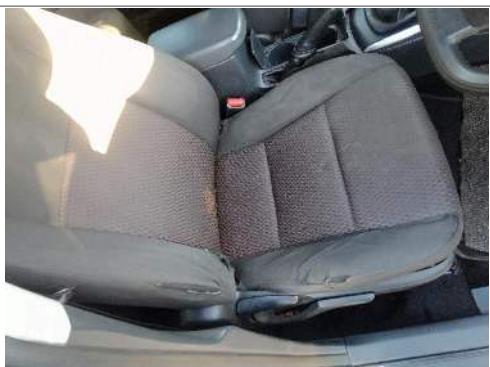
| Damage | Repair Way |
|--|---|
| Seat Front Right Worn | Repair |

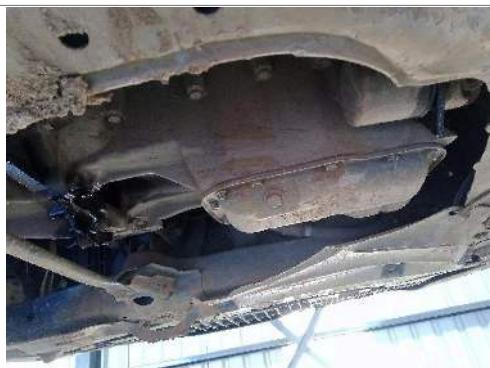
| Damage | Repair Way |
|--|---|
| Engine Oil Leak | Repair |

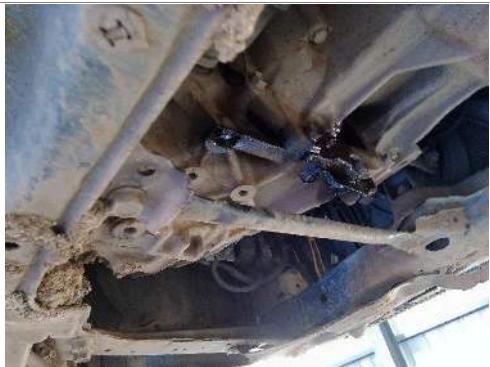
| Damage | Repair Way |
|---|---|
| Gearbox Oil Leak | Repair |

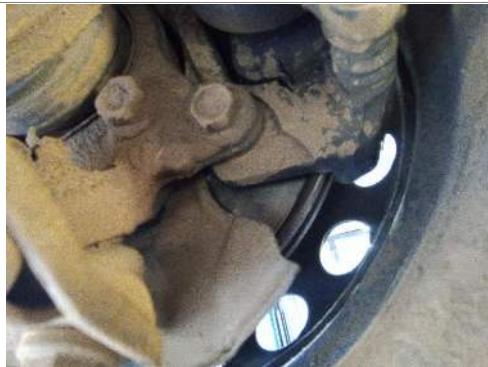
| Damage | Repair Way |
|--|---|
| Brake disc 1. Axle left Worn | Replace |

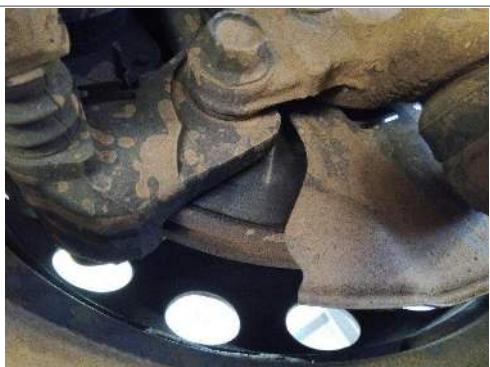
| Damage | Repair Way |
|--|---|
| Brake disc 1. Axle right Worn | Replace |

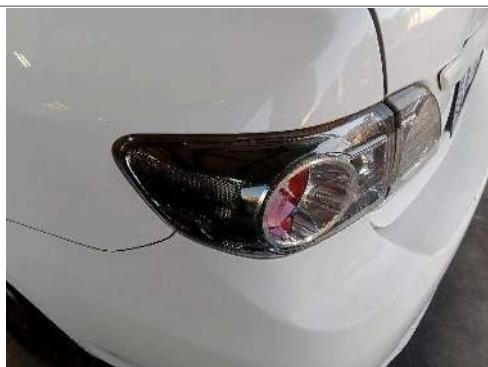
| Damage | Repair Way |
|--|---|
| Tail Light Left Damaged | Replace |
