## CONDITION REPORT

Report No: 2016289113

MFC Auction House  
M57 Pretoria Rd, Glenmarais, KEMPTON PARK  
Gauteng

Vehicle Type	PASSENGER VEHICLE	Registered Owner	MFC AUCTION HOUSE
Manufacturer	TOYOTA	Registration Number	JPN790MP
Model	COROLLA QUEST	Register Number	
VIN	AHTLB52E403102125	Date Of First Licensing	
Engine Number		Last COR	
Doors	4	License Expiry Date	31/05/2024
Color	SILVER	Power / Displacement	
Year Model		Paint Finish	M - METALLIC
Km Reading	286,495 KM	Fuel	PETROL
Cab / Body Type	SEDAN	Transmission	MANUAL

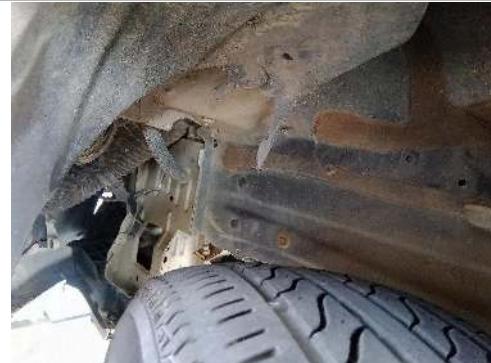
L/F fender liner missing

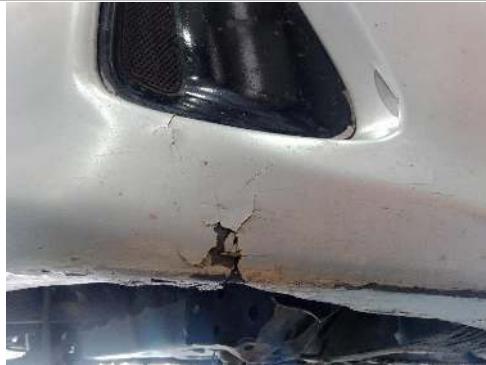
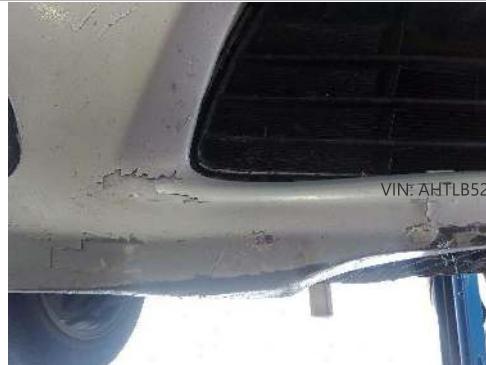
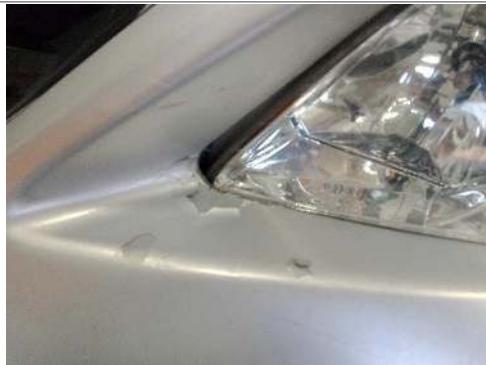
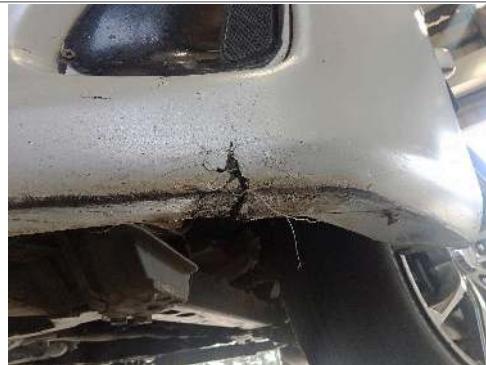
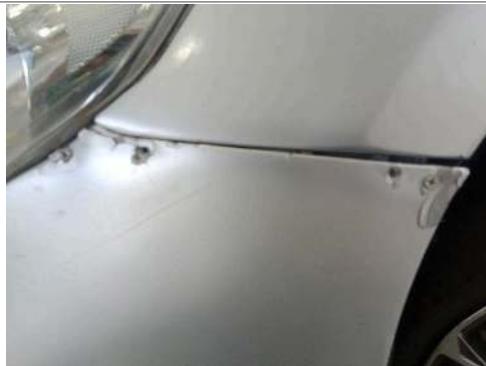
Damage	Repair Way
Engine Oil Leak	Repair
Dim Light Right Defective	Replace
Bright Light Right Defective	Replace
Seat Front Right Torn / Cut	Repair
Seat Rear Torn / Cut	Replace
Side Mirror Left Damaged	Replace
Rear Lower Valance Damaged	Repair
Front Bumper Damaged	Repair
Sill Panel Right Dented	Repair
Windscreen Cracked	Replace
Parking Brake Performance Left / Right Difference out of legal range	Repair
Tie Rod End left Damaged	Replace
Tie Rod End right Damaged	Replace
Split Pin Right Missing	Replace
Shock Absorber Front Right Sweat	Replace
Stabilizer Mounting Front Left Damaged	Replace
Stabilizer Mounting Front Right Damaged	Replace
Alignment Poor Alignment	Repair
Tyre Rear Right Excessive Wear & Tear	Replace
Rim Front Left Welded	Repair
Rim Front Right Dented	Repair
Main Beam Left Damaged	Repair
Gearbox Oil Leak	Repair
CV Joint(s) Boot(s) Front Right (inner/outer) Damaged	Replace
R/R tyre is flat.	Repair.
Electronics	L/F electric mirror malfunction.

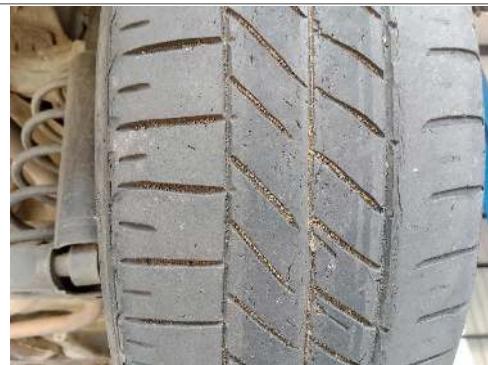
Tyre Rear Right

Size	Load/Speed Index	Manufacture	Model	Type*	Production Date	Tread Depth (mm)
Front Left	185/65R15	88H	Timax	Eco comfort	V	1323	5 mm
Front Right	185/65R15	88H	Timax	Eco comfort	V	1323	5 mm
Rear Left	195/65R15	91H	Autogrip	Grip	V	3221	4 mm
Rear Right	195/65R15	91T	General	Altimax	V	4022	1 mm
Spare	185/65R15	88H	Continental	Contact	V	//////////	1 mm
