## CONDITION REPORT

Report No:  
2017293105  
DATE  
02/09/2026

| Manufacturer | TOYOTA | Registration Number | CX21ZXGP |
| Model | COROLLA 1.3 PROFESSIONAL [2010-2014] | Register Number | |

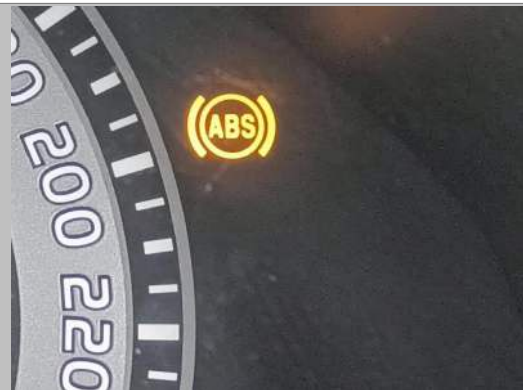
| Damage | Repair Way |
|---|---|
| Warning lights illuminated | Repair |

ABS warning lights illuminated

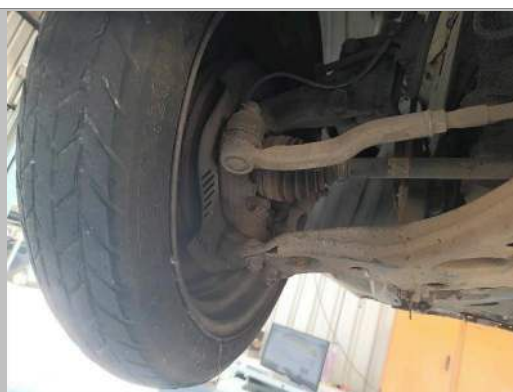
LF TYRE TREAD

| Damage | Repair Way |
|---|---|
| Front tyre size differs | Replace |

| | Size | Load/Speed Index | Manufacture | Model | Type* | Production Date | Tread Depth (mm) |
|---|---|---|---|---|---|---|---|
| Front Left | T125/70D17 | 98M | Bf Goodrich | Temporary | V | 4306 | 0 mm |

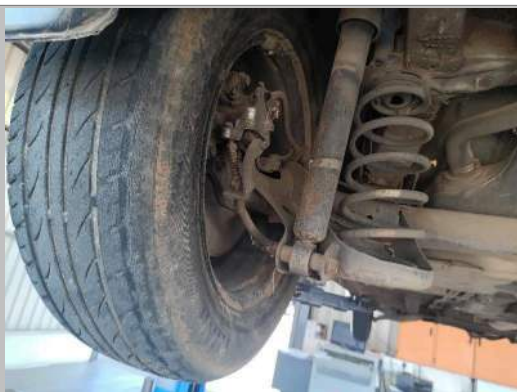
LR TYRE TREAD

| | Size | Load/Speed Index | Manufacture | Model | Type* | Production Date | Tread Depth (mm) |
|---|---|---|---|---|---|---|---|
| Rear Left | 195/65R15 | 91H | llink | L comfort | V | 1422 | 0 mm |

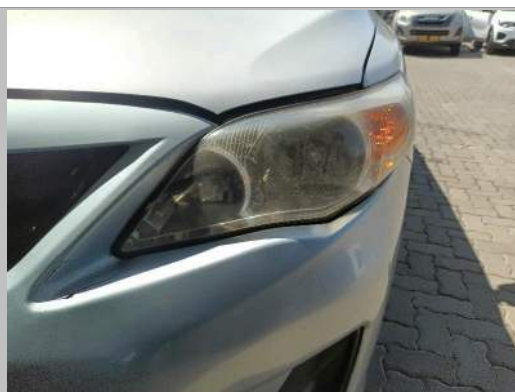
| Damage | Repair Way |
|---|---|
| Park Light Front Left Defective | Repair |

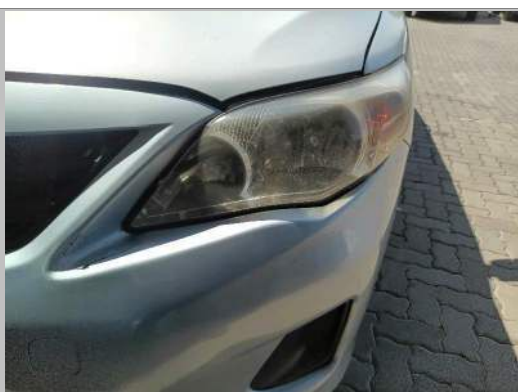
| Damage | Repair Way |
|---|---|
| Dim Light Left Defective | Repair |

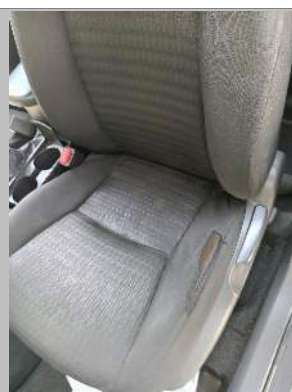
| Damage | Repair Way |
|---|---|
| Seat Front Left Torn / Cut | Repair |

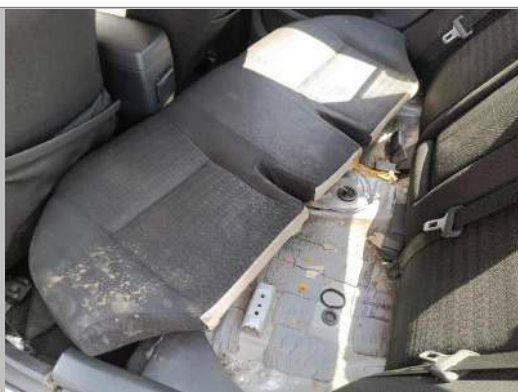
| Damage | Repair Way |
|---|---|
| Seat Rear Damaged | Repair |

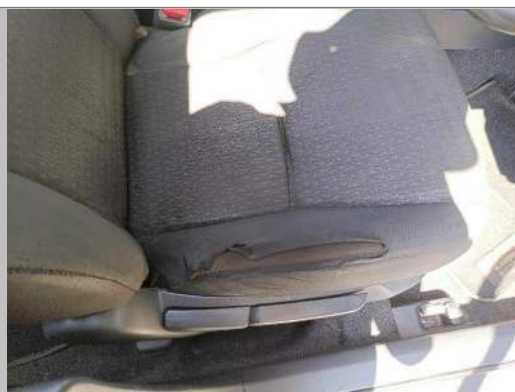
| Damage | Repair Way |
|---|---|
| Seat Front Right Torn / Cut | Repair |

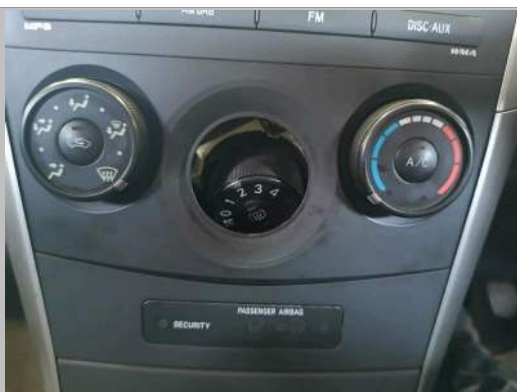
| Damage | Repair Way |
|---|---|
| Center Console / Cubbyhole + Lid Damaged | Repair |

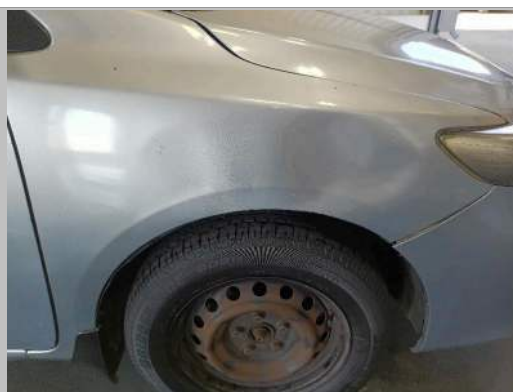
| Damage | Repair Way |
|---|---|
| Front Fender Right Residual Traces of Repair | Repair |

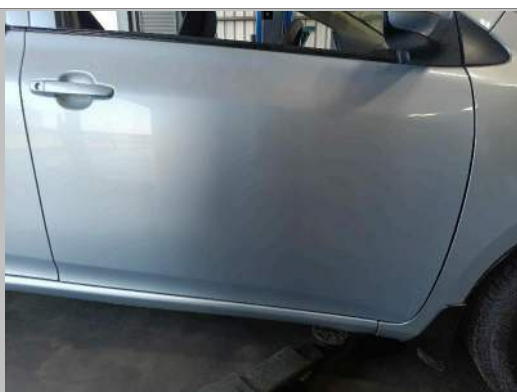
| Damage | Repair Way |
|---|---|
| Door Front Right Paintwork • Scratched | Repair |

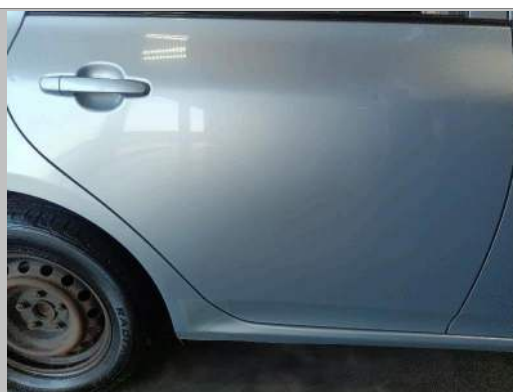
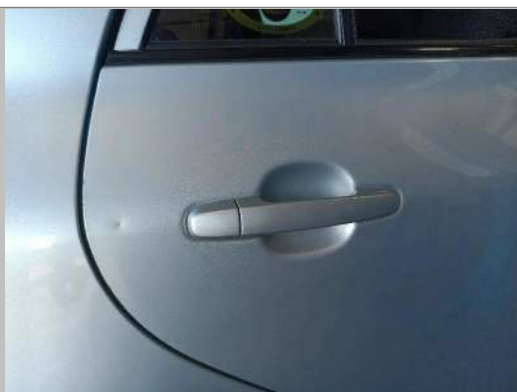
| Damage | Repair Way |
|---|---|
| Door Rear Right Dented | Repair |

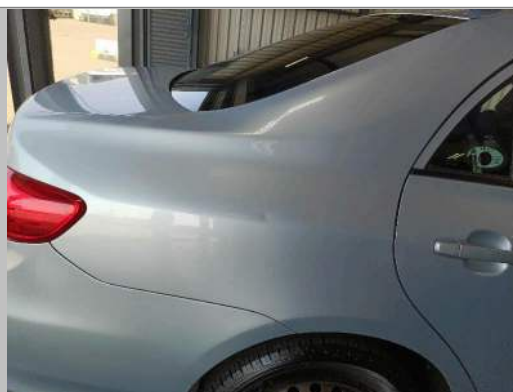
| Damage | Repair Way |
|---|---|
| Rear Fender Right Dented | Repair |

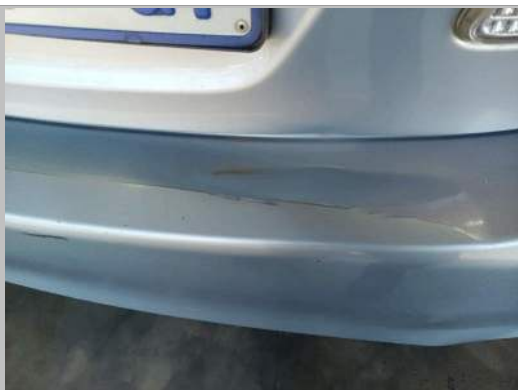
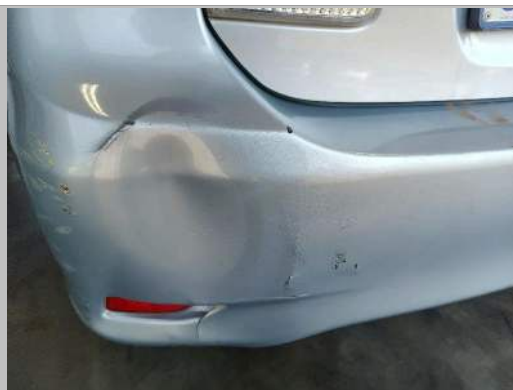
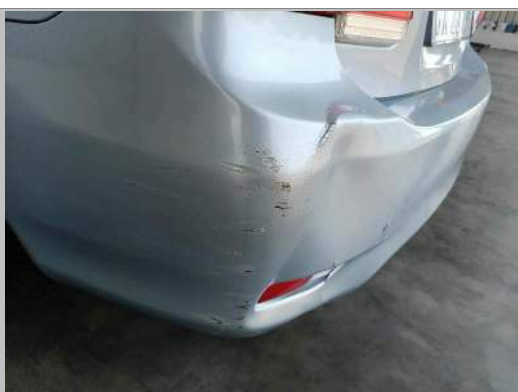
| Damage | Repair Way |
|---|---|
| Rear bumper Damaged | Repair |

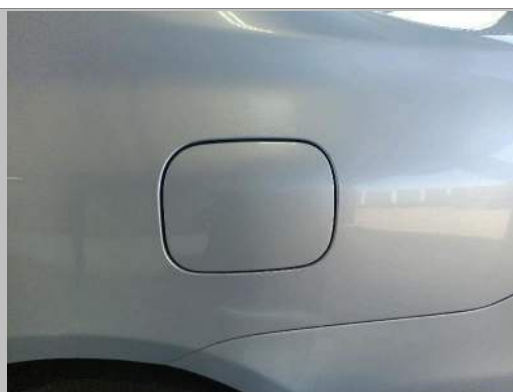
| Damage | Repair Way |
|---|---|
| Fuel Flap Damaged | Repair |

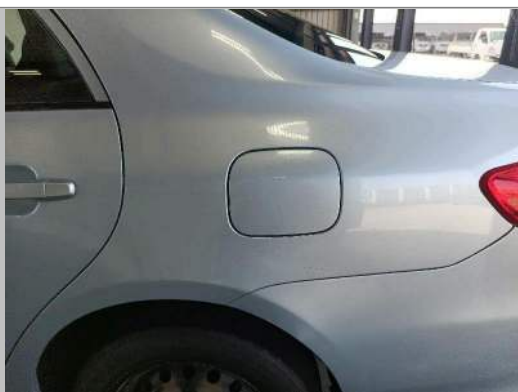
| Damage | Repair Way |
|---|---|
| Rear Fender Left Paintwork • Scratched | Repair |

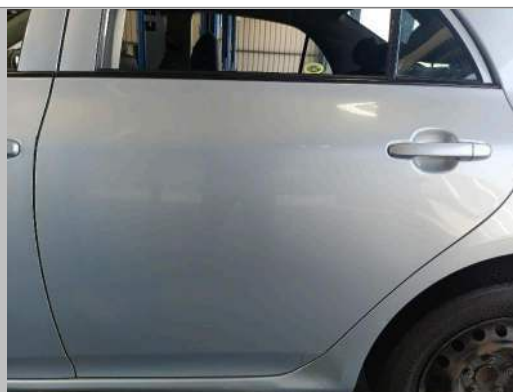
| Damage | Repair Way |
|---|---|
| Door Rear Left Paintwork • Scratched | Repair |

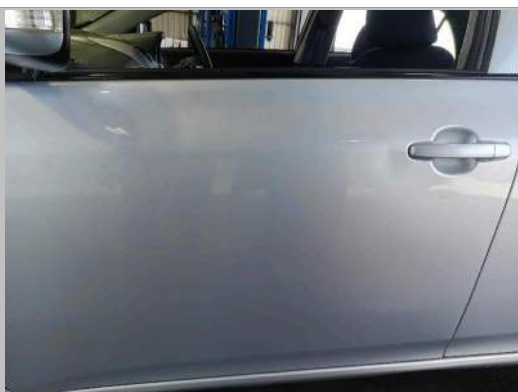
| Damage | Repair Way |
|---|---|
| Door Front Left Dented | Repair |

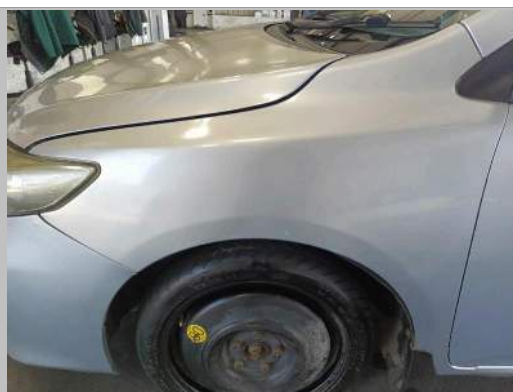
| Damage | Repair Way |
|---|---|
| Front Fender Left Residual Traces of Repair | Repair |

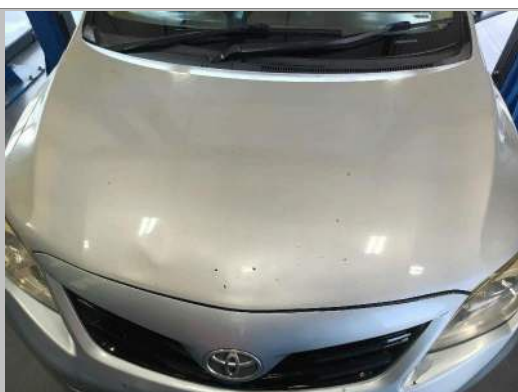
| Damage | Repair Way |
|---|---|
| Bonnet Residual Traces of Repair | Repair |

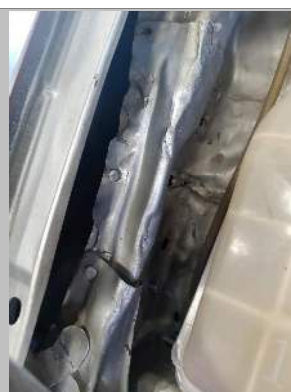
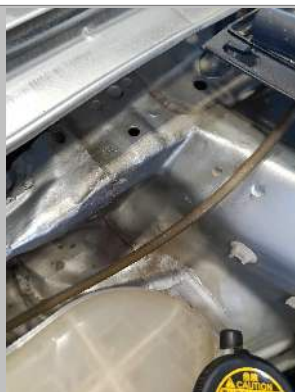
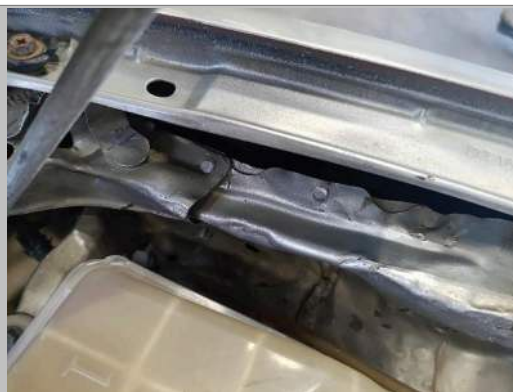
| Damage | Repair Way |
|---|---|
| Bonnet slam plate (Shock tower/ Inner tray) Damaged | Repair |

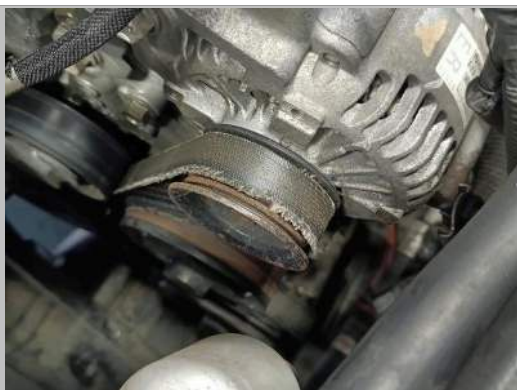
| Damage | Repair Way |
|---|---|
| Fan Belt Excessive Wear & Tear | Replace |

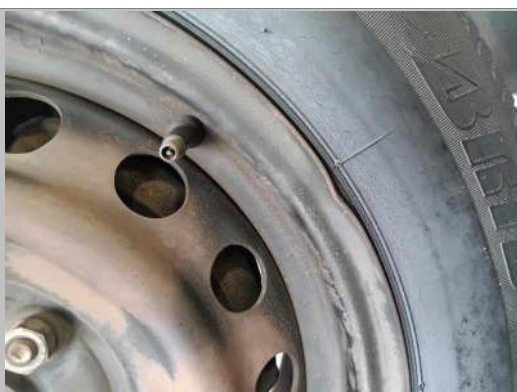
| Damage | Repair Way |
|---|---|
| Rim Front Right Deformed | Repair |

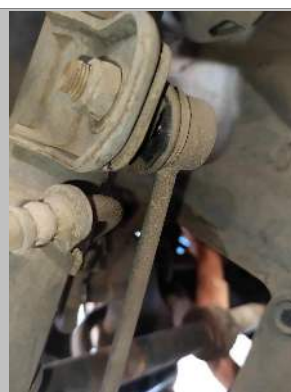
| Damage | Repair Way |
|---|---|
| Stabilizer Mounting Front Right Damaged | Replace |

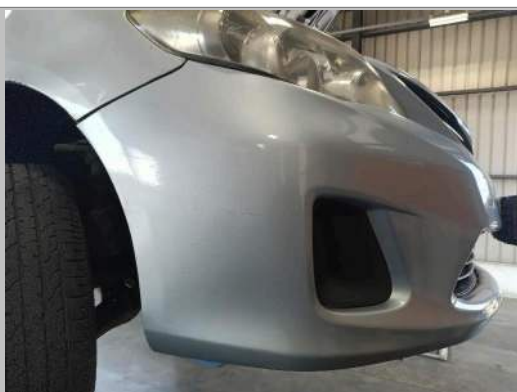
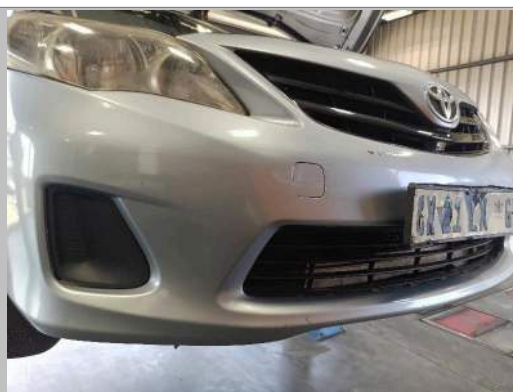
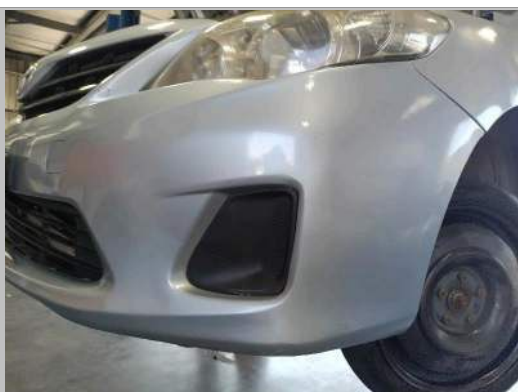
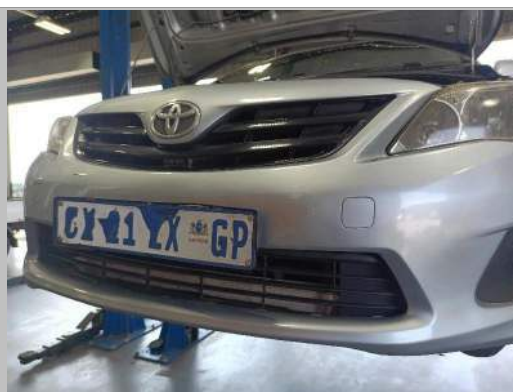
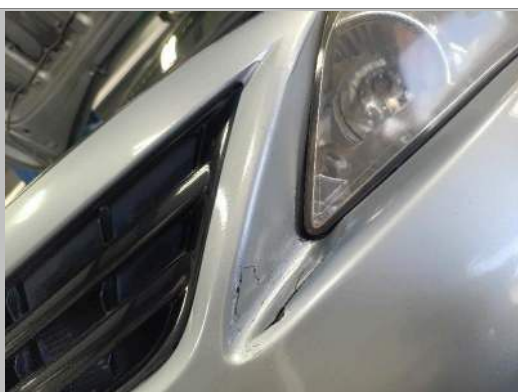
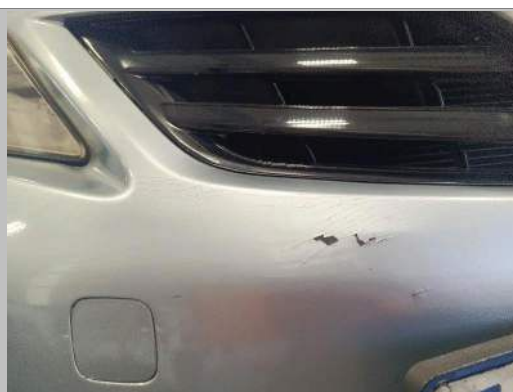
| Damage | Repair Way |
|---|---|
| Front Bumper Residual Traces of Repair | Repair |

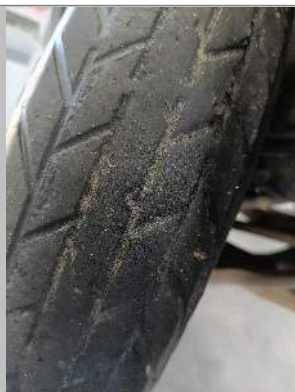
| Damage | Repair Way |
|---|---|
| Tyre Front Left Smooth | Replace |

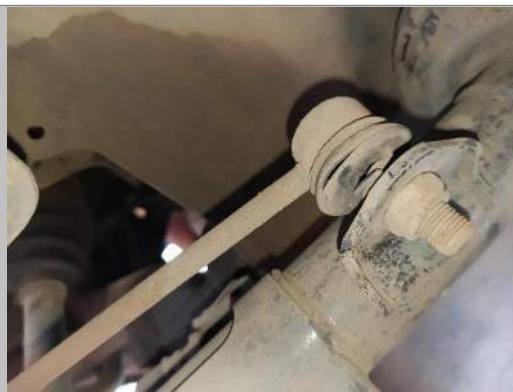
| Damage | Repair Way |
|---|---|
| Stabilizer Mounting Front Left Damaged | Replace |

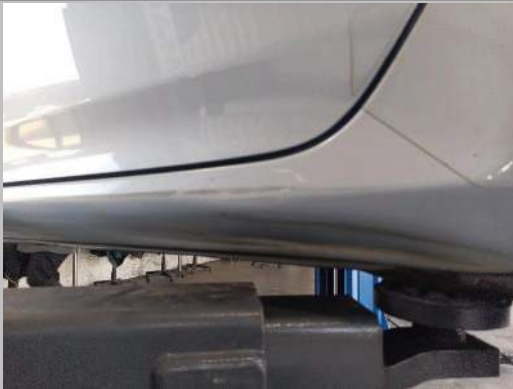
| Damage | Repair Way |
|---|---|
| Sill Panel Left Paintwork • Scratched | Repair |

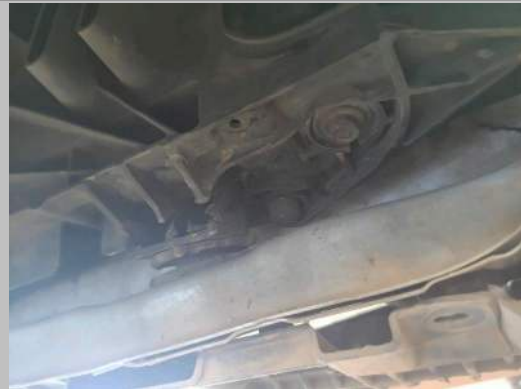
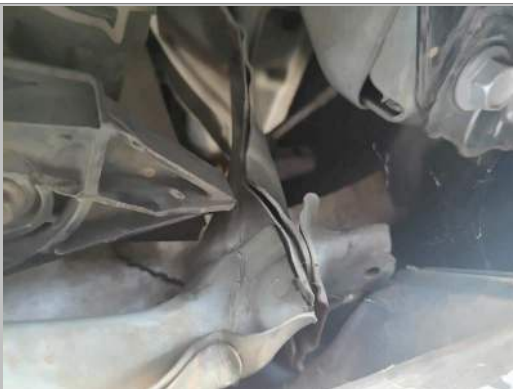
| Damage | Repair Way |
|---|---|
| Radiator Cross Member Damaged | Repair |

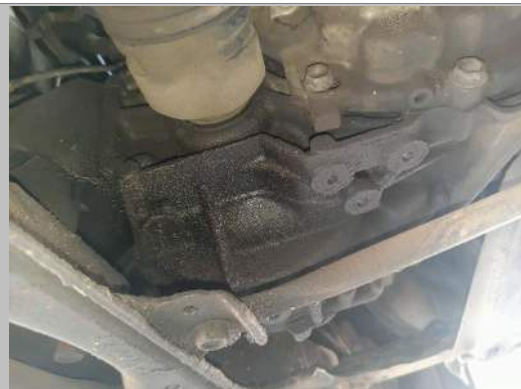
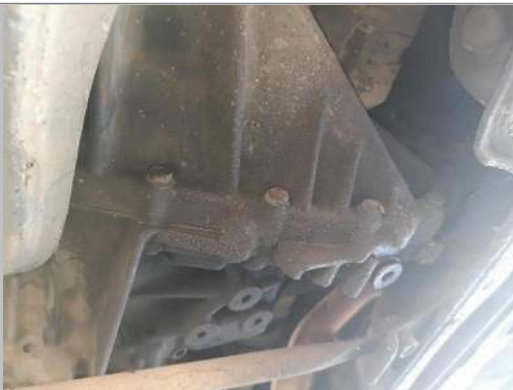
| Damage | Repair Way |
|---|---|
| Gearbox Oil Leak | Repair |

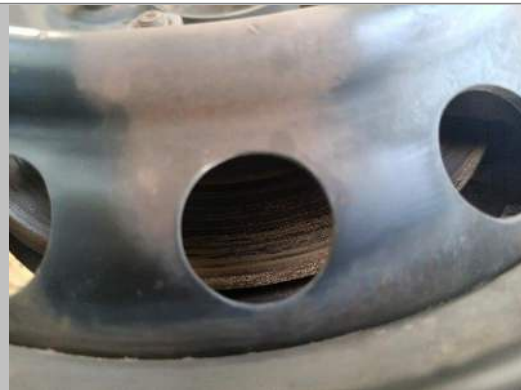
| Damage | Repair Way |
|---|---|
| Brake disc 2. Axle left Corrosion | Replace |

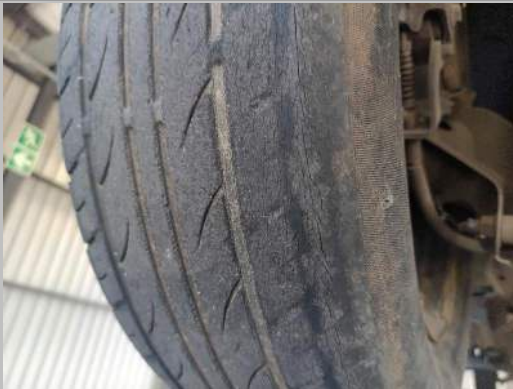
| Damage | Repair Way |
|---|---|
| Tyre Rear Left Smooth | Replace |

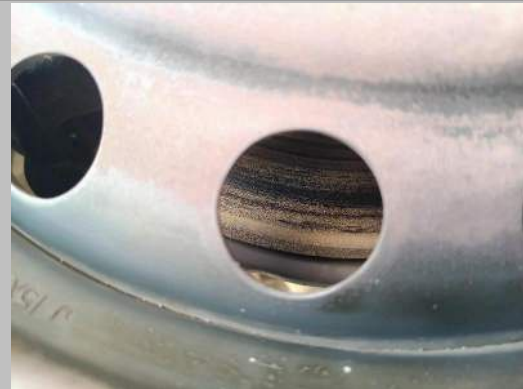
| Damage | Repair Way |
|---|---|
| Brake disc 2. Axle right Corrosion | Replace |
