CONDITION REPORT

Report No: 2016850176

MFC Auction House  
M57 Pretoria Rd, Glenmarais, KEMPTON PARK  
Gauteng

| Model | HI-ACE 2.5 SESFIKILE 16-S DSL MINIBUS [2021-2024] | Register Number | |

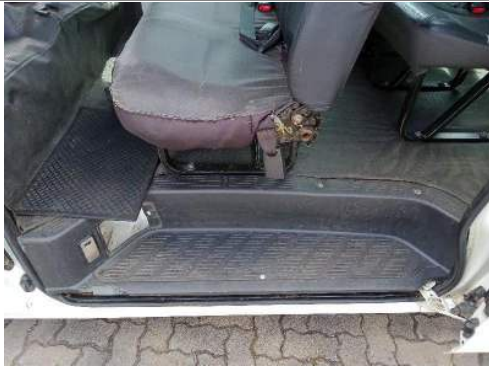
Rear left door step box

| Damage | Repair Way |
|---|---|
| Interior | Rear left door side step damaged |

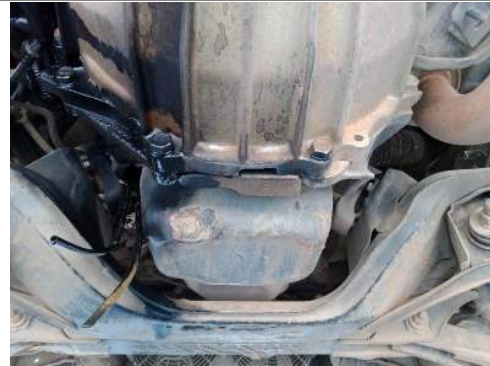
| Damage | Repair Way |
|---|---|
| Engine | Engine oil sump |

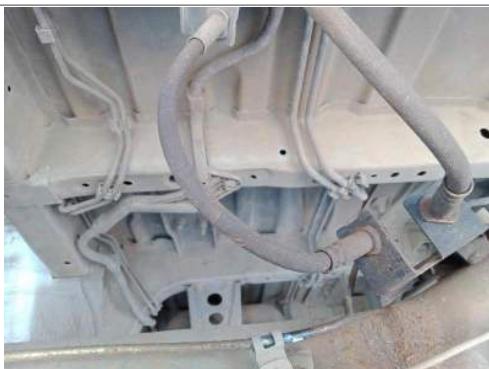
| Damage | Repair Way |
|---|---|
| Brakes | Rear left brake piping damaged |

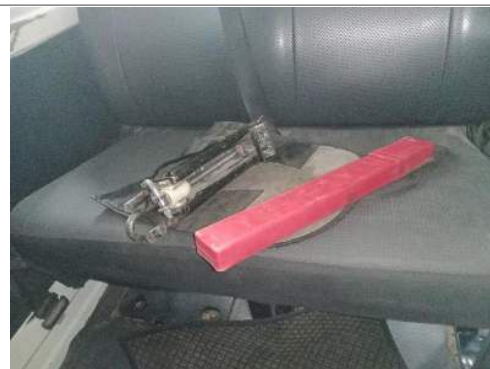
Spare wheel Accessories

| Damage | Repair Way |
|---|---|
| Tyres and rims | Spare wheel missing |

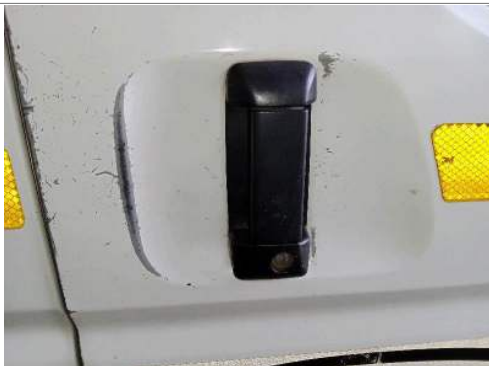
| Damage | Repair Way |
|---|---|
| Body and Exterior | Rear left door lock damaged |

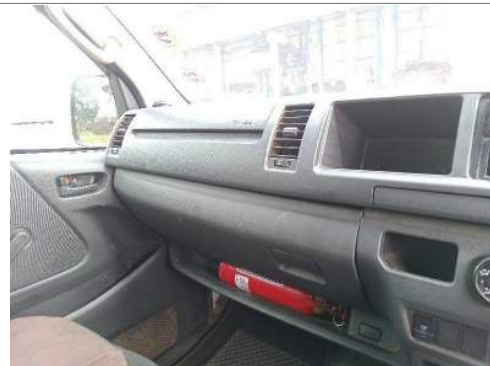
| Damage | Repair Way |
|---|---|
| Center Console / Cubbyhole + Lid Damaged | Repair |

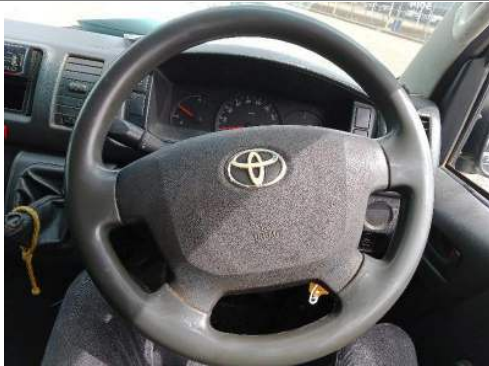
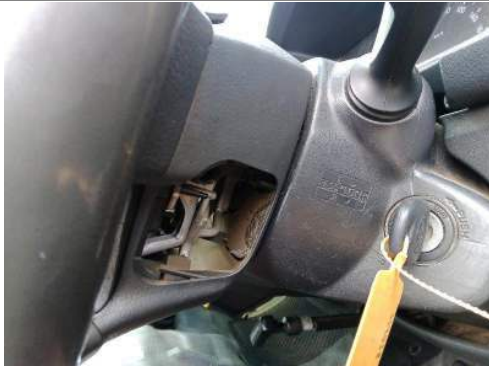
| Damage | Repair Way |
|---|---|
| Steering Wheel Trim Defective | Repair |

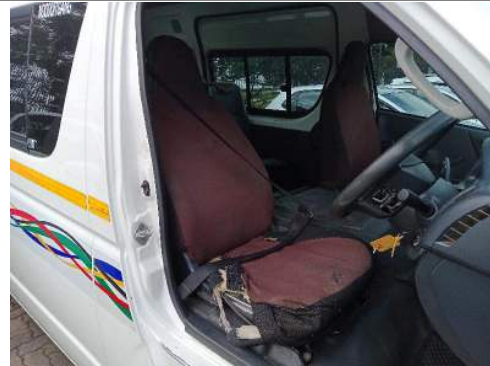
| Damage | Repair Way |
|---|---|
| Seat Front Right Damaged | Repair |

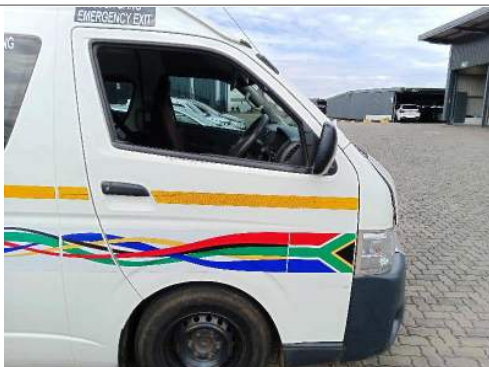
| Damage | Repair Way |
|---|---|
| Door Front Right Damaged | Repair |

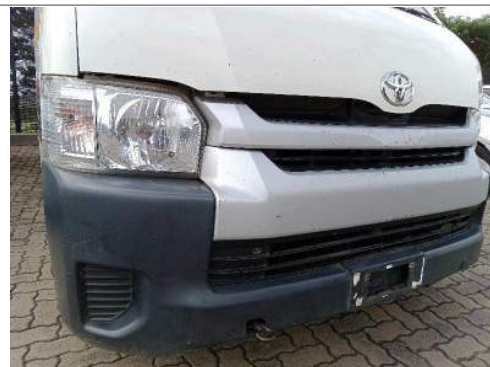
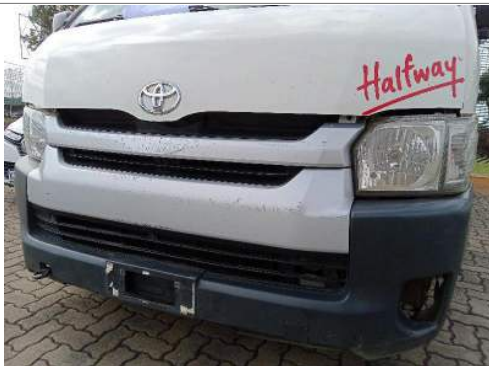
| Damage | Repair Way |
|---|---|
| Front Bumper Damaged | Repair |

| Damage | Repair Way |
|---|---|
| Body and Exterior | Signs of impact damage to front of vehicle |

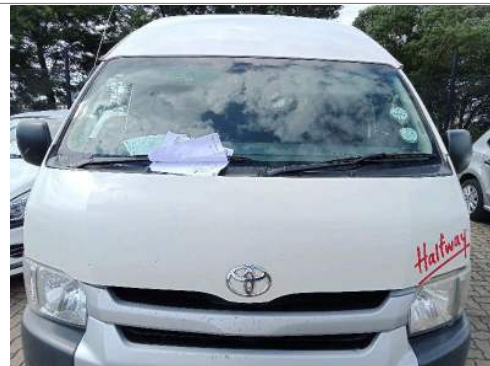
| Damage | Repair Way |
|---|---|
| Bonnet Damaged | Repair |

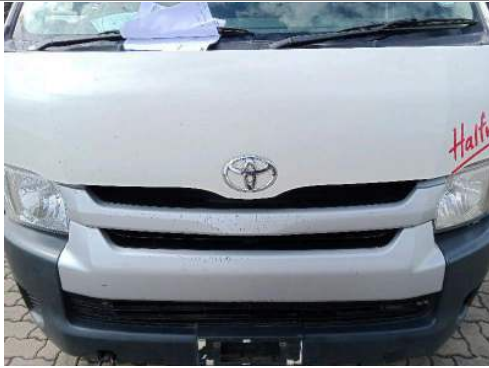
| Damage | Repair Way |
|---|---|
| Grill Paintwork • Scratched | Repair |

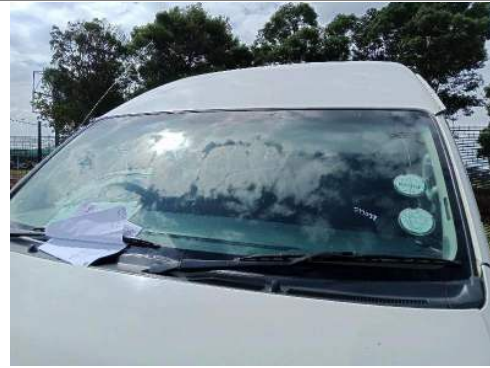
| Damage | Repair Way |
|---|---|
| Windscreen Cracked | Replace |

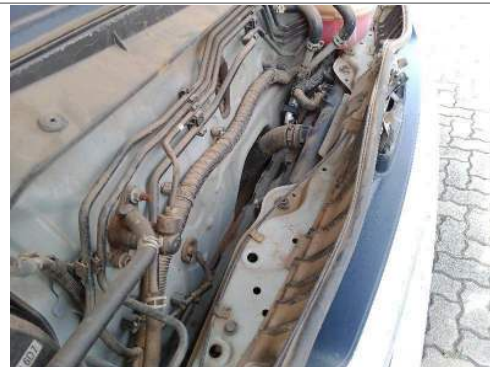
| Damage | Repair Way |
|---|---|
| Bonnet slam plate (Shock tower/ Inner tray) Damaged | Repair |

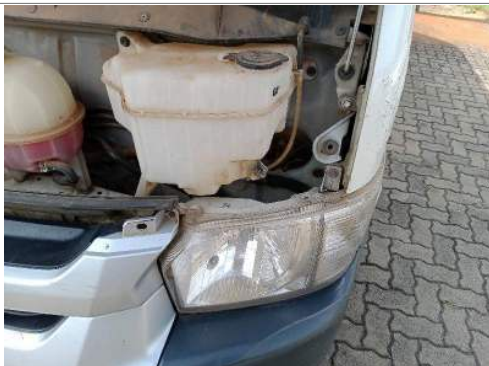
| Damage | Repair Way |
|---|---|
| Headlight Left Damaged | Replace |

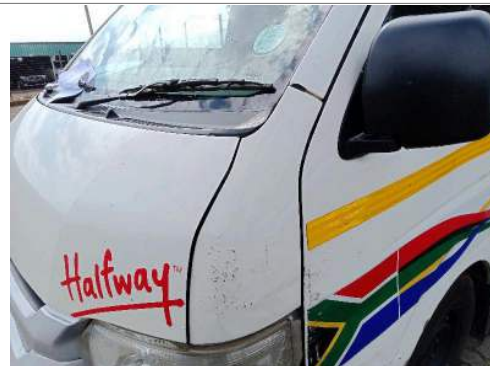
| Damage | Repair Way |
|---|---|
| Front Fender Left Damaged | Repair |

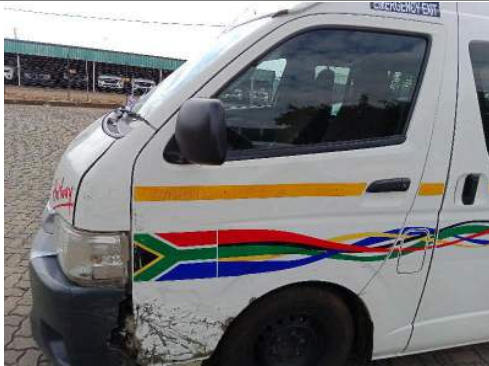
| Damage | Repair Way |
|---|---|
| Door Front Left Damaged | Repair |

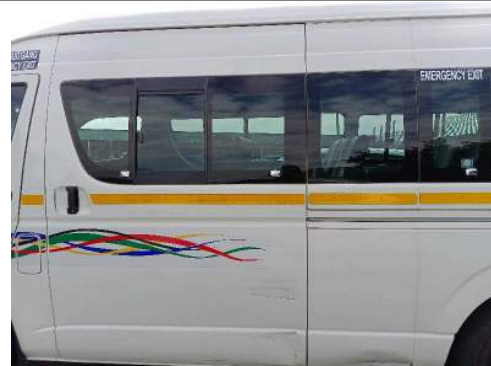
| Damage | Repair Way |
|---|---|
| Door Rear Left Damaged | Repair |

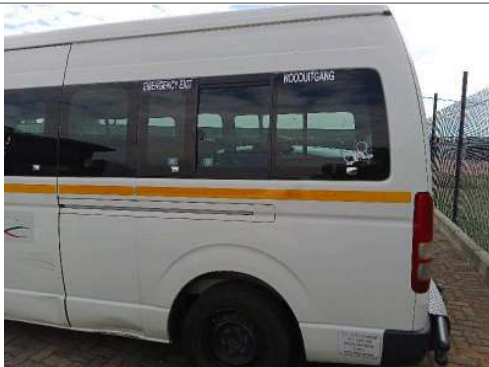
| Damage | Repair Way |
|---|---|
| Rear Fender Left Damaged | Repair |

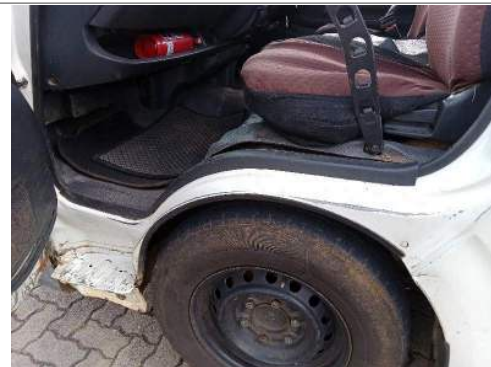
| Damage | Repair Way |
|---|---|
| Sill Panel Left Damaged | Repair |

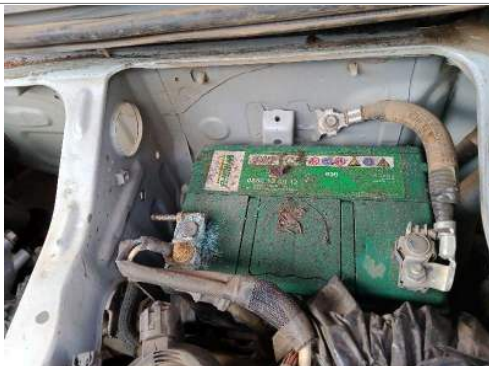
| Damage | Repair Way |
|---|---|
| Battery clamps Corrosion | Repair |

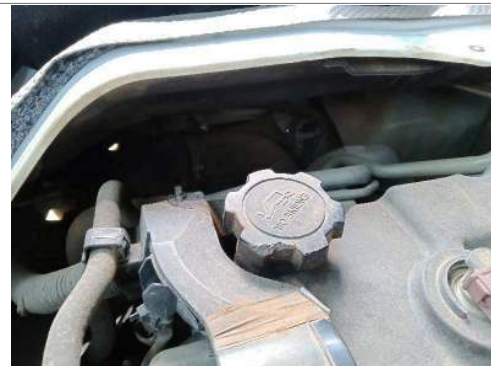
| Damage | Repair Way |
|---|---|
| Caps Damaged | Replace |

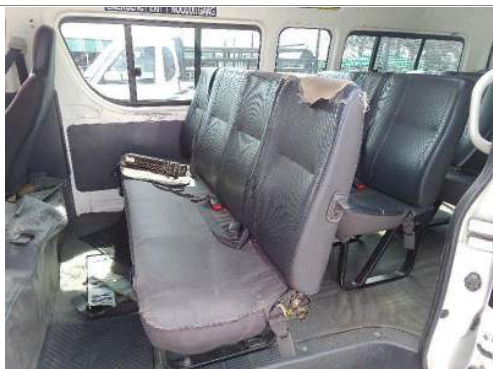
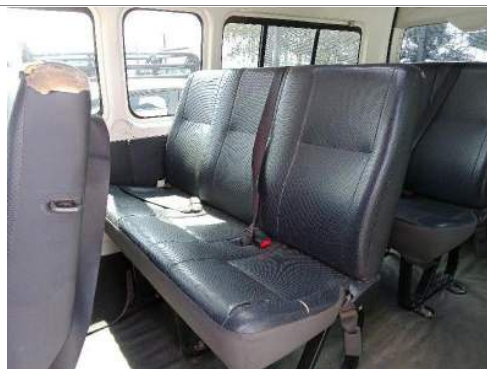
| Damage | Repair Way |
|---|---|
| Seat Rear Damaged | Repair |

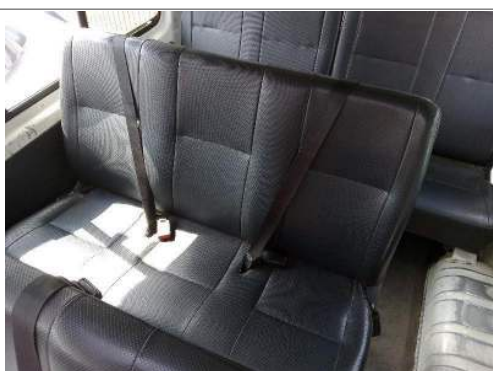
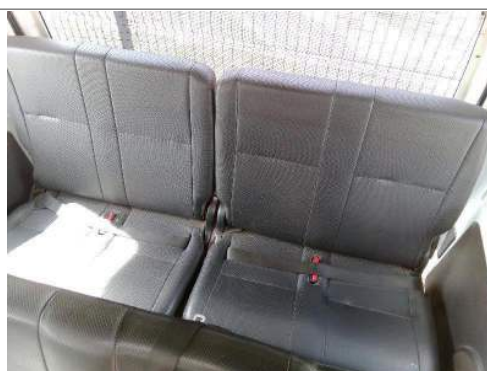
| Damage | Repair Way |
|---|---|
| Seat Rear ( 2. Row) Damaged | Repair |

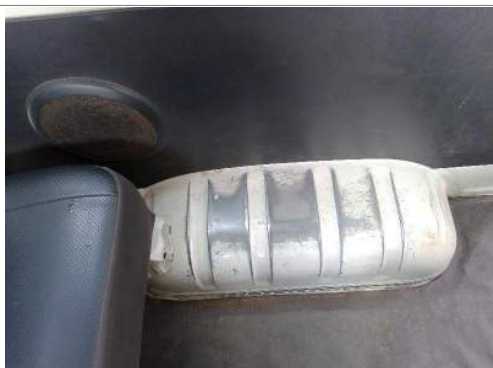
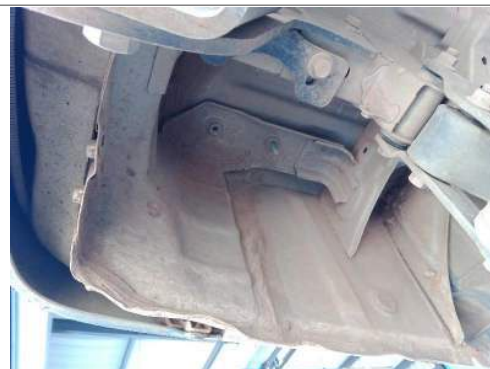
| Damage | Repair Way |
|---|---|
| Rear Fender Left / Inner Tray Damaged | Repair |

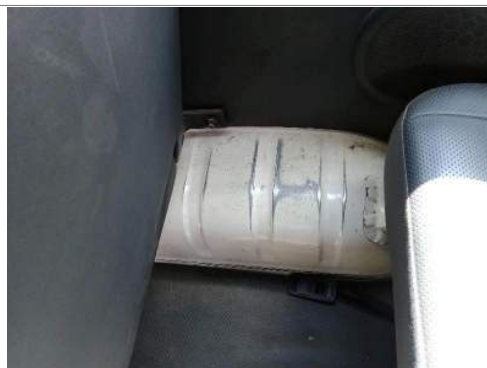
| Damage | Repair Way |
|---|---|
| Rear Fender Right / Inner Tray Paintwork • Scratched | Repair |

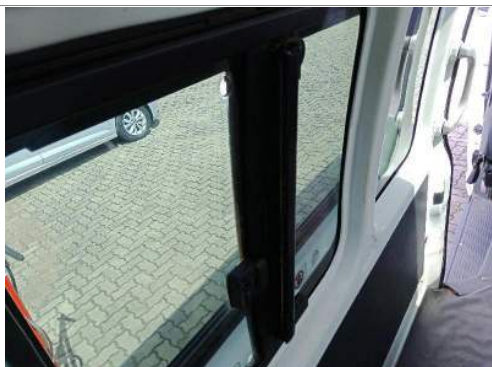
| Damage | Repair Way |
|---|---|
| Window Rear Door Left Defective | Repair |

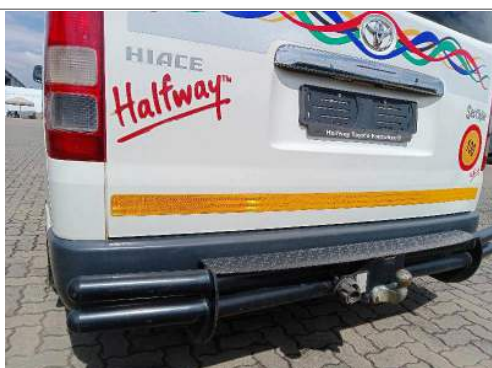
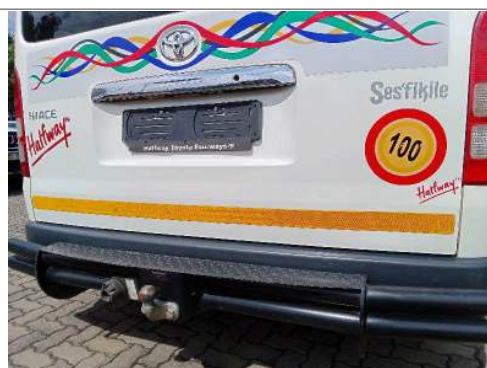
| Damage | Repair Way |
|---|---|
| Rear bumper Damaged | Repair |
| Body and Exterior | Signs of impact damage to rear of vehicle |

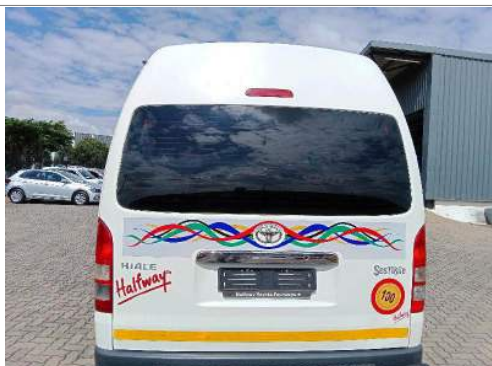
| Damage | Repair Way |
|---|---|
| Boot Lid / Hatch door Dented | Repair |

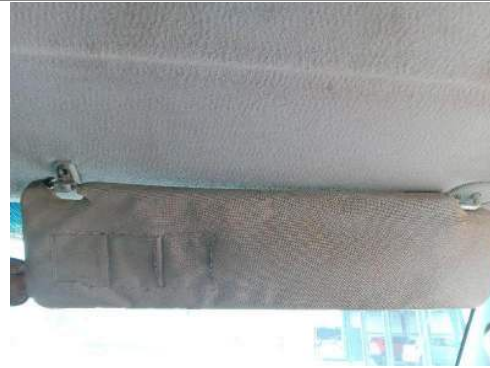
| Damage | Repair Way |
|---|---|
| Sun Visor Right Damaged | Repair |

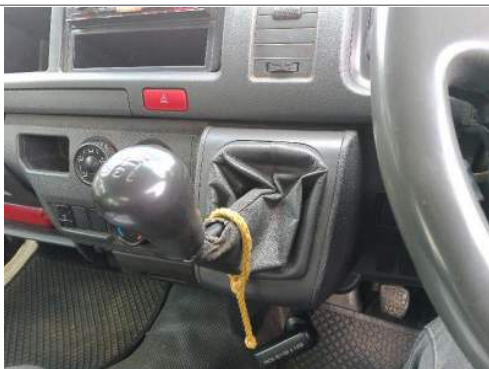
| Damage | Repair Way |
|---|---|
| Gear Lever Dust Boot Damaged | Repair |

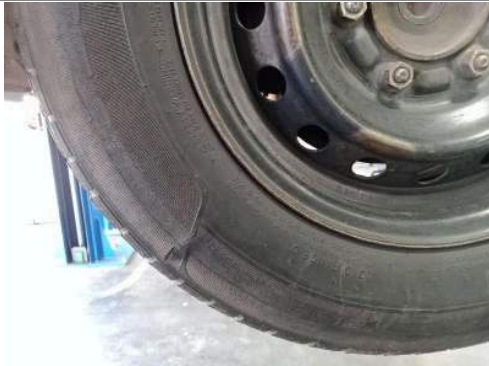
| Damage | Repair Way |
|---|---|
| Tyre Front Right Torn / Cut | Replace |

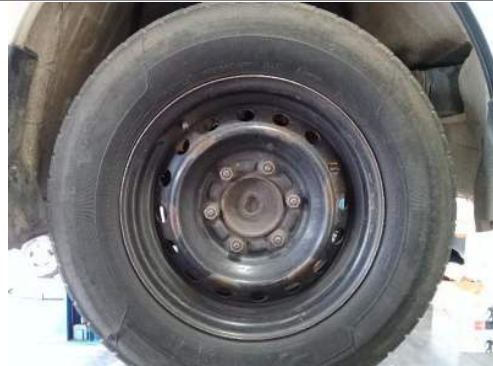
| Damage | Repair Way |
|---|---|
| Rim Front Right Dented | Repair |

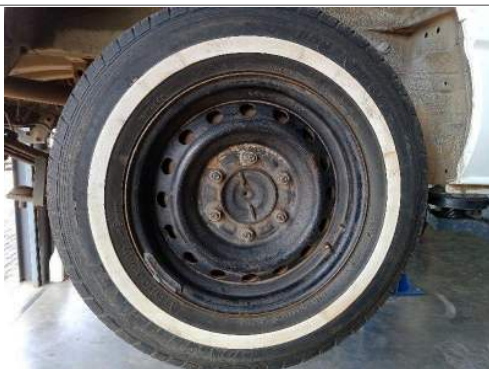
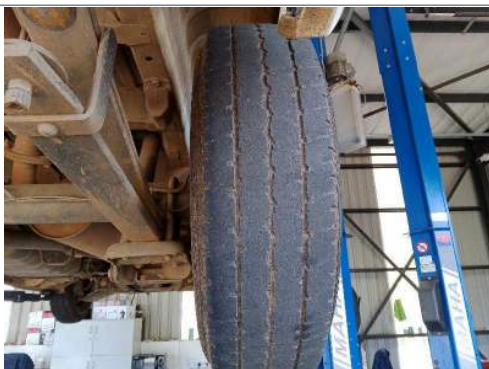
| Damage | Repair Way |
|---|---|
| Tyre Rear Right Damaged | Replace |

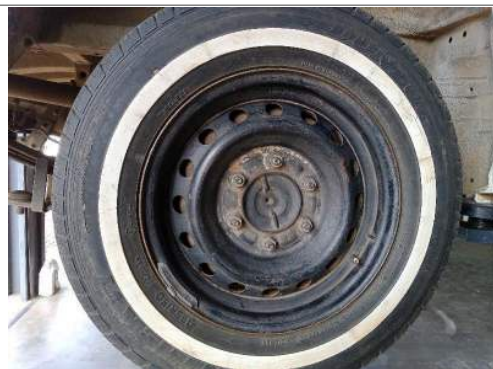
| Damage | Repair Way |
|---|---|
| Rim Rear Right Scratched | Repair |

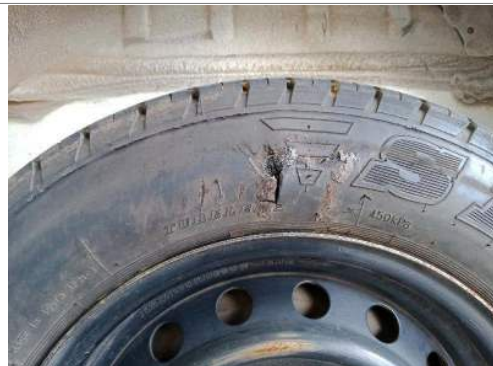
| Damage | Repair Way |
|---|---|
| Tyre Rear Left Damaged | Replace |

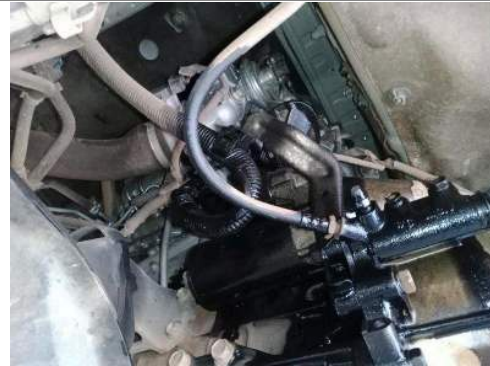
| Damage | Repair Way |
|---|---|
| Engine Oil Leak | Repair |

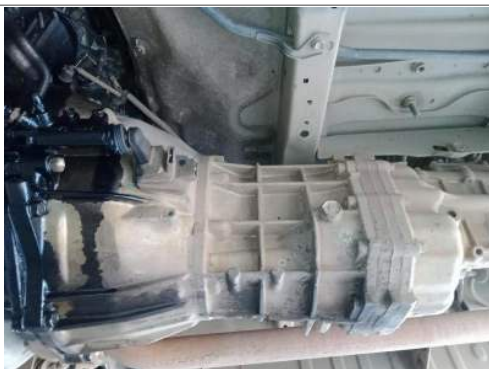
| Damage | Repair Way |
|---|---|
| Gearbox Oil Leak | Repair |

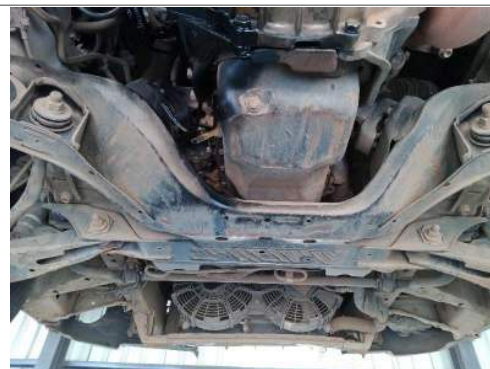
| Damage | Repair Way |
|---|---|
| Sub Frame Dented | Repair |

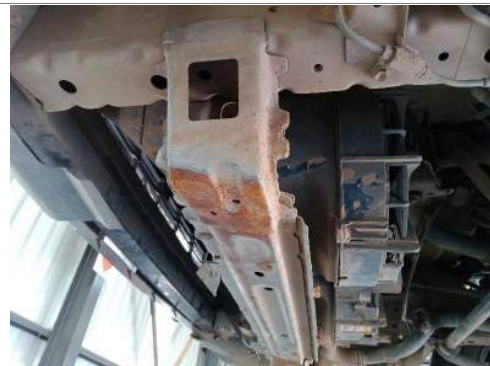
| Damage | Repair Way |
|---|---|
| Radiator Cradle Damaged | Repair |

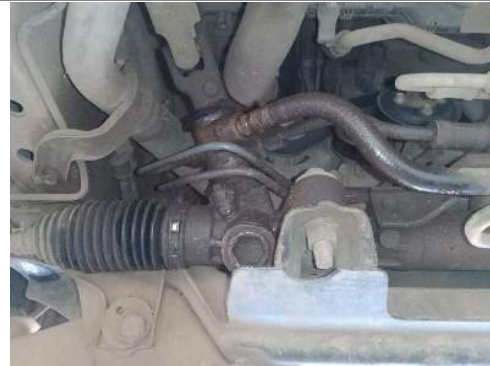
| Damage | Repair Way |
|---|---|
| Steering Rack Defective | Replace |

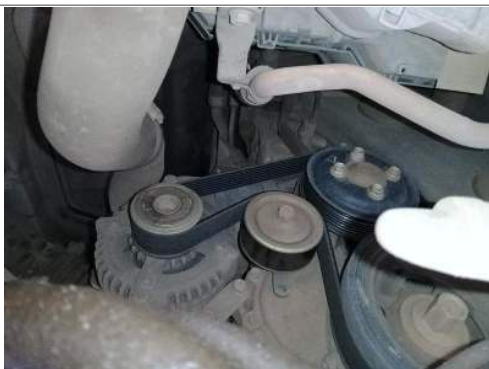
| Damage | Repair Way |
|---|---|
| Fan Belt Defective | Replace |

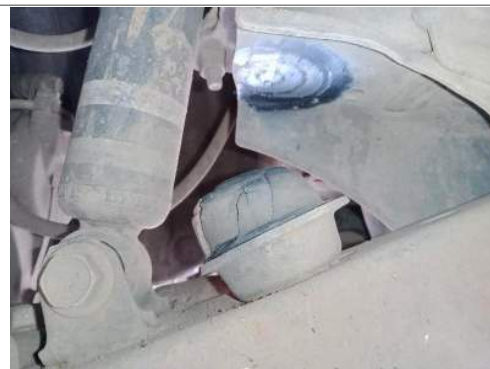
| Damage | Repair Way |
|---|---|
| Rebound Rubber Front Axle Right Cracked | Replace |

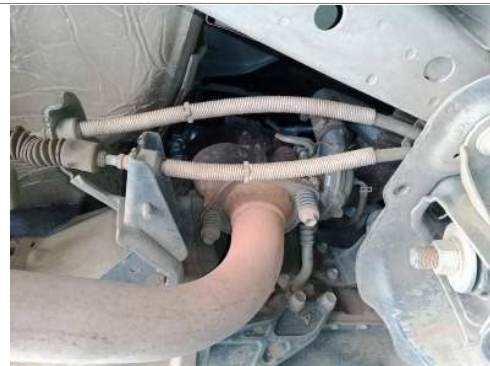
| Damage | Repair Way |
|---|---|
| Catalytic converter Missing | Replace |

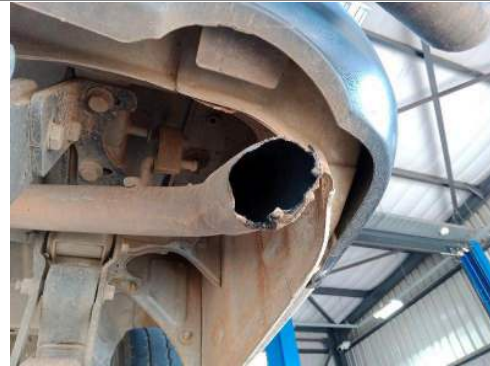
| Damage | Repair Way |
|---|---|
| Engine to silencer pipe Damaged | Repair |

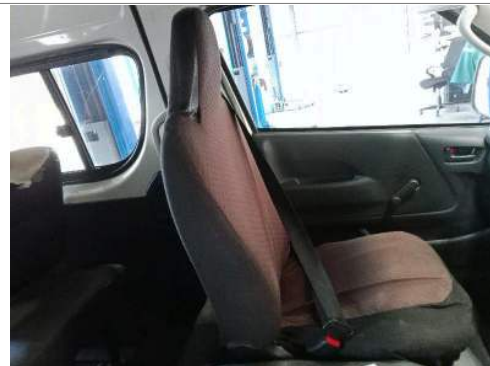
| Damage | Repair Way |
|---|---|
| Seat Front Left Defective | Repair |

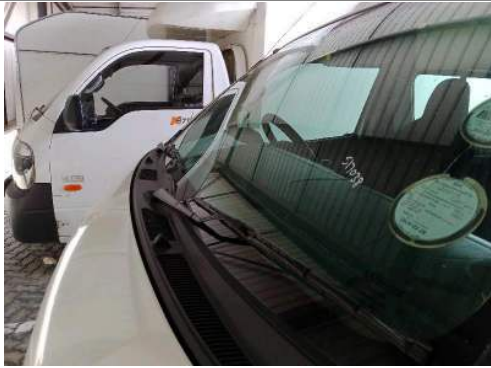
| Damage | Repair Way |
|---|---|
| Windscreen Wiper Damaged | Replace |
