CONDITION REPORT

Report No:  
2017306428  
DATE  
02/10/2026

| Manufacturer | TOYOTA | Registration Number | KF05YRGP |
| Model | HI-ACE 2.5 SESFIKILE 16-S DSL MINIBUS [2020-2022] | Register Number | |

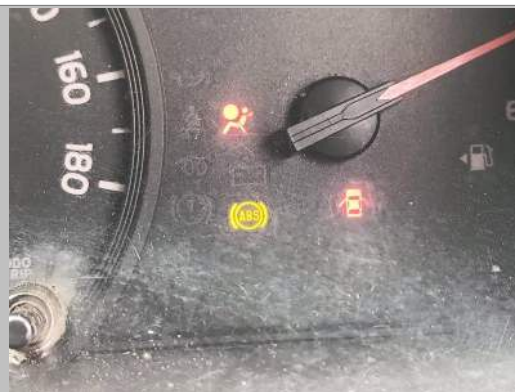
| Warning lights illuminated | Repair |

Warning lights illuminated

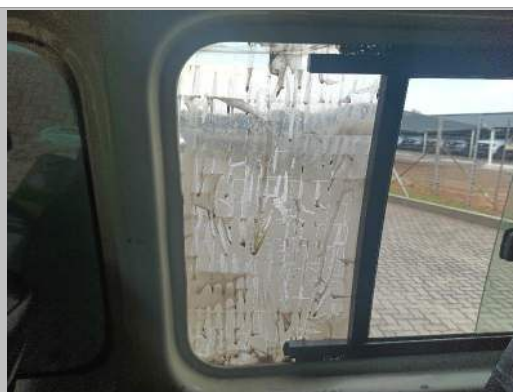
| R/R window is broken | Replace |

R/R window broken

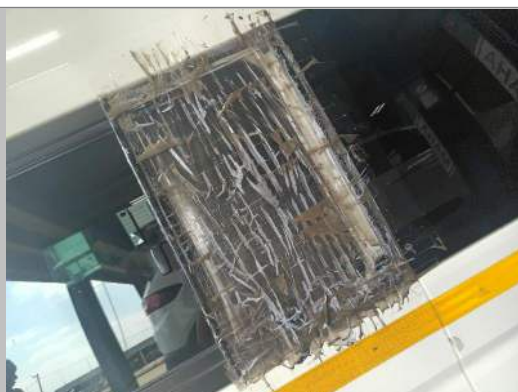
R/R window broken

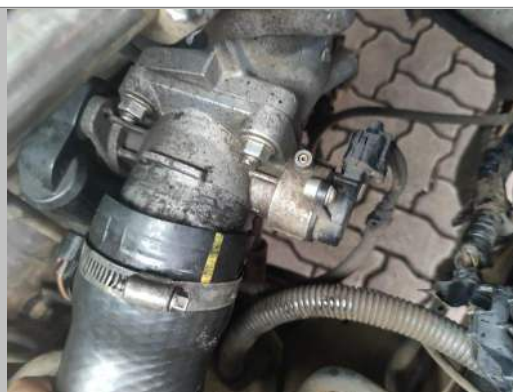
| Hoses Damaged | Repair |

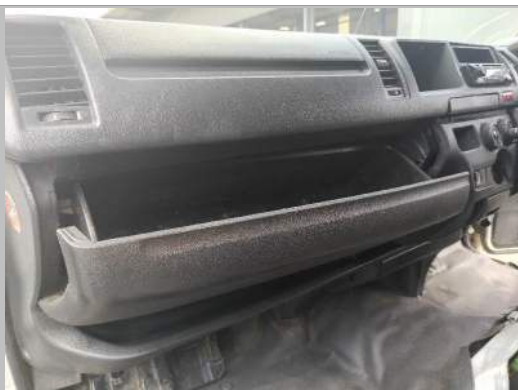
| Center Console / Cubbyhole + Lid Damaged | Replace |

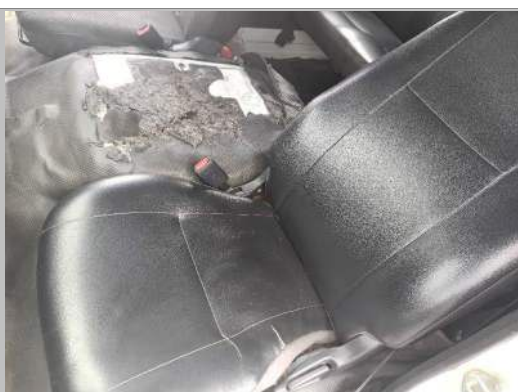
| Seat Front Left Torn / Cut | Repair |

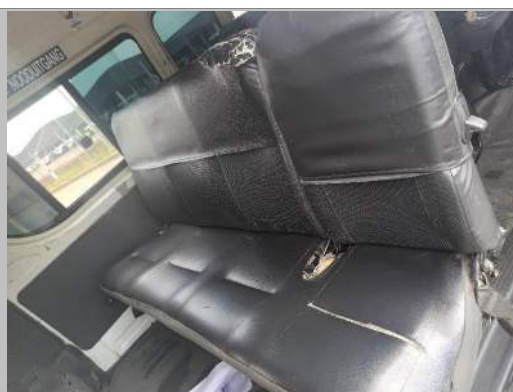
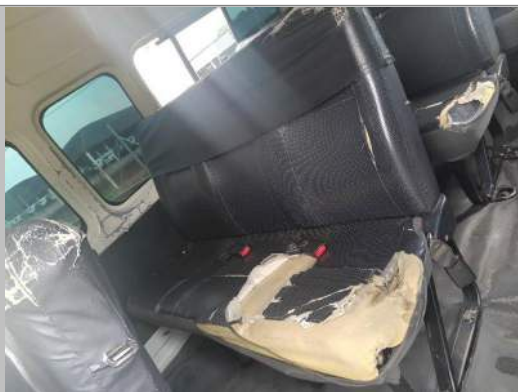
| Seat Rear Torn / Cut | Repair |

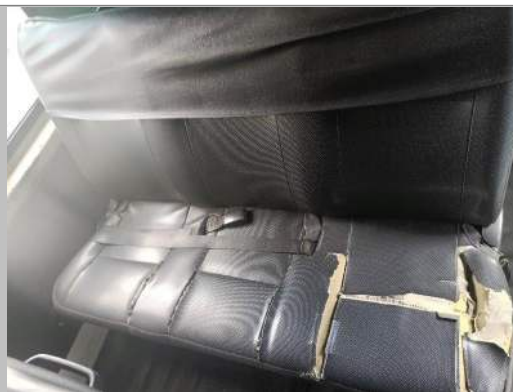
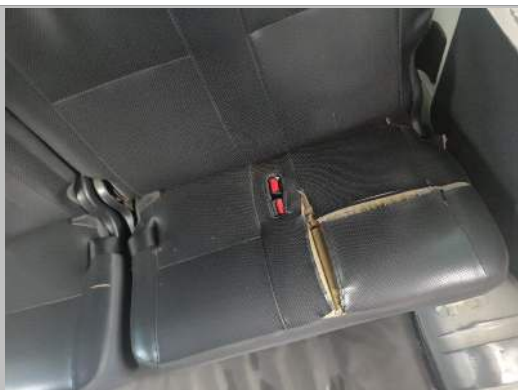
| Seat Rear ( 2. Row) Torn / Cut | Repair |

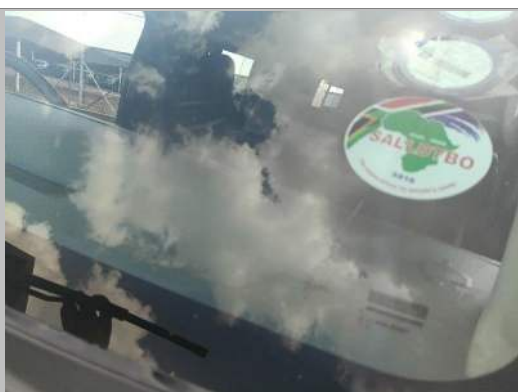
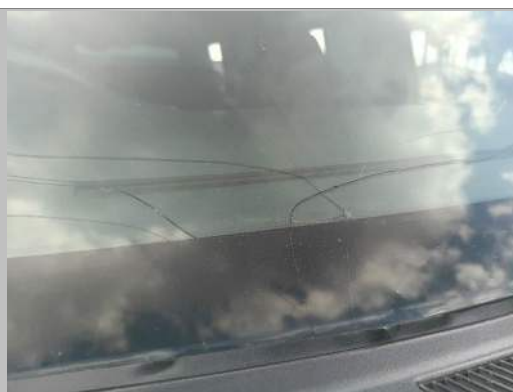
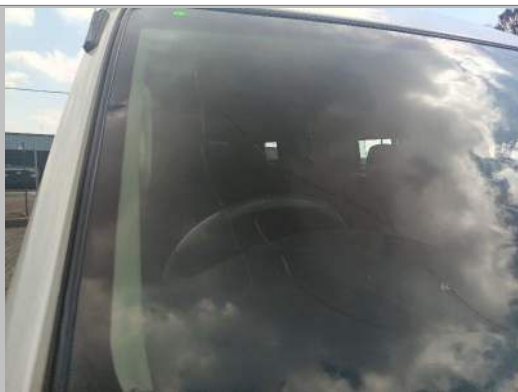
| Windscreen Cracked | Replace |

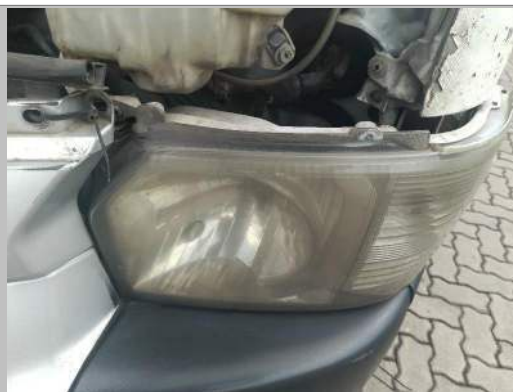
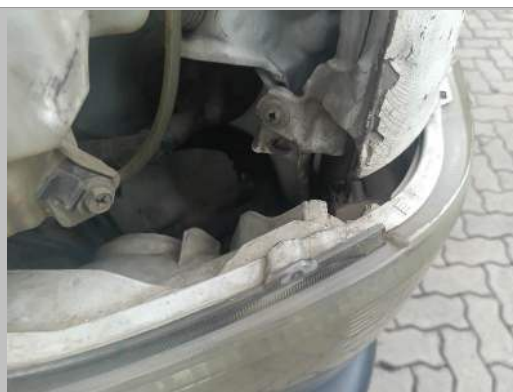
| Headlight Left Damaged | Replace |

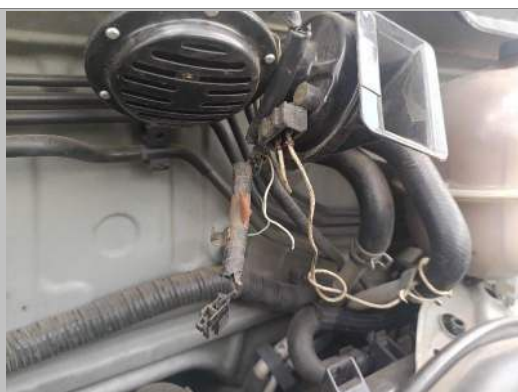
| Engine Wiring Defective | Repair |

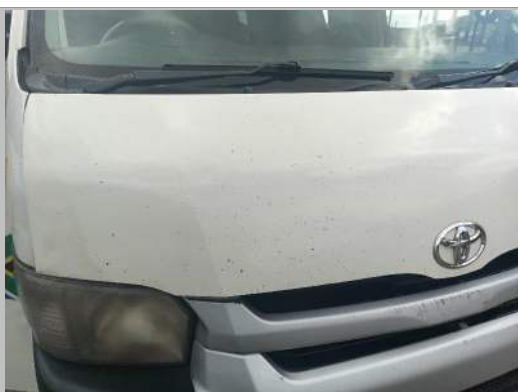
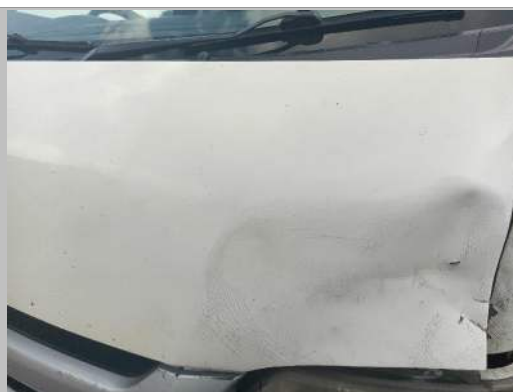
| Bonnet Paintwork • Chipmarks | Repair |

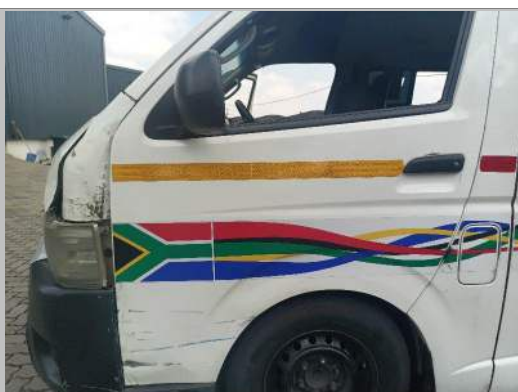
| Door Front Left Paintwork • Scratched | Repair |

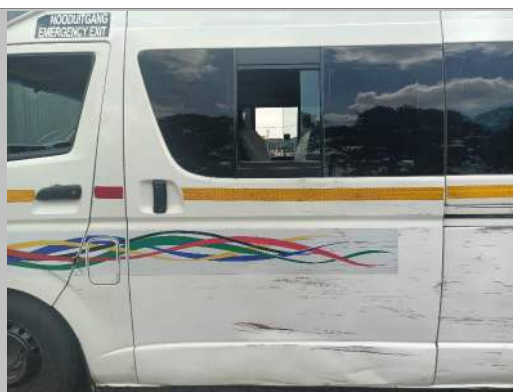
| Sliding Door Paintwork • Scratched | Repair |

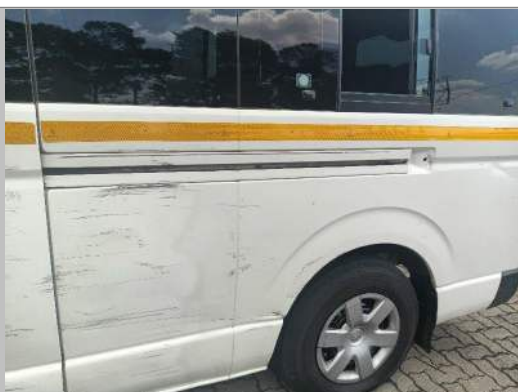
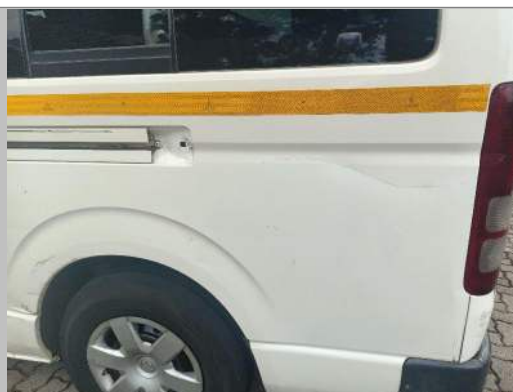
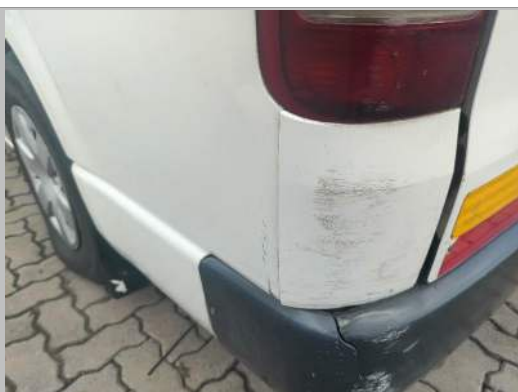
| Rear Fender Left Paintwork • Scratched | Repair |

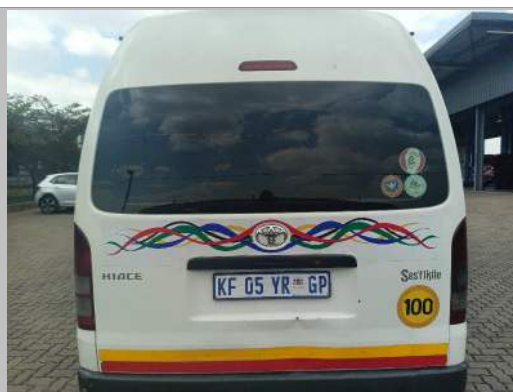
| Boot Lid / Hatch door Dented | Repair |

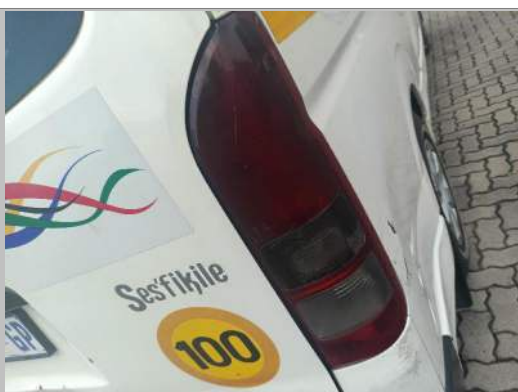
| Tail Light Right Cracked | Replace |

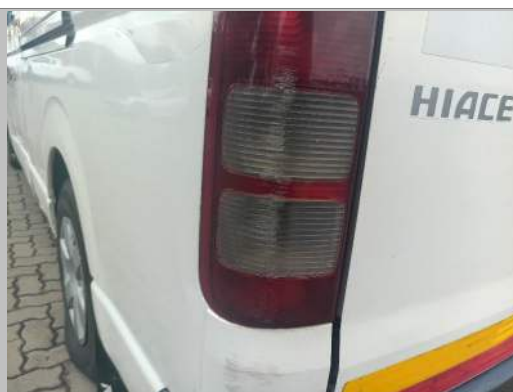
| Tail Light Left Cracked | Replace |

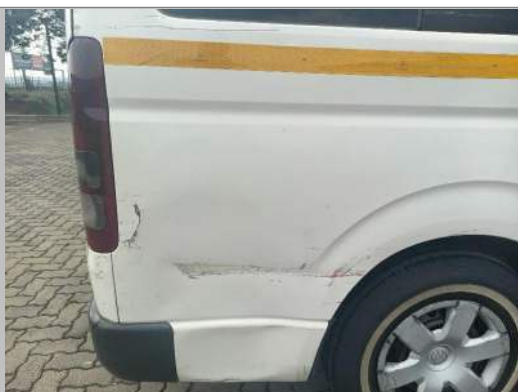
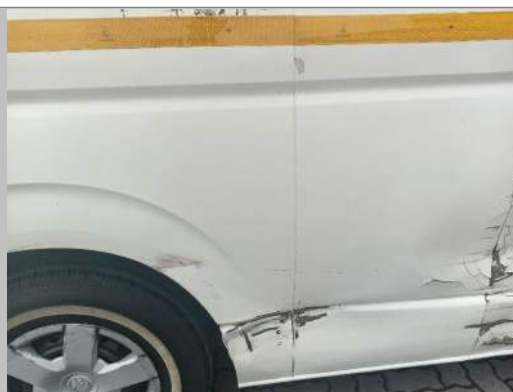
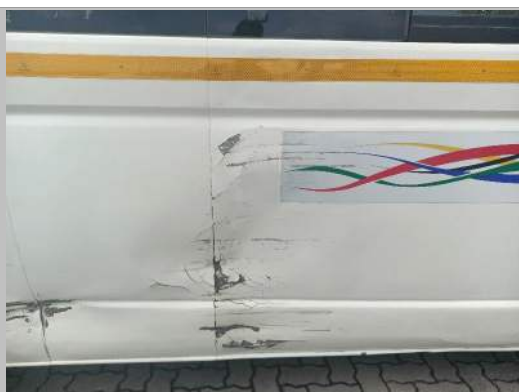
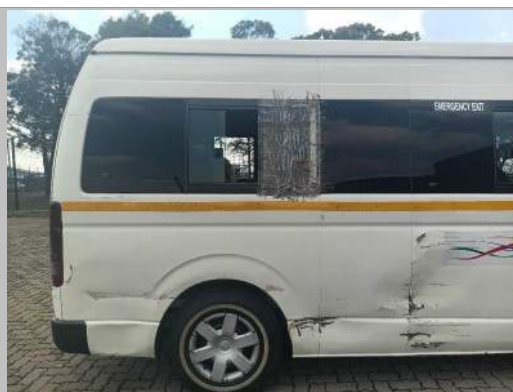
| Rear Fender Right Damaged | Repair |

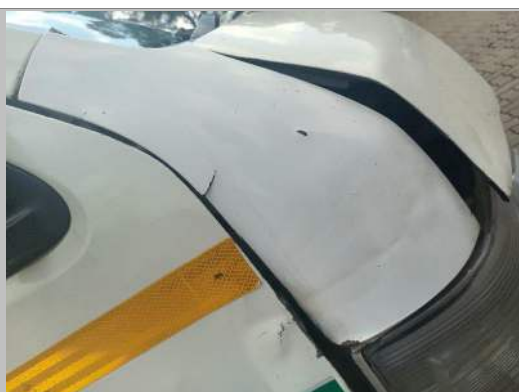
| Front Fender Right Damaged | Repair |

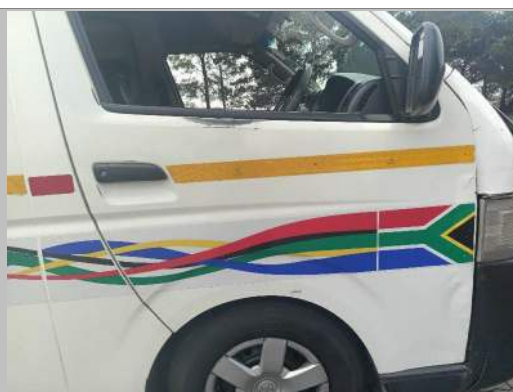
| Door Front Right Dented | Repair |

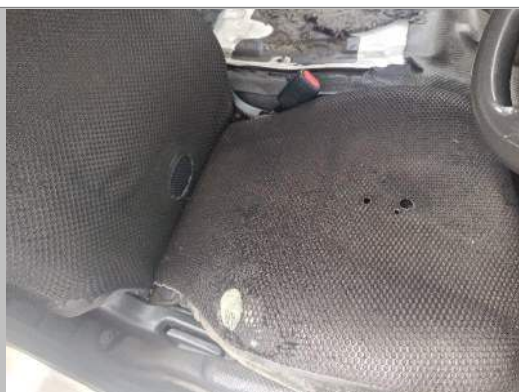
| Seat Front Right Torn / Cut | Repair |

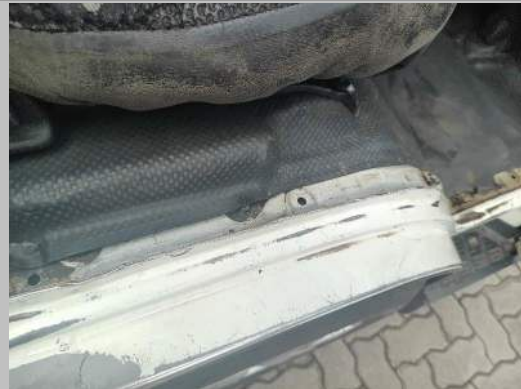
| Door Sealing Rubber Front Right Missing | Repair |

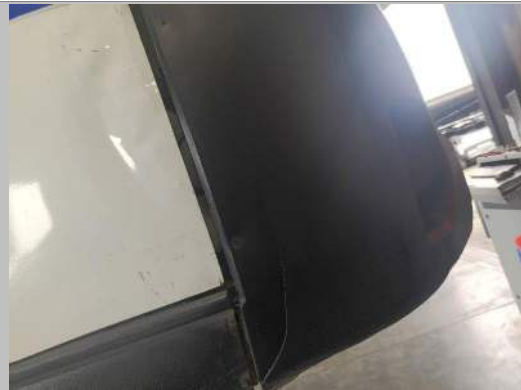
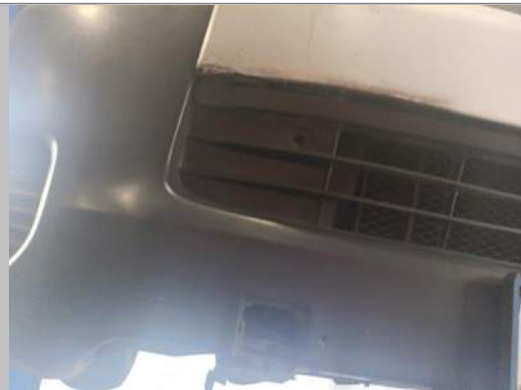
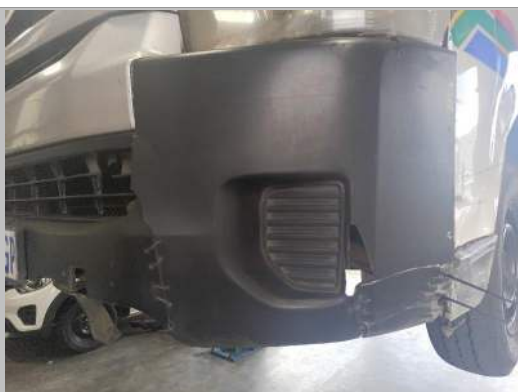
| Front Bumper Damaged | Repair |

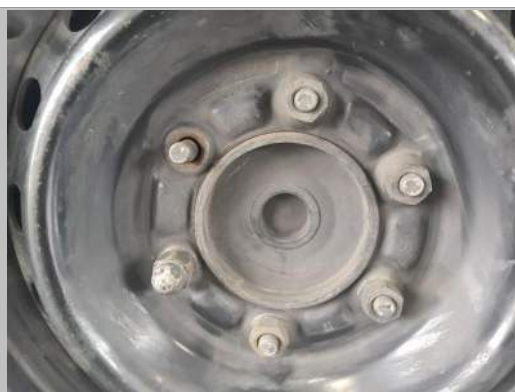
| Bolt(s) / Nut(s) Front Wheel Left Missing | Replace |

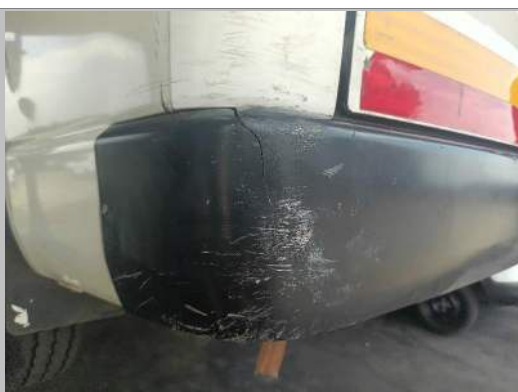
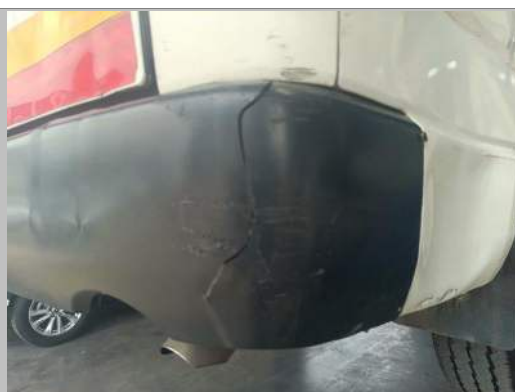
| Rear bumper Damaged | Repair |

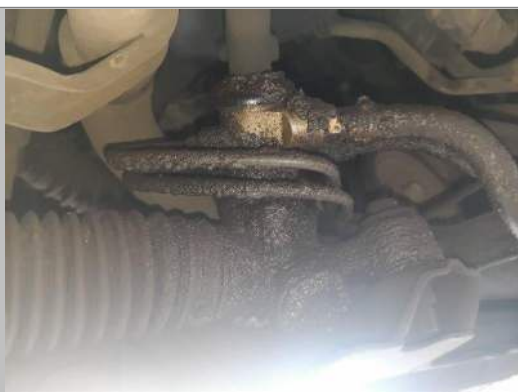
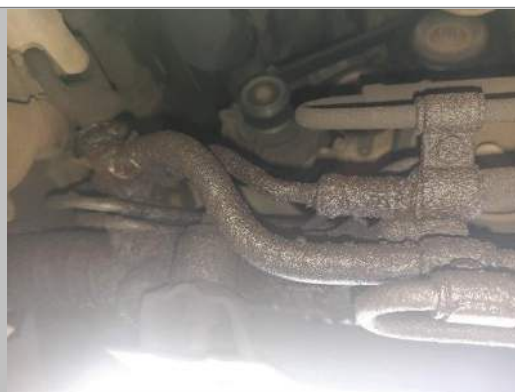
| Hydraulics System Leak | Repair |

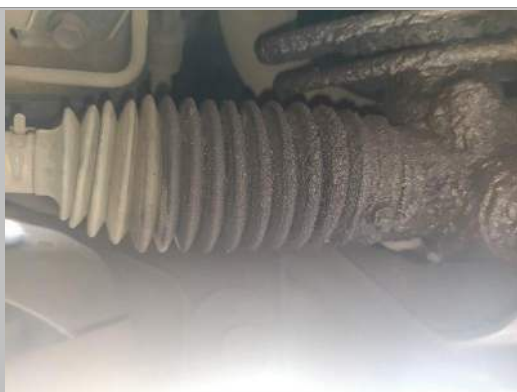
| Steering Rack Boot Right Leak | Repair |

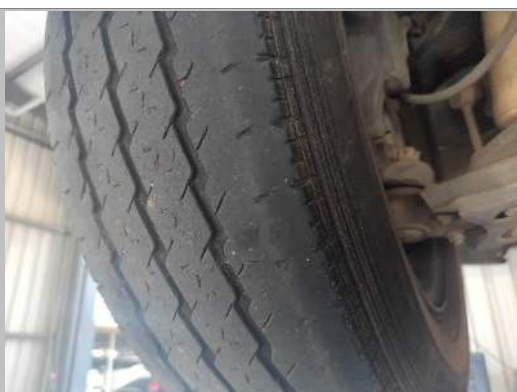
| Tyre Front Left Smooth | Replace |

| | Size | Load/Speed Index | Manufacture | Model | Type* | Production Date | Tread Depth (mm) |
|---|---|---|---|---|---|---|---|
| Front Left | 195R15 | 106/104R | Annaite | AC838 | V | 0000 | 0 mm |

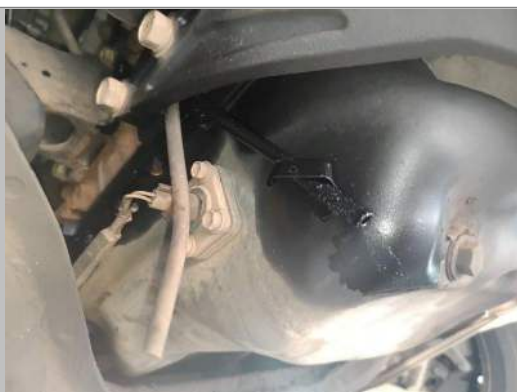
| Engine Oil Leak | Repair |
| Engine Smoke Excessive | Repair |

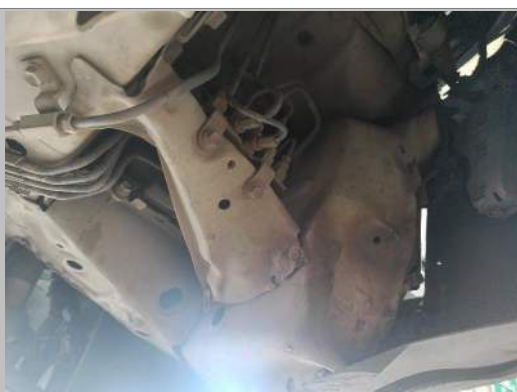
| Front Fender Left / Inner Tray Damaged | Replace |

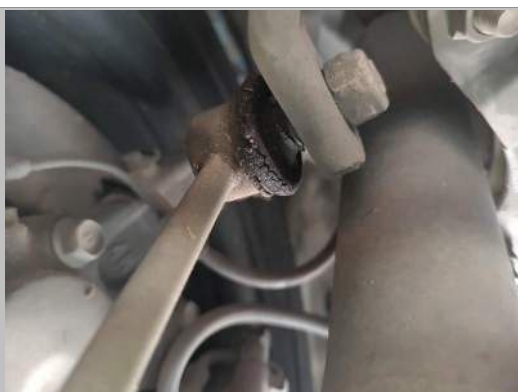
| Stabilizer Mounting Front Right Damaged | Replace |

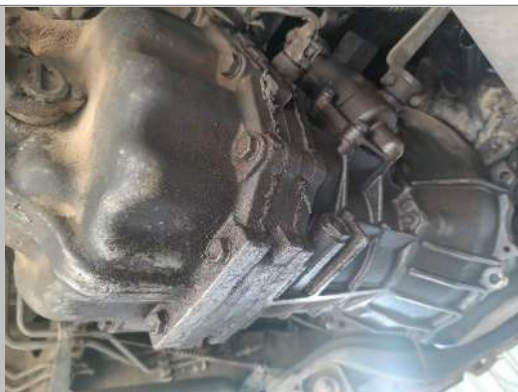
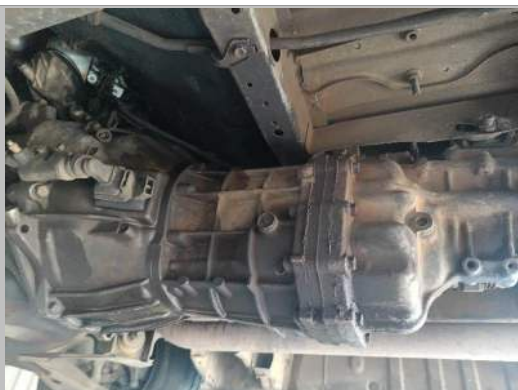
| Gearbox Oil Leak | Repair |

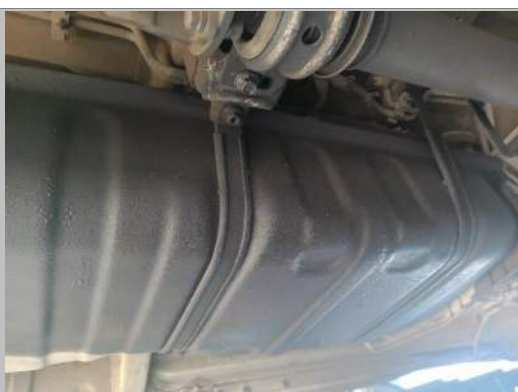
| Fuel Tank Sweat | Repair |

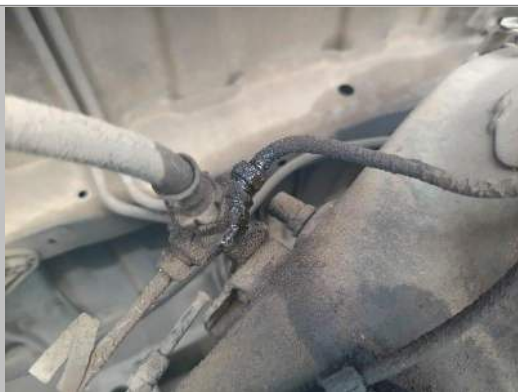
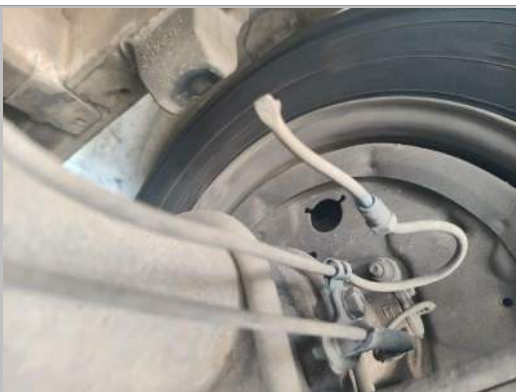
| Brake Piping Leak | Replace |

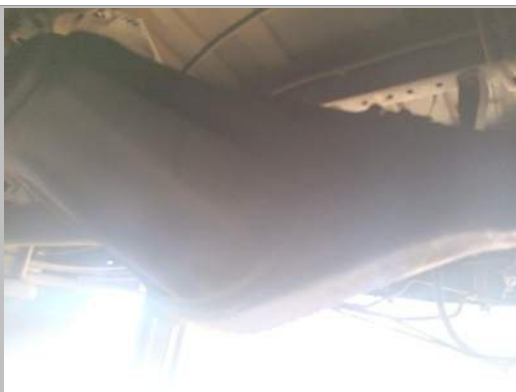
| Differential Oil Sweat | Repair |
