CONDITION REPORT

Report No:  
2017165812  
DATE  
20/02/2026

MFC Auction House  
M57 Pretoria Rd, Glenmarais, KEMPTON PARK  
Gauteng

| Manufacturer | TOYOTA | Registration Number | KYH098MP |

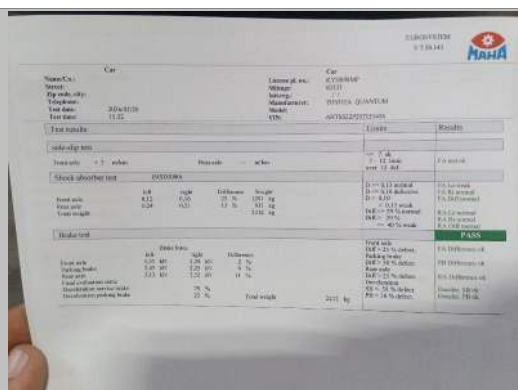
Brake test.

| Damage | Repair Way |
|---|---|
| Brakes Insufficient | Repair |

| | Left | Right | | |
|---|---|---|---|---|
| Front | 5.35 | 5.24 | - | |
| Rear | 3.13 | 3.52 | - | |
| Emergency / Parking | 2.45 | 2.25 | - | |

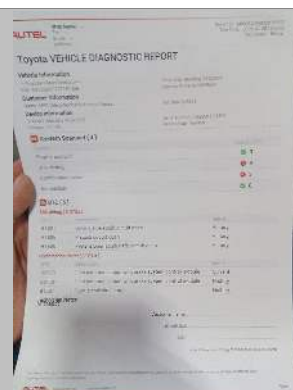
Diagnostic.

| No | System | Code | Description | Status |
|---|---|---|---|---|
| 1 | SRS AIRBAG | B1801 | DRIVING SIDE SQUIB CIRCUIT OPEN | |

THIS REPORT HAS BEEN DRAWN UP IMPARTIALLY AND TO THE BEST OF OUR KNOWLEDGE  
6 DTC'S AT TIME OF TESTIN  
G SEE DTC REPORT.

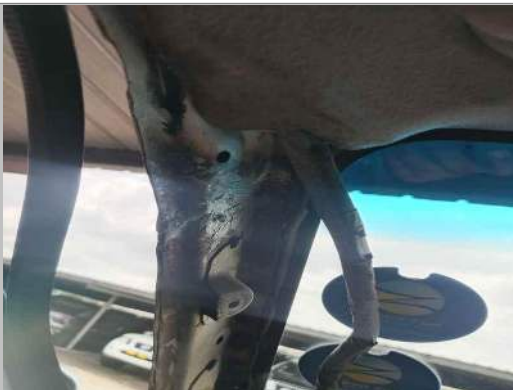
General Comments: ACCORDING TO THE AGE AND MILEAGE OF THE VEHICLE, NORMAL WEAR AND TEAR MARKS ARE VISIBLE ON THE INTERIOR, EXTERIOR, ELECTRICAL AND MECHANICAL PARTS. VEHICLE IS A CUT AND JOIN. Body • Exterior: Minor dents and scratches and stone chips to some body panels. Signs of repair work done to somebody panels. Repair work done to vehicle below standard. Signs of impact damage to front of vehicle.

vehicle is a cut and join

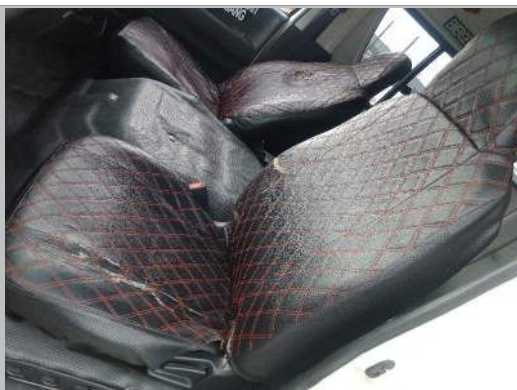
| Damage | Repair Way |
|---|---|
| Seat Front Left Worn | Repair |

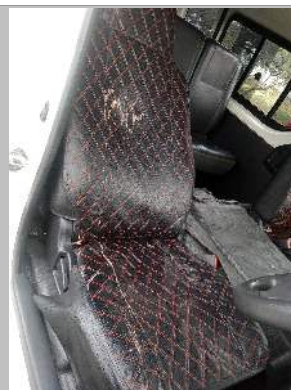
| Damage | Repair Way |
|---|---|
| Seat Front Right Worn | Repair |

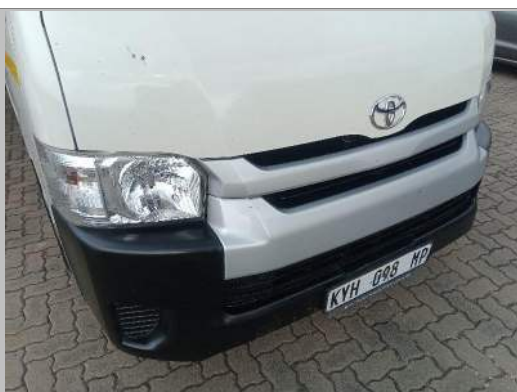
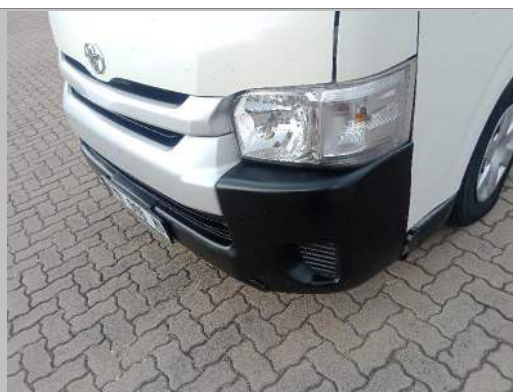
| Damage | Repair Way |
|---|---|
| Front Bumper Damaged | Repair |

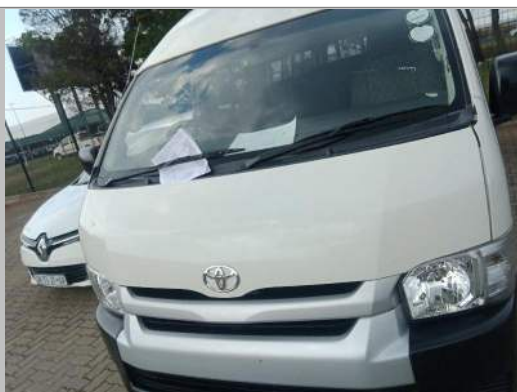
| Damage | Repair Way |
|---|---|
| Bonnet Damaged | Repair |

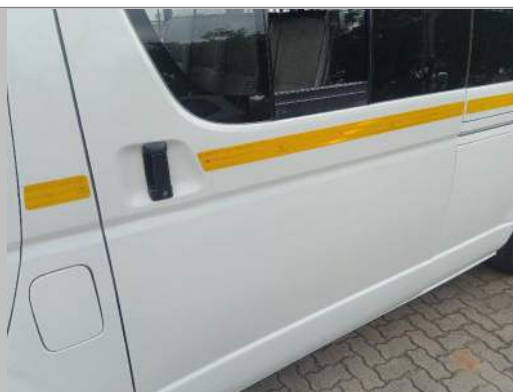
| Damage | Repair Way |
|---|---|
| Door Rear Left Damaged | Repair |

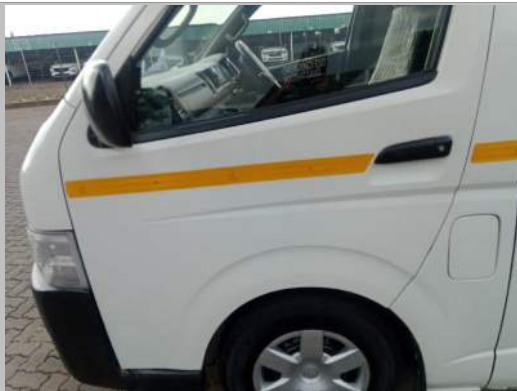
| Damage | Repair Way |
|---|---|
| Door Front Left Damaged | Repair |

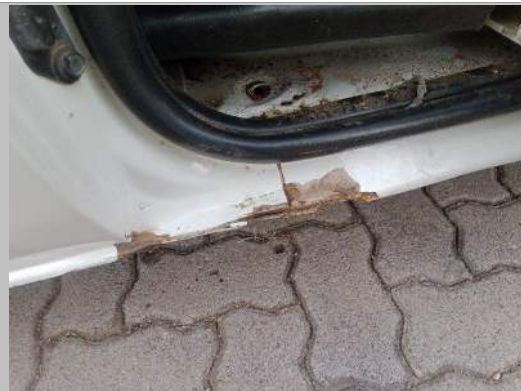
| Damage | Repair Way |
|---|---|
| Sill Panel Left Damaged | Repair |

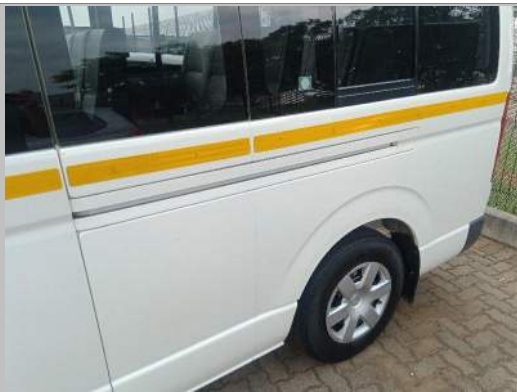
| Damage | Repair Way |
|---|---|
| Rear Fender Left Damaged | Repair |

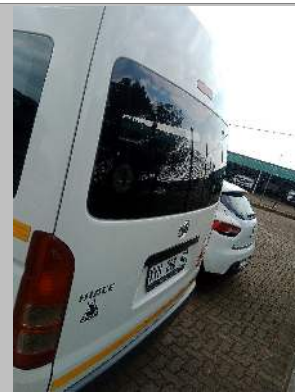
| Damage | Repair Way |
|---|---|
| Boot Lid / Hatch door Damaged | Repair |

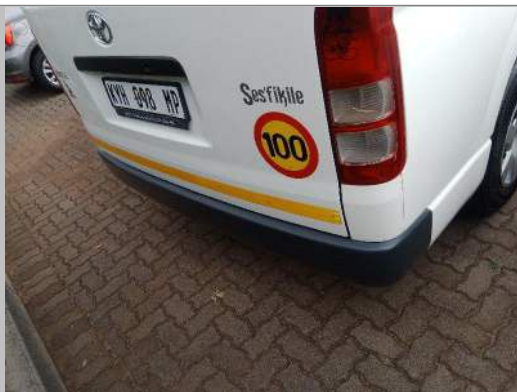
| Damage | Repair Way |
|---|---|
| Rear bumper Damaged | Repair |

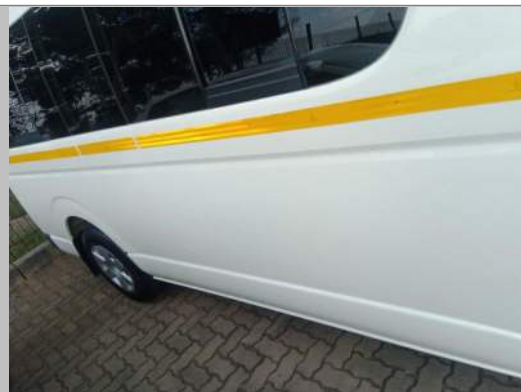
| Damage | Repair Way |
|---|---|
| Rear Fender Right Damaged | Repair |

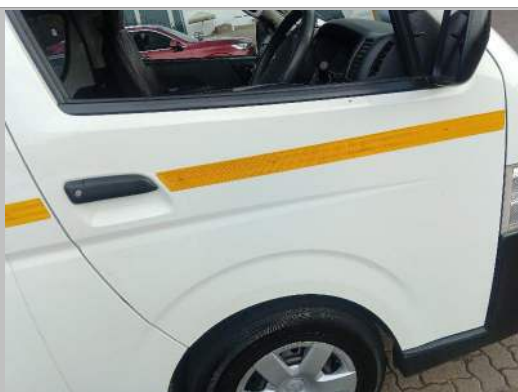
| Damage | Repair Way |
|---|---|
| Door Front Right Damaged | Repair |

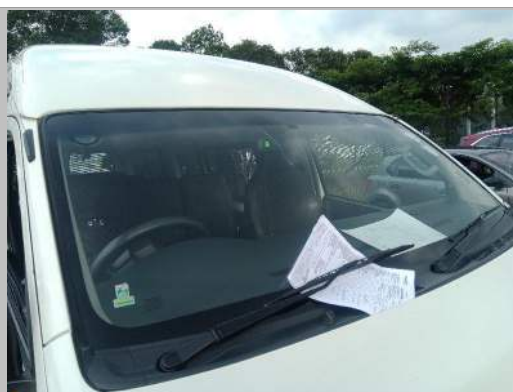
| Damage | Repair Way |
|---|---|
| Windscreen Damaged | Replace |

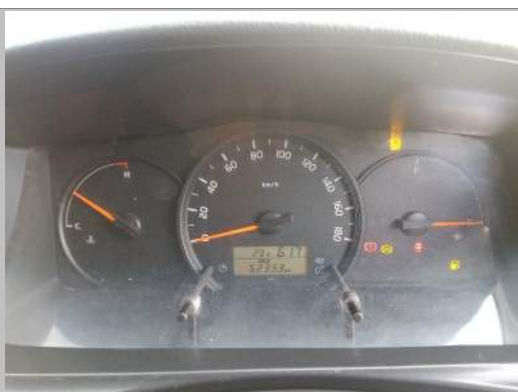
| Damage | Repair Way |
|---|---|
| Engine Management Lights Set | Repair |

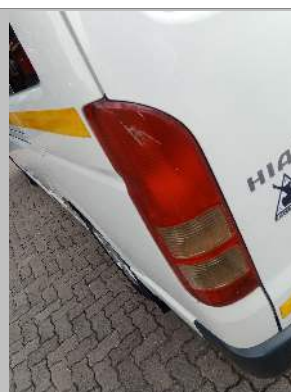
| Damage | Repair Way |
|---|---|
| Tail Light Left Damaged | Replace |

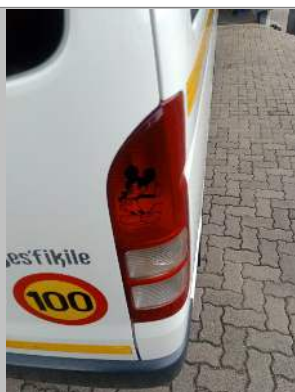
| Damage | Repair Way |
|---|---|
| Tail Light Right Damaged | Replace |

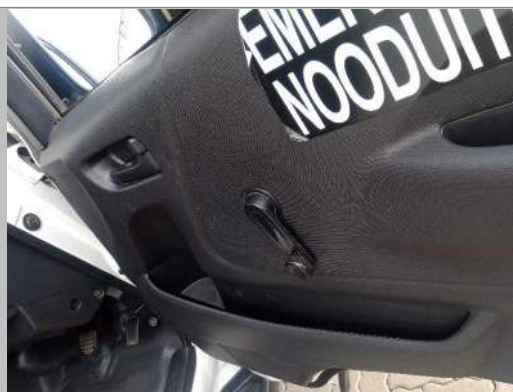
| Damage | Repair Way |
|---|---|
| Window Winder front right Damaged | Replace |

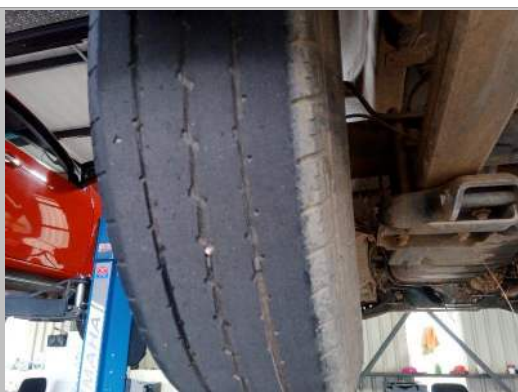
| Damage | Repair Way |
|---|---|
| Tyre Rear Left Worn | Replace |

| | Size | Load/Speed Index | Manufacture | Model | Type* | Production Date | Tread Depth (mm) |
|---|---|---|---|---|---|---|---|
| Rear Left | 195R15C | 104S | Toyo | Radial | V | 2323 | 0 mm |

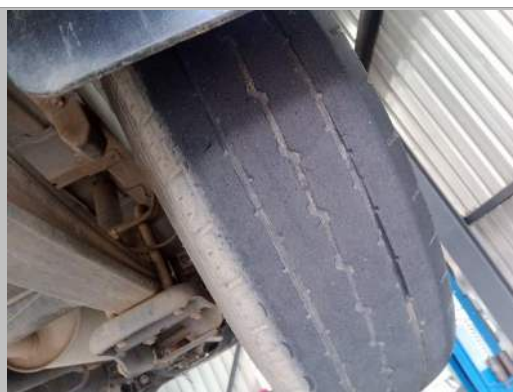
| Damage | Repair Way |
|---|---|
| Tyre Rear Right Worn | Replace |

| | Size | Load/Speed Index | Manufacture | Model | Type* | Production Date | Tread Depth (mm) |
|---|---|---|---|---|---|---|---|
| Rear Right | 195R15C | 104S | Toyo | Radial | V | 2223 | 0 mm |

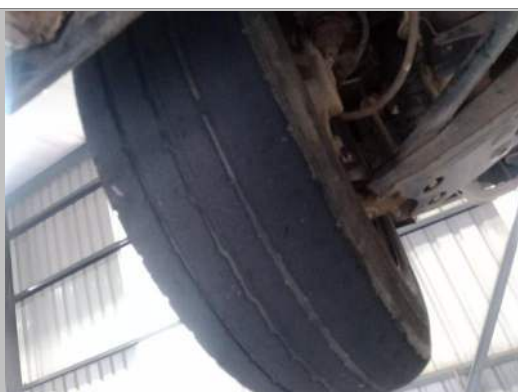
| Damage | Repair Way |
|---|---|
| Tyre Front Left Worn | Replace |

| | Size | Load/Speed Index | Manufacture | Model | Type* | Production Date | Tread Depth (mm) |
|---|---|---|---|---|---|---|---|
| Front Left | 195R15C | 104S | Toyo | Radial | V | 2123 | 0 mm |

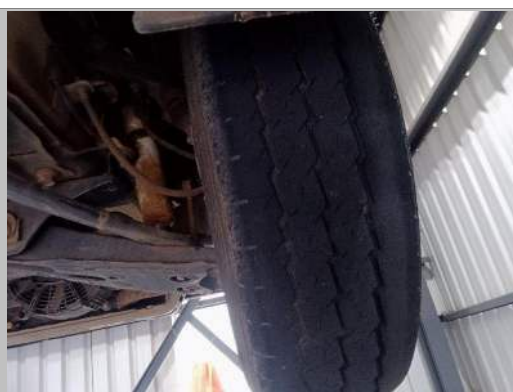
| Damage | Repair Way |
|---|---|
| Tyre Front Right Worn | Replace |

| | Size | Load/Speed Index | Manufacture | Model | Type* | Production Date | Tread Depth (mm) |
|---|---|---|---|---|---|---|---|
| Front Right | 195R15C | 104R | Autogrip | Radial | V | 0325 | 0 mm |

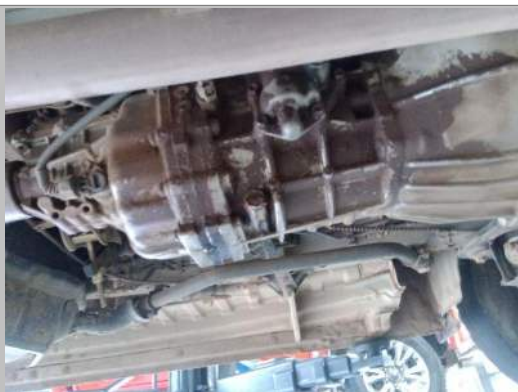
| Damage | Repair Way |
|---|---|
| Gearbox Oil Leak | Repair |

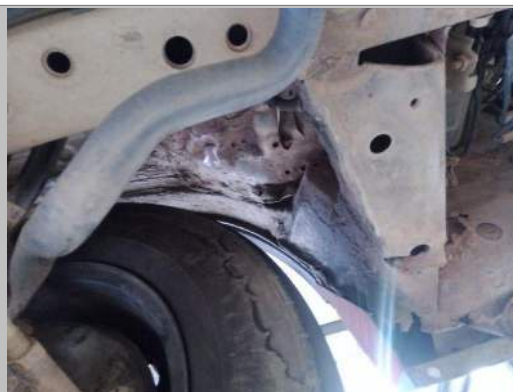
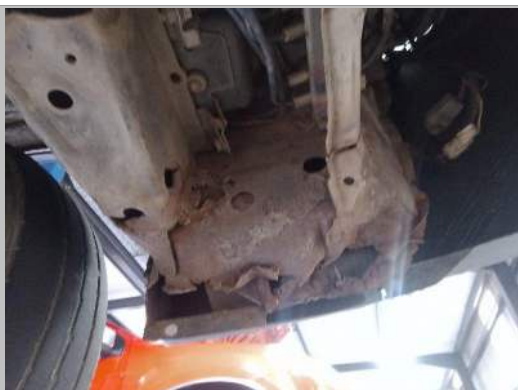
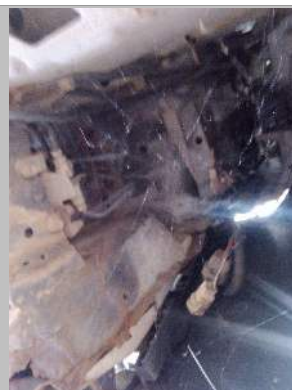
| Damage | Repair Way |
|---|---|
| Front Fender Left / Inner Tray Damaged | Replace |
