## CONDITION REPORT

Report No:  
2017305252  
DATE  
30/09/2026

| Manufacturer | TOYOTA | Registration Number | LD21KFGP |
| Model | HI-ACE 2.5 SESFIKILE 16-S DSL MINIBUS [2021-2024] | Register Number | |

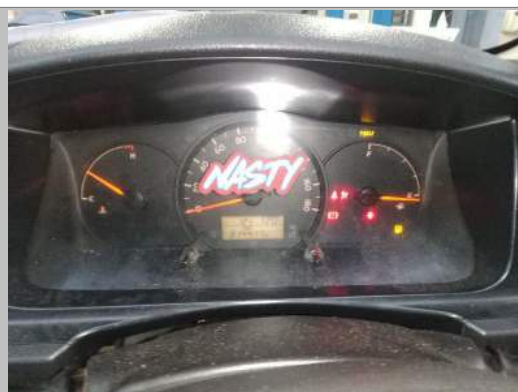
DASHBOARD (W/ ENGINE RUNNING)

| Warning light illuminated | Repair |

| No | System | Code | Description | Status |
|---|---|---|---|---|
| 1 | CURRENT | B1801 | DRIVING SIDE SQUIB CIRCUIT OPEN | |

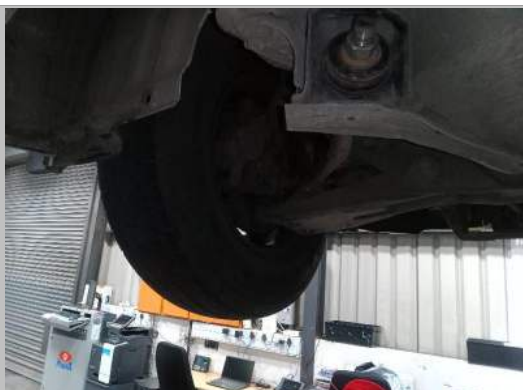
LF TYRE TREAD

| | Size | Load/Speed Index | Manufacture | Model | Type* | Production Date | Tread Depth (mm) |
|---|---|---|---|---|---|---|---|
| Front Left | 195R15 | 106/104S | Toyo | Ho7 | V | 0325 | 2 mm |

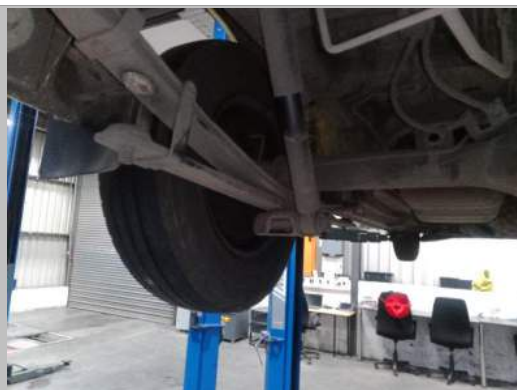
LR TYRE TREAD

| | Size | Load/Speed Index | Manufacture | Model | Type* | Production Date | Tread Depth (mm) |
|---|---|---|---|---|---|---|---|
| Rear Left | 195R15 | 106/104S | Toyo | Ho7 | V | 0925 | 3 mm |

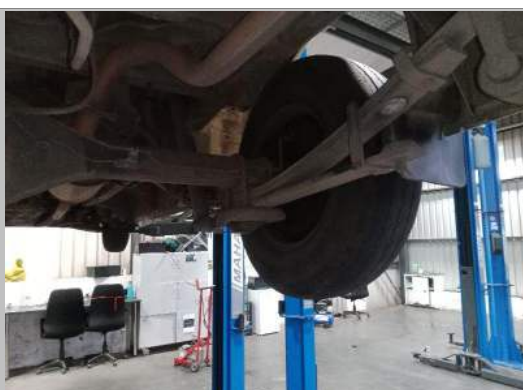
RR TYRE TREAD

| | Size | Load/Speed Index | Manufacture | Model | Type* | Production Date | Tread Depth (mm) |
|---|---|---|---|---|---|---|---|
| Rear Right | 195R15 | 106/104S | Toyo | Ho7 | V | 2025 | 2 mm |

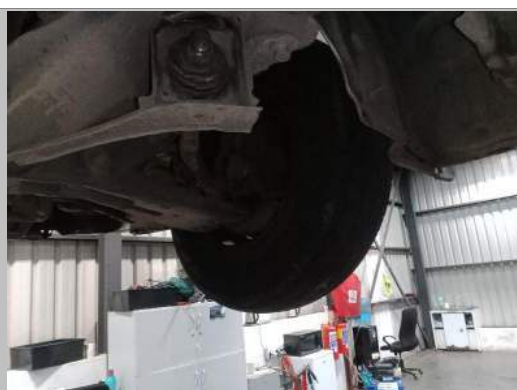
RF TYRE TREAD

| | Size | Load/Speed Index | Manufacture | Model | Type* | Production Date | Tread Depth (mm) |
|---|---|---|---|---|---|---|---|
| Front Right | 195R15 | 106/104S | Toyo | Ho7 | V | 1124 | 1 mm |

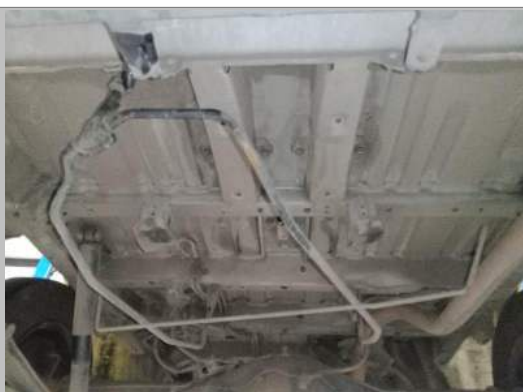
No spare wheel

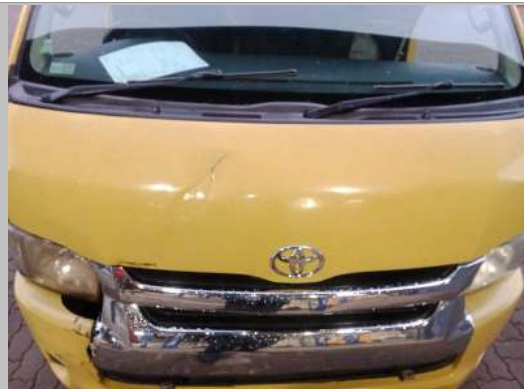
| Bonnet Dented | Repair |

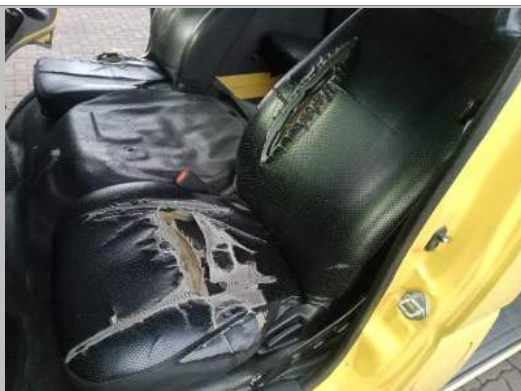
| Seat Front Left Damaged | Repair |

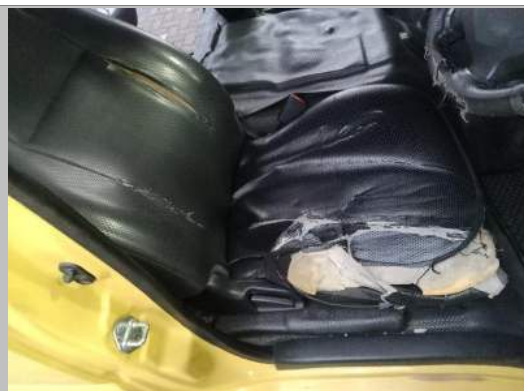
| Seat Front Right Damaged | Repair |

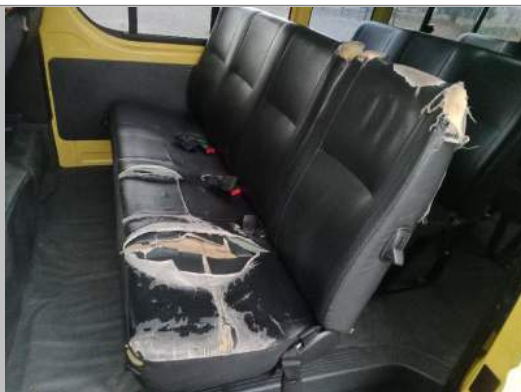
| Seat Rear Damaged | Repair |

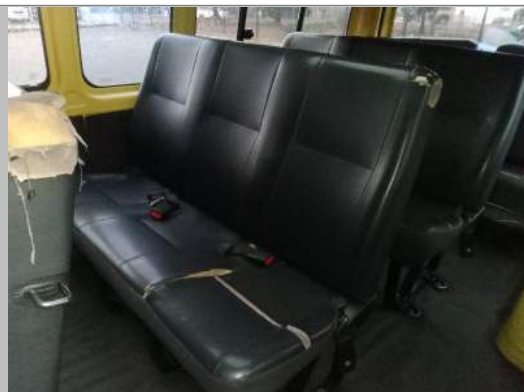
| Seat Rear ( 2. Row) Damaged | Repair |

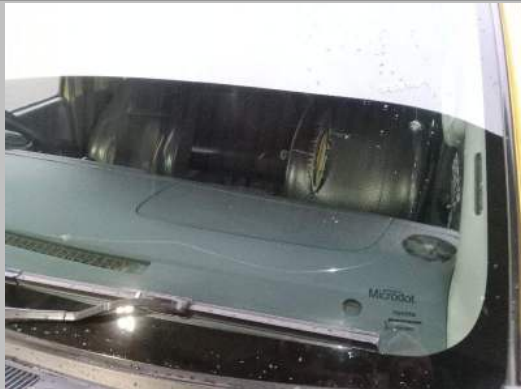
| Windscreen Cracked | Replace |

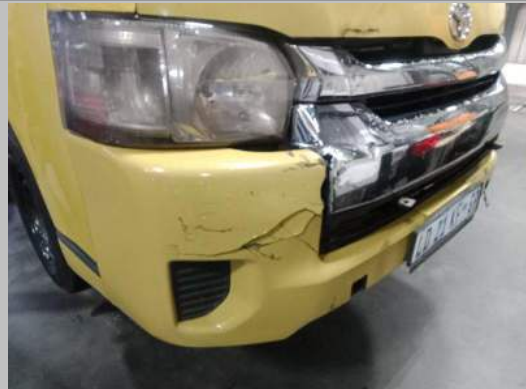
| Front Bumper Damaged | Repair |

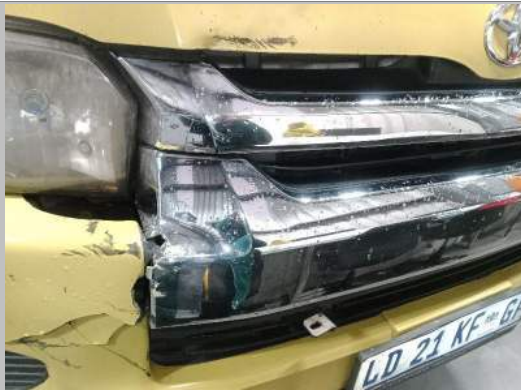
| Grill Damaged | Repair |

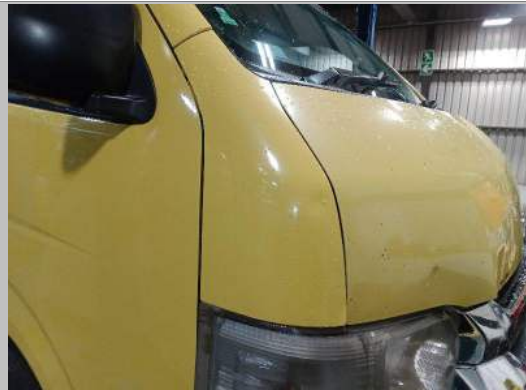
| Front Fender Right Dented | Repair |

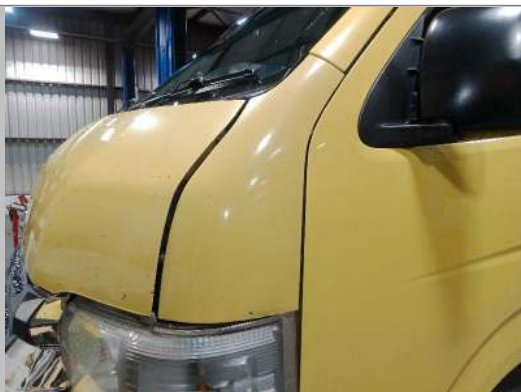
| Front Fender Left Paintwork • Scratched | Repair |

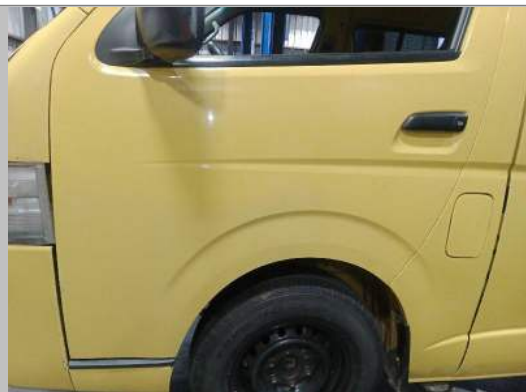
| Door Front Left Paintwork • Chipmarks | Repair |

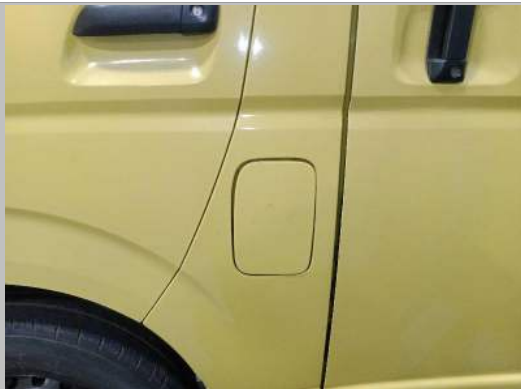
| B • Pillar Left Paintwork • Scratched | Repair |

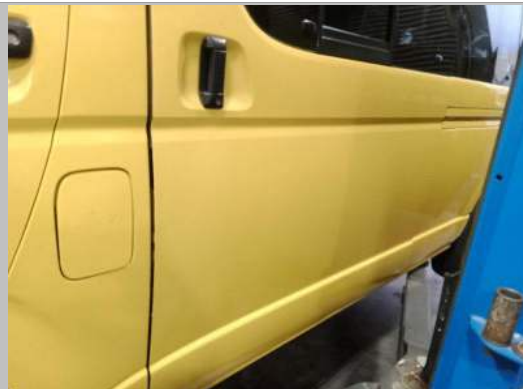
| Sliding Door Poor Alignment | Repair |

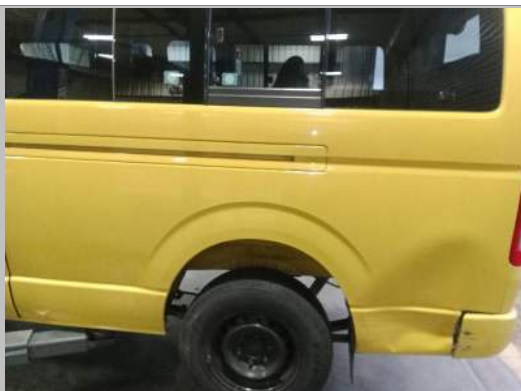
| Rear Fender Left Dented | Repair |

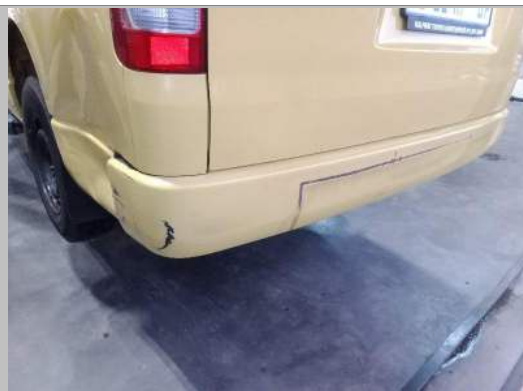
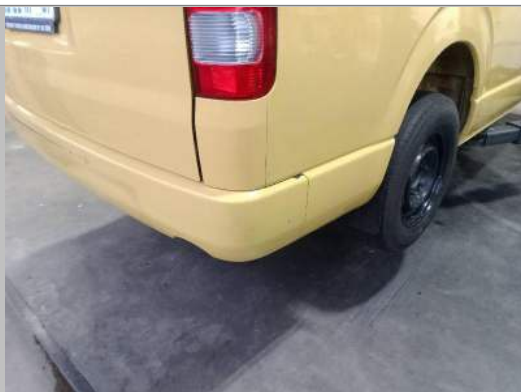
| Rear bumper Paintwork • Scratched | Repair |

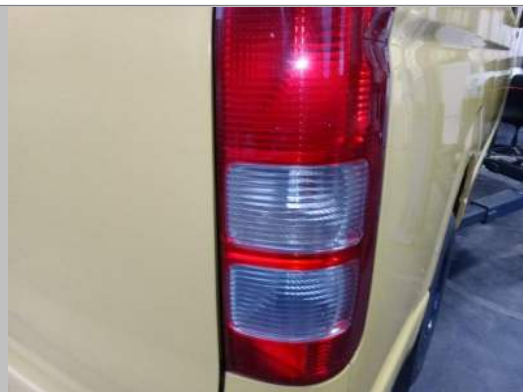
| Tail Light Right Cracked | Replace |

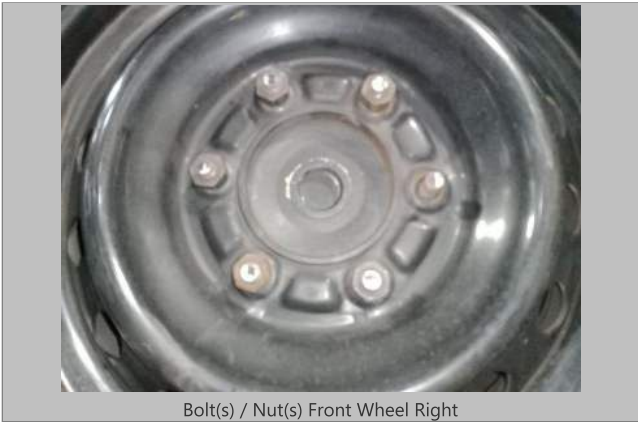
| Bolt(s) / Nut(s) Front Wheel Right Missing | Replace |
