CONDITION REPORT

Report No:  
2017305374  
DATE  
30/09/2026

| Manufacturer | TOYOTA | Registration Number | KXW151MP |
| Model | HI-ACE 2.5 SESFIKILE 16-S DSL MINIBUS [2021-2024] | Register Number | |

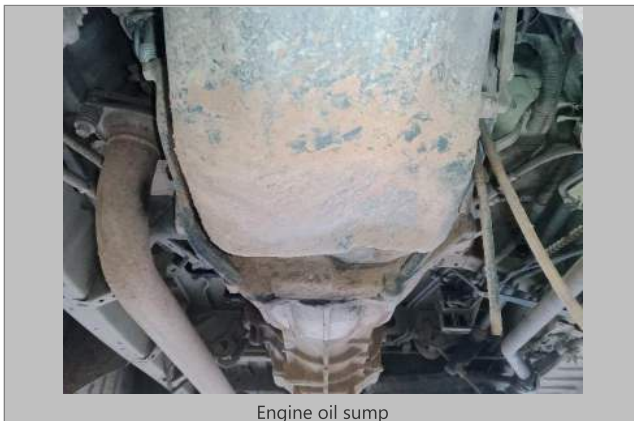
| Damage | Repair Way |
|---|---|
| Engine oil sump damaged | Replace |

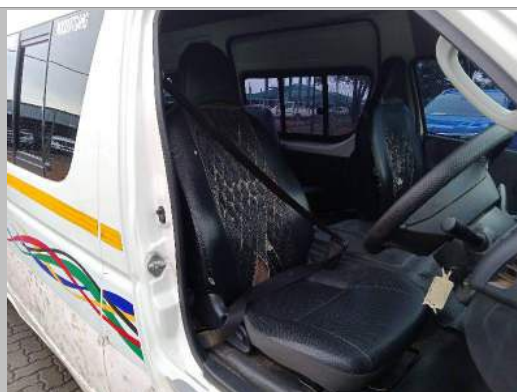
| Damage | Repair Way |
|---|---|
| Seat Front Right Damaged | Repair |

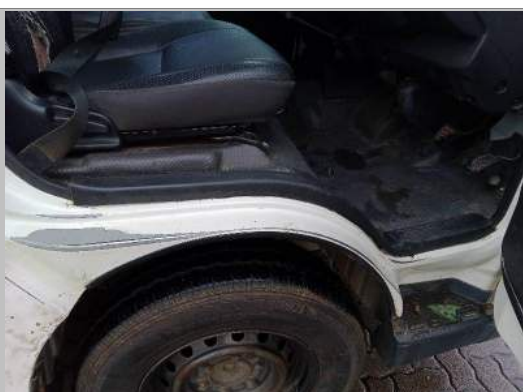
| Damage | Repair Way |
|---|---|
| Front Fender Right / Inner Tray Damaged | Repair |

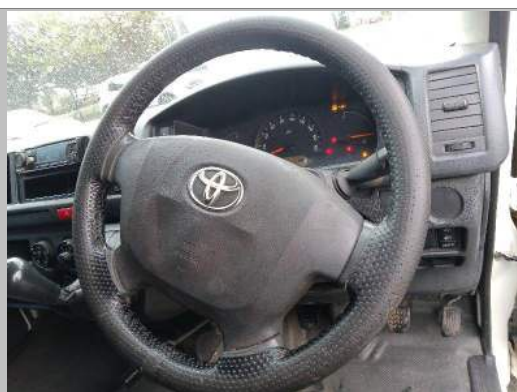
| Damage | Repair Way |
|---|---|
| Steering Wheel Trim Excessive Wear & Tear | Repair |

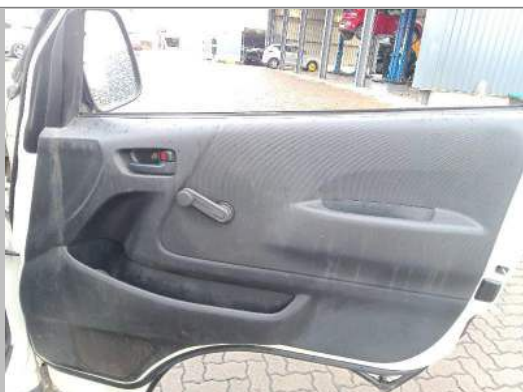
| Damage | Repair Way |
|---|---|
| Door Panel Front Right Dirty | Repair |

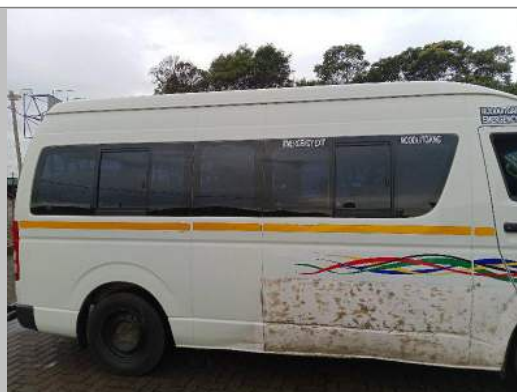
| Damage | Repair Way |
|---|---|
| Rear Fender Right Damaged | Repair |

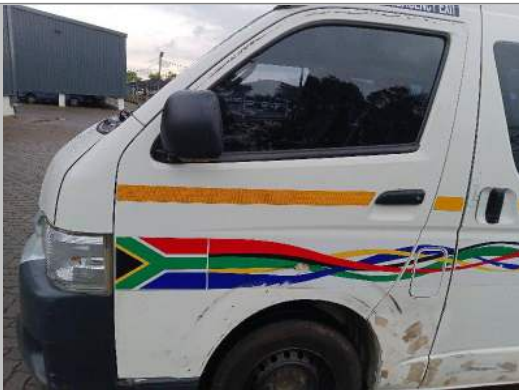
| Damage | Repair Way |
|---|---|
| Door Front Left Damaged | Repair |

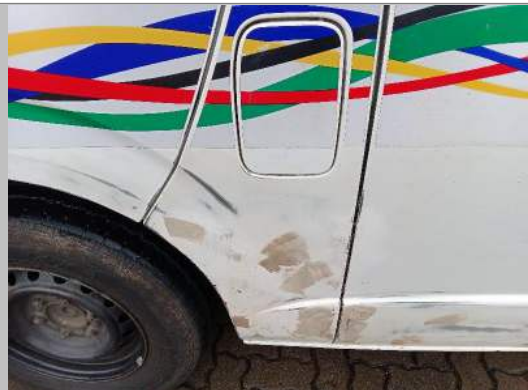
| Damage | Repair Way |
|---|---|
| B • Pillar Left Residual Traces of Repair | Repair |

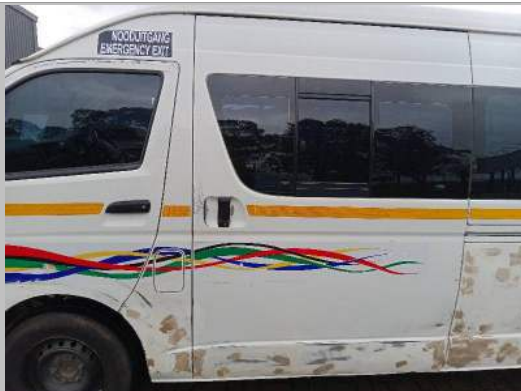
| Damage | Repair Way |
|---|---|
| Door Rear Left Residual Traces of Repair | Repair |

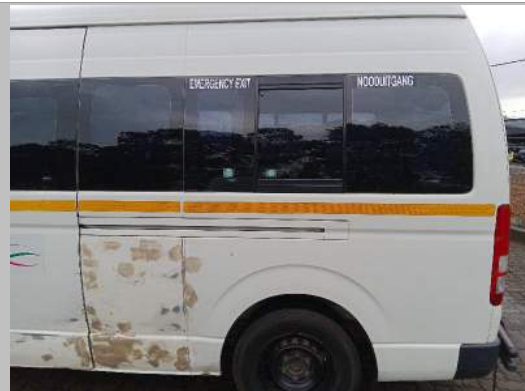
| Damage | Repair Way |
|---|---|
| Rear Fender Left Residual Traces of Repair | Repair |

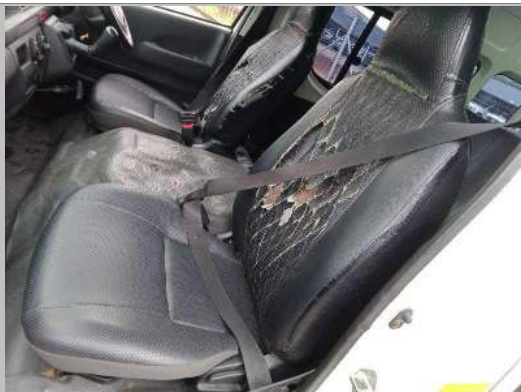
| Damage | Repair Way |
|---|---|
| Seat Front Left Damaged | Repair |

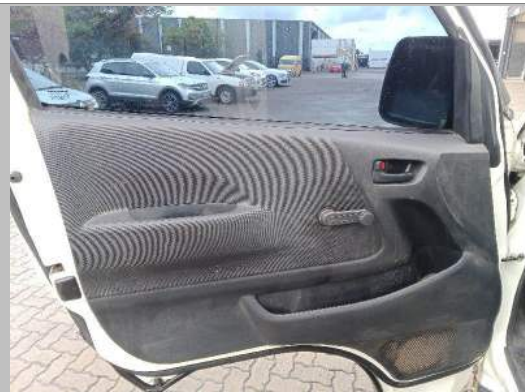
| Damage | Repair Way |
|---|---|
| Door Panel Front Left Dirty | Repair |

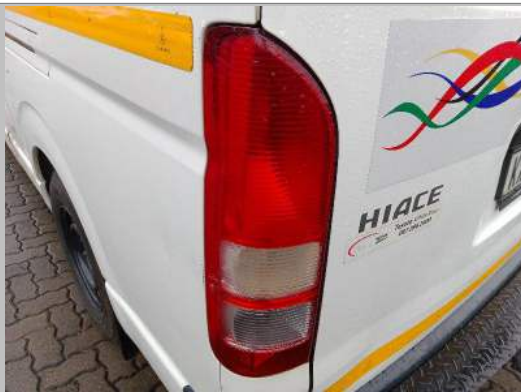
| Damage | Repair Way |
|---|---|
| Tail Light Left Cracked | Replace |

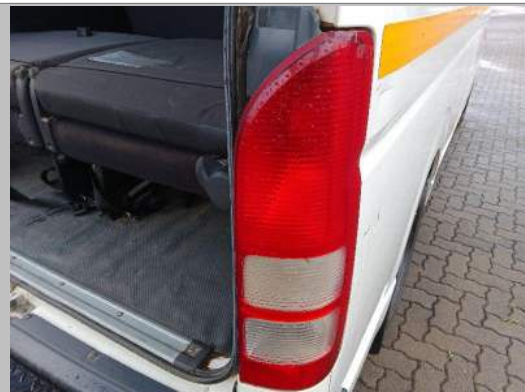
| Damage | Repair Way |
|---|---|
| Tail Light Right Defective | Repair |

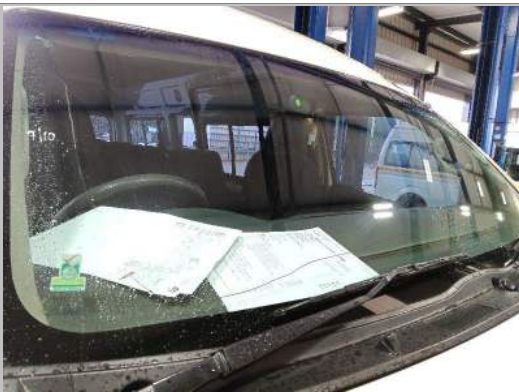
| Damage | Repair Way |
|---|---|
| Windscreen Cracked | Replace |

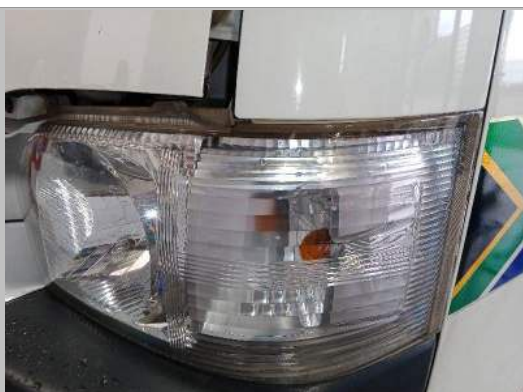
| Damage | Repair Way |
|---|---|
| Headlight Left Scratched | Replace |

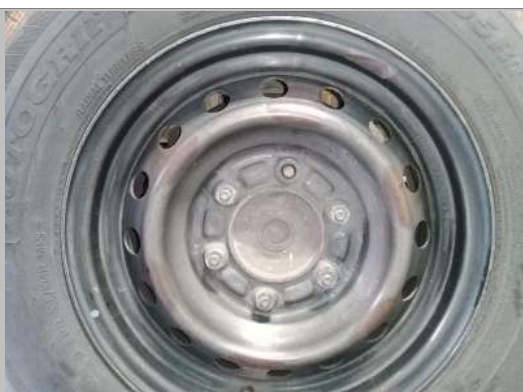
| Damage | Repair Way |
|---|---|
| Bolt(s) / Nut(s) Front Wheel Right Missing | Replace |

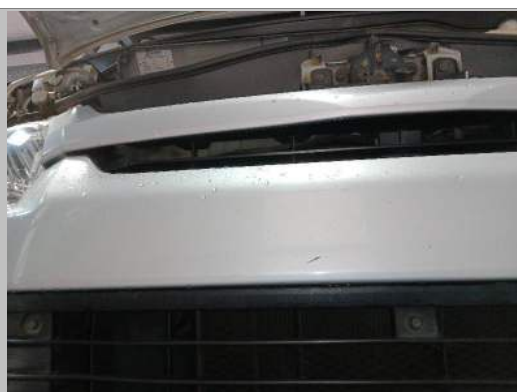
| Damage | Repair Way |
|---|---|
| Grill Paintwork • Scratched | Repair |

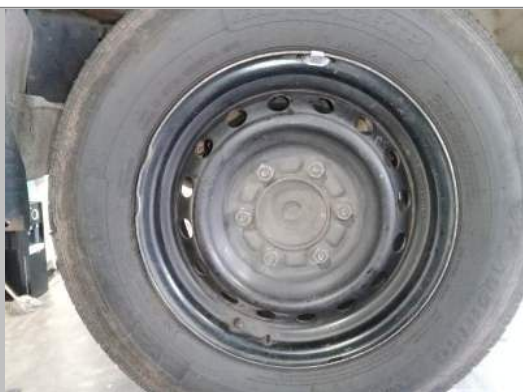
| Damage | Repair Way |
|---|---|
| Rim Front Left Dented | Repair |

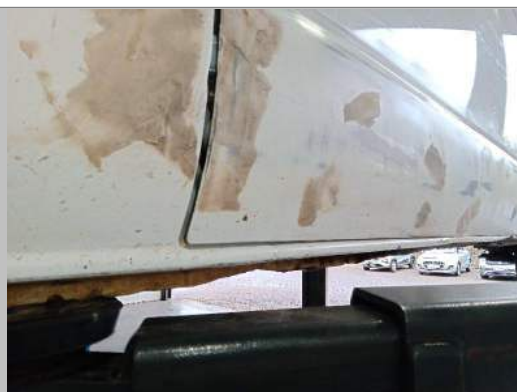
| Damage | Repair Way |
|---|---|
| Sill Panel Left Damaged | Repair |

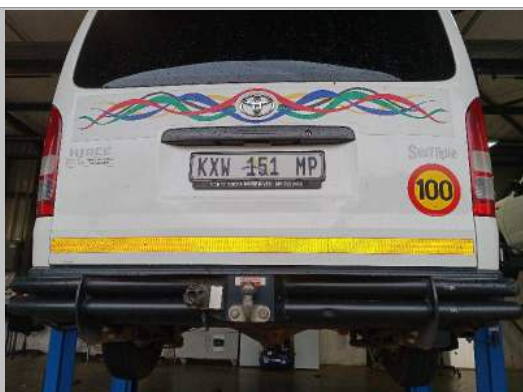
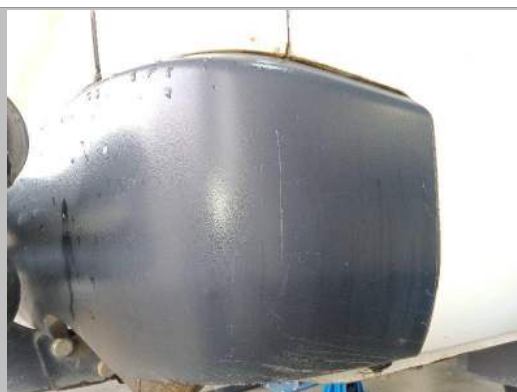
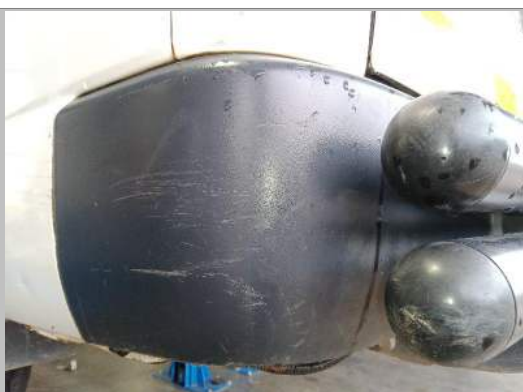
| Damage | Repair Way |
|---|---|
| Rear bumper Paintwork • Scratched | Repair |

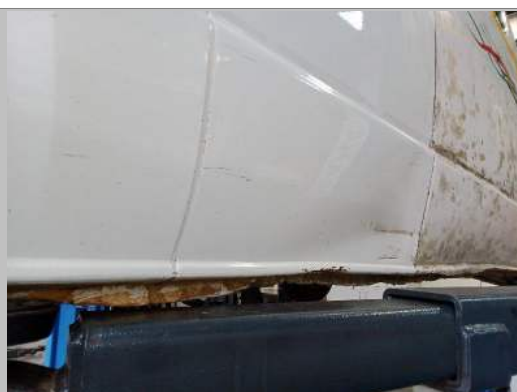
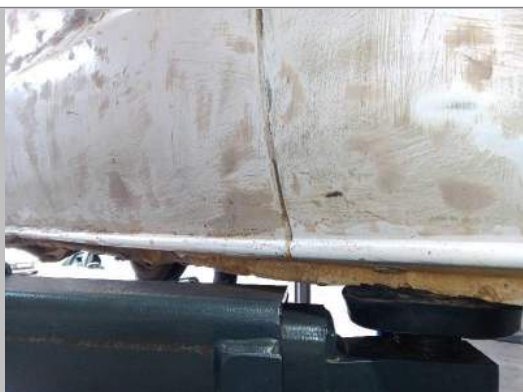
| Damage | Repair Way |
|---|---|
| Sill Panel Right Damaged | Repair |

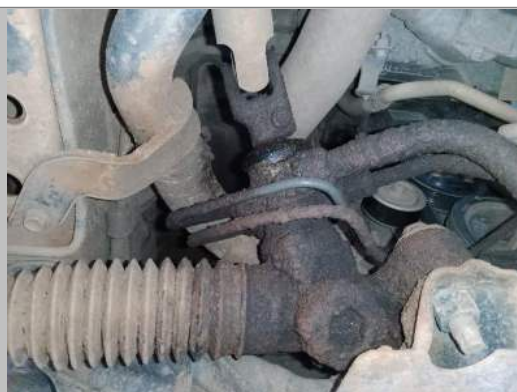
| Damage | Repair Way |
|---|---|
| Steering Rack Defective | Replace |

General Comments: ACCORDING TO THE AGE AND MILEAGE OF THE VEHICLE, NORMAL WEAR AND TEAR MARKS ARE VISIBLE ON THE INTERIOR, EXTERIOR, ELECTRICAL AND MECHANICAL PARTS. Interior: Rear left window net loose. Vehicle interior dirty and panels scratched.  
Body • Exterior: Tow bar damaged. Poor residual traces of repair on body panels. Body panels misaligned. Stone chips and spray work on body panels. Dents and scratches on body panels. Signs of impact damage to front of vehicle.  
Steering: Steering rack leak.

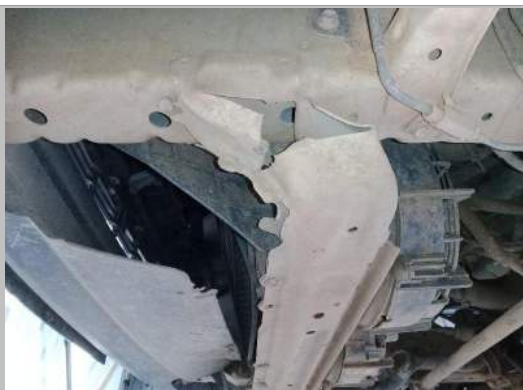
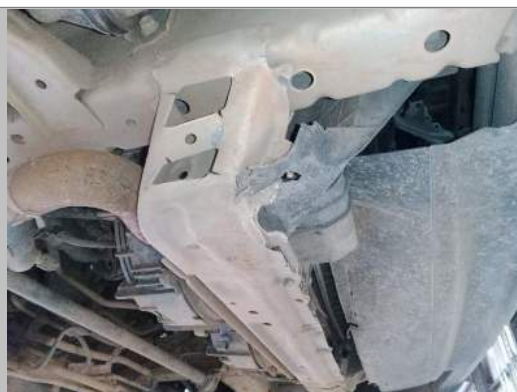
| Damage | Repair Way |
|---|---|
| Radiator Cradle Damaged | Replace |

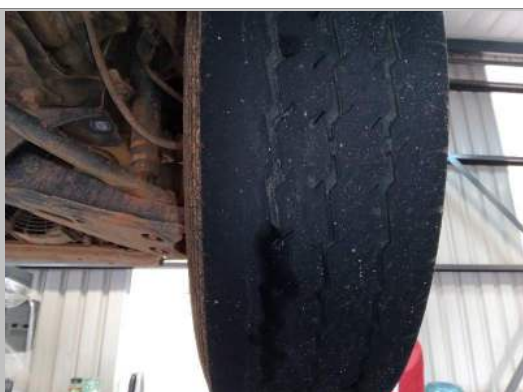
| Damage | Repair Way |
|---|---|
| Tyre Front Right Worn | Replace |

| | Size | Load/Speed Index | Manufacture | Model | Type* | Production Date | Tread Depth (mm) |
|---|---|---|---|---|---|---|---|
| Front Right | 195R15C | 106R | Autogrip | Vanmax | V | 2925 | 0 mm |

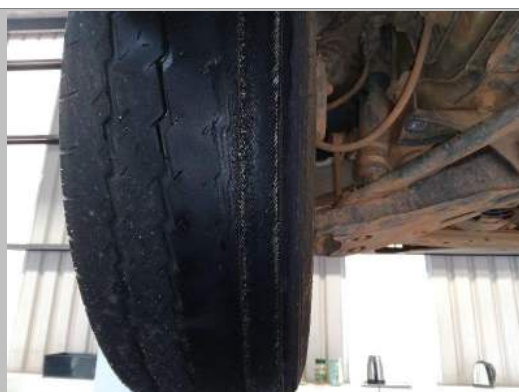
| Damage | Repair Way |
|---|---|
| Tyre Front Left Damaged | Replace |

| | Size | Load/Speed Index | Manufacture | Model | Type* | Production Date | Tread Depth (mm) |
|---|---|---|---|---|---|---|---|
| Front Left | 195R15C | 106R | Autogrip | Vanmax | V | 2925 | 0 mm |

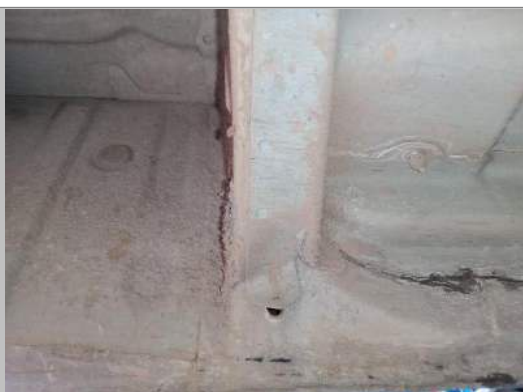
| Damage | Repair Way |
|---|---|
| Chassis Damaged | Repair |

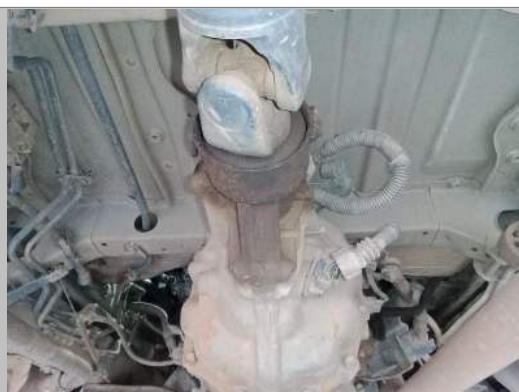
| Damage | Repair Way |
|---|---|
| Gearbox Oil Sweat | Repair |
| Gear Selections Malfunction | Repair |

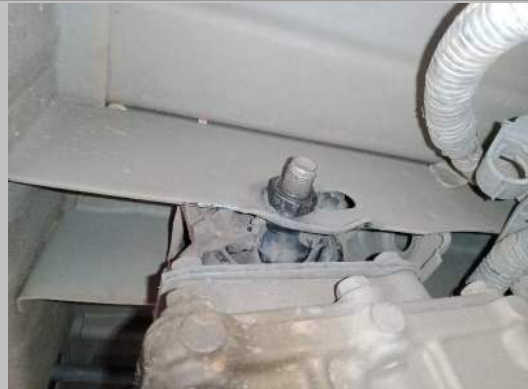
| Damage | Repair Way |
|---|---|
| Gearbox Mountings Damaged | Replace |

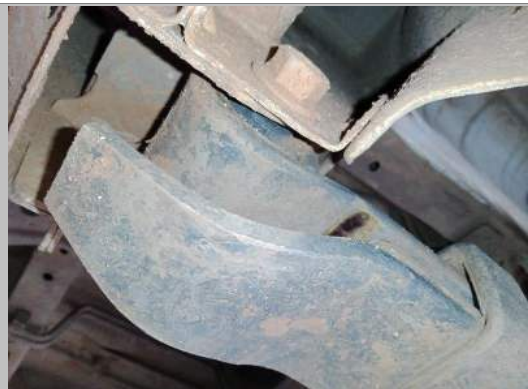
| Damage | Repair Way |
|---|---|
| Mounting Rubber(s) Rear Axle Left Damaged | Replace |

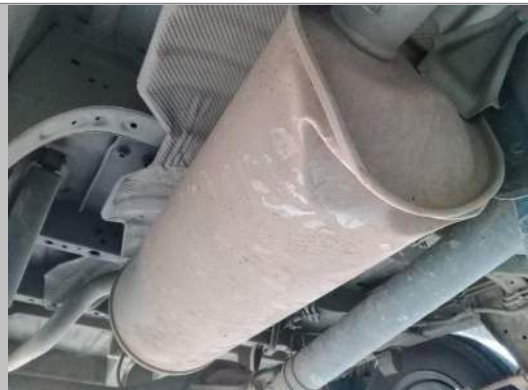
| Damage | Repair Way |
|---|---|
| Silencer Damaged | Replace |

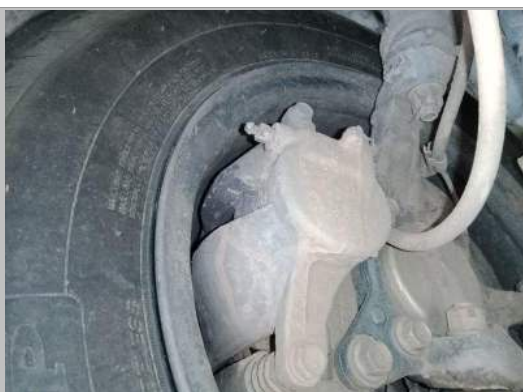
| Damage | Repair Way |
|---|---|
| Caliper 1. Axle left Damaged | Replace |

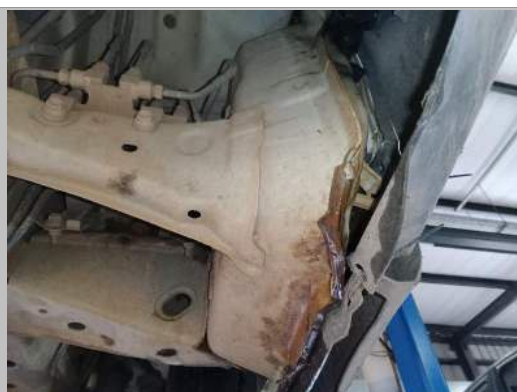
| Damage | Repair Way |
|---|---|
| Front Fender Left / Inner Tray Damaged | Repair |

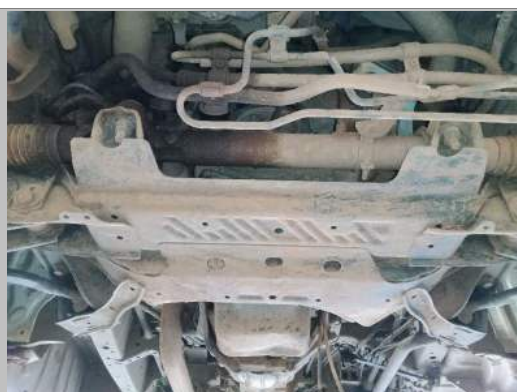
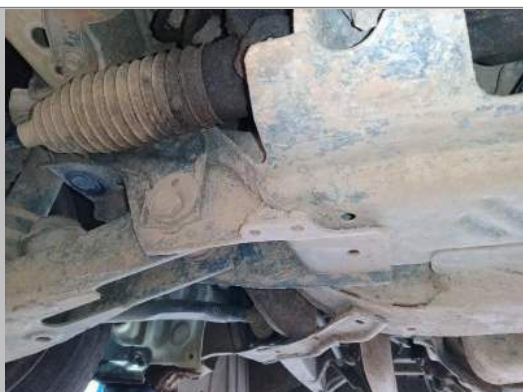
| Damage | Repair Way |
|---|---|
| Sub Frame Damaged | Repair |

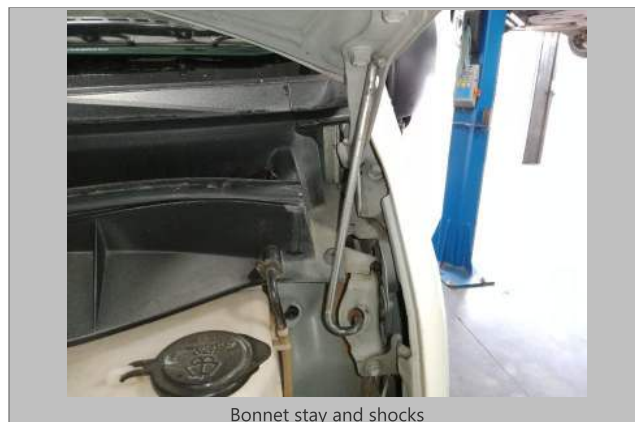
| Damage | Repair Way |
|---|---|
| Bonnet stay and shocks Defective | Repair |

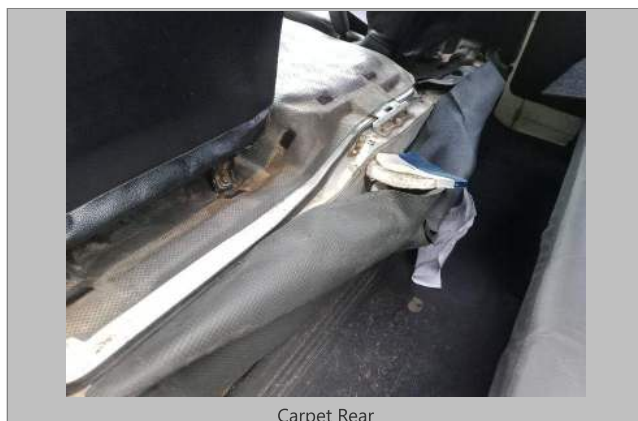
| Damage | Repair Way |
|---|---|
| Carpet Rear Damaged | Repair |

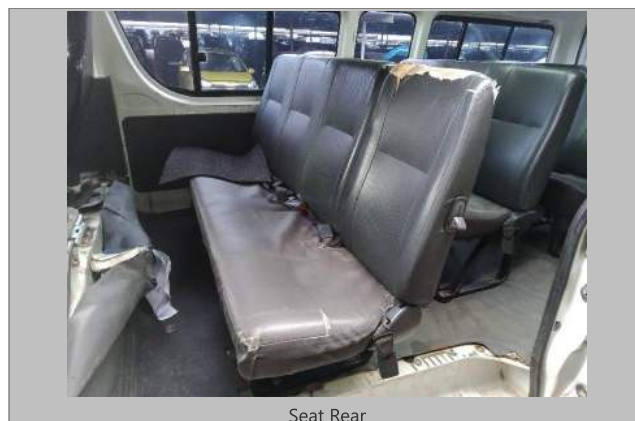
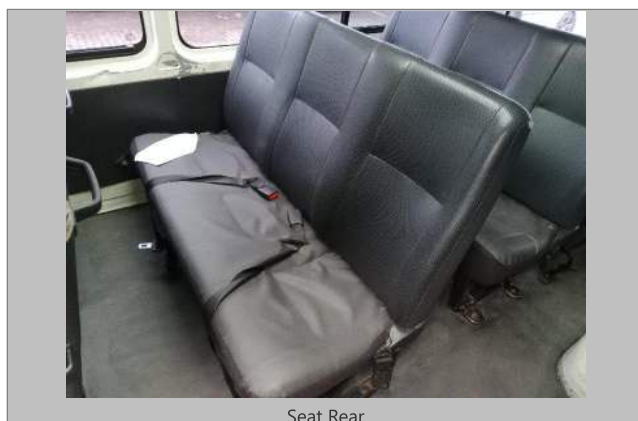
| Damage | Repair Way |
|---|---|
| Seat Rear Damaged | Repair |

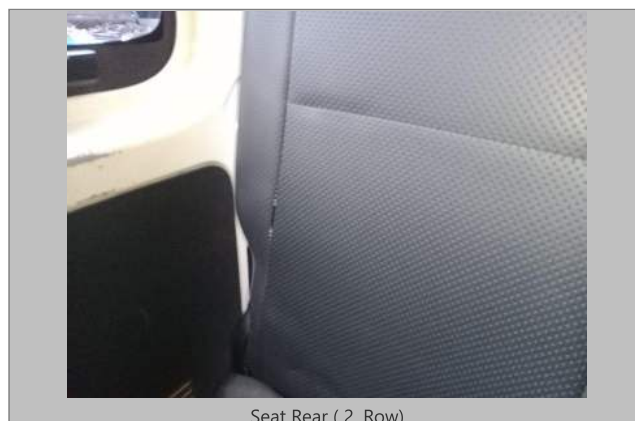
| Damage | Repair Way |
|---|---|
| Seat Rear ( 2. Row) Torn / Cut | Repair |

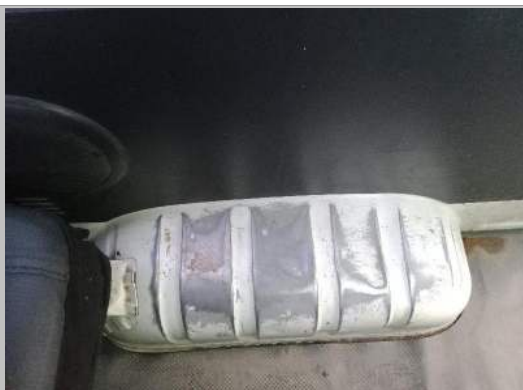
| Damage | Repair Way |
|---|---|
| Rear Fender Left / Inner Tray Damaged | Repair |

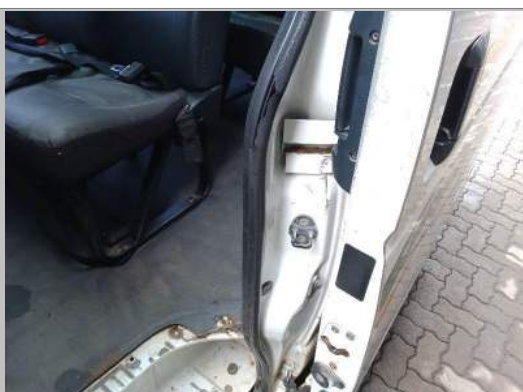
| Damage | Repair Way |
|---|---|
| Door Sealing Rubber Rear Left Damaged | Replace |
