MFC Auction House  
M57 Pretoria Rd, Glenmarais, KEMPTON PARK  
Gauteng

DEKRA MFC  
M57 Pretoria Rd - 1619  
KEMPTON PARK - GT  
08610 33572

VEHICLE INSPECTION

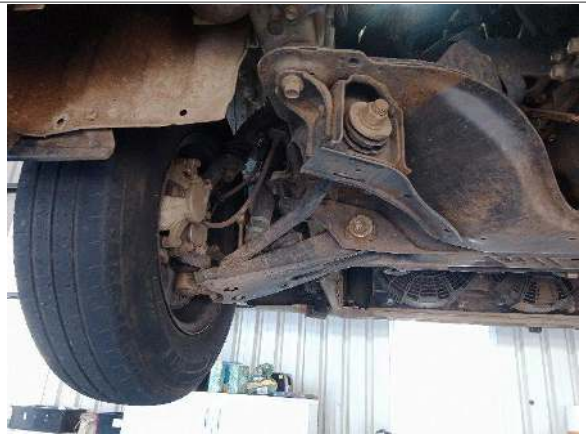
LF TYRE TREAD

Size	Load/Speed Index	Manufacture	Model	Type*	Production Date	Tread Depth (mm)
Front Left	195R15C	106R	Arivo	Transito	V	3223	0 mm
Front Right	195R15C	106R	Arivo	Transito	V	3523	0 mm
Rear Left	195R15C	106S	Toyo	Radial	V	0923	0 mm
Rear Right	195R15C	106R	Trazano	Radial	V	2223	2 mm

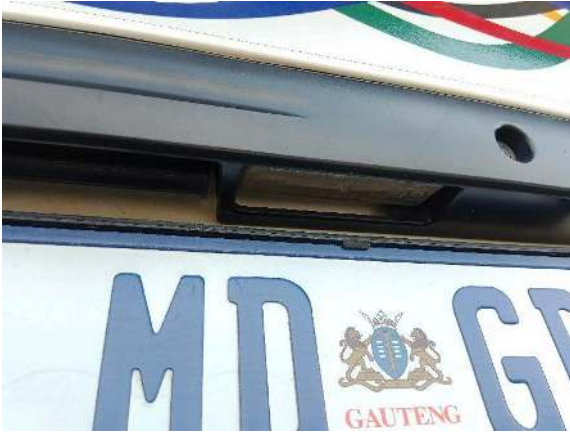
Damage	Repair Way
Engine Wiring Defective	Repair
Hoses Oil Leak	Repair
Tail Light Left Defective	Replace
Tail Light Right Defective	Replace
Number Plate Light Left Defective	Repair
Number Plate Light Right Defective	Repair
Seat Rear Torn / Cut	Repair
Hood Lining Dirty	Repair
Door Panel Rear Left Defective	Repair
Dash Padding Defective	Repair
Carpet Rear Defective	Repair
Side Mirror Right Paintwork • Scratched	Repair
Front Bumper Paintwork • Scratched	Repair
Bonnet Dented	Repair
Rear Fender Left Dented	Repair
Rear Fender Right Paintwork • Scratched	Repair
Rear Fender Left / Inner Tray Defective	Repair
Rear Fender Right / Inner Tray Defective	Repair
Door Front Left Paintwork • Scratched	Repair
Door Rear Left Paintwork • Scratched	Repair
Rear bumper Paintwork • Scratched	Repair
Sill Panel Right Paintwork • Scratched	Repair
Rocker Panel Left Dented	Repair
Windscreen Damaged	Replace
Steering box Leak	Repair
Shock Absorber Front Right Defective	Replace

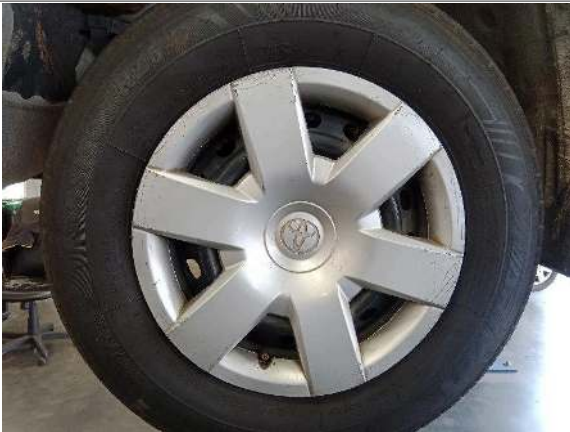
Damage	Repair Way
Ball Joint(s) Front Axle Right Damaged	Replace
Tyre Front Left Torn / Cut	Replace
Tyre Front Right Worn	Replace
Tyre Rear Left Worn	Replace
Rim Front Left Defective	Repair
Rim Front Right Scratched	Repair
Rim Rear Left Scratched	Repair
Rim Rear Right Scratched	Repair
Radiator Cradle Defective	Repair
Abnormal noise from front and rear suspension	Repair
Spare wheel missing	Replace

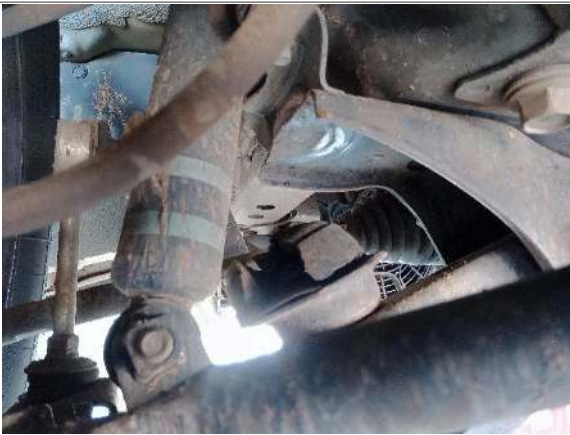
Shock Absorber Rear Right Defective	Replace
Rebound Rubber Front Axle Left Damaged	Replace
Control Arm Bush(es) Front Axle Right Defective	Replace
