CONDITION REPORT

Report No: 2016850329

DATE  
22/04/2025

| Manufacturer | TOYOTA | Registration Number | HDN122L |

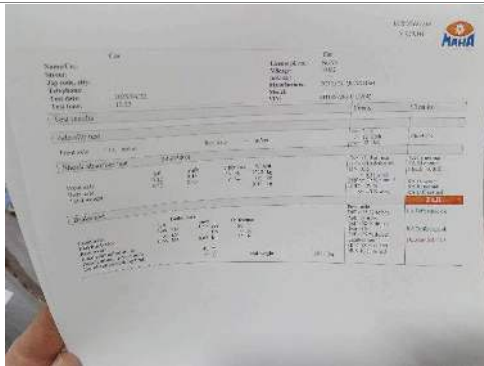
Brake test

| Damage | Repair Way |
|---|---|
| Brakes Insufficient | Repair |

| | Left<br>Braking Force [KN] | Right<br>Braking Force [KN] | Axle Weight [KG] | Deceleration [m/s²] |
|---|---|---|---|---|
| Front | 4.48 | 3.57 | - | |
| Rear | 0.64 | 0.83 | - | |
| Emergency / Parking | 0 | 0 | - | |

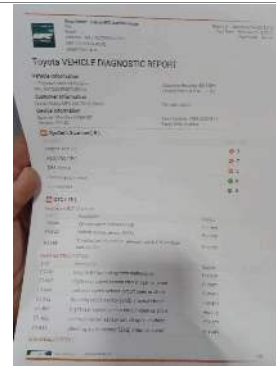
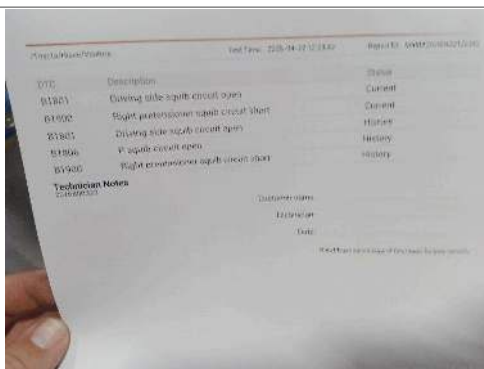
| No | System | Code | Description | Status |
|---|---|---|---|---|
| 1 | ENGINE AND ECT | P0500 | VEHICLE SPEED SENSOR | |

General Comments: 15 DTC'S AT TIME OF TESTING SEE DTC REPORT.Engine Compartment: vehicle is leaking diesel on engine. starter bolts loose.  
Body • Exterior: Minor dents and scratches to some body panels. Signs of stone chips to some body panels. Signs of repair work done to somebody panels. Poor alignment to somebody panels.  
Brakes: handbrake does not work.  
Road Test: Vehicle is unsafe to drive.

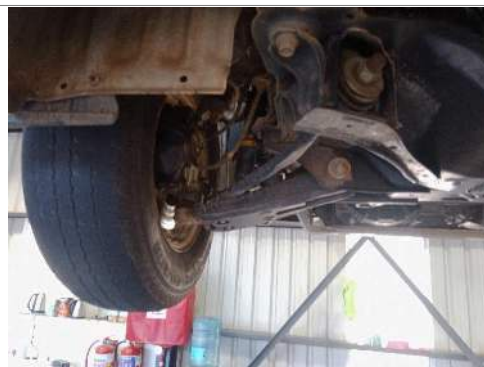
LF TYRE TREAD

| Damage | Repair Way |
|---|---|
| Tyre Front Left Worn | Replace |

| | Size | Load/Speed Index | Manufacture | Model | Type* | Production Date | Tread Depth (mm) |
|---|---|---|---|---|---|---|---|
| Front Left | 205/75R14 | 107S | Yokohama | Radial | V | 4722 | 0 mm |

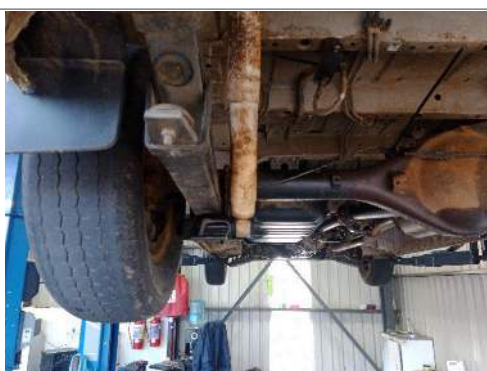
LR TYRE TREAD

| Damage | Repair Way |
|---|---|
| Tyre Rear Left Worn | Replace |

| | Size | Load/Speed Index | Manufacture | Model | Type* | Production Date | Tread Depth (mm) |
|---|---|---|---|---|---|---|---|
| Rear Left | 205/75R14 | 107S | Yokohama | Radial | V | 4820 | 0 mm |

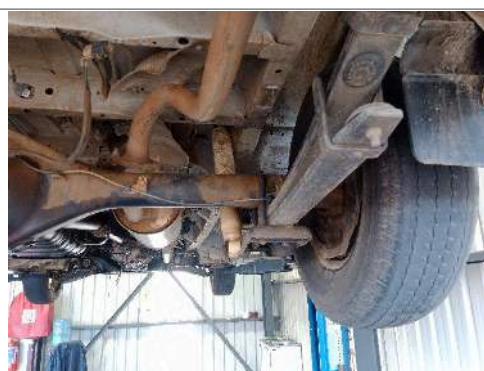
RR TYRE TREAD

| Damage | Repair Way |
|---|---|
| Tyre Rear Right Worn | Replace |

| | Size | Load/Speed Index | Manufacture | Model | Type* | Production Date | Tread Depth (mm) |
|---|---|---|---|---|---|---|---|
| Rear Right | 205/75R14 | 107S | Yokohama | Radial | V | 4822 | 0 mm |

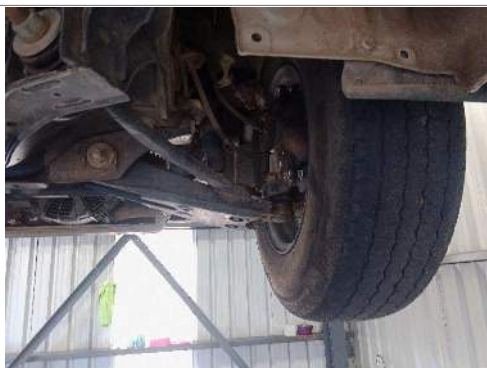
RF TYRE TREAD

| Damage | Repair Way |
|---|---|
| Tyre Front Right Damaged | Replace |

| | Size | Load/Speed Index | Manufacture | Model | Type* | Production Date | Tread Depth (mm) |
|---|---|---|---|---|---|---|---|
| Front Right | 205/75R14 | 107S | Yokohama | Radial | V | 2223 | 2 mm |

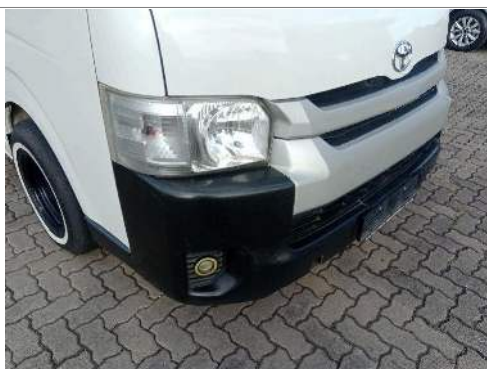
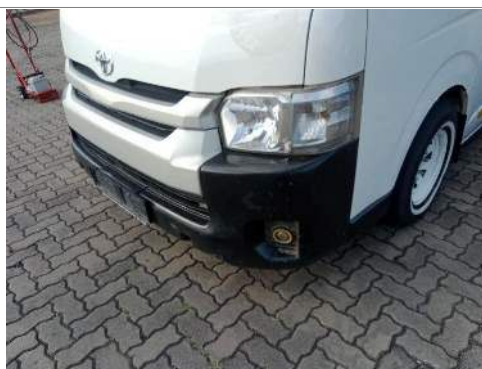
| Damage | Repair Way |
|---|---|
| Front Bumper Damaged | Repair |

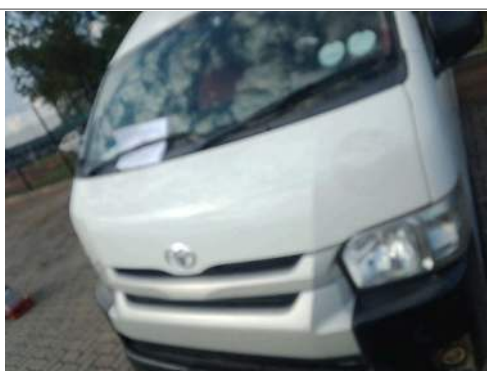
| Damage | Repair Way |
|---|---|
| Bonnet Damaged | Repair |

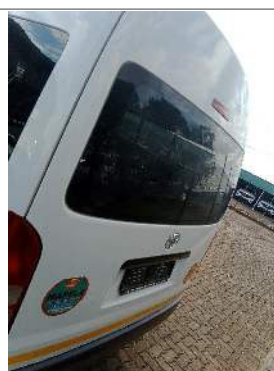
| Damage | Repair Way |
|---|---|
| Boot Lid / Hatch door Damaged | Repair |

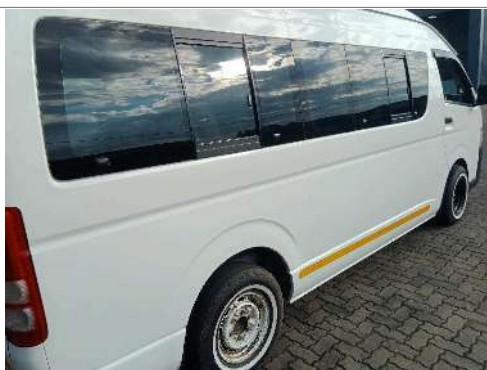
| Damage | Repair Way |
|---|---|
| Rear Fender Right Damaged | Repair |

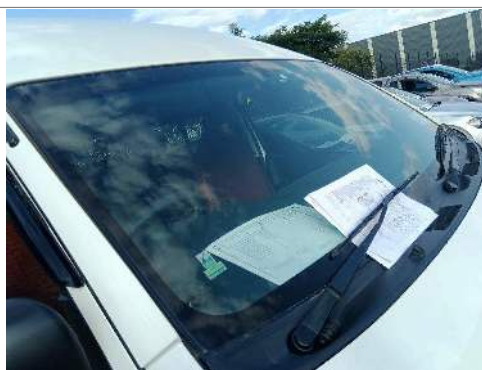
| Damage | Repair Way |
|---|---|
| Windscreen Damaged | Replace |

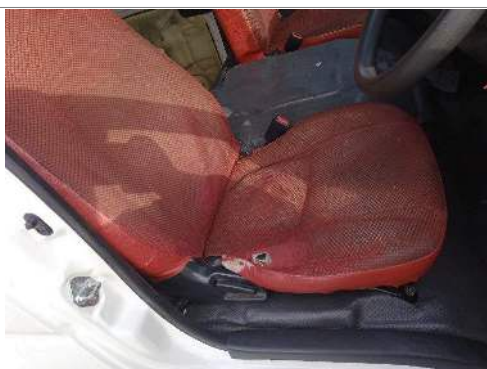
| Damage | Repair Way |
|---|---|
| Seat Front Right Damaged | Repair |

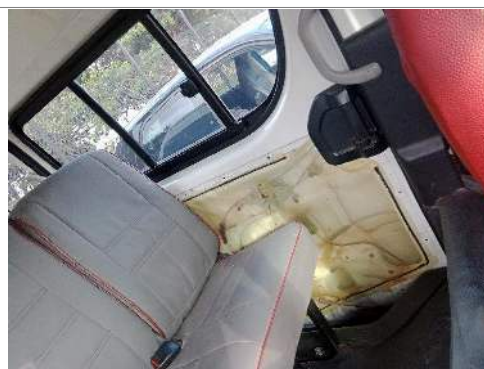
| Damage | Repair Way |
|---|---|
| Door Panel Rear Left Damaged | Repair |

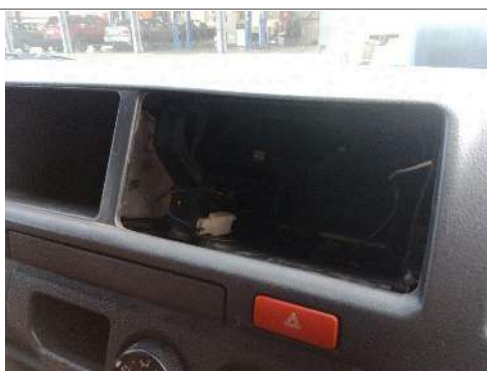
| Damage | Repair Way |
|---|---|
| Radio/CD/USB Damaged | Repair |

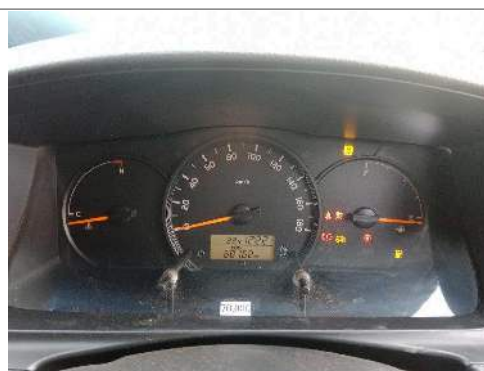
| Damage | Repair Way |
|---|---|
| Engine Management Lights Set | Repair |

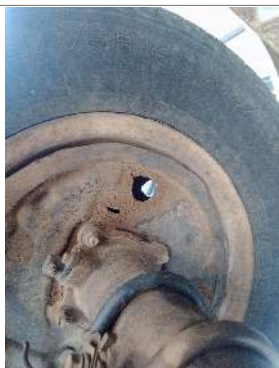
| Damage | Repair Way |
|---|---|
| Wheel Cylinder / Caliper 2. Axle left Damaged | Replace |

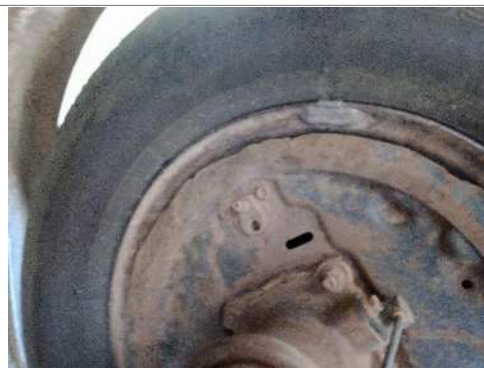
| Damage | Repair Way |
|---|---|
| Wheel Cylinder / Caliper 2. Axle right Damaged | Repair |

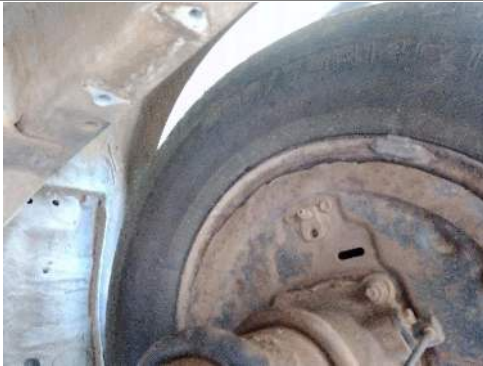
| Damage | Repair Way |
|---|---|
| Brake Piping Damaged | Repair |

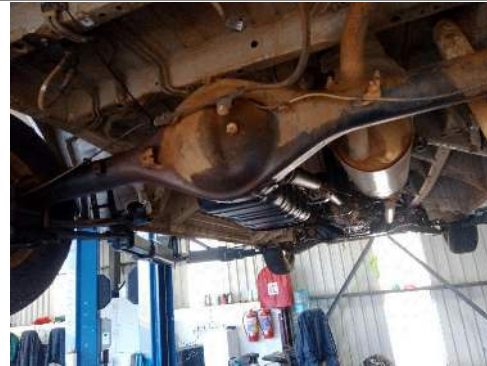
| Damage | Repair Way |
|---|---|
| Differential Oil Leak | Repair |

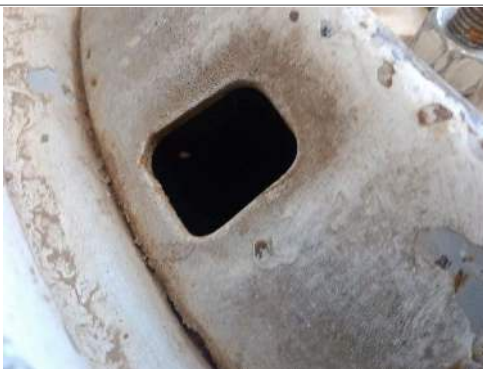
| Damage | Repair Way |
|---|---|
| Brake Drum 2. Axle left Defective | Replace |

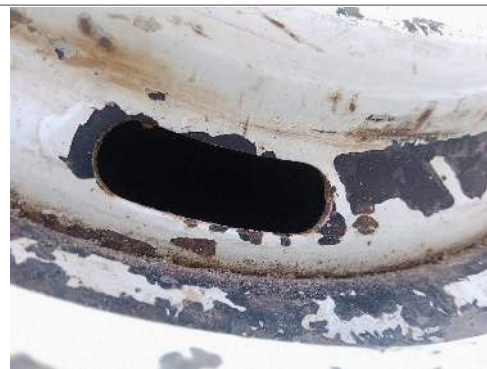
| Damage | Repair Way |
|---|---|
| Brake Drum 2. Axle right Defective | Repair |

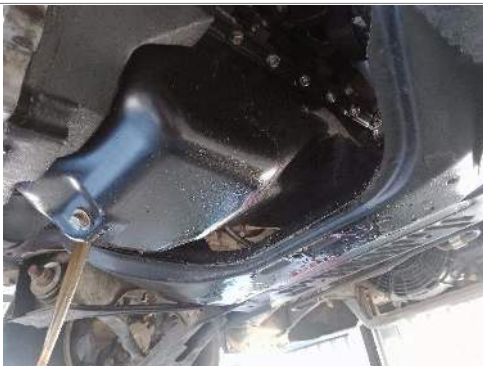
| Damage | Repair Way |
|---|---|
| Engine Oil Leak | Repair |

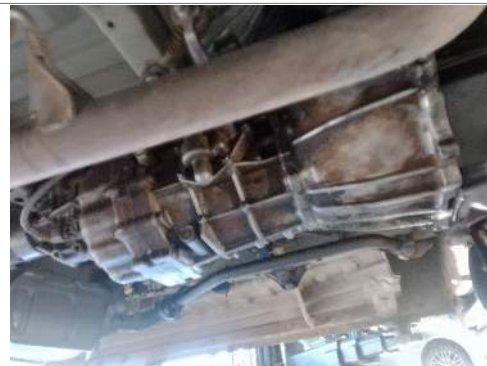
| Damage | Repair Way |
|---|---|
| Gearbox Oil Leak | Repair |

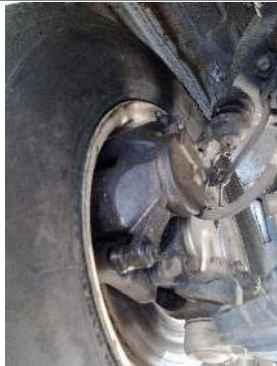
| Damage | Repair Way |
|---|---|
| Caliper 1. Axle left Leak | Repair |

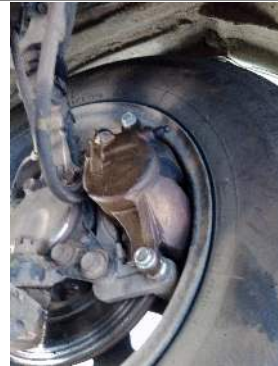
| Damage | Repair Way |
|---|---|
| Caliper 1. Axle right Leak | Repair |

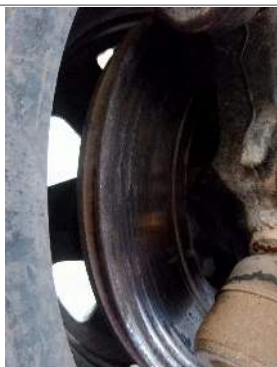
| Damage | Repair Way |
|---|---|
| Brake disc 1. Axle right Worn | Replace |

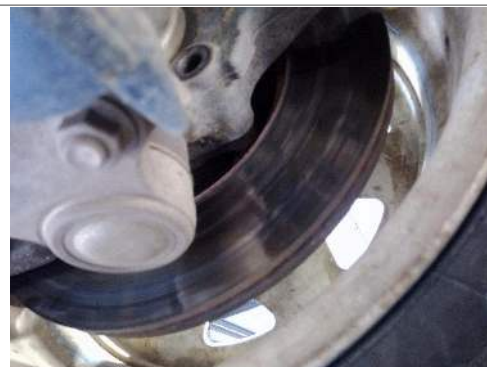
| Damage | Repair Way |
|---|---|
| Brake disc 1. Axle left Worn | Replace |

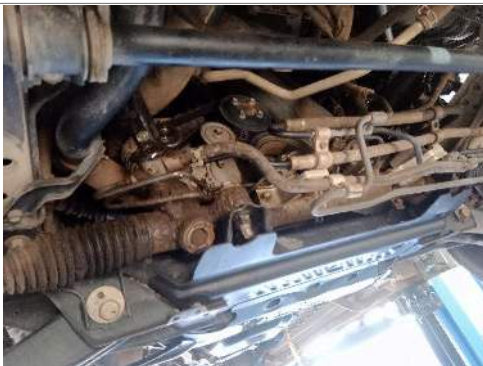
| Damage | Repair Way |
|---|---|
| Steering box Leak | Repair |
