## CONDITION REPORT

Report No: 2016866417

| Manufacturer | MAZDA | Registration Number | HGL017L |
| Model | CX-3 2.0 ACTIVE [2018-2021] | Register Number | |

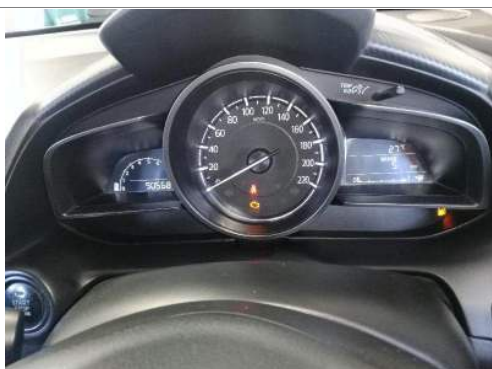
DASHBOARD (W/ ENGINE RUNNING)

| Damage | Repair Way |
|---|---|
| Engine management lights illuminated | Repair |

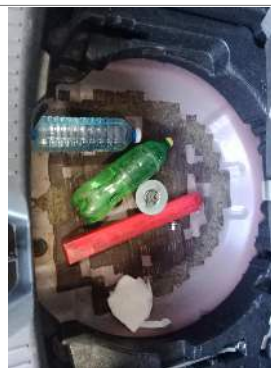
No spare wheel

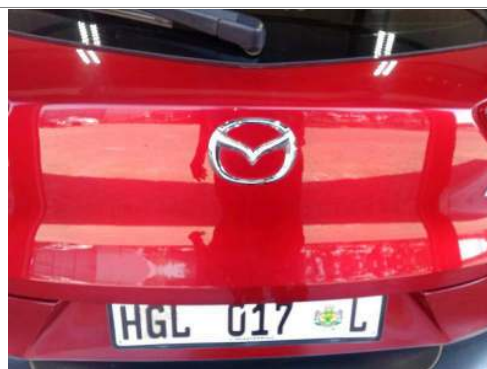
| Damage | Repair Way |
|---|---|
| Boot Lid / Hatch door Paintwork • Scratched | Repair |

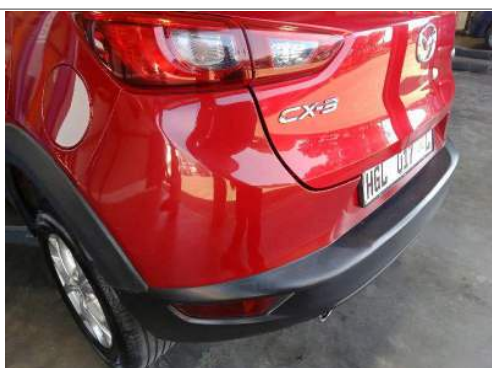
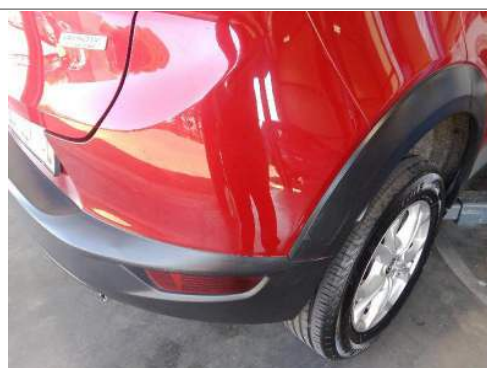
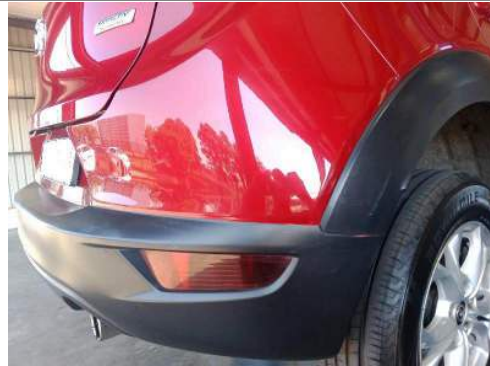
| Damage | Repair Way |
|---|---|
| Rear bumper Paintwork • Scratched | Repair |

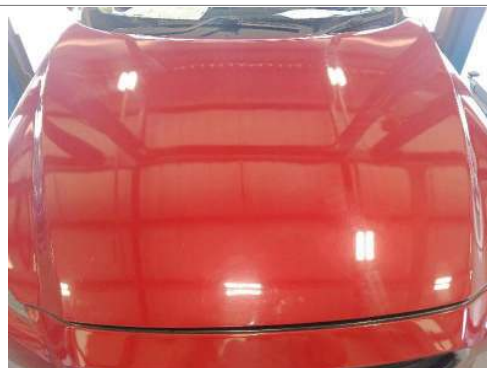
| Damage | Repair Way |
|---|---|
| Bonnet Paintwork • Scratched | Repair |

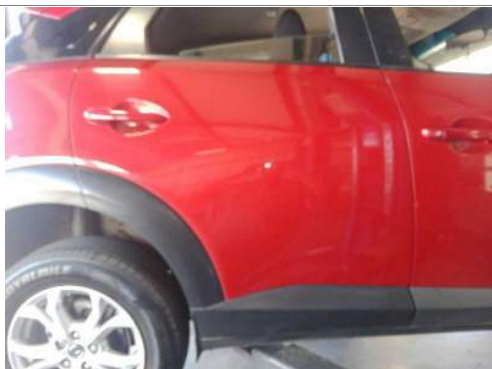
| Damage | Repair Way |
|---|---|
| Door Rear Right Paintwork • Scratched | Repair |

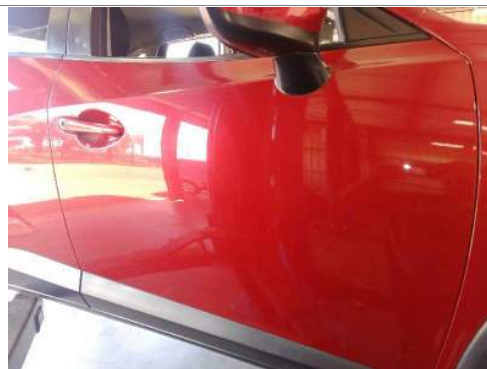
| Damage | Repair Way |
|---|---|
| Door Front Right Paintwork • Scratched | Repair |

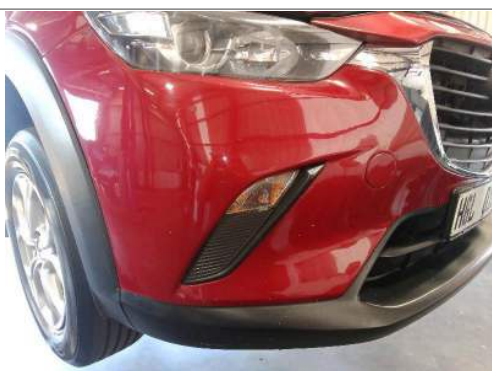
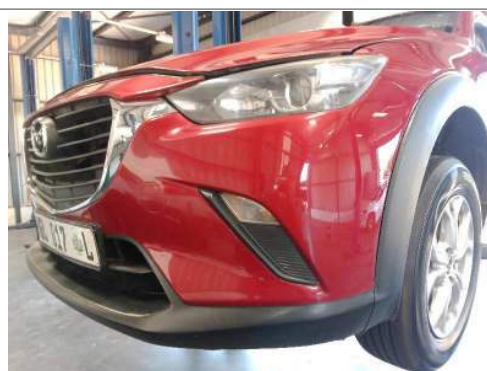
| Damage | Repair Way |
|---|---|
| Front Bumper Paintwork • Scratched | Repair |

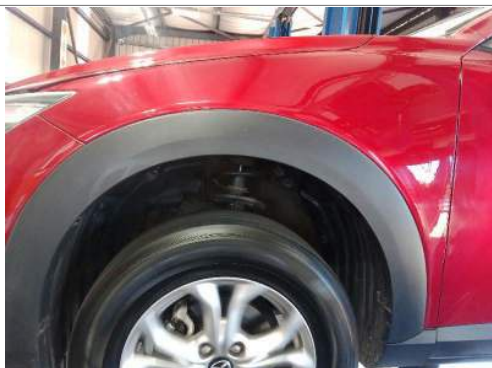
| Damage | Repair Way |
|---|---|
| Front Fender Left Paintwork • Scratched | Repair |

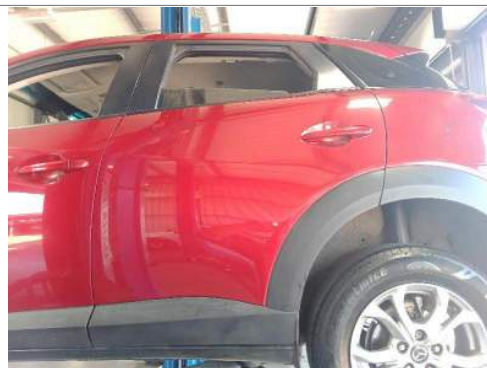
| Damage | Repair Way |
|---|---|
| Door Rear Left Paintwork • Scratched | Repair |

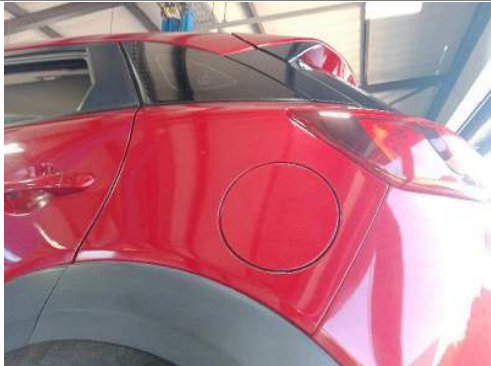
| Damage | Repair Way |
|---|---|
| Rear Fender Left Paintwork • Scratched | Repair |
