## CONDITION REPORT

Report No:  
2017306440  
DATE  
02/10/2026

| Manufacturer | MITSUBISHI MOTORS | Registration Number | BC40JYGP |
| Model | LANCER 2.0 GLS [2007-2012] | Register Number | |

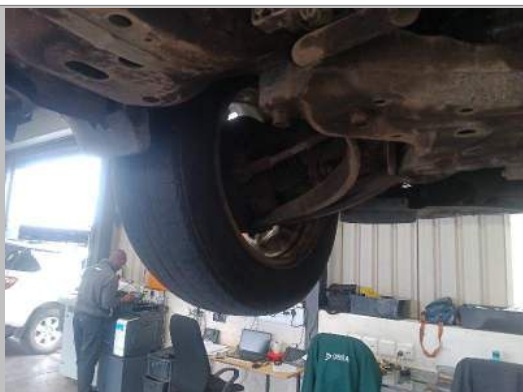
LF TYRE TREAD

| | Size | Load/Speed Index | Manufacture | Model | Type* | Production Date | Tread Depth (mm) |
|---|---|---|---|---|---|---|---|
| Front Left | 205/60R16 | 92H | Goodride | Radial rp28 | V | 3216 | 1 mm |

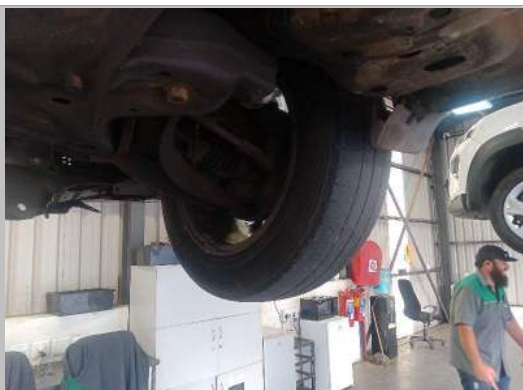
RF TYRE TREAD

| | Size | Load/Speed Index | Manufacture | Model | Type* | Production Date | Tread Depth (mm) |
|---|---|---|---|---|---|---|---|
| Front Right | 205/60R16 | 92H | Goodride | Radial rp28 | V | 3216 | 1 mm |

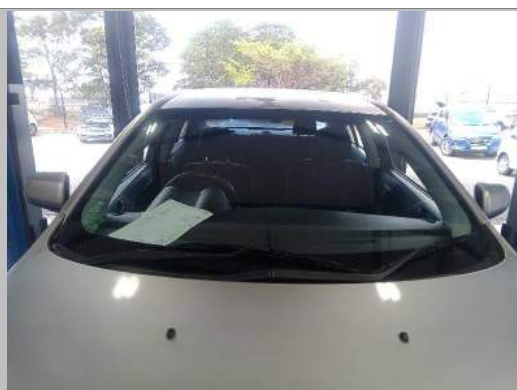
| No license disc | Replace |

LICENSE DISC MISSING

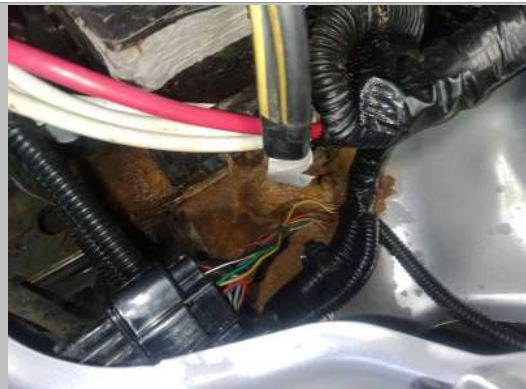
| Bonnet slam plate (Shock tower/ Inner tray) Corrosion | Repair |

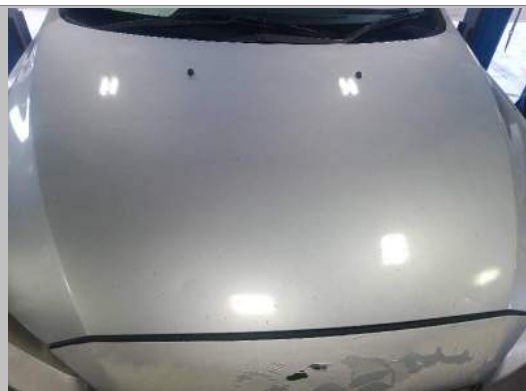
| Bonnet Dented | Repair |

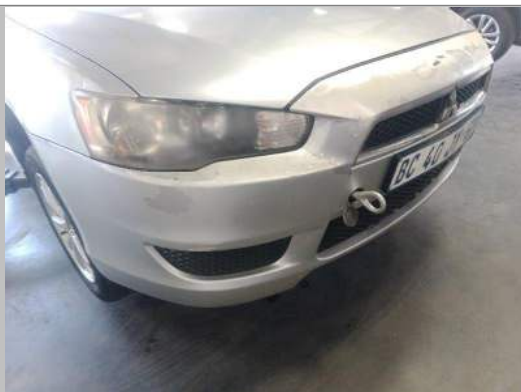
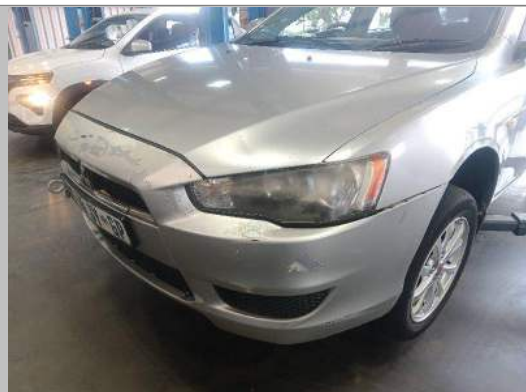
| Front Bumper Paintwork • Discoloured | Repair |

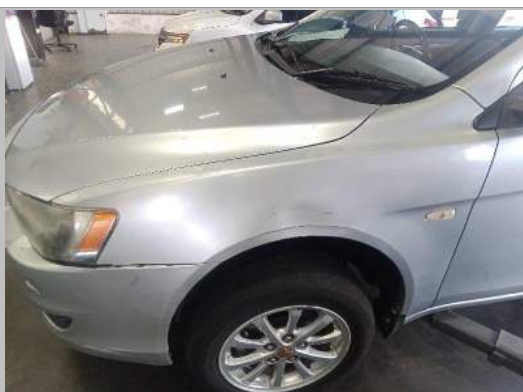
| Front Fender Left Dented | Repair |

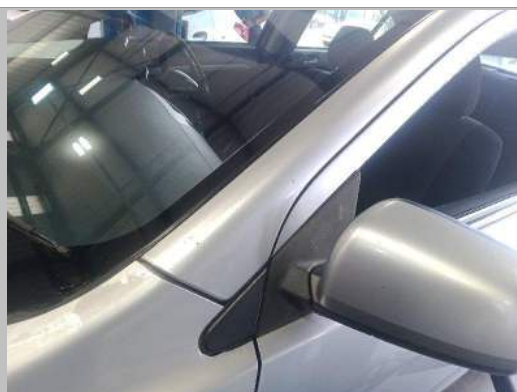
| A • Pillar Left Dented | Repair |

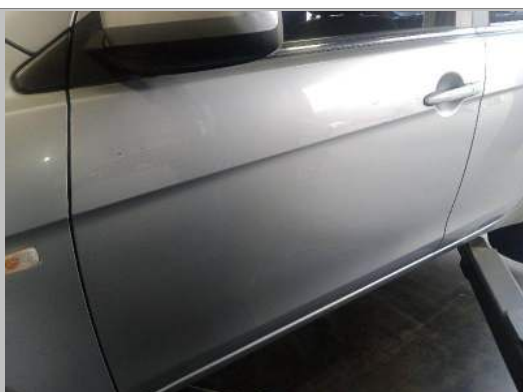
| Door Front Left Dented | Repair |

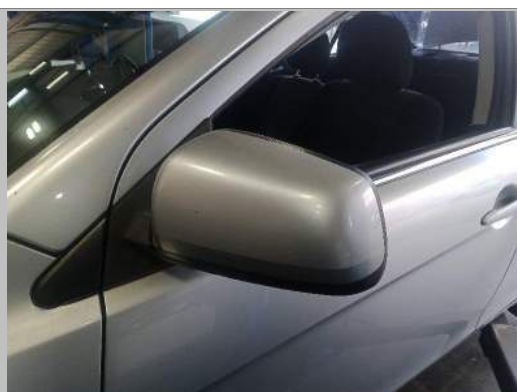
| Side Mirror Left Paintwork • Scratched | Repair |

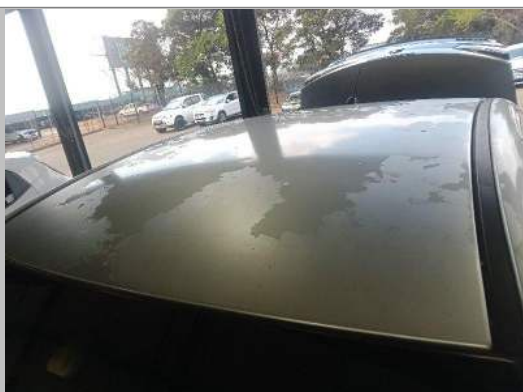
| Roof Paintwork • Flaking | Repair |

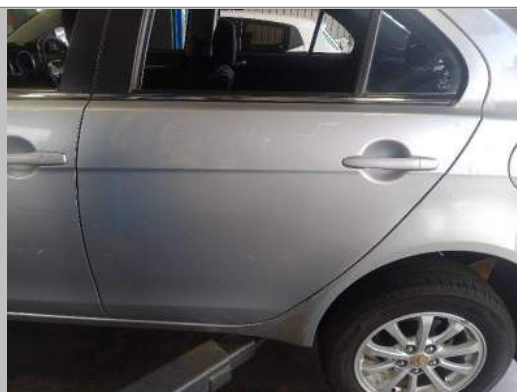
| Door Rear Left Paintwork • Scratched | Repair |

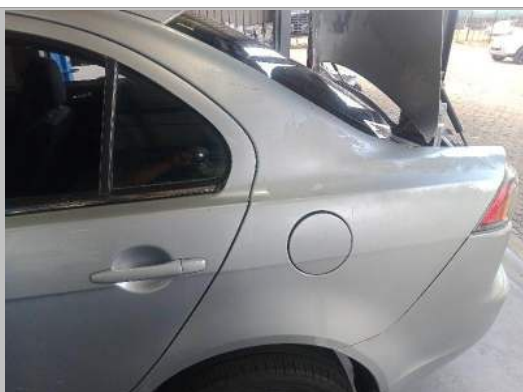
| Rear Fender Left Paintwork • Flaking | Repair |

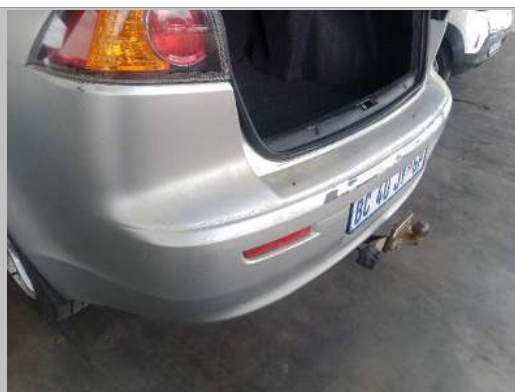
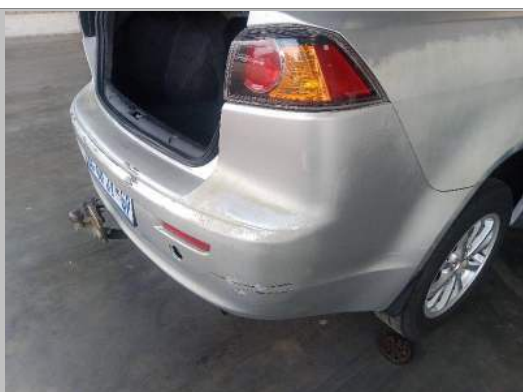
| Rear bumper Paintwork • Discoloured | Repair |

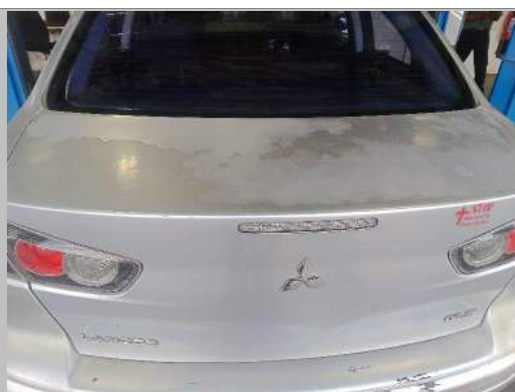
| Boot Lid / Hatch door Paintwork • Flaking | Repair |

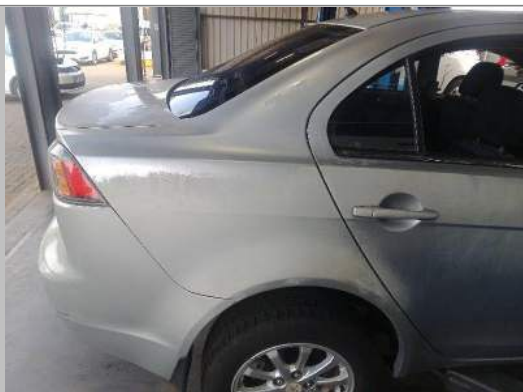
| Rear Fender Right Paintwork • Discoloured | Repair |

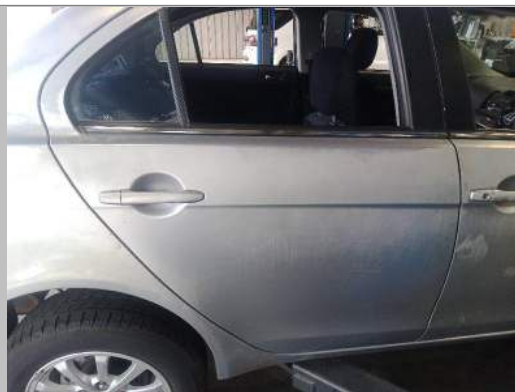
| Door Rear Right Paintwork • Discoloured | Repair |

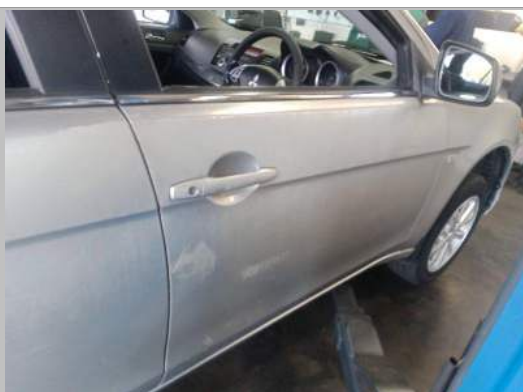
| Door Front Right Paintwork • Discoloured | Repair |

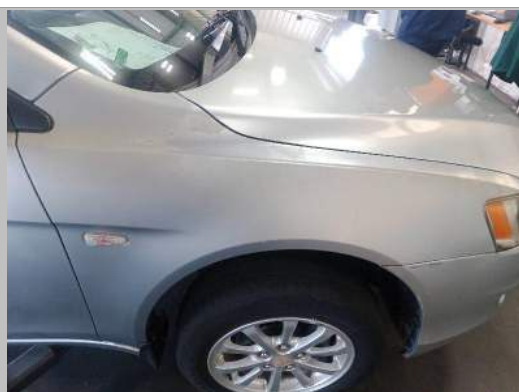
| Front Fender Right Paintwork • Discoloured | Repair |

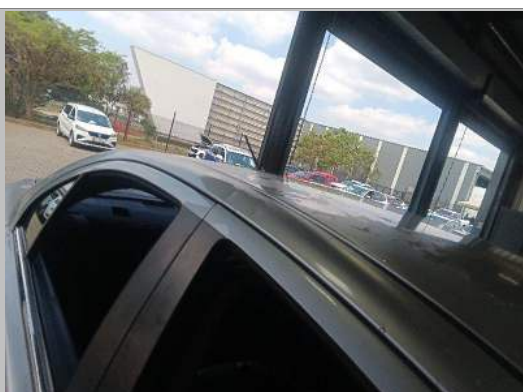
| A • Pillar Right Dented | Repair |

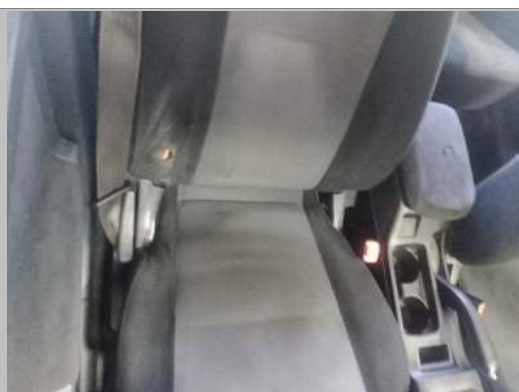
| Seat Front Right Damaged | Repair |

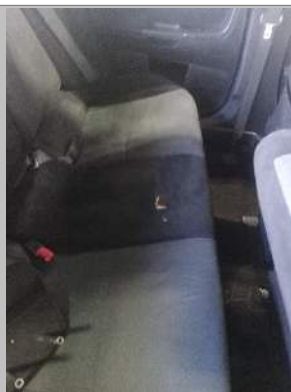
| Seat Rear Torn / Cut | Repair |

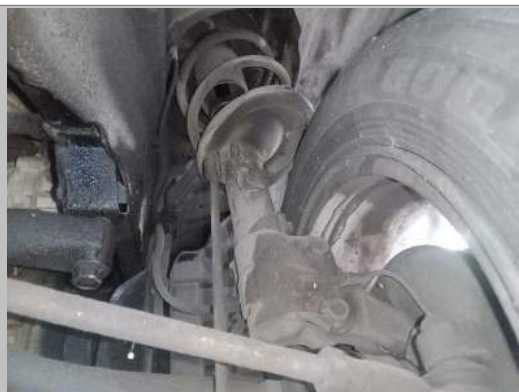
| Shock Absorber Front Right Leak | Replace |

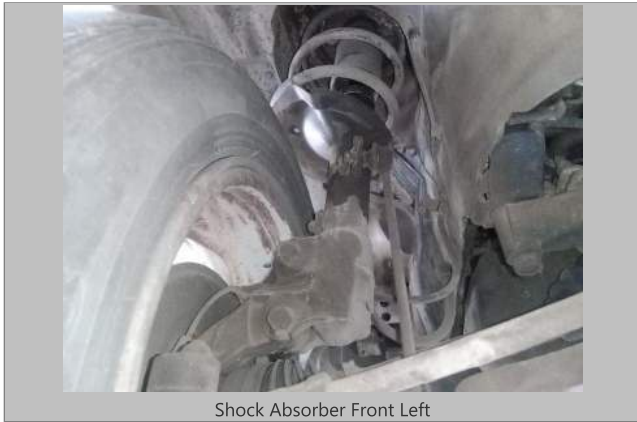
| Shock Absorber Front Left Leak | Replace |
