CONDITION REPORT

Report No: 2016260091

MFC Auction House
M57 Pretoria Rd, Glenmarais, KEMPTON PARK
Gauteng

Vehicle Type	PASSENGER VEHICLE	Registered Owner	MFC AUCTION HOUSE
Manufacturer	MITSUBISHI	Registration Number	HPY327EC
Model	ASX	Register Number	
VIN	JMYXTGA2WFZ002379	Date Of First Licensing	
Engine Number		Last COR	
Doors	5	License Expiry Date	31/03/2024
Color	RED	Power / Displacement	
Year Model		Paint Finish	M - METALLIC
Km Reading	176,655 KM	Fuel	PETROL
Cab / Body Type	STATION WAGON	Transmission	AUTOMATIC

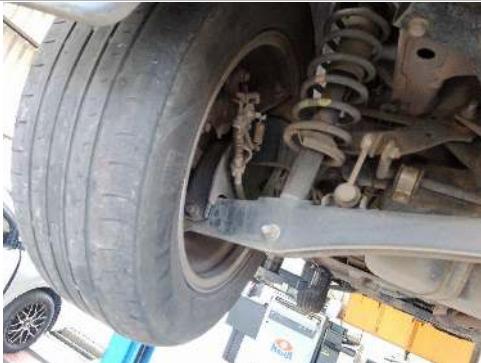
LR TYRE TREAD

Size	Load/Speed Index	Manufacture	Model	Type*	Production Date	Tread Depth (mm)
Front Left	215/60R17	96H	Continental	Contact	V	2319	3 mm
Front Right	215/60R17	96H	Yokohama	Aspec	V	0315	1 mm
Rear Left	215/60R17	96H	Kumho	Solus	V	0319	0 mm
Rear Right	215/60R17	96H	Continental	Contact	V	5017	5 mm
Spare	215/60R17	96H	Kumho	Solus	V	//////	3 mm

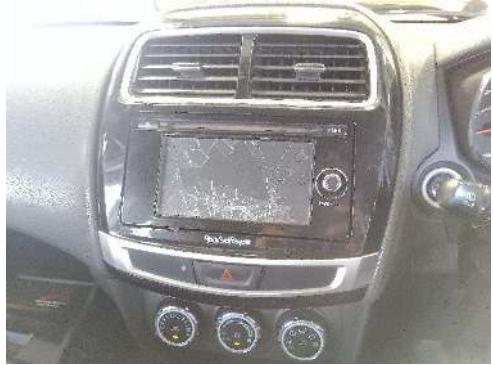
General Comments: ACCORDING TO THE AGE AND MILEAGE OF THE VEHICLE, NORMAL WEAR AND TEAR MARKS ARE VISIBLE ON THE INTERIOR, EXTERIOR, ELECTRICAL AND MECHANICAL PARTS. Electrical Components and Instruments: Electronics malfunction. Radio not working.

Radio screen damage

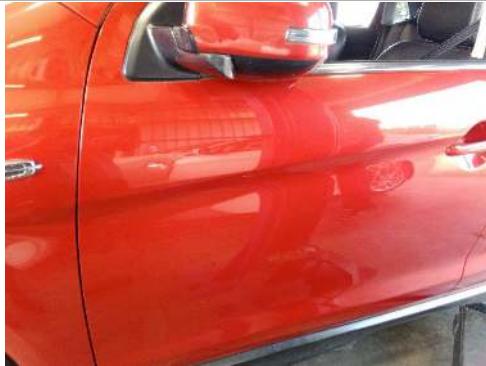
Damage	Repair Way
Engine Oil Leak	Repair
Rear Fender Left Dented	Repair
Door Front Left Paintwork • Scratched	Repair
Tyre Rear Left Smooth	Replace
