## CONDITION REPORT

Report No:  
2017303166  
DATE  
25/09/2026

| Manufacturer | TOYOTA | Registration Number | KT48KMGP |
| Model | URBAN CRUISER | Register Number | |

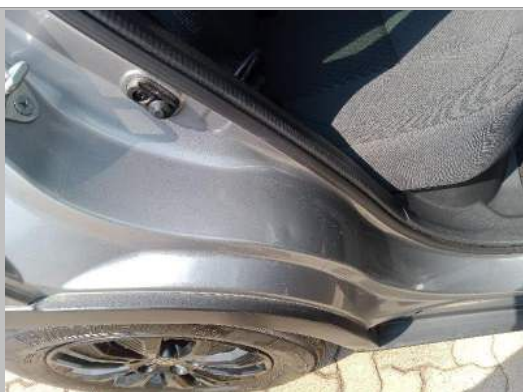
| C • Pillar Right Dented | Repair |

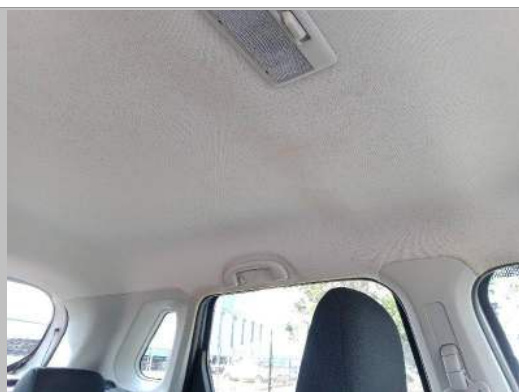
| Hood Lining Dirty | Repair |

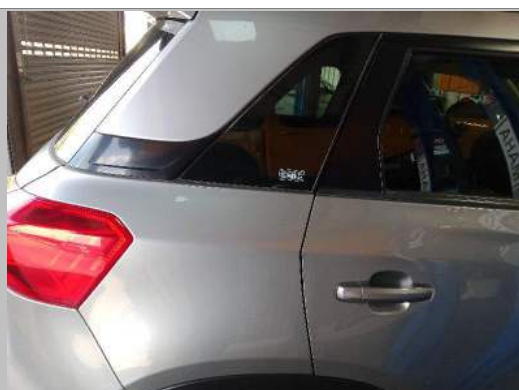
| Rear Fender Right Dented | Repair |

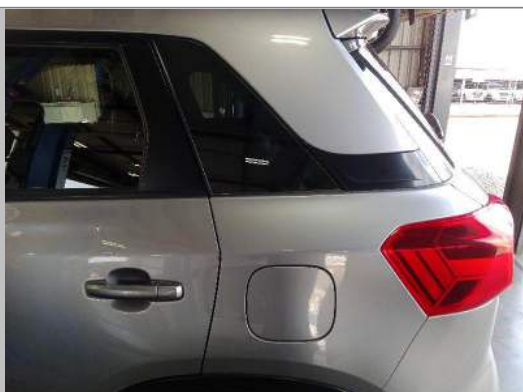
| Rear Fender Left Dented | Repair |

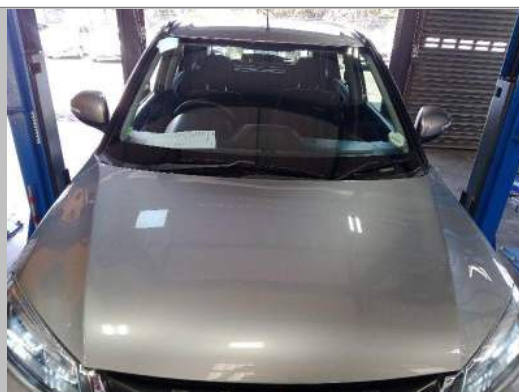
| Bonnet Dented | Repair |

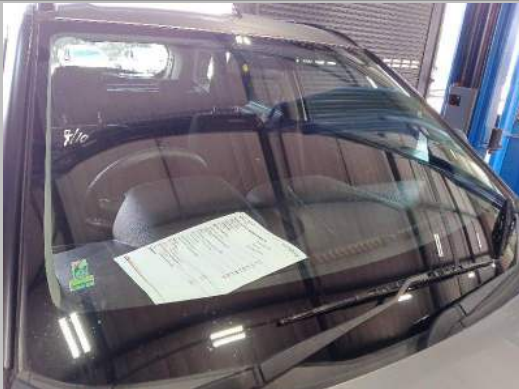
| Windscreen Chipped | Repair |

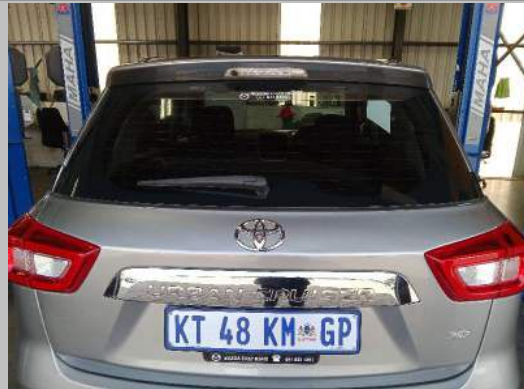
| Boot Lid / Hatch door Dented | Repair |

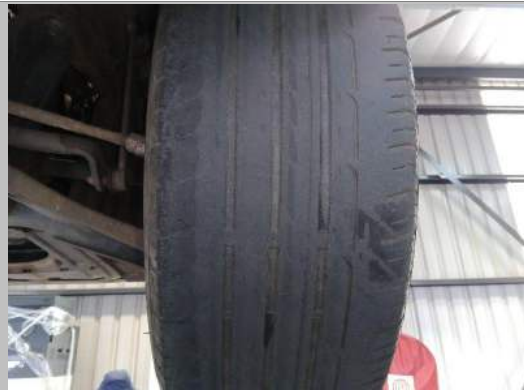
| Tyre Front Right Worn | Replace |

| | Size | Load/Speed Index | Manufacture | Model | Type* | Production Date | Tread Depth (mm) |
|---|---|---|---|---|---|---|---|
| Front Right | 215/60 R16 | 95V | Bridgestone | Turanza | V | 3120 | 0 mm |

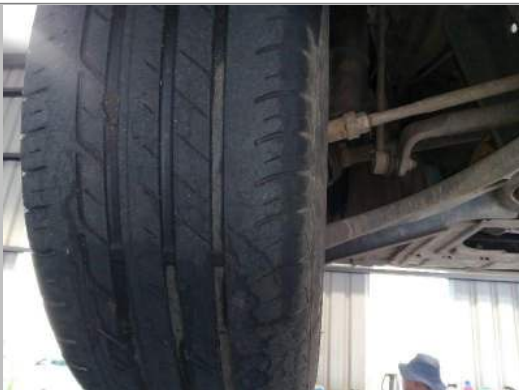
| Tyre Front Left Worn | Replace |

| | Size | Load/Speed Index | Manufacture | Model | Type* | Production Date | Tread Depth (mm) |
|---|---|---|---|---|---|---|---|
| Front Left | 215/60 R16 | 95V | Bridgestone | Turanza | V | 3120 | 0 mm |

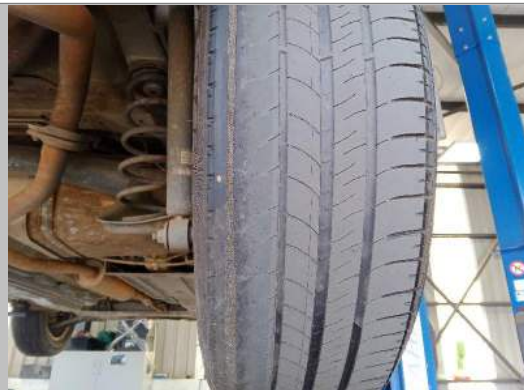
| Tyre Rear Right Damaged | Replace |

| | Size | Load/Speed Index | Manufacture | Model | Type* | Production Date | Tread Depth (mm) |
|---|---|---|---|---|---|---|---|
| Rear Right | 205/65 R16 | 95V | Michelin | GreenX | V | 1822 | 0 mm |

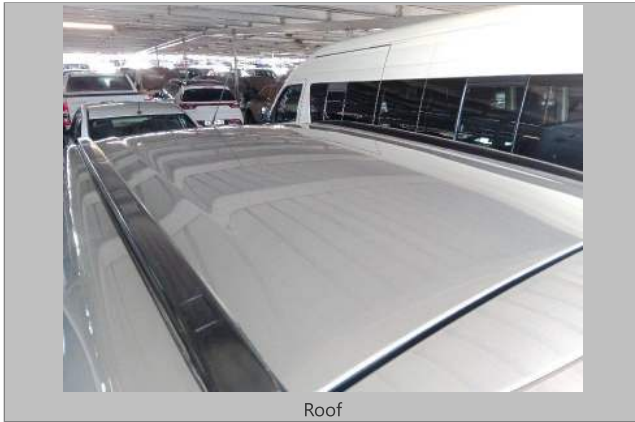
| Roof Dented | Repair |
