MFC Auction House  
M57 Pretoria Rd, Glenmarais, KEMPTON PARK  
Gauteng

| Manufacturer | TOYOTA | Registration Number | LK73ZYGP |

## CONDITION REPORT

Report No: 2016818293

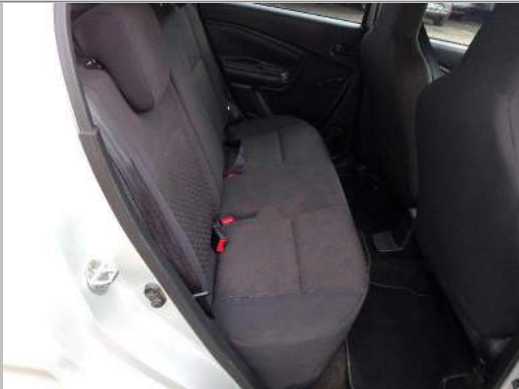
| Damage | Repair Way |
|---|---|
| Seat Rear Dirty | Repair |

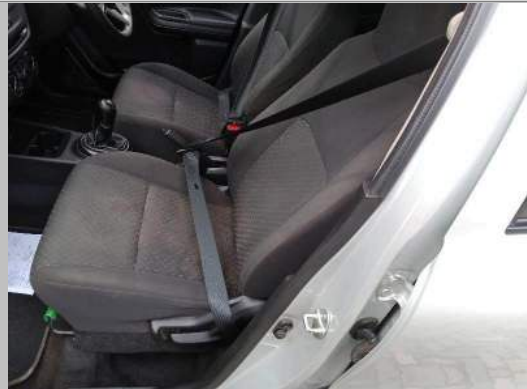
| Damage | Repair Way |
|---|---|
| Seat Front Left Dirty | Repair |

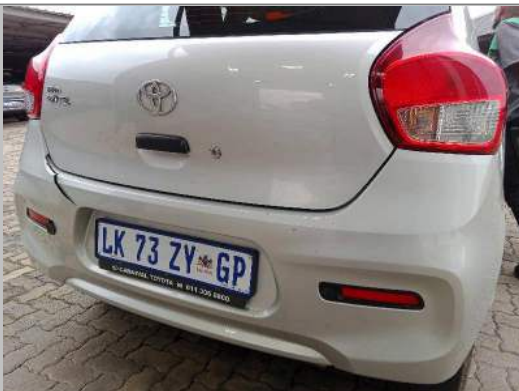
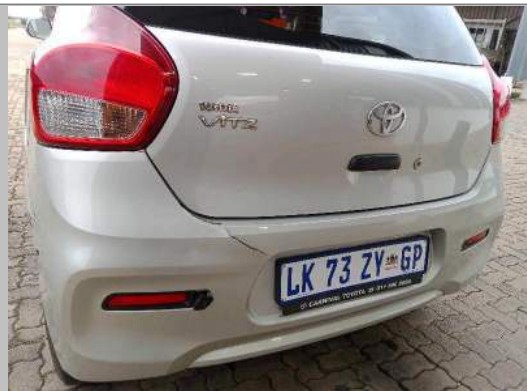
| Damage | Repair Way |
|---|---|
| Rear bumper Damaged | Repair |

| Damage | Repair Way |
|---|---|
| Body and Exterior | Signs of impact damage to rear of vehicle. |

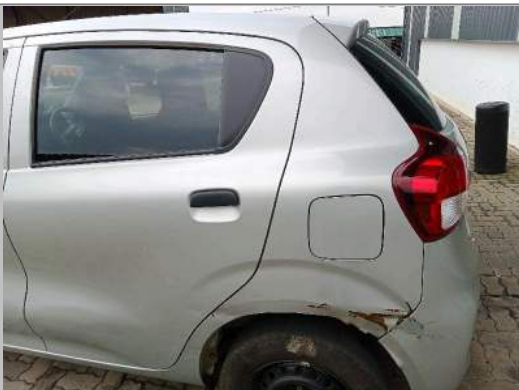
| Damage | Repair Way |
|---|---|
| Rear Fender Left Damaged | Repair |

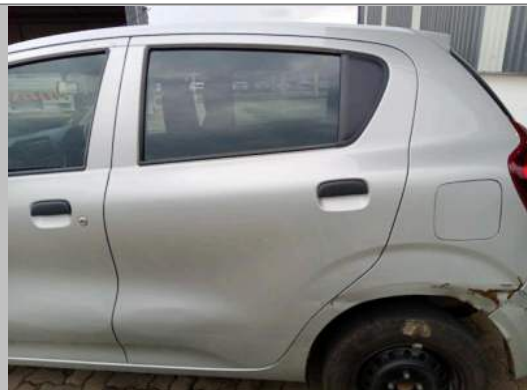
| Damage | Repair Way |
|---|---|
| Door Rear Left Damaged | Repair |

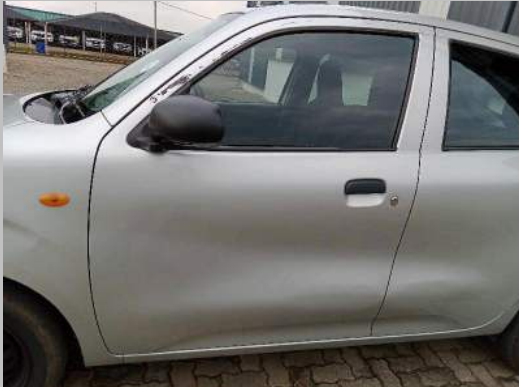
| Damage | Repair Way |
|---|---|
| Door Front Left Damaged | Repair |

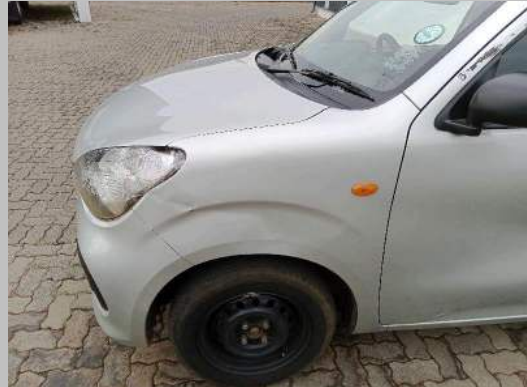
| Damage | Repair Way |
|---|---|
| Front Fender Left Damaged | Repair |

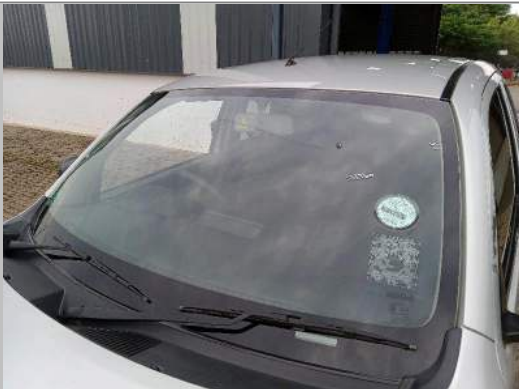
| Damage | Repair Way |
|---|---|
| Windscreen Cracked | Replace |

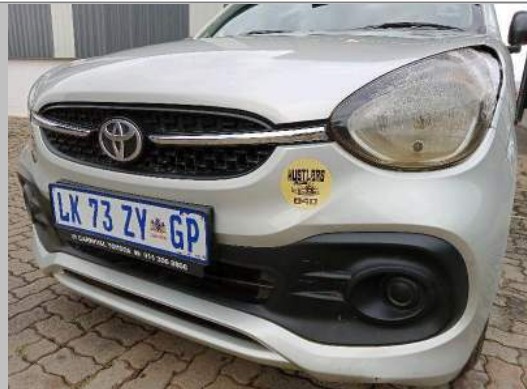
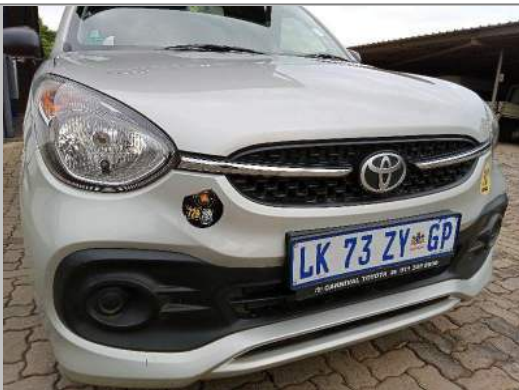
| Damage | Repair Way |
|---|---|
| Front Bumper Damaged | Repair |

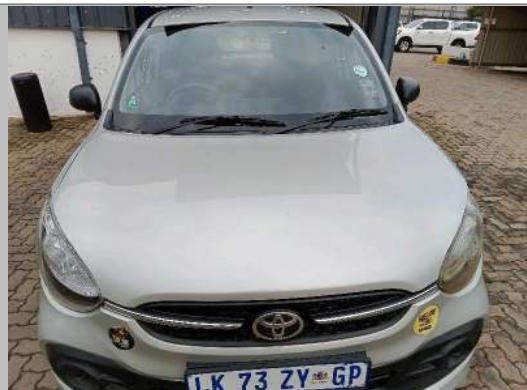
| Damage | Repair Way |
|---|---|
| Bonnet Dented | Repair |

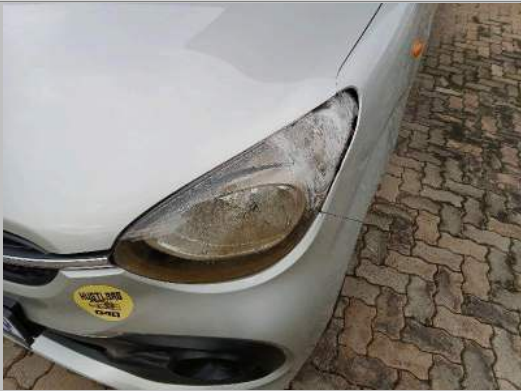
| Damage | Repair Way |
|---|---|
| Headlight Left Damaged | Replace |

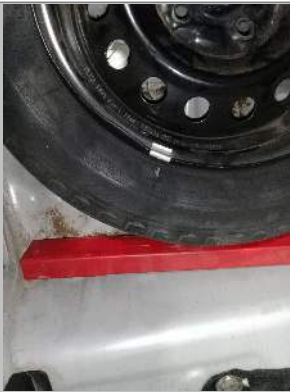
| Damage | Repair Way |
|---|---|
| Spare Tyre Damaged | Replace |

| | Size | Load/Speed Index | Manufacture | Model | Type* | Production Date | Tread Depth (mm) |
|---|---|---|---|---|---|---|---|
| Spare | 165/70 R14 | 81S | Bridgestone | Ecopia | V | 0723 | 2 mm |

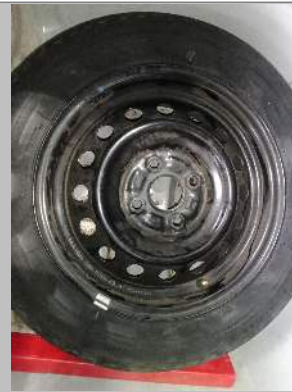
| Damage | Repair Way |
|---|---|
| Rim Spare Wheel Dented | Repair |

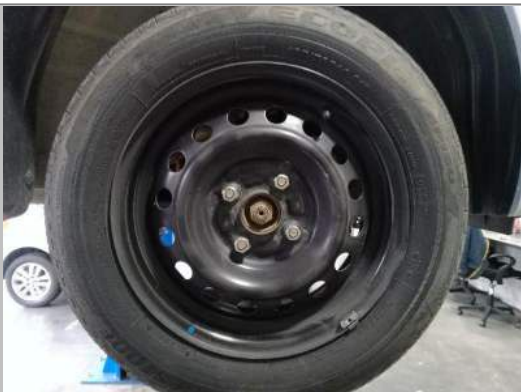
| Damage | Repair Way |
|---|---|
| Rim Front Right Dented | Repair |

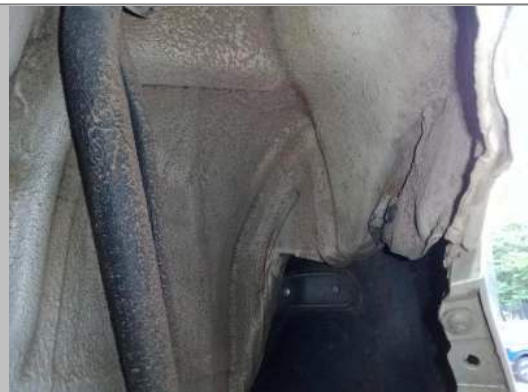
| Damage | Repair Way |
|---|---|
| Rear Fender Left / Inner Tray Damaged | Repair |

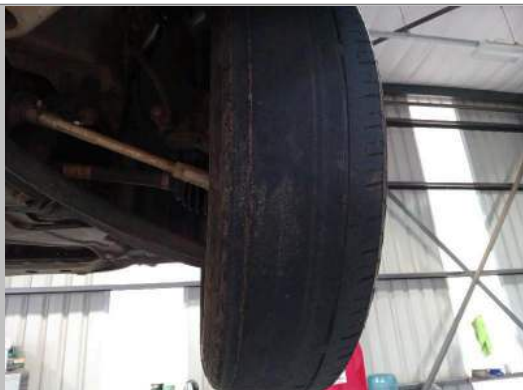
| Damage | Repair Way |
|---|---|
| Tyre Front Right Damaged | Replace |

| | Size | Load/Speed Index | Manufacture | Model | Type* | Production Date | Tread Depth (mm) |
|---|---|---|---|---|---|---|---|
| Front Right | 165/70 R14 | 81S | Bridgestone | Ecopia | V | 0823 | 0 mm |

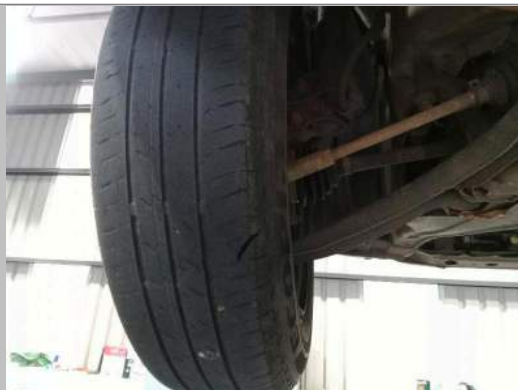
| Damage | Repair Way |
|---|---|
| Tyre Front Left Damaged | Replace |

| | Size | Load/Speed Index | Manufacture | Model | Type* | Production Date | Tread Depth (mm) |
|---|---|---|---|---|---|---|---|
| Front Left | 165/70 R14 | 81S | Bridgestone | Ecopia | V | 0823 | 0 mm |

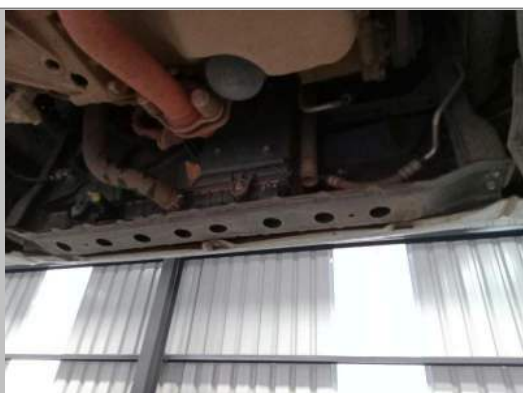
| Damage | Repair Way |
|---|---|
| Radiator Cradle Dented | Repair |

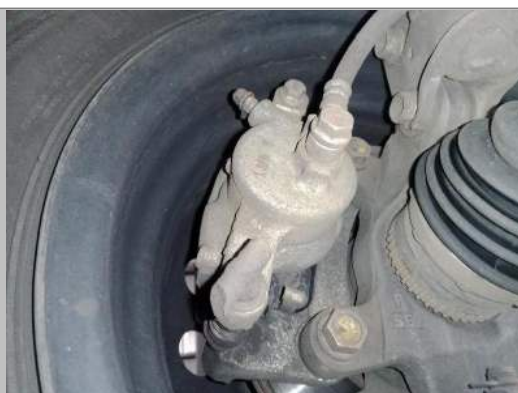
| Damage | Repair Way |
|---|---|
| Caliper 1. Axle right Defective | Repair |

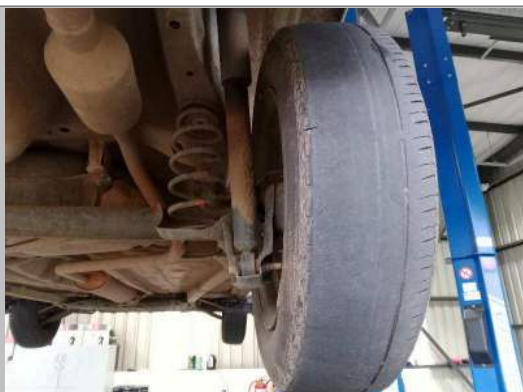
| Damage | Repair Way |
|---|---|
| Tyre Rear Right Worn | Replace |

| | Size | Load/Speed Index | Manufacture | Model | Type* | Production Date | Tread Depth (mm) |
|---|---|---|---|---|---|---|---|
| Rear Right | 165/70 R14 | 81S | Bridgestone | Ecopia | V | 0823 | 0 mm |

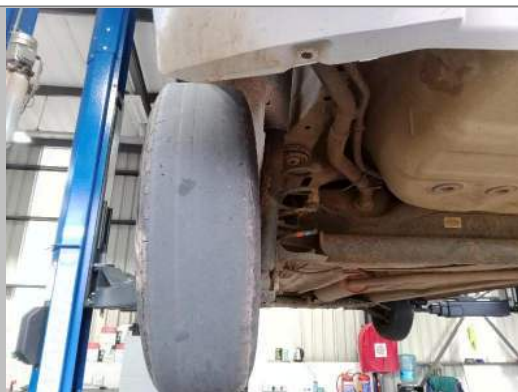
| Damage | Repair Way |
|---|---|
| Tyre Rear Left Worn | Replace |

| | Size | Load/Speed Index | Manufacture | Model | Type* | Production Date | Tread Depth (mm) |
|---|---|---|---|---|---|---|---|
| Rear Left | 165/70 R14 | 81S | Bridgestone | Ecopia | V | 0723 | 0 mm |

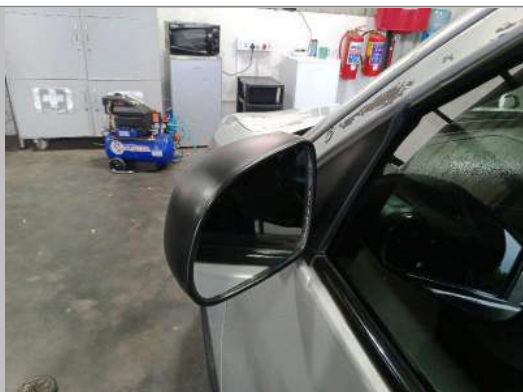
| Damage | Repair Way |
|---|---|
| Side Mirror Left Residual Traces of Repair | Replace |

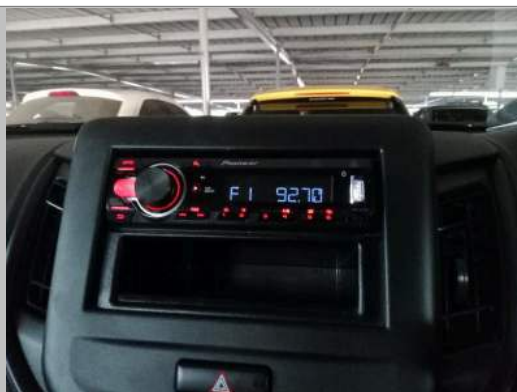
| Damage | Repair Way |
|---|---|
| Radio/CD/USB Defective | Repair |

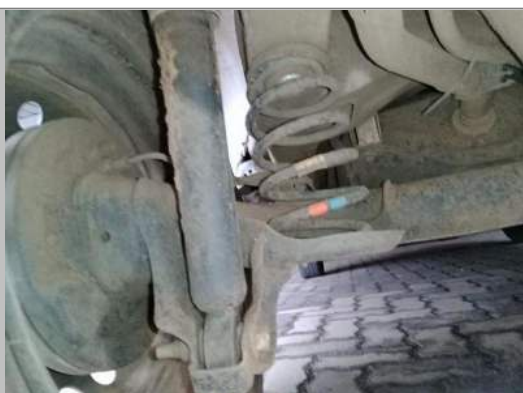
| Damage | Repair Way |
|---|---|
| Rear Axle Defective | Repair |
