## CONDITION REPORT

Report No: 2016871664

| Manufacturer | CHEVROLET | Registration Number | HZC416MP |
| Model | CRUZE 1.6 L [2012-2013] | Register Number | |

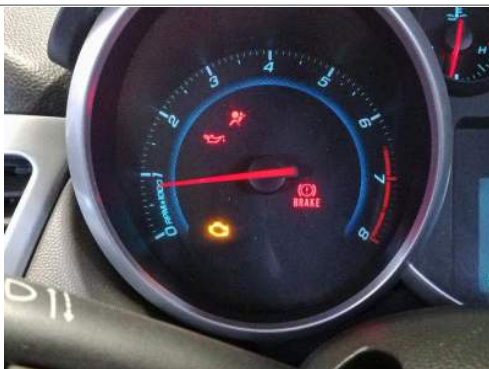
| Damage | Repair Way |
|---|---|
| Multiple warning lights illuminated | Repair |

Multiple warning lights illumi

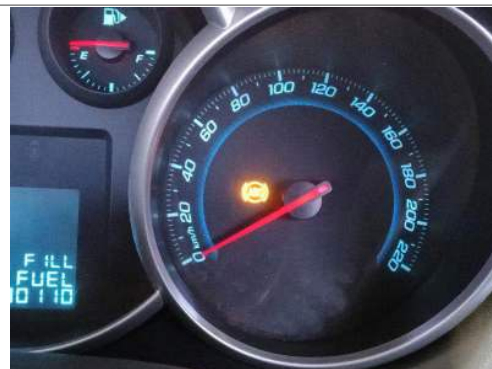
ABS warning lights illuminated

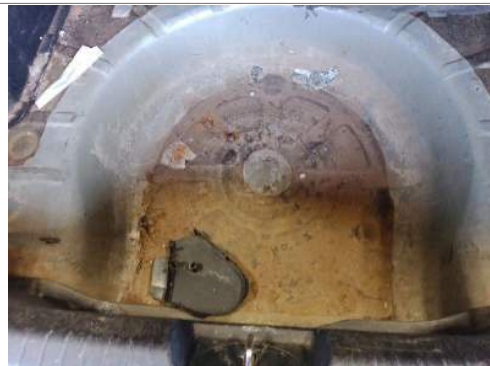
No sparewheel

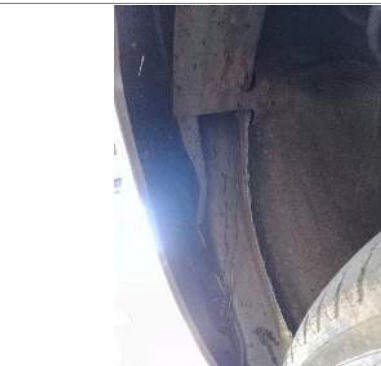
R/F fender liner missing

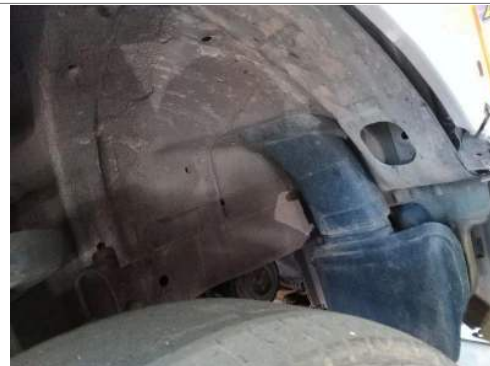
R/F fender liner missing

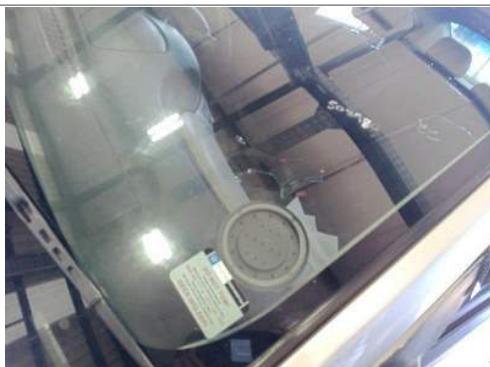
No license disc

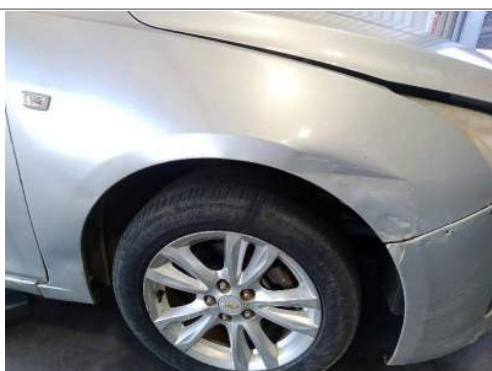
| Damage | Repair Way |
|---|---|
| Front Fender Right Damaged | Repair |

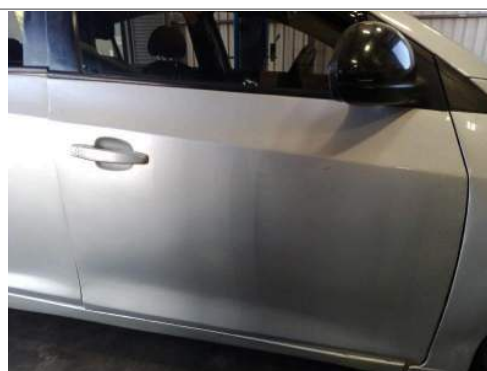
| Damage | Repair Way |
|---|---|
| Door Front Right Residual Traces of Repair | Repair |

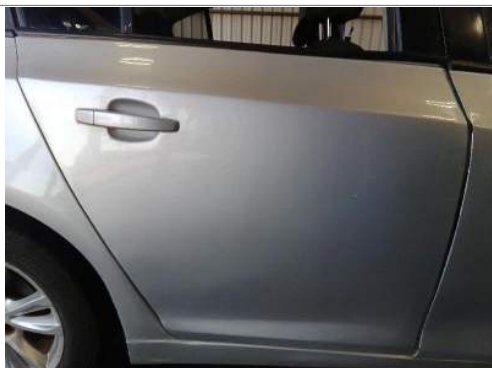
| Damage | Repair Way |
|---|---|
| Door Rear Right Residual Traces of Repair | Repair |

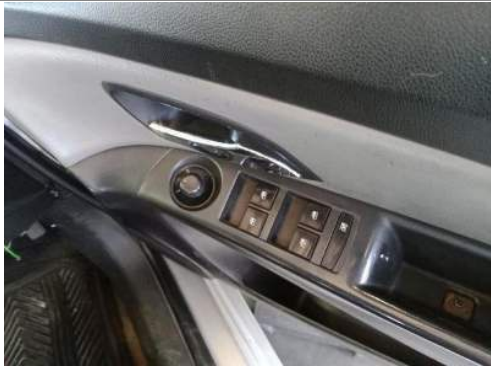
| Damage | Repair Way |
|---|---|
| Switch Electrical Window Winder front right Defective | Repair |

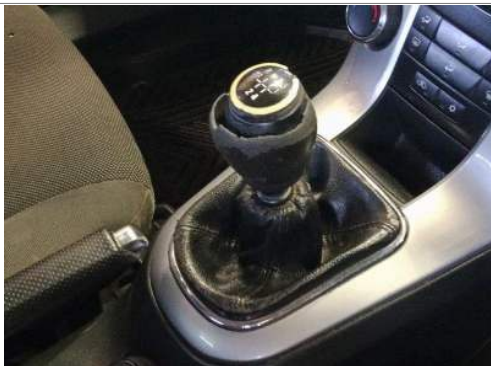
| Damage | Repair Way |
|---|---|
| Gear Lever Dust Boot Torn / Cut | Repair |

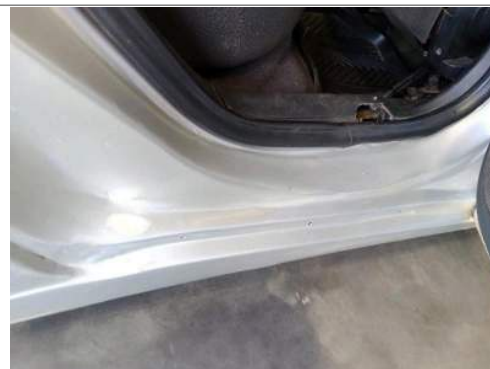
| Damage | Repair Way |
|---|---|
| Sill Panel Right Residual Traces of Repair | Repair |

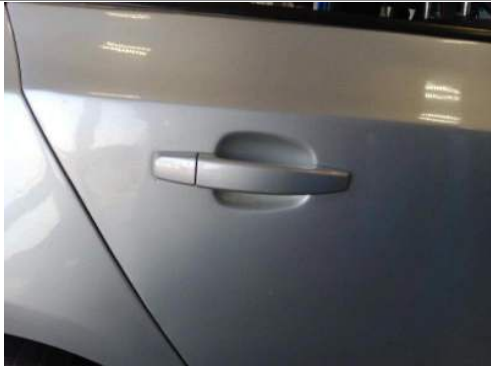
| Damage | Repair Way |
|---|---|
| Door Handle Rear Right Damaged | Repair |

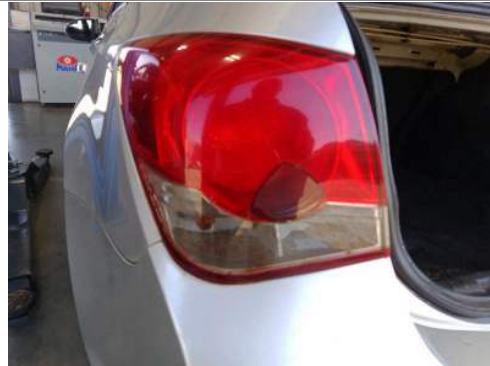
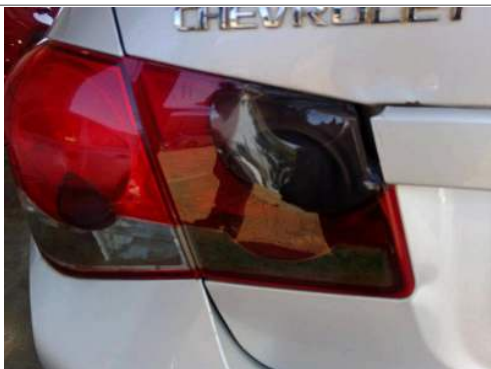
| Damage | Repair Way |
|---|---|
| Tail Light Left Damaged | Replace |

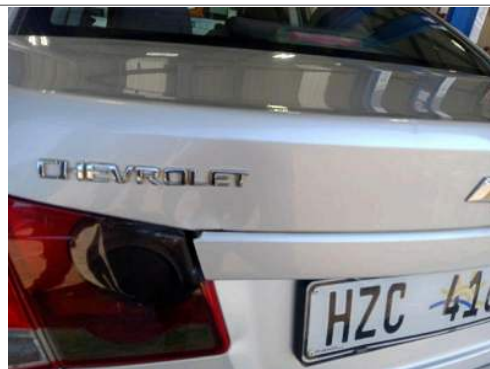
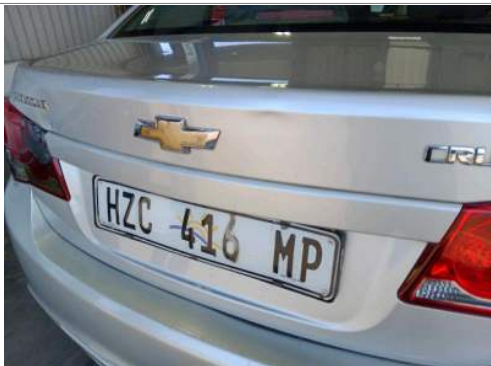
| Damage | Repair Way |
|---|---|
| Boot Lid / Hatch door Dented | Repair |

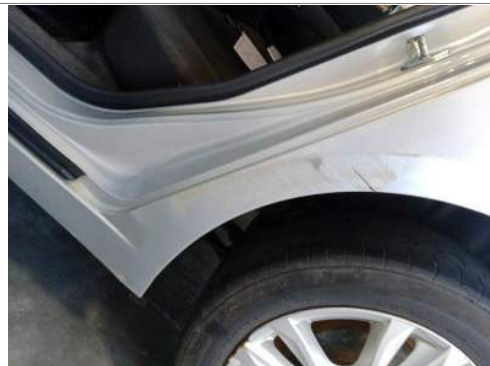
| Damage | Repair Way |
|---|---|
| C • Pillar Left Paintwork • Scratched | Repair |

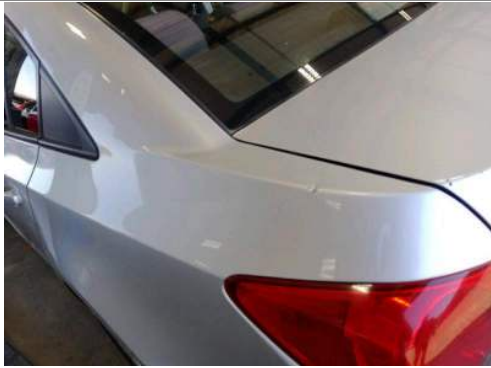
| Damage | Repair Way |
|---|---|
| Rear Fender Left Dented | Repair |

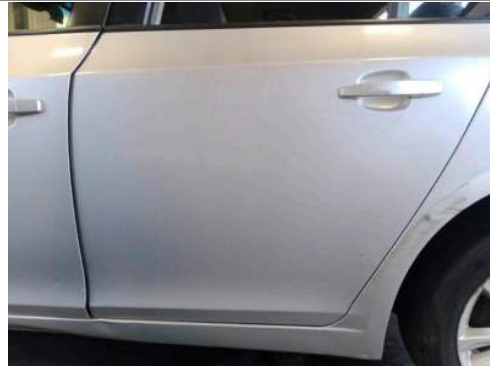
| Damage | Repair Way |
|---|---|
| Door Rear Left Paintwork • Scratched | Repair |

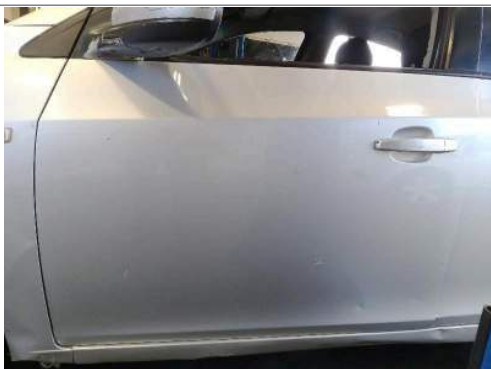
| Damage | Repair Way |
|---|---|
| Door Front Left Paintwork • Scratched | Repair |

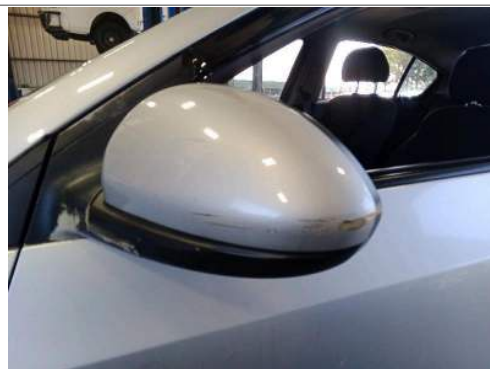
| Damage | Repair Way |
|---|---|
| Side Mirror Left Paintwork • Scratched | Repair |

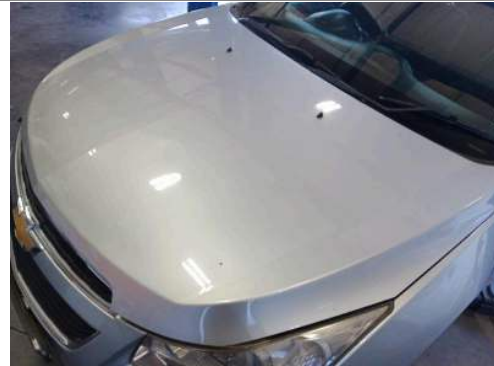
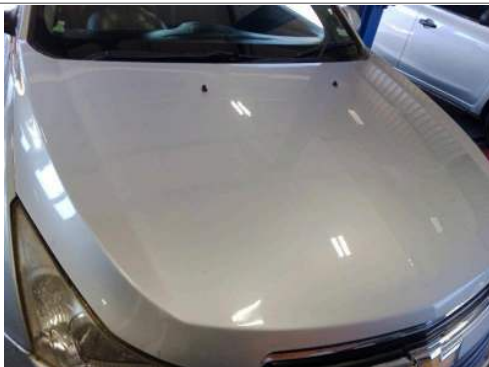
| Damage | Repair Way |
|---|---|
| Bonnet Dented | Repair |

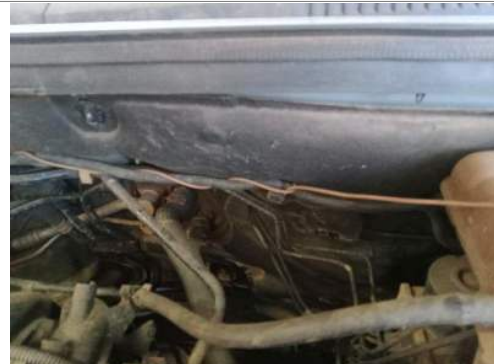
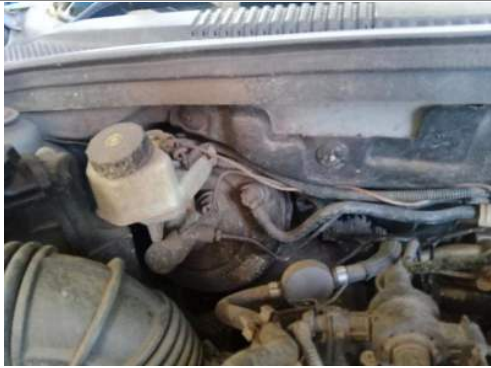
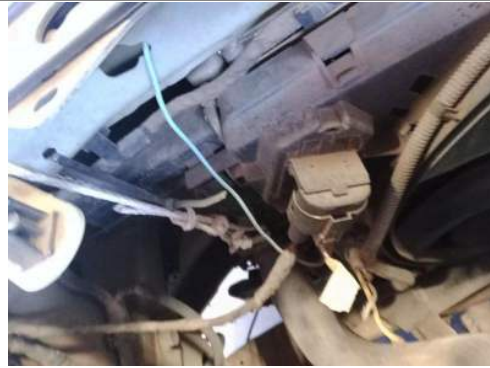
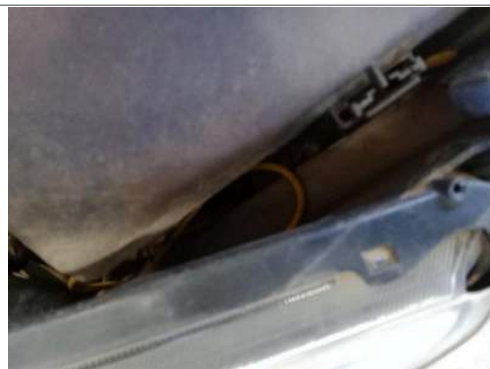
| Damage | Repair Way |
|---|---|
| Engine Wiring Defective | Repair |

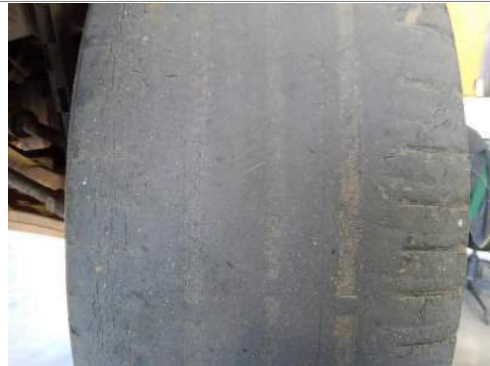
| Damage | Repair Way |
|---|---|
| Tyre Front Right Smooth | Replace |

| | Size | Load/Speed Index | Manufacture | Model | Type* | Production Date | Tread Depth (mm) |
|---|---|---|---|---|---|---|---|
| Front Right | 205/55R16 | 91H | Michelin | Energy | V | 0000 | 0 mm |

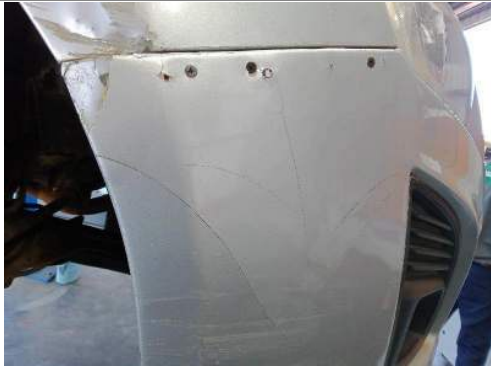
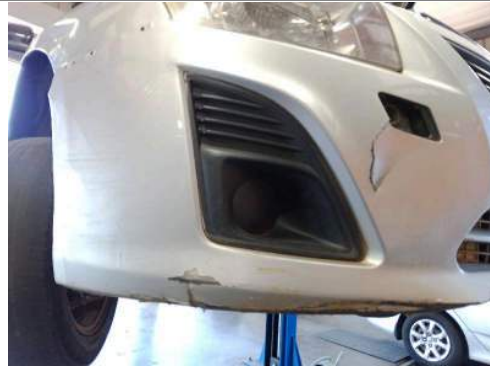
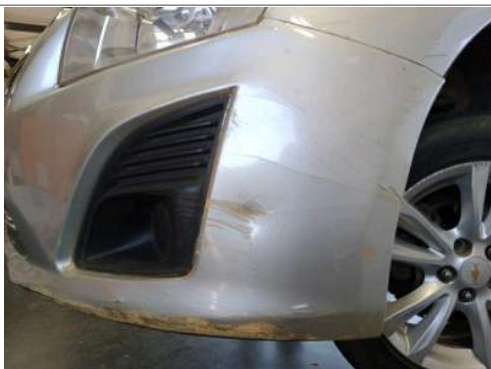
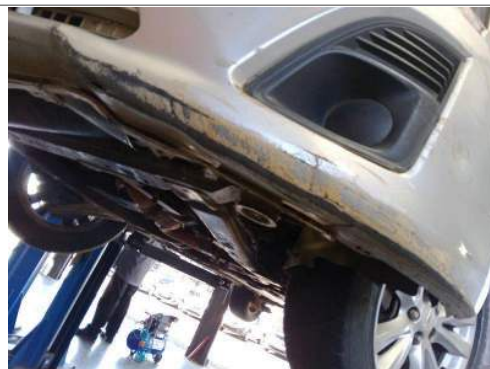
| Damage | Repair Way |
|---|---|
| Front Bumper Damaged | Repair |

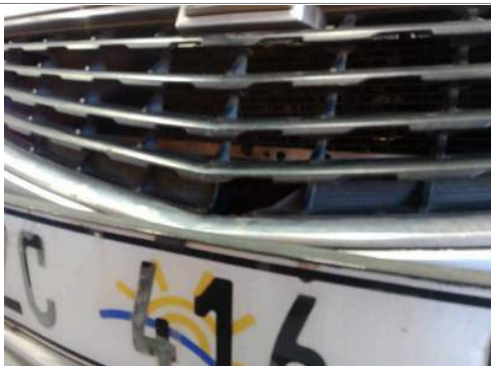
| Damage | Repair Way |
|---|---|
| Grill Damaged | Repair |

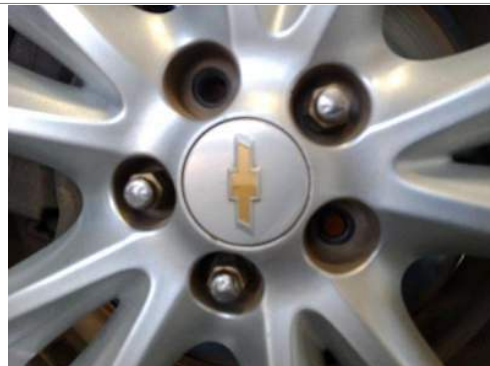
| Damage | Repair Way |
|---|---|
| Bolt(s) / Nut(s) Front Wheel Left Missing | Replace |

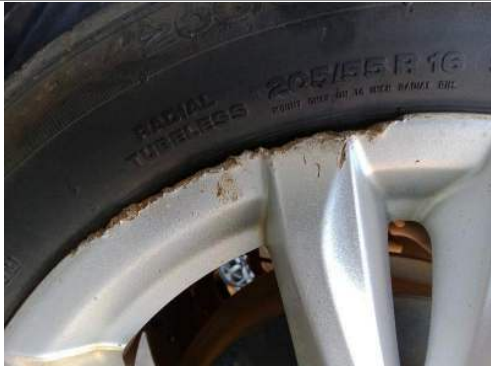
| Damage | Repair Way |
|---|---|
| Rim Rear Left Damaged | Repair |

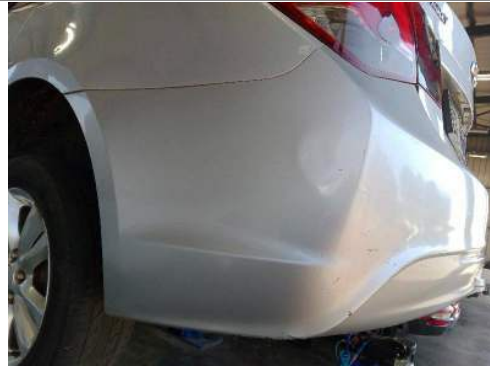
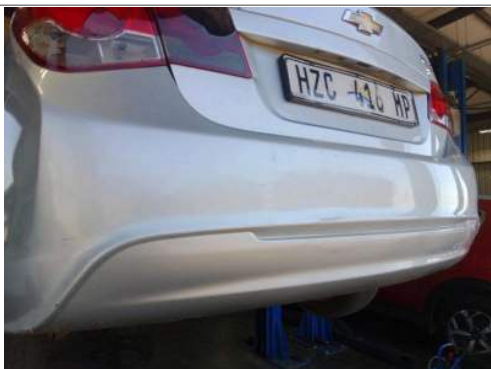
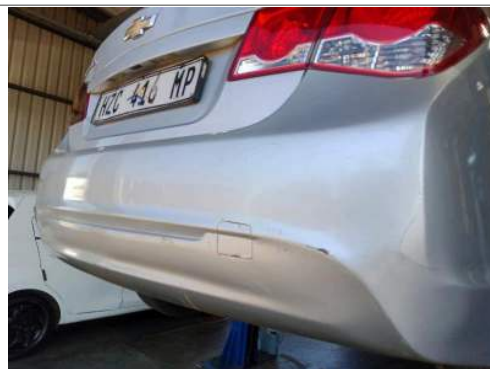
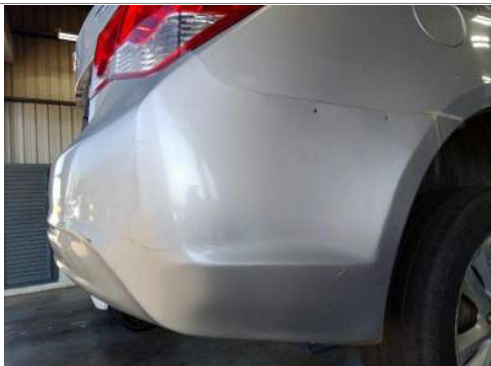
| Damage | Repair Way |
|---|---|
| Rear bumper Residual Traces of Repair | Repair |

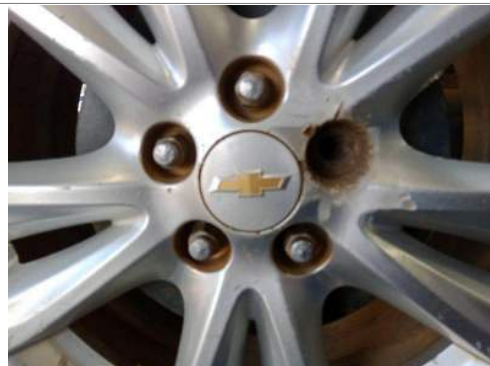
| Damage | Repair Way |
|---|---|
| Bolt(s) / Nut(s) Rear Wheel Right Missing | Replace |

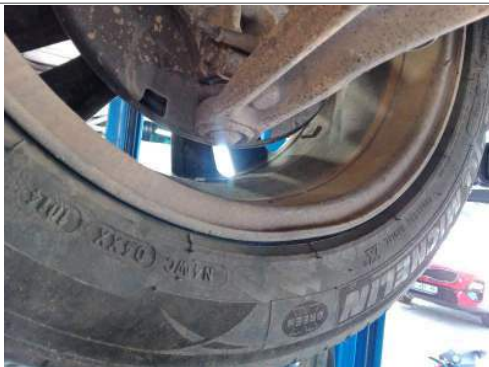
| Damage | Repair Way |
|---|---|
| Rim Front Right Dented | Repair |

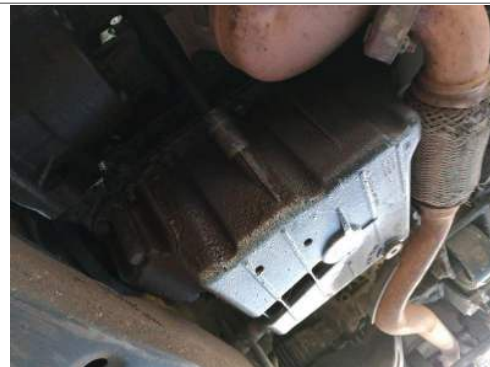
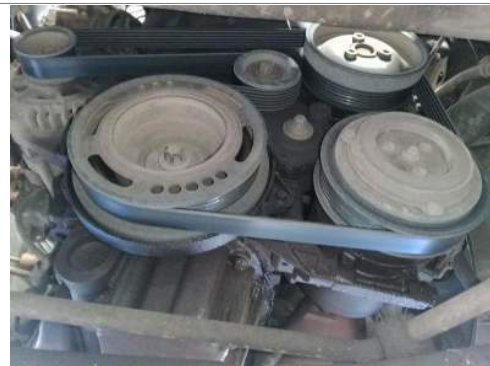
| Damage | Repair Way |
|---|---|
| Engine Oil Leak | Repair |

| Damage | Repair Way |
|---|---|
| Engine Performance Insufficient | Repair |
| Engine Noise Excessive | Repair |

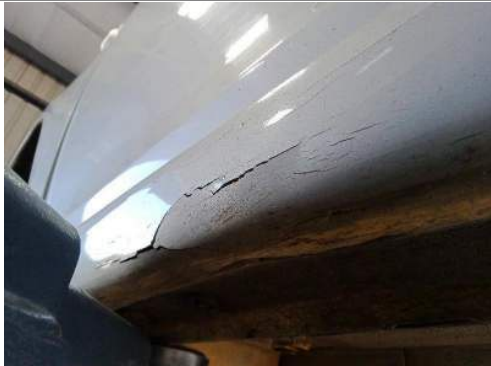
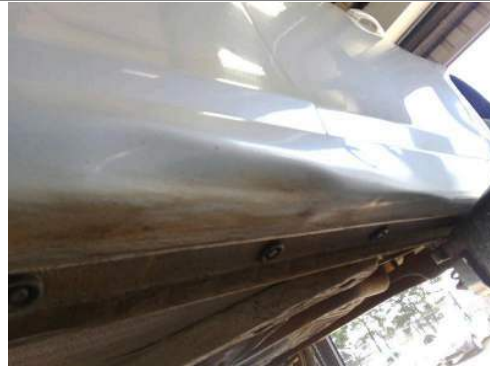
| Damage | Repair Way |
|---|---|
| Sill Panel Left Residual Traces of Repair | Repair |

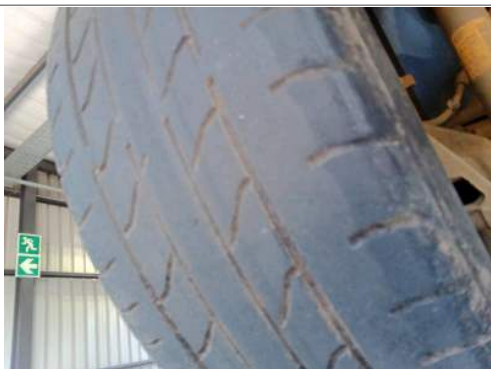
| Damage | Repair Way |
|---|---|
| Tyre Rear Left Excessive Wear & Tear | Replace |

| | Size | Load/Speed Index | Manufacture | Model | Type* | Production Date | Tread Depth (mm) |
|---|---|---|---|---|---|---|---|
| Rear Left | 205/55R16 | 91W | Continental | Contact | V | 0000 | 2 mm |

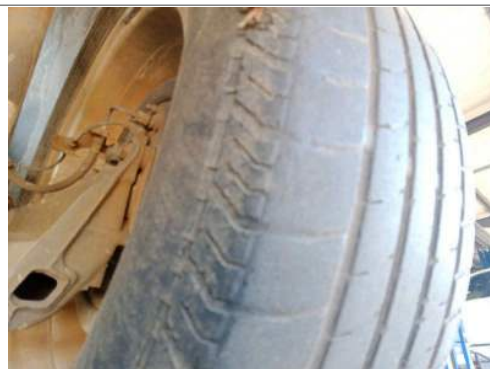
| Damage | Repair Way |
|---|---|
| Tyre Rear Right Smooth | Replace |

| | Size | Load/Speed Index | Manufacture | Model | Type* | Production Date | Tread Depth (mm) |
|---|---|---|---|---|---|---|---|
| Rear Right | 215/55R16 | 95H | Continental | Contact | V | 4308 | 0 mm |

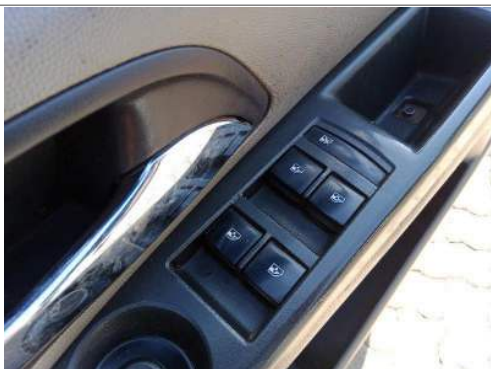
| Damage | Repair Way |
|---|---|
| Switch Electrical Window Winder rear left Defective | Repair |

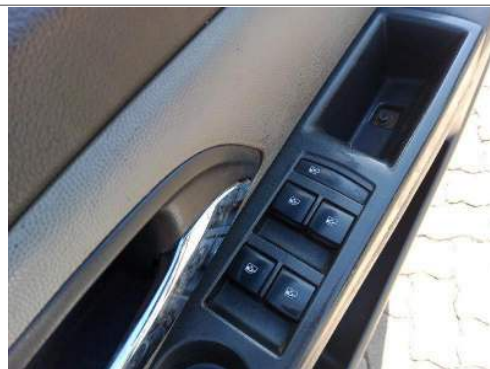
| Damage | Repair Way |
|---|---|
| Switch Electrical Window Winder rear right Defective | Repair |

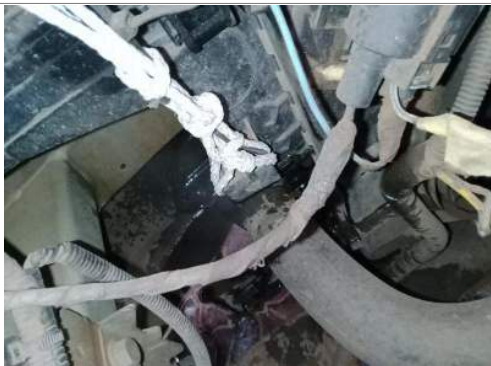
| Damage | Repair Way |
|---|---|
| Radiator Water Leak | Repair |
