MFC Auction House  
M57 Pretoria Rd, Glenmarais, KEMPTON PARK  
Gauteng

Vehicle Type	PASSENGER VEHICLE	Registered Owner	
Manufacturer	CHEVROLET	Registration Number	JLJ977MP
Model	SONIC 1.4T RS 5-DR [2014-2016]	Register Number	
VIN	KL1JH6D84GB513841	Date Of First Licensing	
Engine Number		Last COR	
Doors	5	License Expiry Date	
Color	WHITE	Power / Displacement	
Year Model	2016	Paint Finish	TWO COAT UNI
Km Reading	134,094 KM	Fuel	PETROL
Cab / Body Type	HATCHBACK	Transmission	MANUAL

## VEHICLE INSPECTION

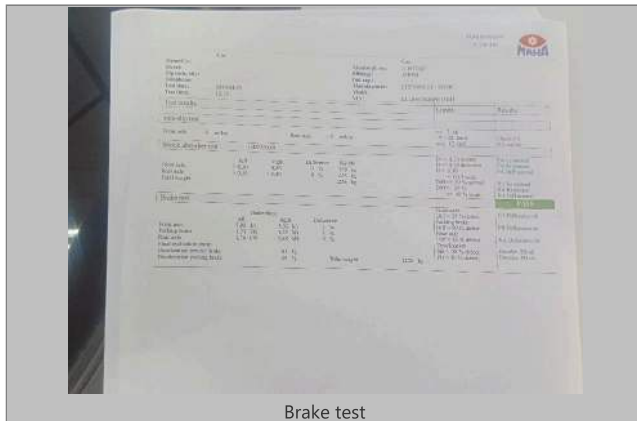
Brake test

Left	Right		
	Braking Force [KN]	Braking Force [KN]	Axle Weight [KG]	Deceleration [m/s <sup>2</sup> ]
Front	3.0	3.02	-	
Rear	1.79	188.0	-	
Emergency / Parking	1.23	1.22	-

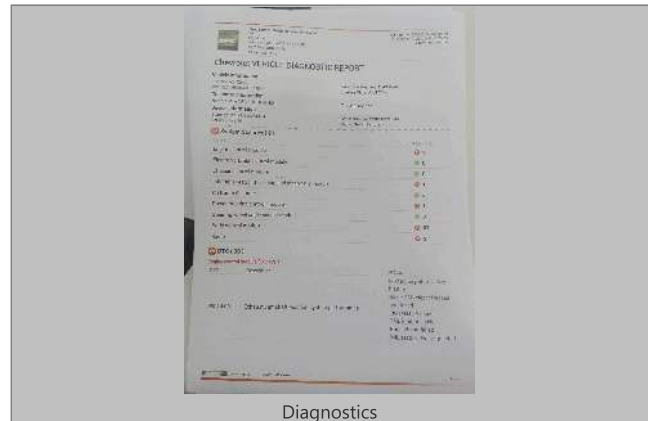
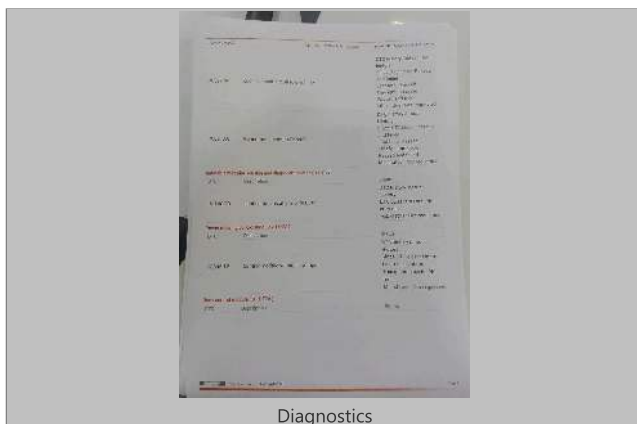
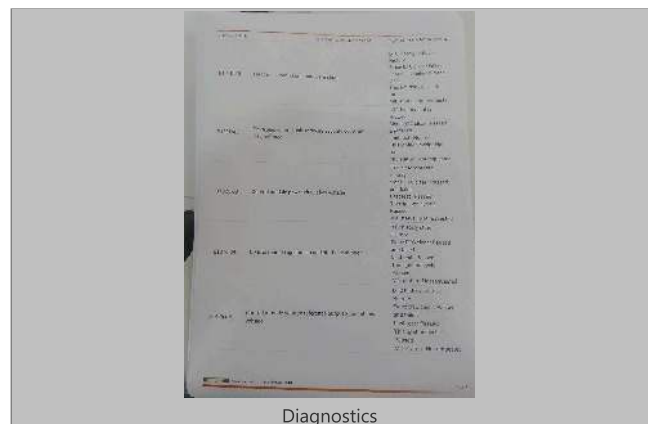
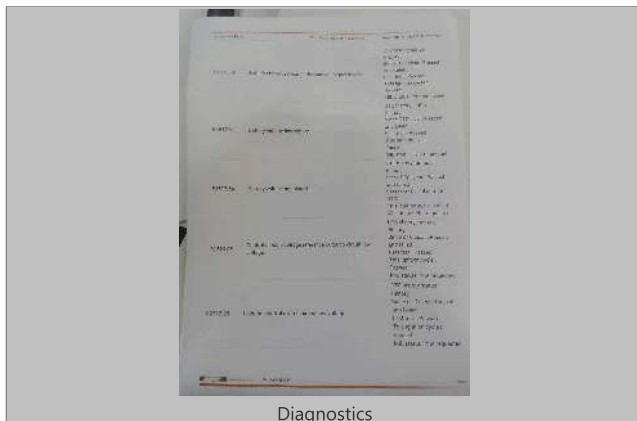
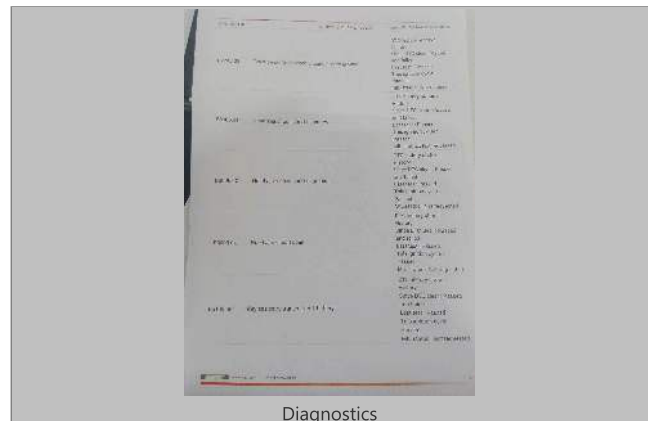
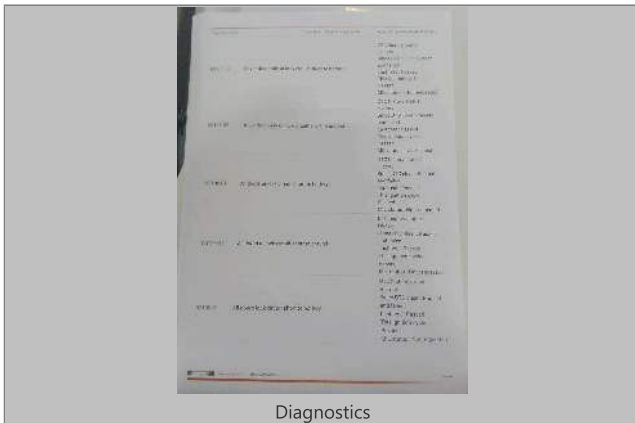
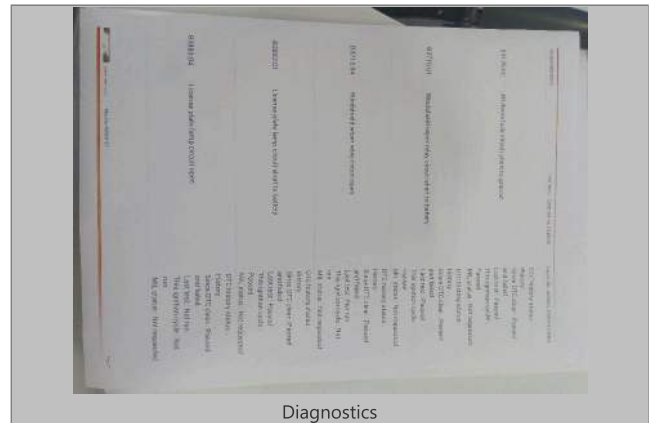
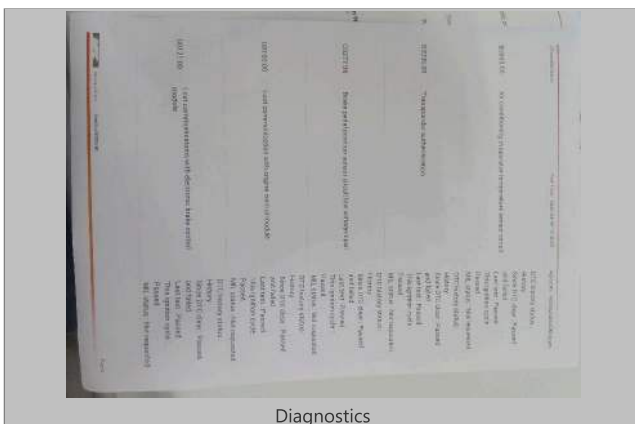
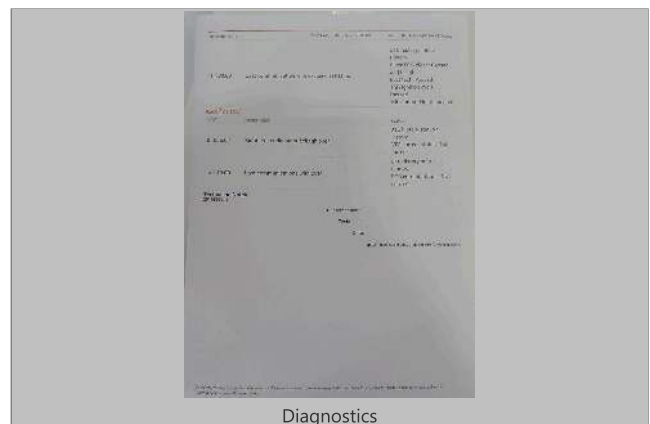
Diagnostics

No	System	Code	Description	Status
1	ENGINE CONTROL MODULE	P0014:00	EXHAUST CAMSHAFT POSITION SYSTEM PERFORMANCE

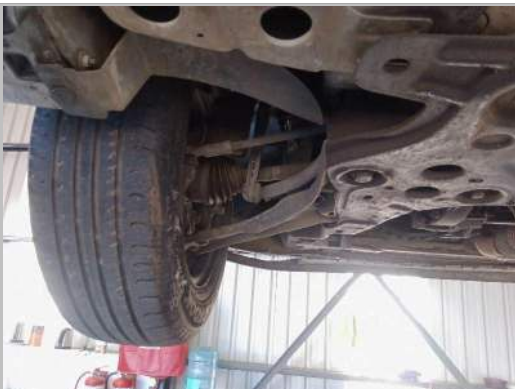
LF TYRE TREAD

Size	Load/Speed Index	Manufacture	Model	Type*	Production Date	Tread Depth (mm)
Front Left	195/65R15	91H	Hankook	Radial	V	3415	3 mm
Front Right	215/45R17	83W	Durun	Radial	V	0000	0 mm
Rear Left	205/50R17	93W	Rapid	Radial	V	2120	2 mm
Rear Right	205/40R17	84W	Landsail	Radial	V	1322	0 mm

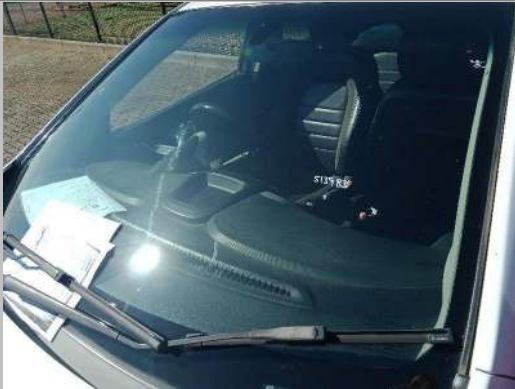
No license disc

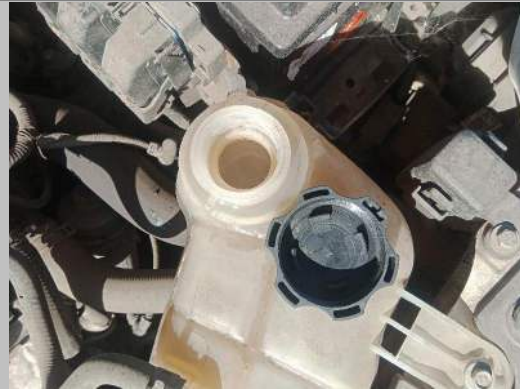
Damage	Repair Way
Engine Oil Leak	Repair
Expansion Bottle Damaged	Replace
Radio/CD/USB Damaged	Replace
Engine Management Lights Set	Repair
Front Bumper Damaged	Repair
Bonnet Damaged	Repair
Front Fender Left Damaged	Repair
Front Fender Right Damaged	Repair
Rear Fender Left Damaged	Repair
Rear Fender Right Damaged	Repair
Door Front Left Damaged	Repair
Door Front Right Damaged	Repair
Door Rear Left Damaged	Repair
Door Rear Right Damaged	Repair
Boot Lid / Hatch door Damaged	Repair
Rear bumper Defective	Repair
Tyre Front Right Worn	Replace
Tyre Rear Right Worn	Replace
Gearbox Oil Leak	Repair
Engine Smoke Excessive	Repair
