MFC Auction House
M57 Pretoria Rd, Glenmarais, KEMPTON PARK
Gauteng

VEHICLE INSPECTION

CONDITION REPORT

Report No: 2016370397

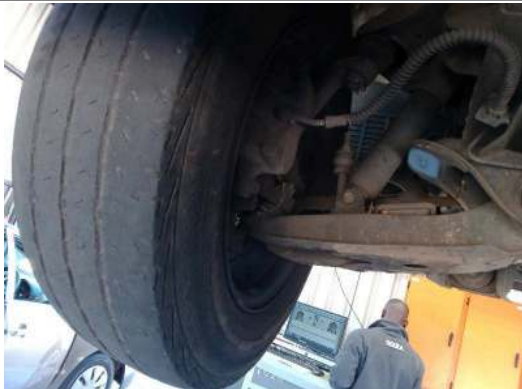
LF TYRE TREAD

Size	Load/Speed Index	Manufacture	Model	Type*	Production Date	Tread Depth (mm)
Front Left	195/70R15	104/102R	Continental	Contact	V	4220	0 mm
Front Right	195/70R15	104/102R	Continental	Contact	V	0000	0 mm
Rear Left	195/70R15	104/102R	Continental	Contact	V	4820	0 mm
Rear Right	195/70R15	104/102R	Leao	Radial	V	2611	1 mm

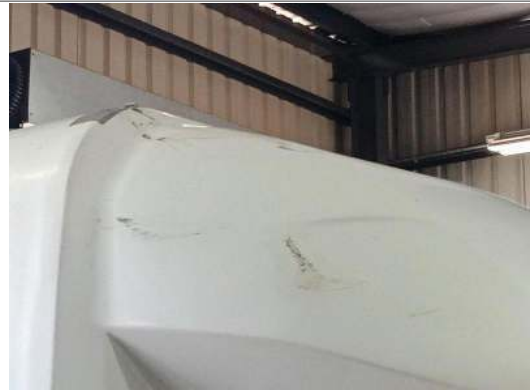
Top of canopy scratches

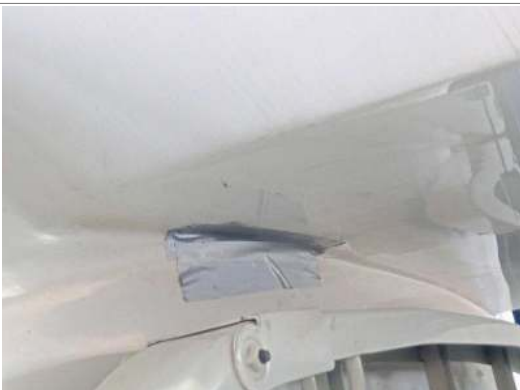
Canopy scratches

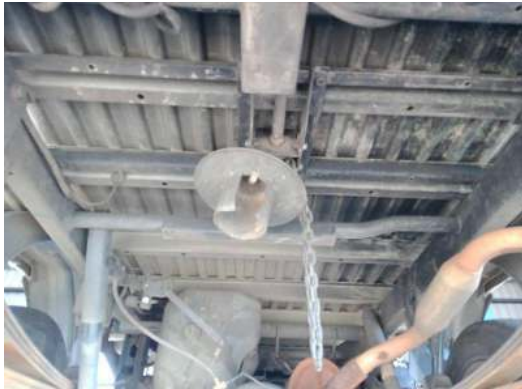
No sparewheel

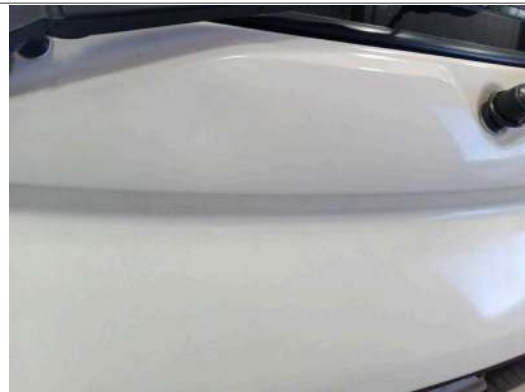
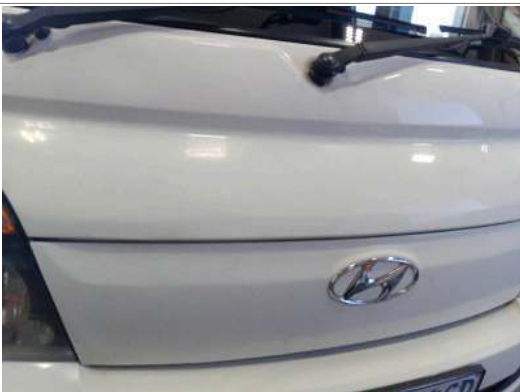
Damage	Repair Way
Engine Oil Leak	Repair
Engine Wiring Defective	Repair
Hoses Oil Leak	Repair
Air conditioner pump Damaged	Repair
Air conditioner pipes Defective	Repair
Front Bumper Residual Traces of Repair	Repair
Bonnet Residual Traces of Repair	Repair
Front Fender Left Residual Traces of Repair	Repair
Front Fender Right Residual Traces of Repair	Repair
Windscreen Cracked	Replace
Parking Brake Performance Left / Right Difference out of legal range	Repair
Ball Joint(s) Front Axle Right Damaged	Replace
Tyre Front Left Smooth	Replace
Tyre Front Right Smooth	Replace
Tyre Rear Left Smooth	Replace
Engine to silencer pipe Welded	Replace
Gearbox Oil Leak	Repair
