## CONDITION REPORT

Report No:  
2016999154  
DATE  
02/09/2025

| Manufacturer | HYUNDAI | Registration Number | LR96NLGP |
| Model | H-100 | Register Number | |

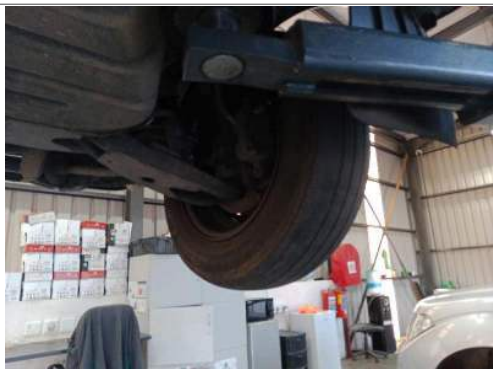
RF TYRE TREAD

| | Size | Load/Speed Index | Manufacture | Model | Type* | Production Date | Tread Depth (mm) |
|---|---|---|---|---|---|---|---|
| Front Right | 195/70R15 | 104/102S | Nexen | Cp321 | V | 2723 | 0 mm |

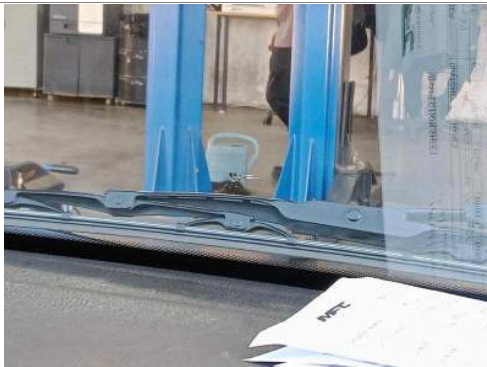
| | Damage | Repair Way |
|---|---|---|
| | Windscreen Chipped | Repair |

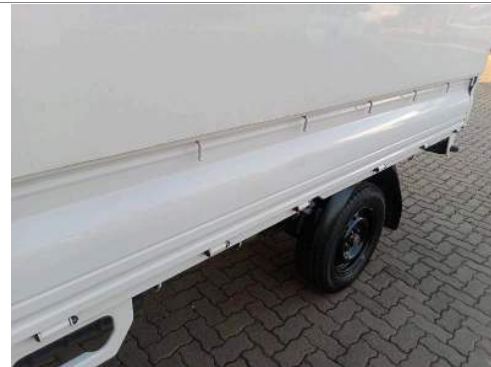
| | Damage | Repair Way |
|---|---|---|
| | Load Body Dented | Repair |

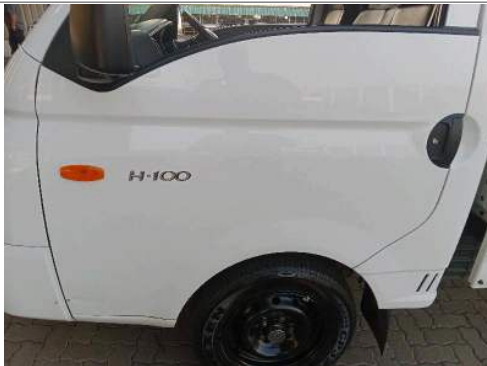
| | Damage | Repair Way |
|---|---|---|
| | Door Front Left Dented | Repair |

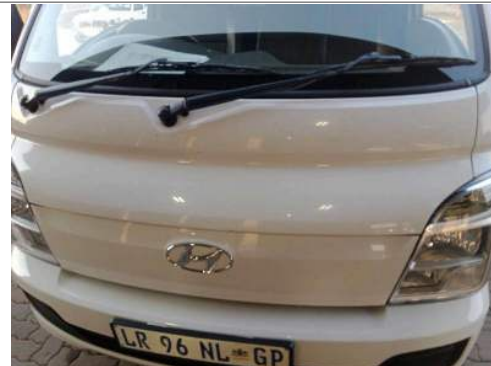
| | Damage | Repair Way |
|---|---|---|
| | Bonnet Paintwork • Chipmarks | Repair |

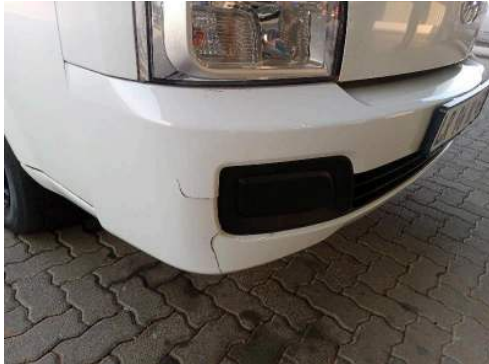
| | Damage | Repair Way |
|---|---|---|
| | Front Bumper Damaged | Repair |

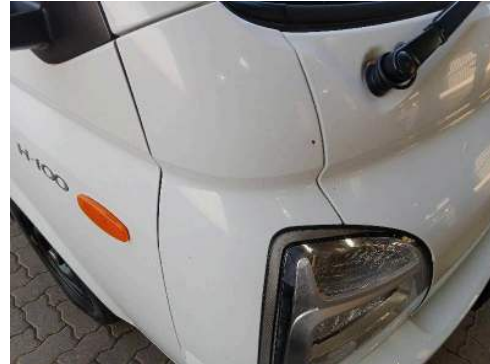
| | Damage | Repair Way |
|---|---|---|
| | Front Fender Right Paintwork • Chipmarks | Repair |

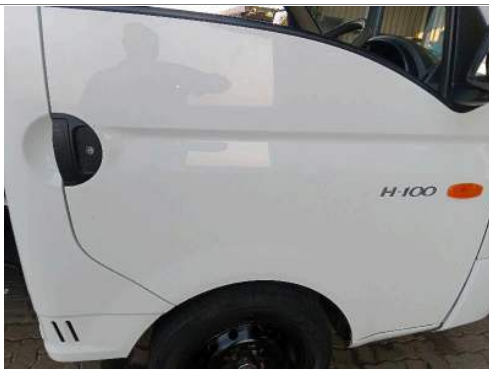
| | Damage | Repair Way |
|---|---|---|
| | Door Front Right Paintwork • Chipmarks | Repair |

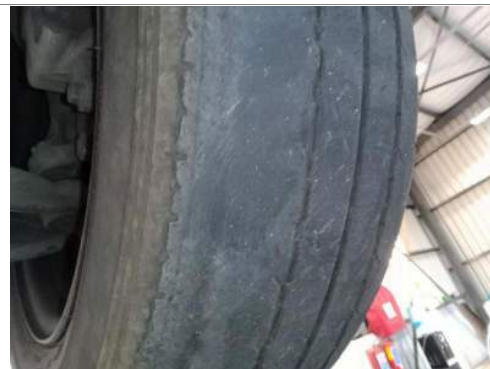
| | Damage | Repair Way |
|---|---|---|
| | Tyre Front Right Smooth | Replace |
