## CONDITION REPORT

Report No:  
2017305874  
DATE  
01/10/2026

| Manufacturer | HYUNDAI | Registration Number | LT66GWGP |
| Model | ACCENT | Register Number | |

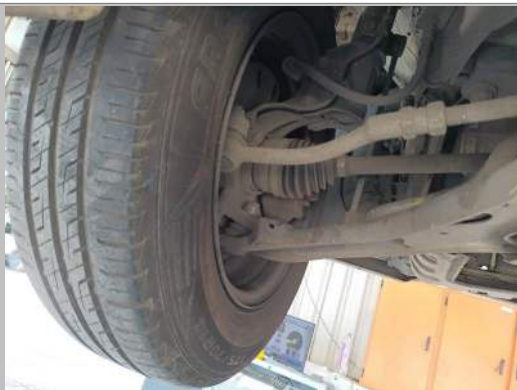
LF TYRE TREAD

| | Size | Load/Speed Index | Manufacture | Model | Type* | Production Date | Tread Depth (mm) |
|---|---|---|---|---|---|---|---|
| Front Left | 175/70R14 | 84T | Roadking | Argos | V | 3725 | 3 mm |

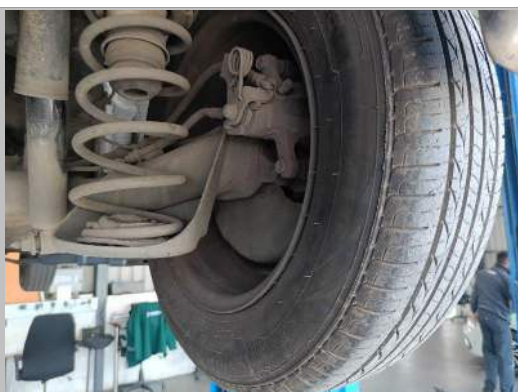
RR TYRE TREAD

| | Size | Load/Speed Index | Manufacture | Model | Type* | Production Date | Tread Depth (mm) |
|---|---|---|---|---|---|---|---|
| Rear Right | 175/70R14 | 84T | Anchee | AC808 | V | 2225 | 3 mm |

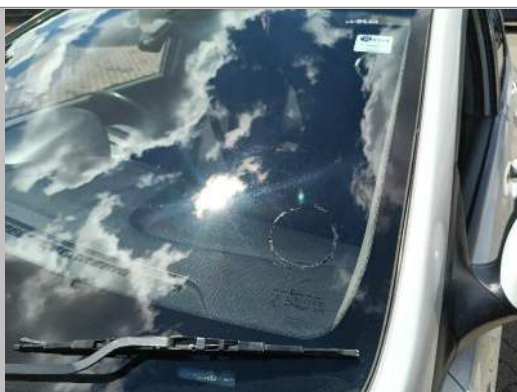
LICENSE DISC MISSING

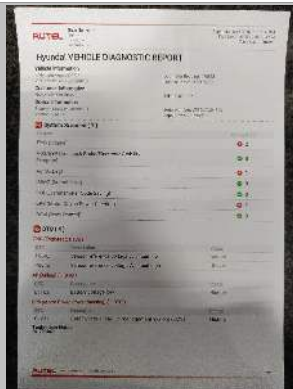
DIAGNOSTIC REPORT PAGE 1

| No | System | Code | Description | Status |
|---|---|---|---|---|
| 1 | ENGINE | P0642 | SENSOR REFERENCE VOLTAGE A CIRCUIT LOW | |

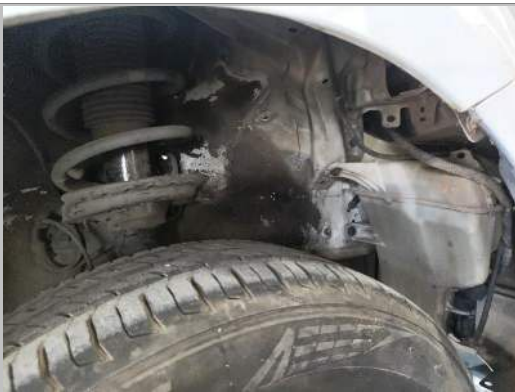
R/F fender liner missing

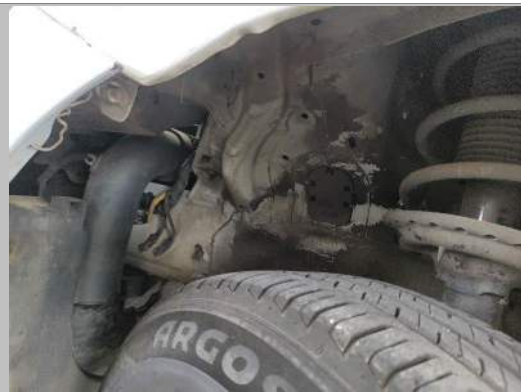
L/F fender liner missing

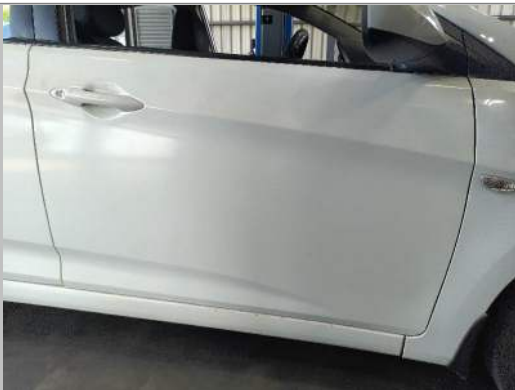
| Damage | Repair Way |
|---|---|
| Door Front Right Residual Traces of Repair | Repair |

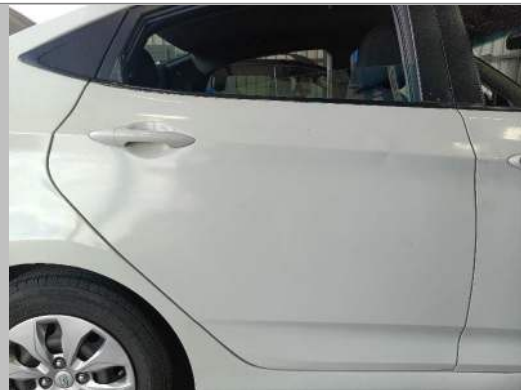
| Damage | Repair Way |
|---|---|
| Door Rear Right Residual Traces of Repair | Repair |

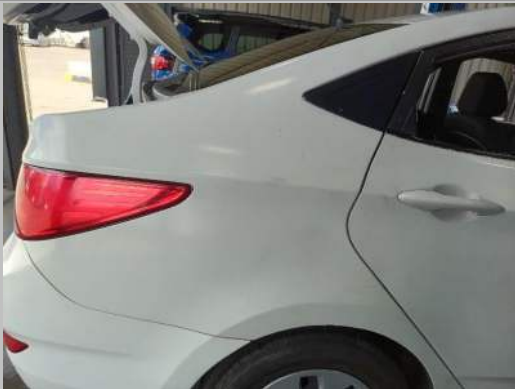
| Damage | Repair Way |
|---|---|
| Rear Fender Right Residual Traces of Repair | Repair |

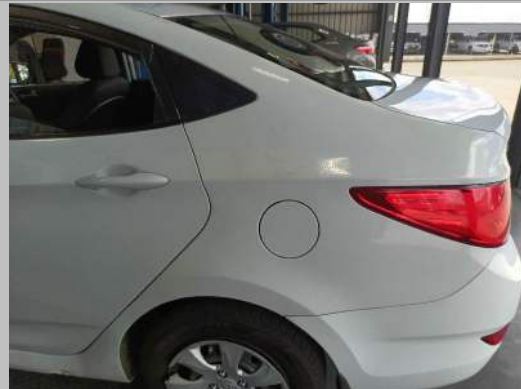
| Damage | Repair Way |
|---|---|
| Rear Fender Left Residual Traces of Repair | Repair |

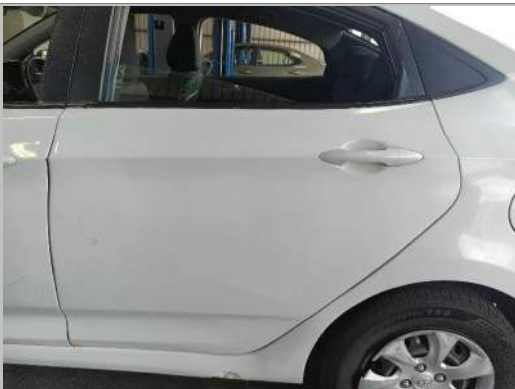
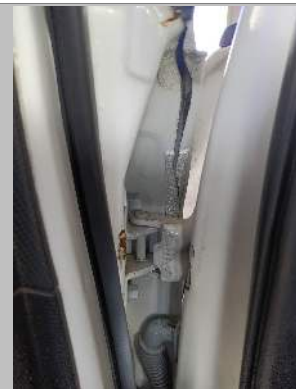
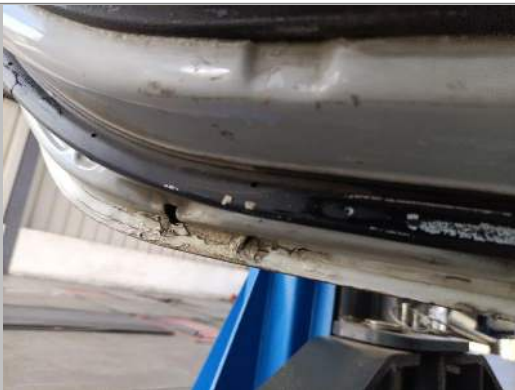
| Damage | Repair Way |
|---|---|
| Door Rear Left Residual Traces of Repair | Repair |

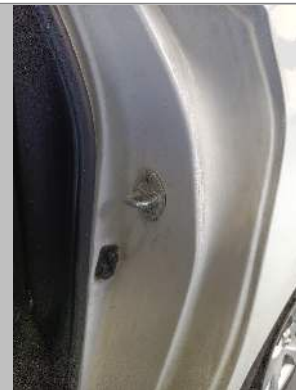
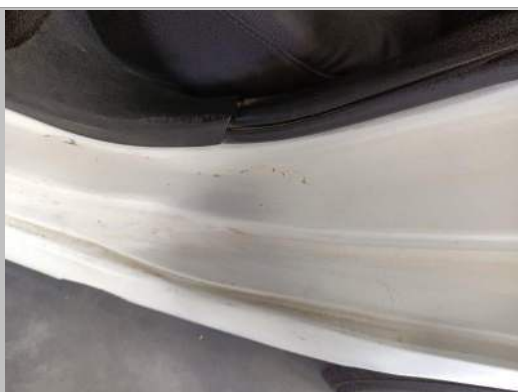
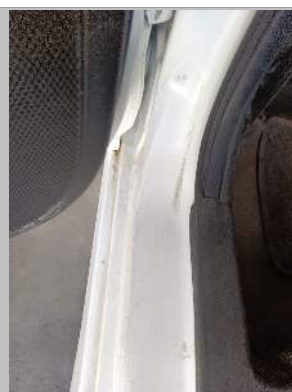
| Damage | Repair Way |
|---|---|
| C • Pillar Left Residual Traces of Repair | Repair |

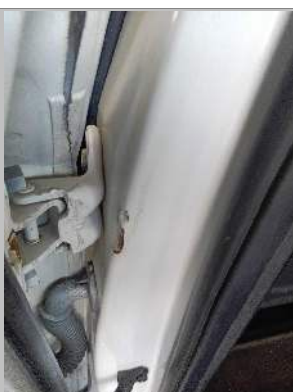
| Damage | Repair Way |
|---|---|
| B • Pillar Left Dented | Repair |

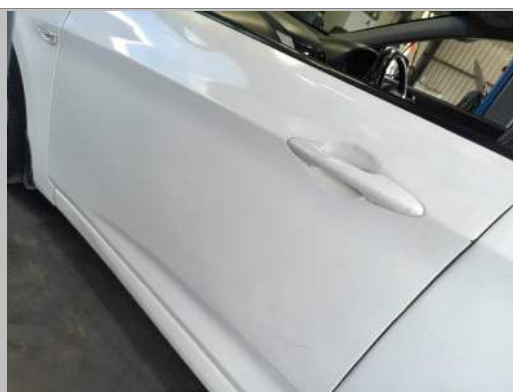
| Damage | Repair Way |
|---|---|
| Door Front Left Residual Traces of Repair | Repair |

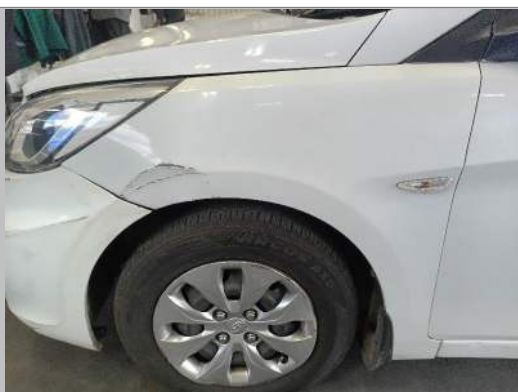
| Damage | Repair Way |
|---|---|
| Front Fender Left Residual Traces of Repair | Repair |

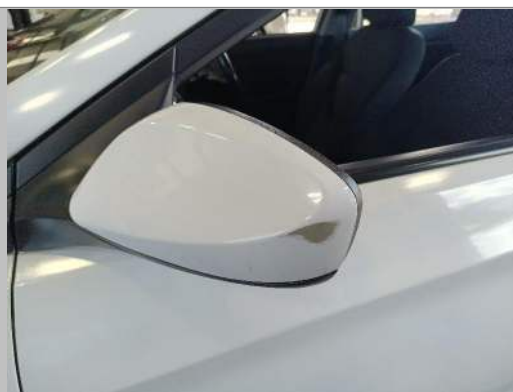
| Damage | Repair Way |
|---|---|
| Side Mirror Left Paintwork • Scratched | Repair |

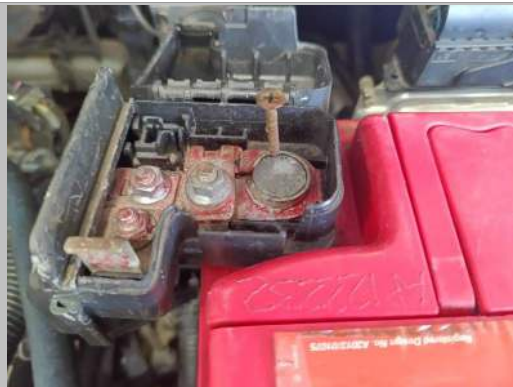
| Damage | Repair Way |
|---|---|
| Clamps Damaged | Replace |

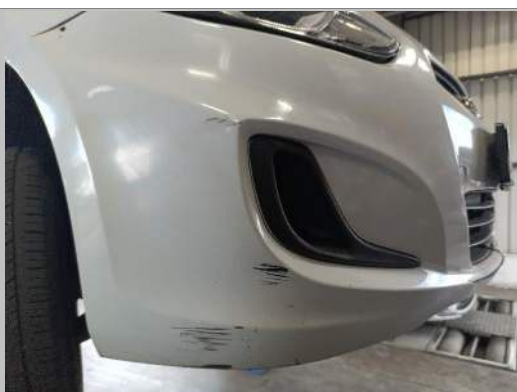
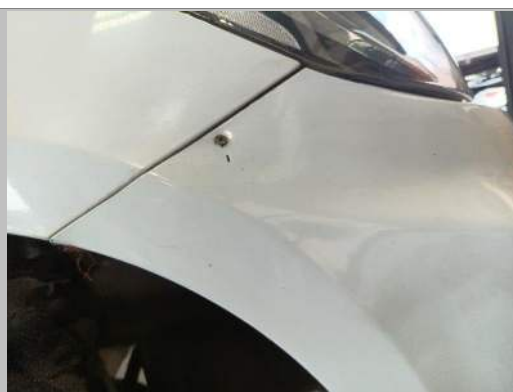
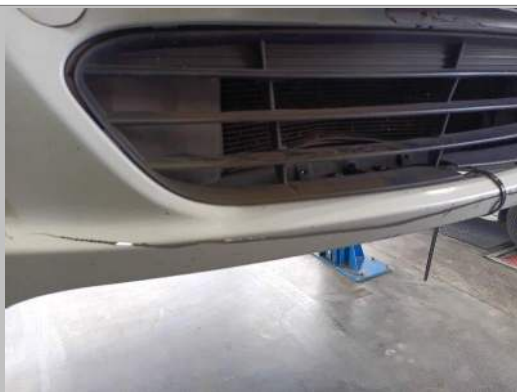
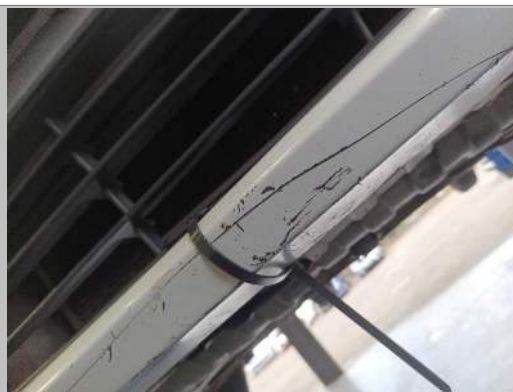
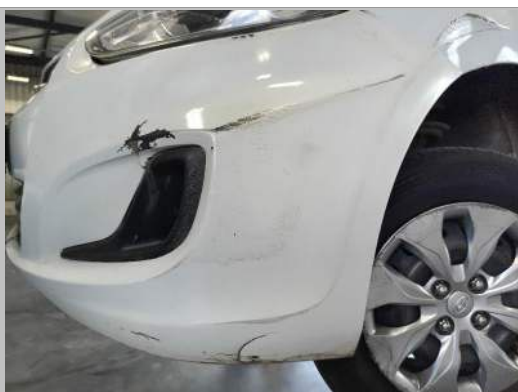
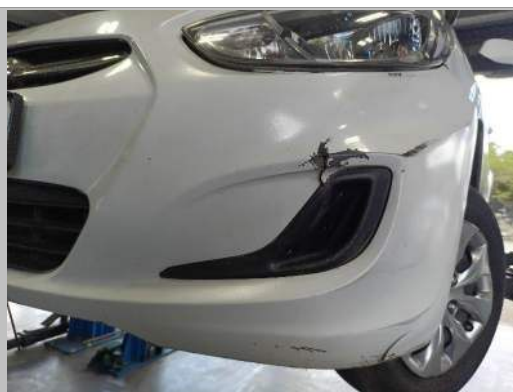
| Damage | Repair Way |
|---|---|
| Front Bumper Paintwork • Scratched | Repair |

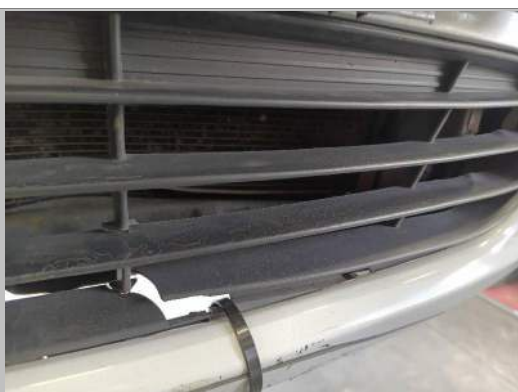
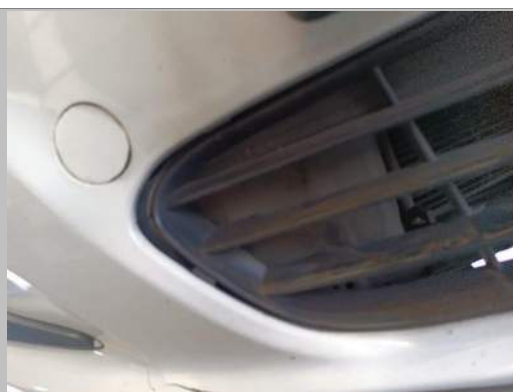
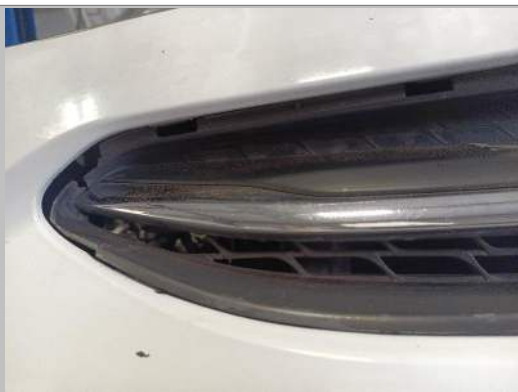
| Damage | Repair Way |
|---|---|
| Grill Damaged | Repair |

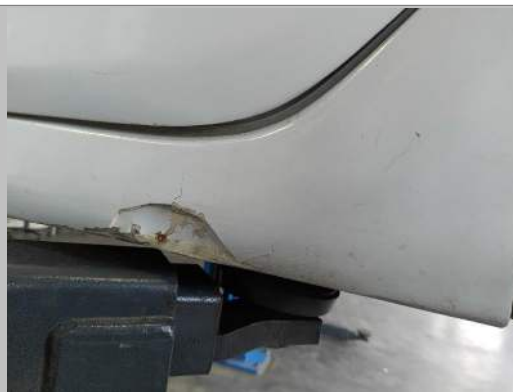
| Damage | Repair Way |
|---|---|
| Sill Panel Left Damaged | Repair |

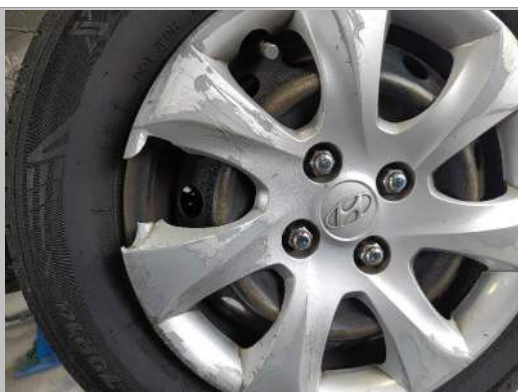
| Damage | Repair Way |
|---|---|
| Rim Rear Left Damaged | Replace |

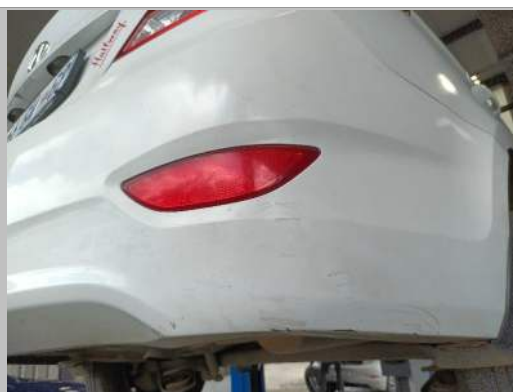
| Damage | Repair Way |
|---|---|
| Rear bumper Paintwork • Scratched | Repair |

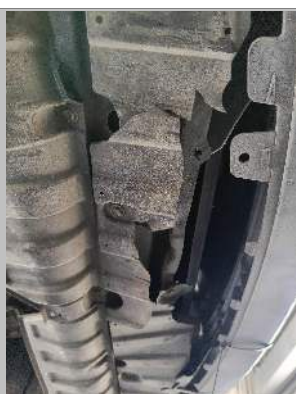
| Damage | Repair Way |
|---|---|
| Belly plates Damaged | Repair |

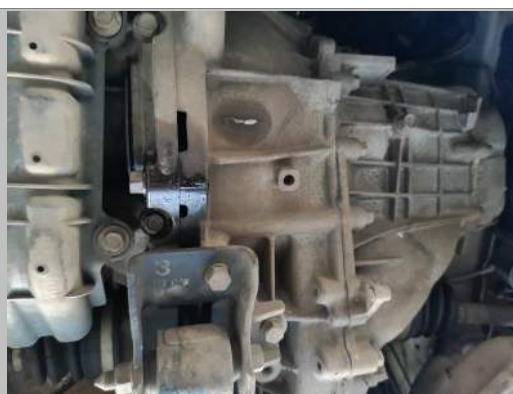
| Damage | Repair Way |
|---|---|
| Gearbox Oil Leak | Repair |
