| Manufacturer | HYUNDAI | Registration Number | HJ83HZGP |
| Model | ACCENT | Register Number | |

CONDITION REPORT

Report No: 2016244506

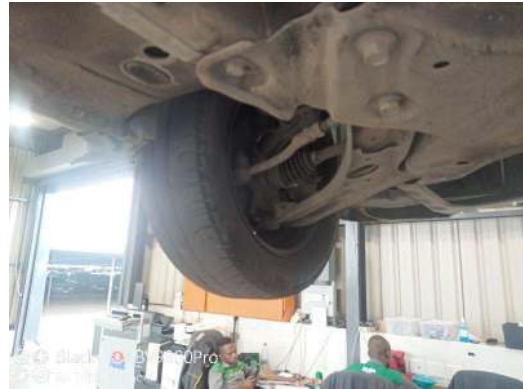
LF TYRE TREAD

| Damage | Repair Way |
|---|---|
| Tyre Front Left Damaged | Replace |

| | Size | Load/Speed Index | Manufacture | Model | Type* | Production Date | Tread Depth (mm) |
|---|---|---|---|---|---|---|---|
| Front Left | 185/60R14 | 82H | Michelin | Energy | V | 3017 | 0 mm |

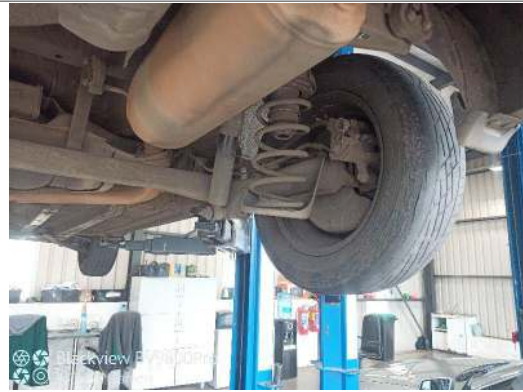
RR TYRE TREAD

| Damage | Repair Way |
|---|---|
| Tyre Rear Right Damaged | Replace |

| | Size | Load/Speed Index | Manufacture | Model | Type* | Production Date | Tread Depth (mm) |
|---|---|---|---|---|---|---|---|
| Rear Right | 185/60R14 | 82H | Yokohama | A539 | V | 0513 | 0 mm |

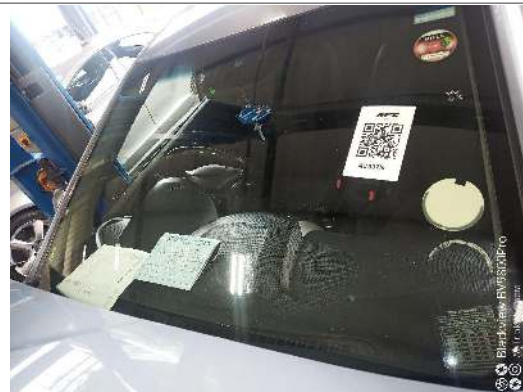
| Damage | Repair Way |
|---|---|
| No license dice | Replace |

LICENSE DISC MISSING

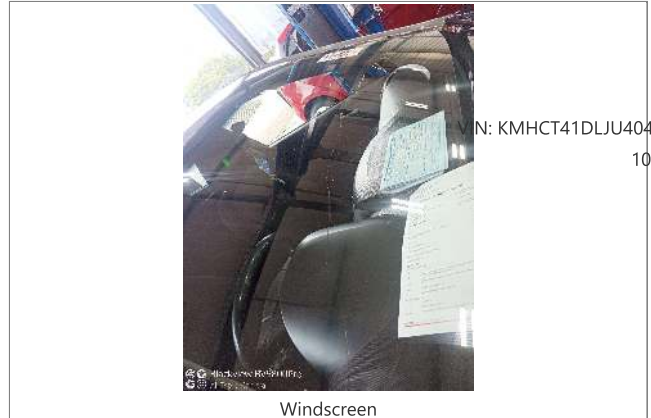
| Damage | Repair Way |
|---|---|
| Windscreen Cracked | Replace |

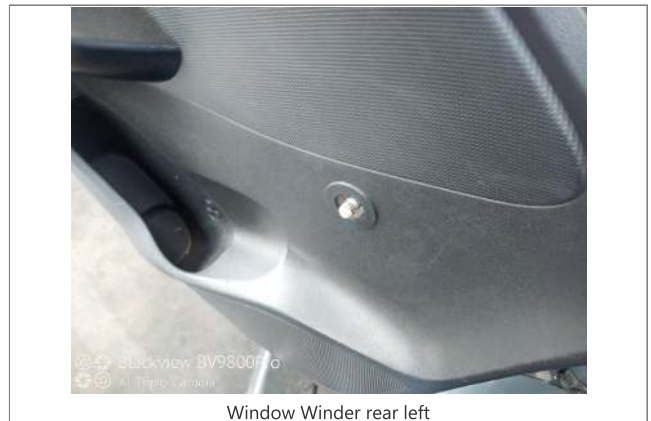
| Damage | Repair Way |
|---|---|
| Window Winder rear left Missing | Replace |

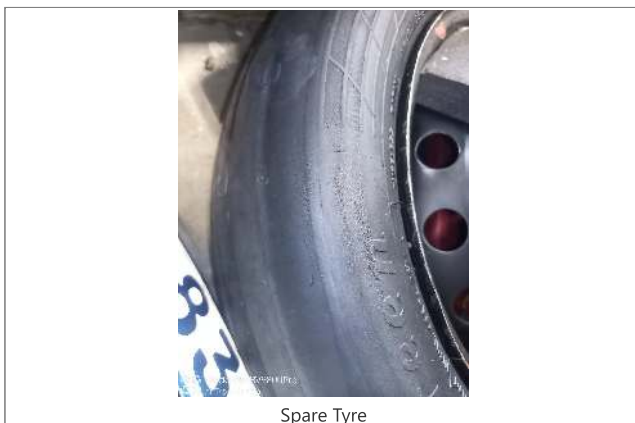
| Damage | Repair Way |
|---|---|
| Spare Tyre Smooth | Replace |

| | Size | Load/Speed Index | Manufacture | Model | Type* | Production Date | Tread Depth (mm) |
|---|---|---|---|---|---|---|---|
| Spare | 175/65R14 | 82H | Neolin | Neogreen | V | 2621 | 0 mm |

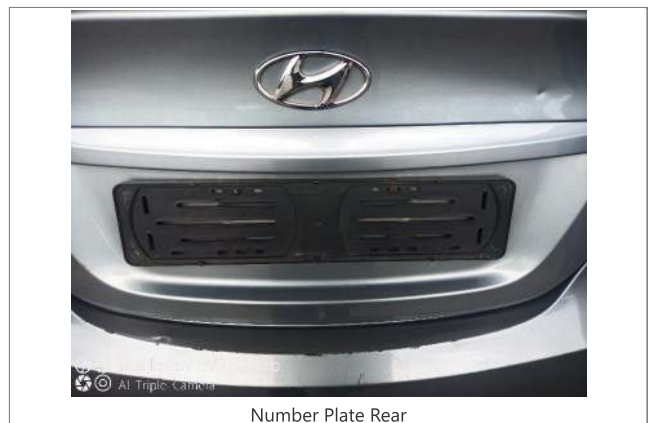
| Damage | Repair Way |
|---|---|
| Number Plate Rear Missing | Replace |

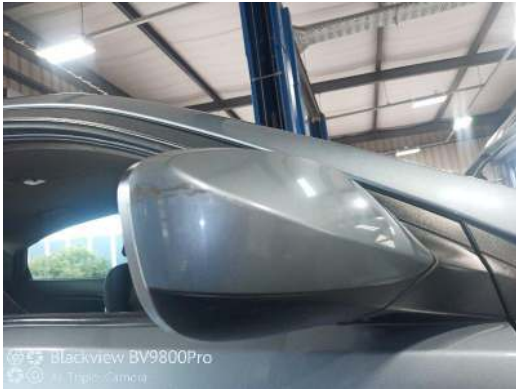
| Damage | Repair Way |
|---|---|
| Side Mirror Right Paintwork • Scratched | Repair |

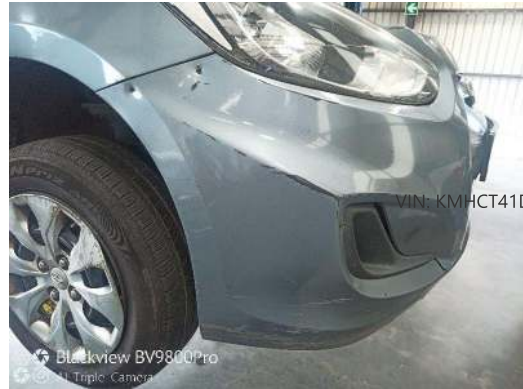
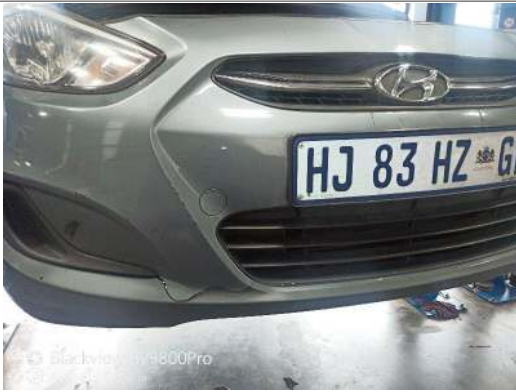
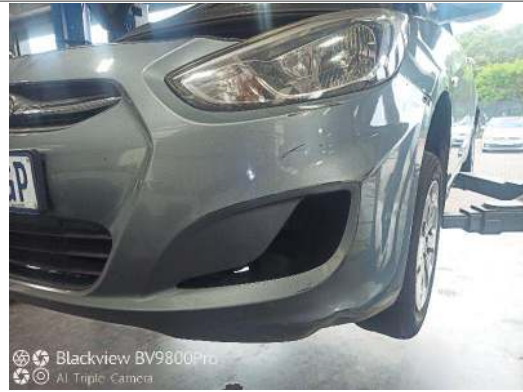
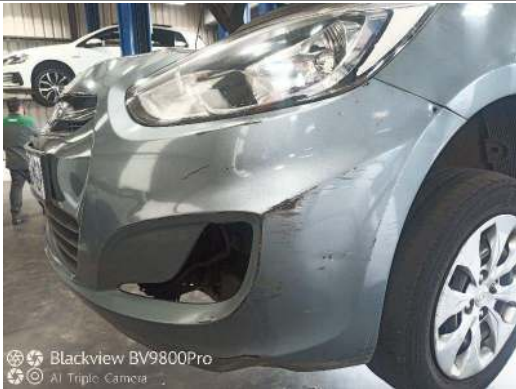
| Damage | Repair Way |
|---|---|
| Front Bumper Damaged | Repair |

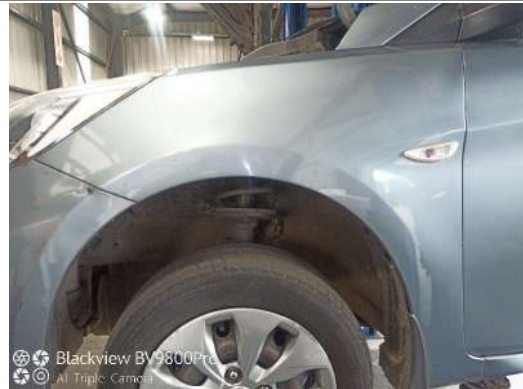
| Damage | Repair Way |
|---|---|
| Front Fender Left Paintwork • Scratched | Repair |

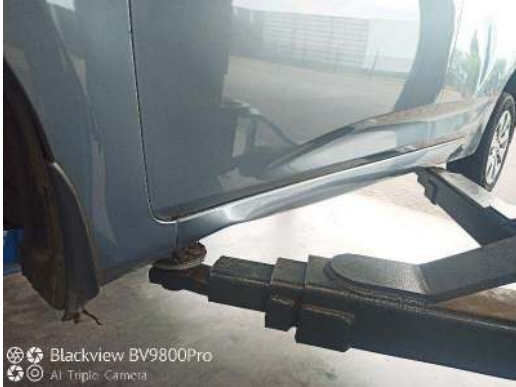
| Damage | Repair Way |
|---|---|
| Sill Panel Left Dented | Repair |

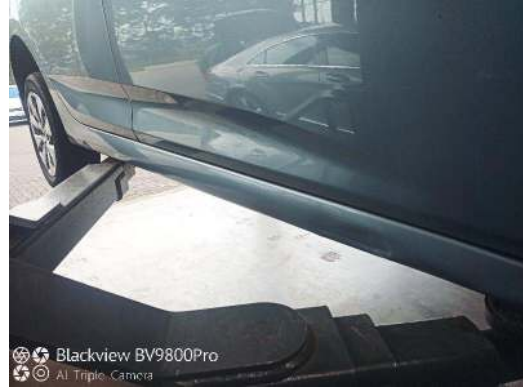
| Damage | Repair Way |
|---|---|
| Sill Panel Right Dented | Repair |

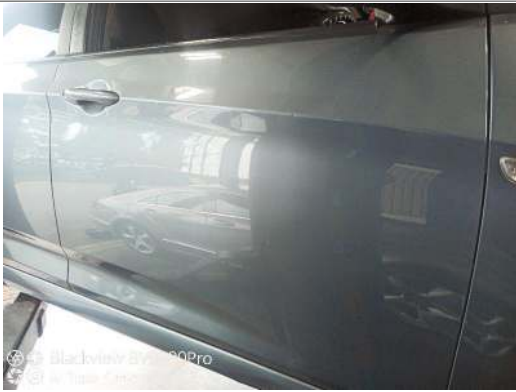
| Damage | Repair Way |
|---|---|
| Door Front Right Dented | Repair |

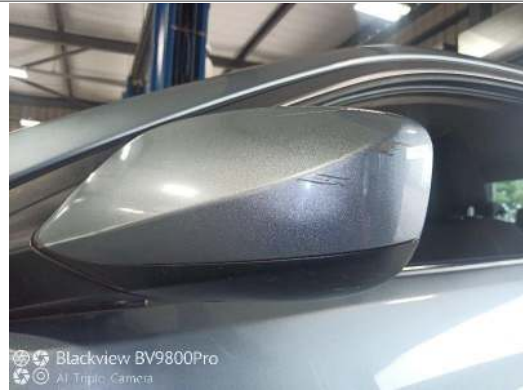
| Damage | Repair Way |
|---|---|
| Side Mirror Left Paintwork • Scratched | Repair |

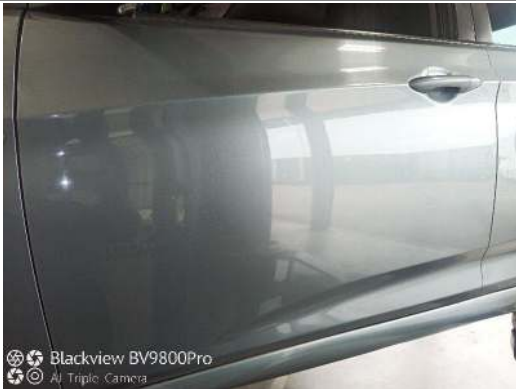
| Damage | Repair Way |
|---|---|
| Door Front Left Paintwork • Scratched | Repair |

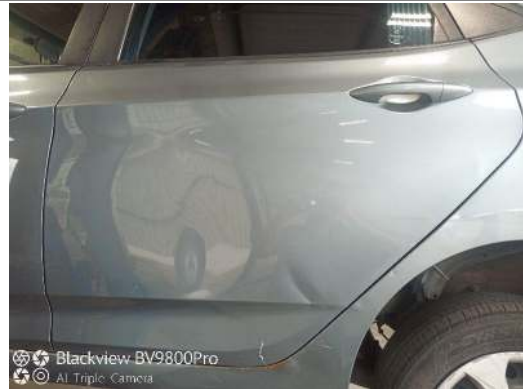
| Damage | Repair Way |
|---|---|
| Door Rear Left Dented | Repair |

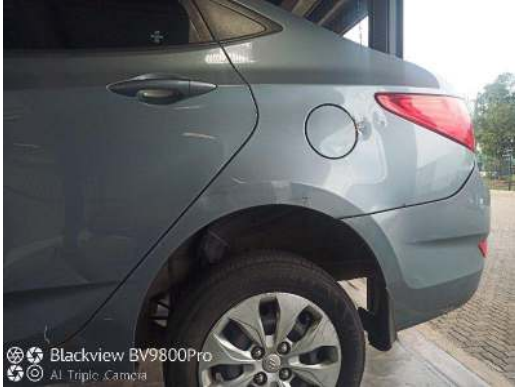
| Damage | Repair Way |
|---|---|
| Rear Fender Left Paintwork • Scratched | Repair |

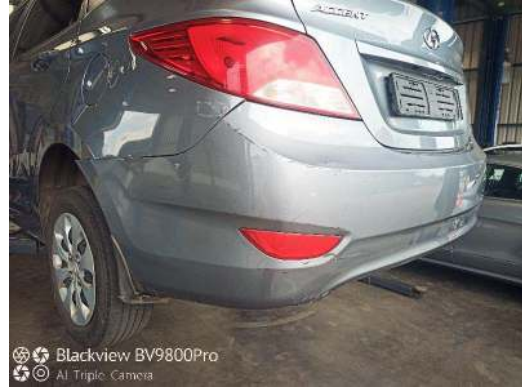
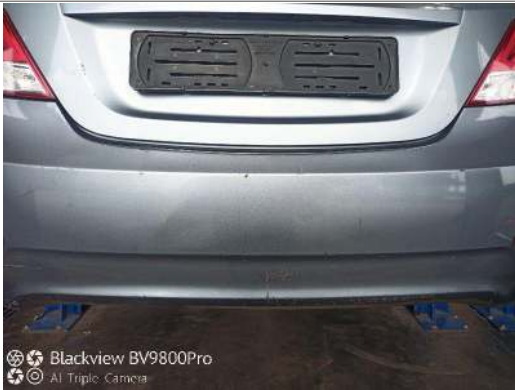
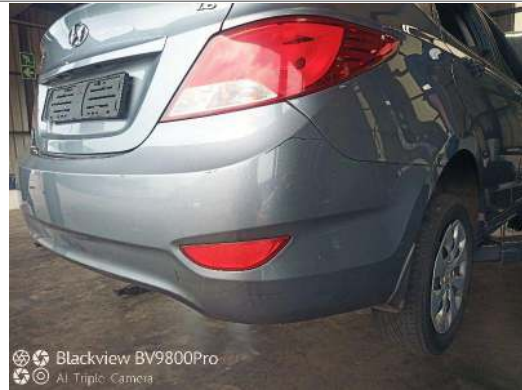
| Damage | Repair Way |
|---|---|
| Rear bumper Paintwork • Scratched | Repair |

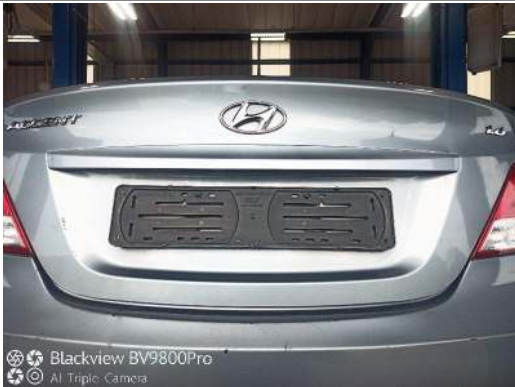
| Damage | Repair Way |
|---|---|
| Boot Lid / Hatch door Dented | Repair |

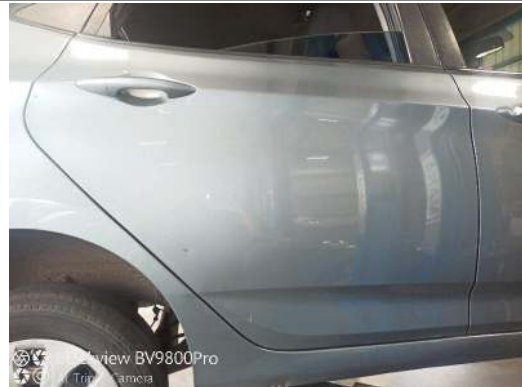
| Damage | Repair Way |
|---|---|
| Door Rear Right Paintwork • Scratched | Repair |

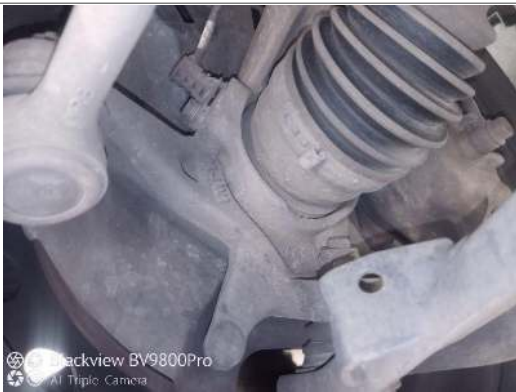
| Damage | Repair Way |
|---|---|
| Wheel bearing Front Left Free play | Replace |

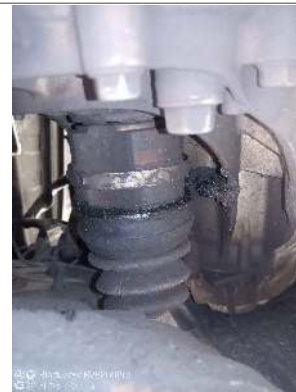
| Damage | Repair Way |
|---|---|
| CV Joint(s) Boot(s) Front Left (inner/outer) Defective | Repair |

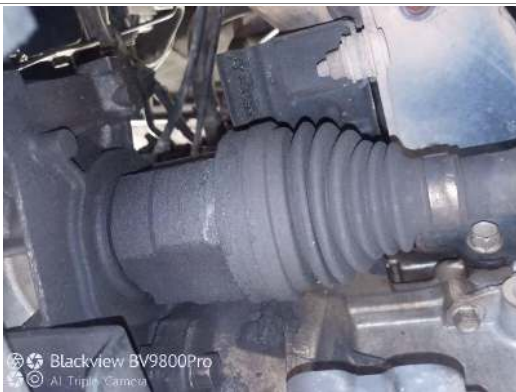
| Damage | Repair Way |
|---|---|
| CV Joint(s) Boot(s) Front Right (inner/outer) Defective | Repair |

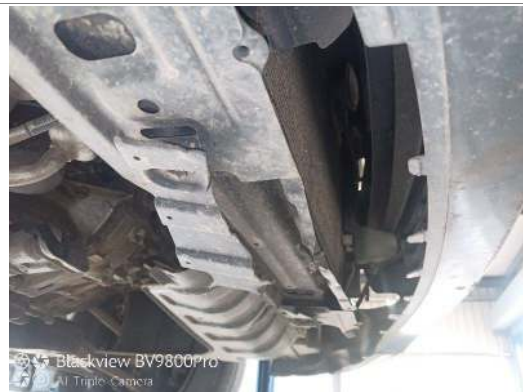
| Damage | Repair Way |
|---|---|
| Radiator Cradle Dented | Repair |

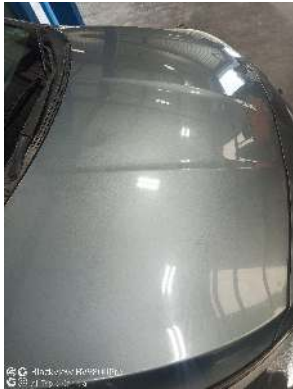
| Damage | Repair Way |
|---|---|
| Bonnet Paintwork • Scratched | Repair |

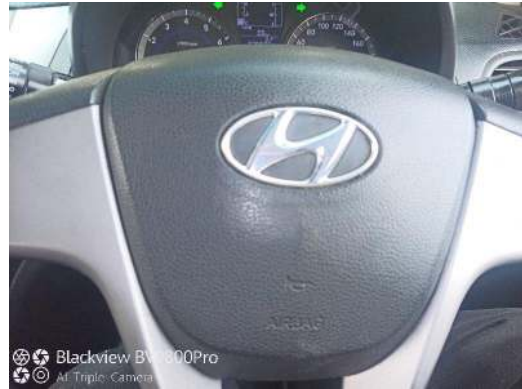
| Damage | Repair Way |
|---|---|
| Hooter Defective | Repair |
