CONDITION REPORT

Report No: 2016887396

Vehicle Type	PASSENGER VEHICLE	Registered Owner	
Manufacturer	HYUNDAI	Registration Number	HR05FYGP
Model	ACCENT	Register Number	
VIN	KMHCT41DLJU438487	Date Of First Licensing	
Engine Number		Last COR	
Doors	4	License Expiry Date	31/08/2019
Color	GREY	Power / Displacement	
Year Model		Paint Finish	M - METALLIC
Km Reading	301,409 KM	Fuel	PETROL
Cab / Body Type	SEDAN	Transmission	MANUAL

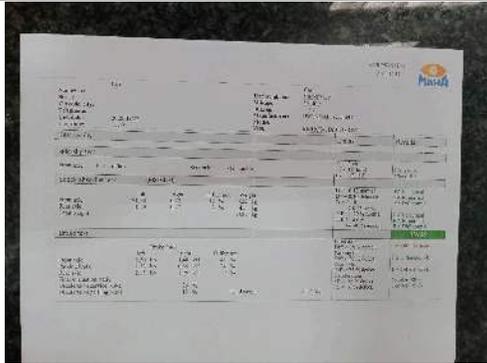
Shock and brake report

Damage	Repair Way
Service Brake Performance Front Axle Left / Right	Repair
Difference out of legal range	
Rim Rear Left Dented	Repair
Body exterior	Residual traces of poor repair on most body panels
Body exterior	Signs of spray work done on most body panels
Engine warning lights illuminated	Repair
Sparewheel well damage	Repair
Bootlid does not close	Repair

Left	Right	Axle Weight [KG]	Deceleration [m/s ²]
	Braking Force [KN]	Braking Force [KN]		
Front	2.5	1.4	-	
Rear	2.1	1.9	-	
Emergency / Parking	1.1	0.8	-

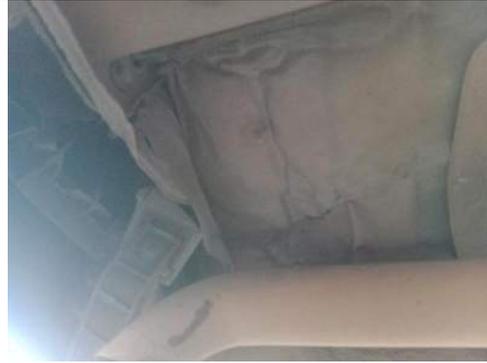
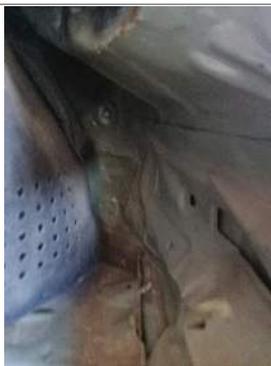
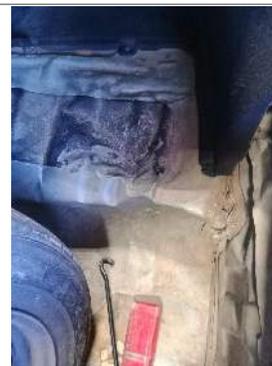
Sparewheel well damage

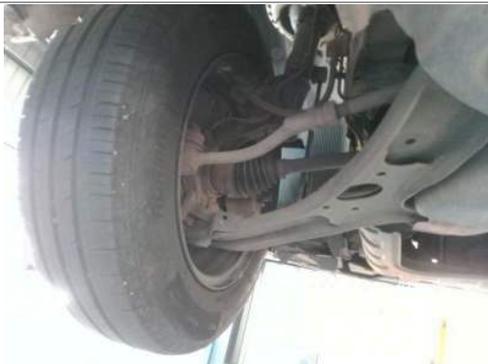
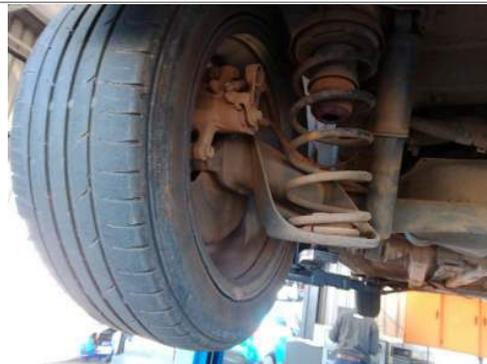
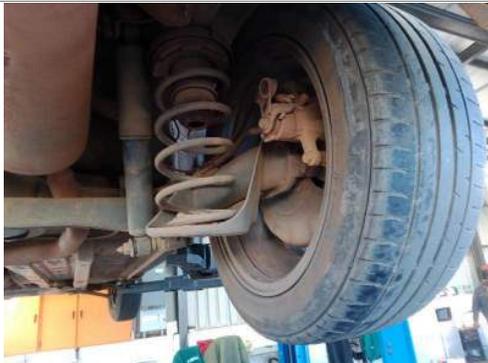
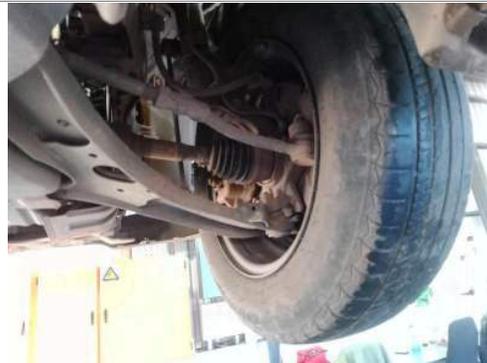
Size	Load/Speed Index	Manufacture	Model	Type*	Production Date	Tread Depth (mm)
Front Left	175/70R14	84H	Powertrac	Adamas	V	3724	4 mm
Front Right	175/70R14	84H	Automatic	Grip200	V	0923	1 mm
Rear Left	195/50R15	82V	Dunlop	Sport	V	0822	1 mm
Rear Right	195/50R15	82V	Dunlop	Sport	V	0822	1 mm
Spare	175/70R14	84T	Kumho	Solus	V	0000	1 mm

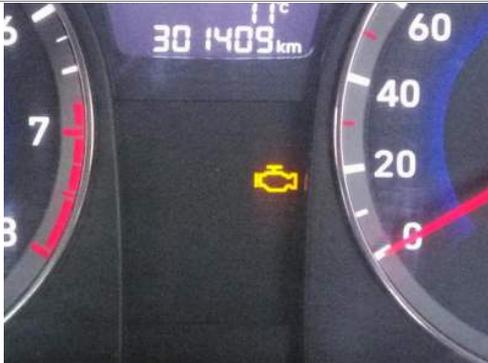
No	System	Code	Description	Status
1	ENGINE	P0268	CYLINDER 3 INJECTOR CIRCUIT HIGH

Engine warning lights illumina

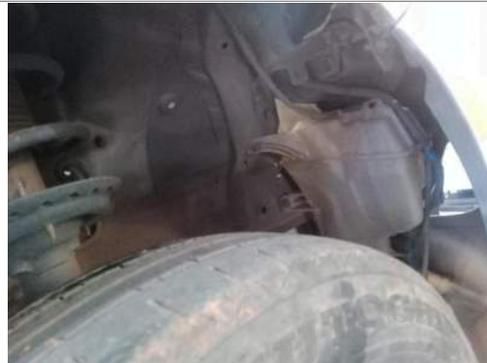
R/F fender liner missing

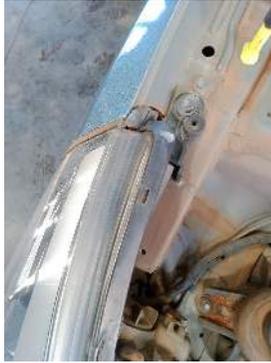
R/F headlight clips broken

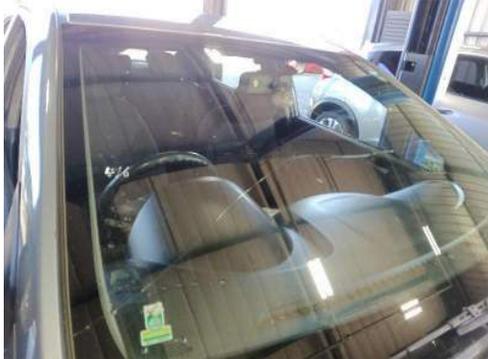
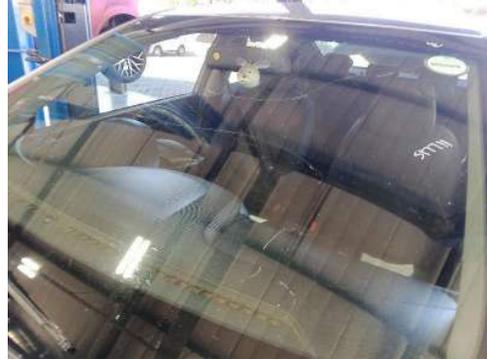
Damage	Repair Way
Air conditioner pump Damaged	Replace
Indicator Light Front Right Cracked	Replace
Side Mirror Left Damaged	Replace
Front Bumper Residual Traces of Repair	Repair
Bonnet Paintwork • Scratched	Repair
A • Pillar Right Residual Traces of Repair	Repair
Front Fender Left Residual Traces of Repair	Repair
Front Fender Right Residual Traces of Repair	Repair
Rear Fender Left Dented	Repair
Rear Fender Right Residual Traces of Repair	Repair
Rear Fender Right / Inner Tray Damaged	Repair
Door Front Left Dented	Repair
Door Front Right Residual Traces of Repair	Repair
Door Rear Left Dented	Repair
Door Rear Right Residual Traces of Repair	Repair
Boot Lid / Hatch door Residual Traces of Repair	Repair
Rear bumper Residual Traces of Repair	Repair
Sill Panel Left Paintwork • Scratched	Repair
Windscreen Cracked	Replace
