CONDITION REPORT

Report No:
2016947361
DATE
15/07/2025

MFC Auction House
M57 Pretoria Rd, Glenmarais, KEMPTON PARK
Gauteng

Vehicle Type	PASSENGER VEHICLE	Registered Owner	
Manufacturer	HYUNDAI	Registration Number	DL80XJGP
Model	ACCENT 1.6 FLUID 6-SP [2013-2021]	Register Number	
VIN	KMHCU41DLFU812502	Date Of First Licensing	
Engine Number		Last COR	
Doors	4	License Expiry Date	31/08/2025
Color	GREY	Power / Displacement	
Year Model	2014	Paint Finish	M - METALLIC
Km Reading	616,861 KM	Fuel	PETROL
Cab / Body Type	SEDAN	Transmission	MANUAL

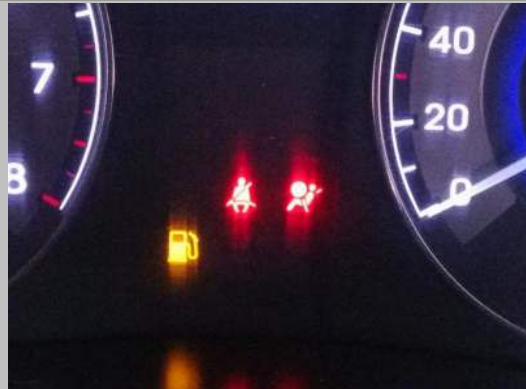
Warning lights illuminated

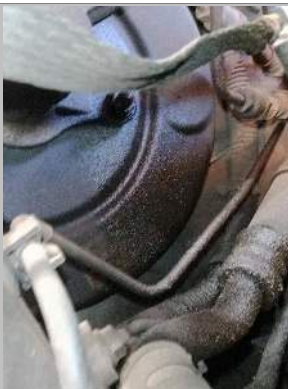
Brake booster oil sweat

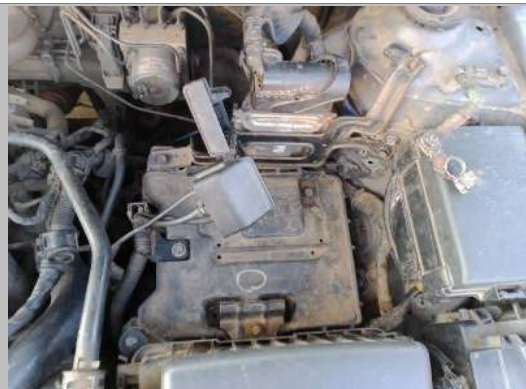
No battery

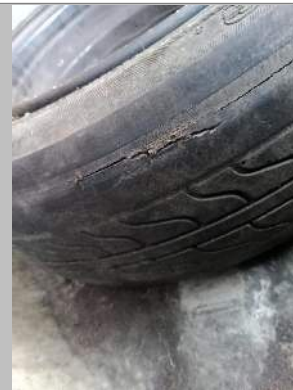
Tyre Rear Right Excessive Wear & Tear	Replace
Spare Tyre Smooth	Replace
Rim Rear Left Damaged	Replace
Gearbox Oil Leak	Repair
CV Joint(s) Boot(s) Front Right (inner/outer) Damaged	Replace
Gear Selections Insufficient	Repair
No battery	Replace
Front tyre size differs	Replace
Rear tyre size differs	Replace
Warning lights illuminated	Repair
Front suspension excessive noise	Repair

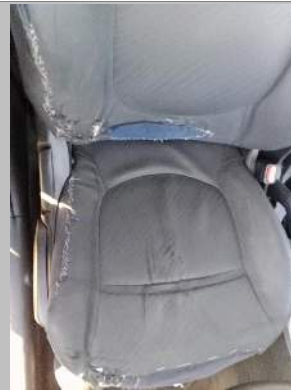
Damage	Repair Way
Engine Oil Leak	Repair
Head Light Switch Damaged	Replace
Switch Electrical Window Winder front left Defective	Repair
Seat Front Right Torn / Cut	Repair
Rear Lower Valance Damaged	Repair
Front Bumper Residual Traces of Repair	Repair
Front Fender Left Residual Traces of Repair	Repair
Rear Fender Left Residual Traces of Repair	Repair
Rear Fender Right Dented	Repair
Rear Fender Right / Inner Tray Residual Traces of Repair	Repair
Door Front Left Residual Traces of Repair	Repair
Door Front Right Residual Traces of Repair	Repair
Rear bumper Residual Traces of Repair	Repair
Sill Panel Left Damaged	Repair
Roof Dented	Repair
Tie Rod End left Damaged	Replace
Split Pin Left Missing	Replace
Stabilizer Mounting Front Left Damaged	Replace
Control Arm Bush(es) Front Axle Left Cracked	Replace
Control Arm Bush(es) Front Axle Right Cracked	Replace
Tyre Front Left Smooth	Replace
Tyre Front Right Torn / Cut	Replace
