## CONDITION REPORT

2017303392

| Manufacturer | HYUNDAI | Registration Number | FL40TDGP |
| Model | ACCENT 1.6 FLUID 6-SP [2013-2021] | Register Number | |

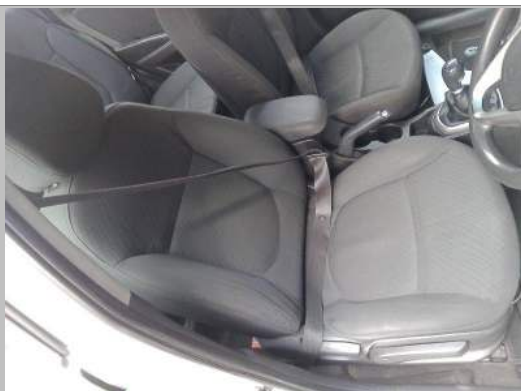
| Seat Front Right Damaged | Repair |

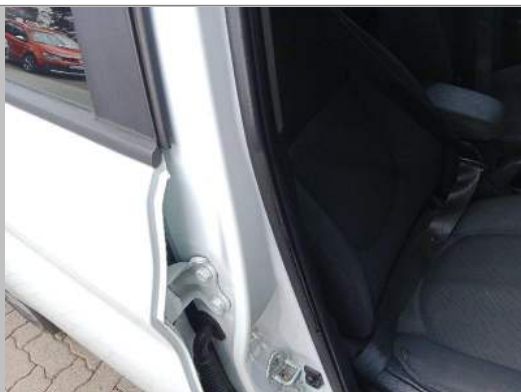
| Door Sealing Rubber Front Right Damaged | Replace |

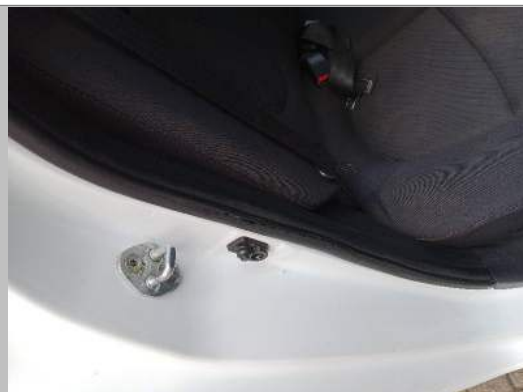
| Door Sealing Rubber Rear Right Damaged | Replace |

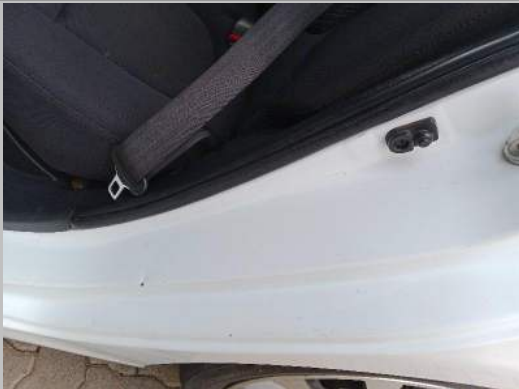
| C • Pillar Left Dented | Repair |

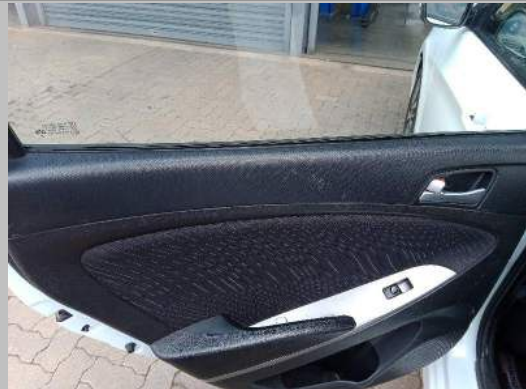
| Door Panel Rear Left Damaged | Repair |

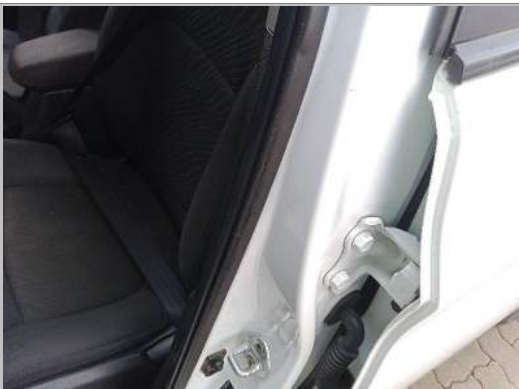
| Door Sealing Rubber Front Left Damaged | Replace |

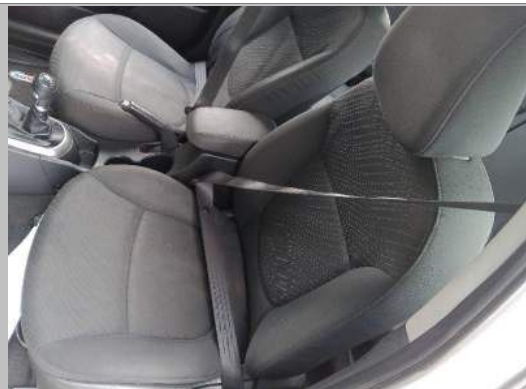
| Seat Front Left Dirty | Repair |

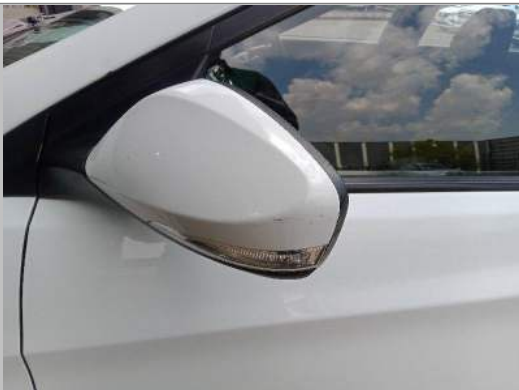
| Side Mirror Left Paintwork • Scratched | Repair |

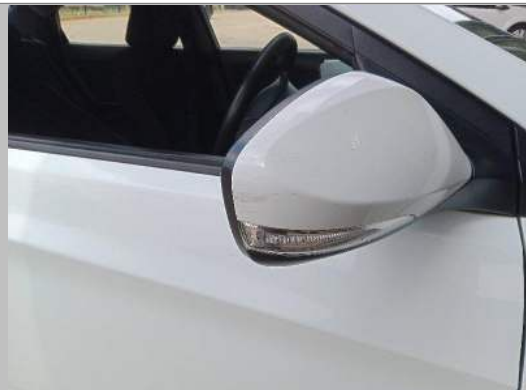
| Side Mirror Right Paintwork • Scratched | Repair |

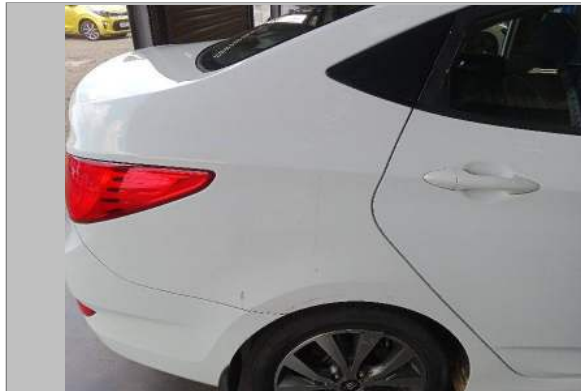
| Rear Fender Right Paintwork • Scratched | Repair |

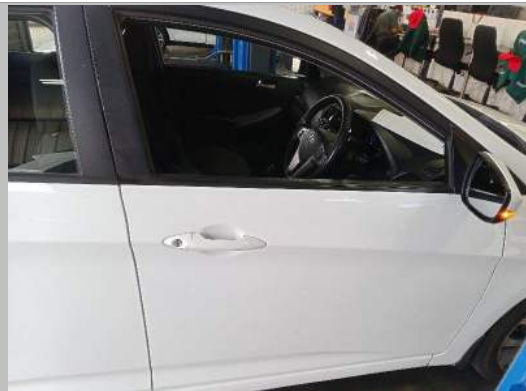
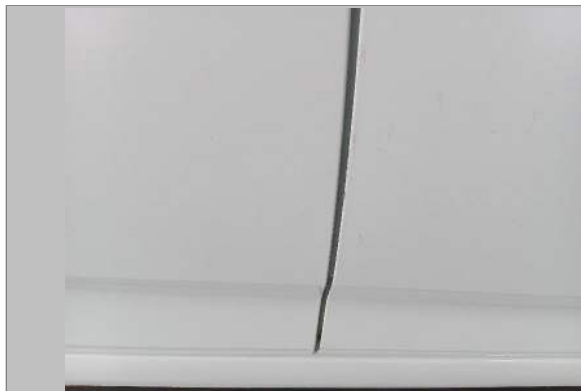
| Door Front Right Paintwork • Scratched | Repair |

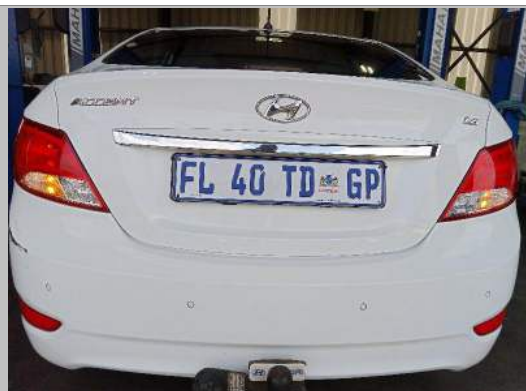
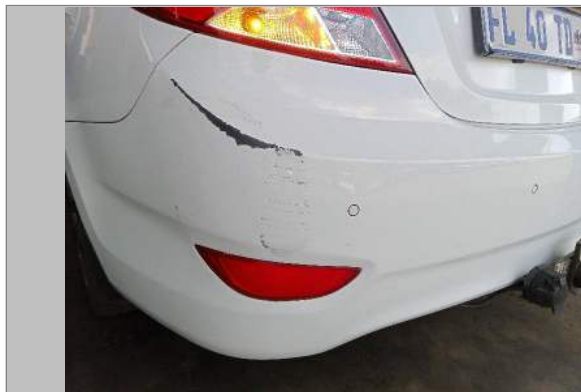
| Rear bumper Damaged | Repair |

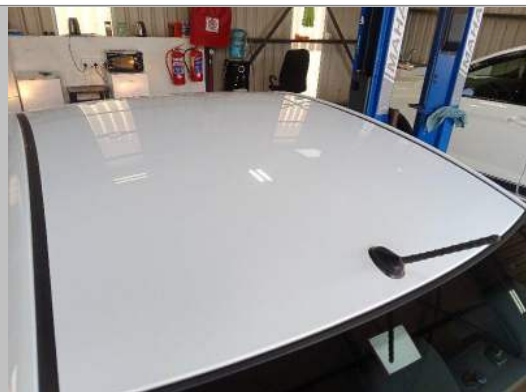
| Roof Dented | Repair |

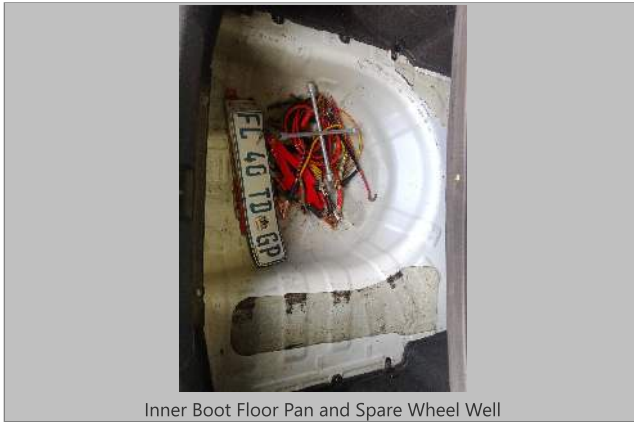
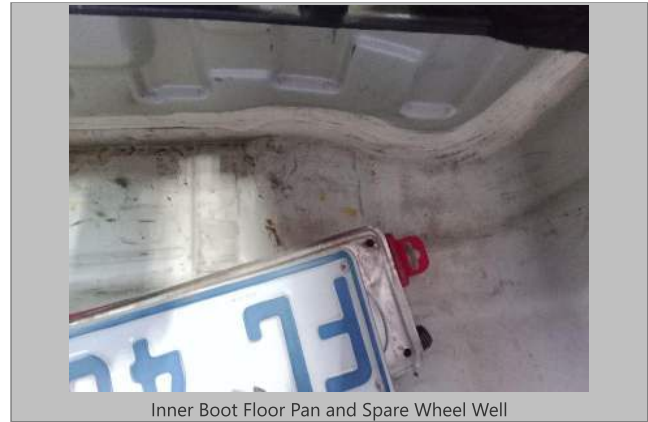
| Inner Boot Floor Pan and Spare Wheel Well Dented | Repair |

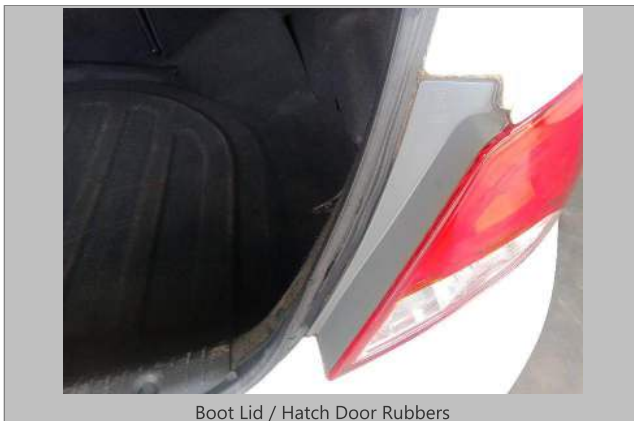
| Boot Lid / Hatch Door Rubbers Damaged | Replace |

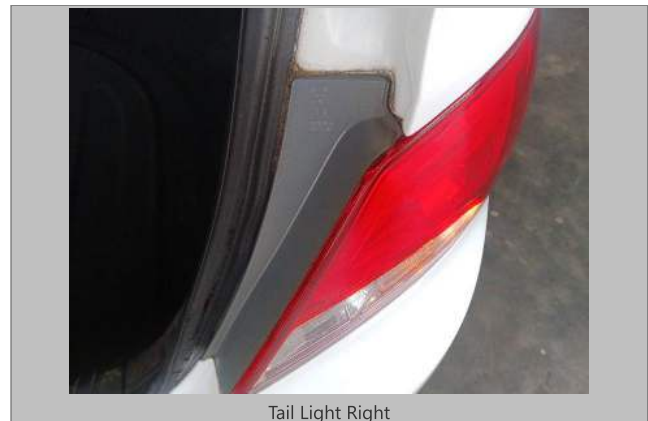
| Tail Light Right Cracked | Replace |

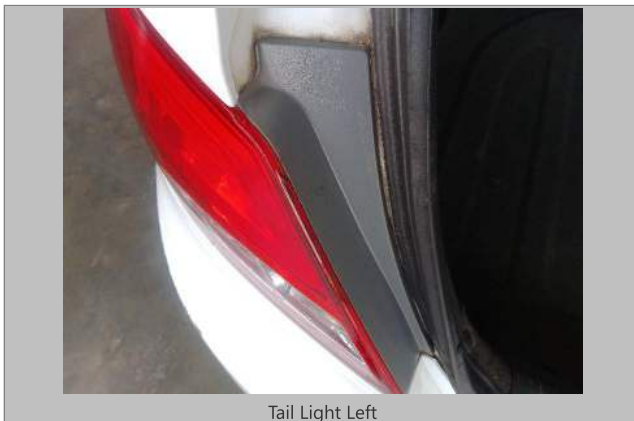
| Tail Light Left Damaged | Replace |

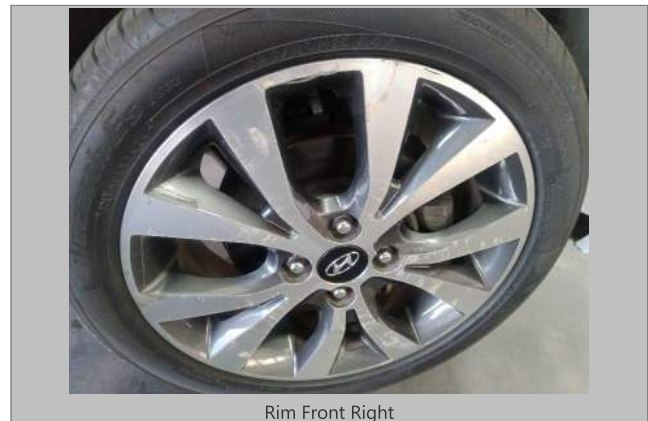
| Rim Front Right Scratched | Repair |

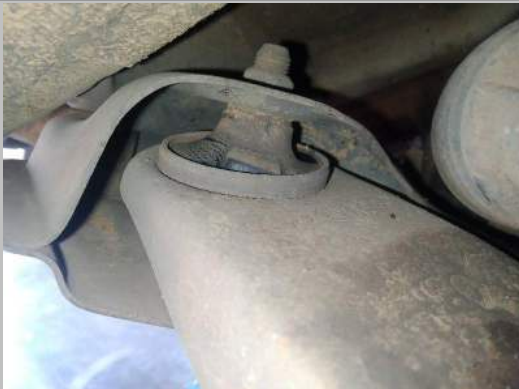
| Control Arm Bush(es) Front Axle Right Cracked | Replace |

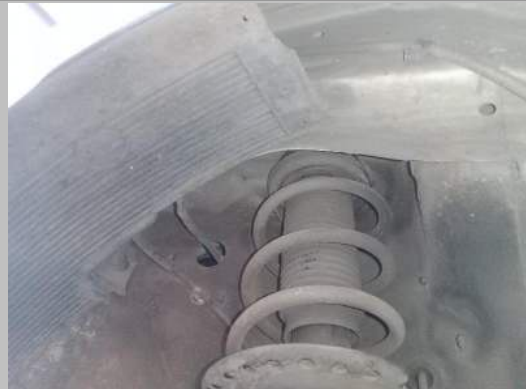
| Front Fender Right / Inner Tray Damaged | Replace |

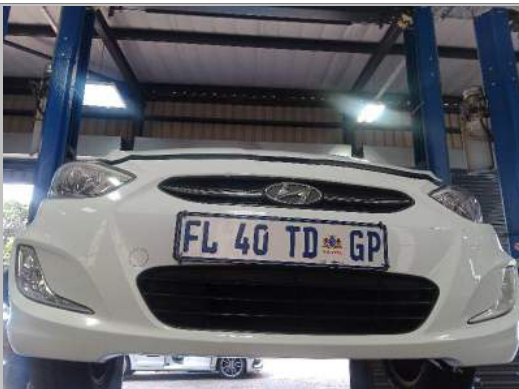
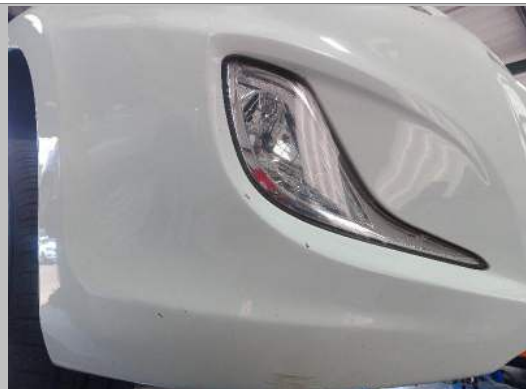
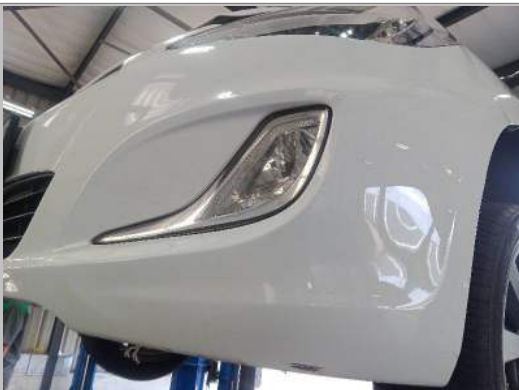
| Front Bumper Paintwork • Scratched | Repair |

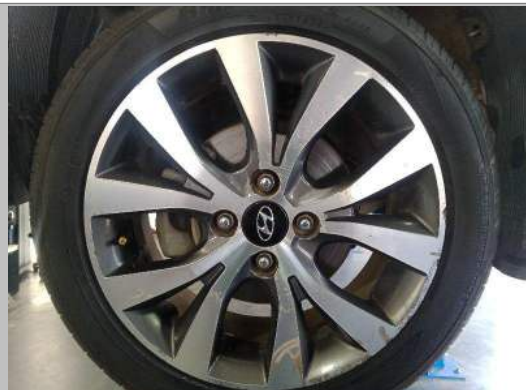
| Rim Front Left Scratched | Repair |

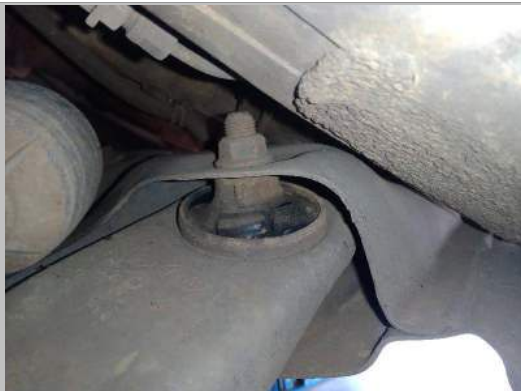
| Control Arm Bush(es) Front Axle Left Cracked | Replace |

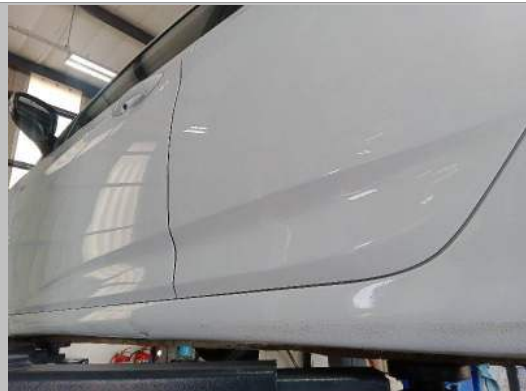
| Sill Panel Left Dented | Repair |

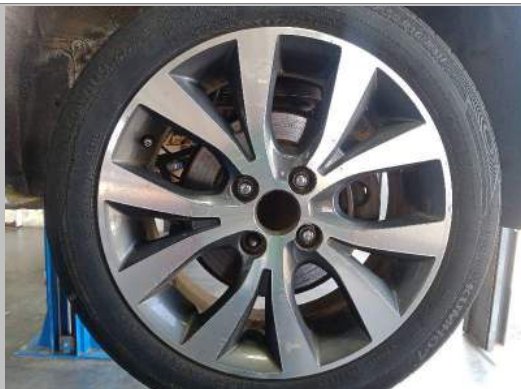
| Rim Rear Left Scratched | Repair |

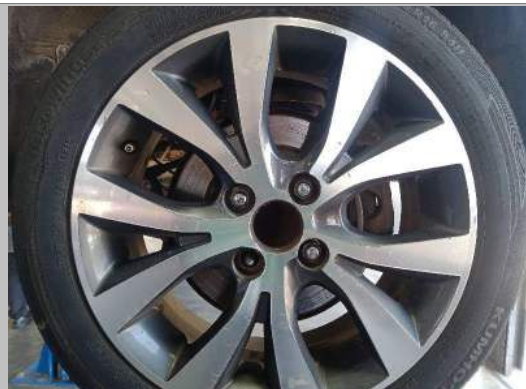
| Bolt(s) / Nut(s) Rear Wheel Left Missing | Replace |

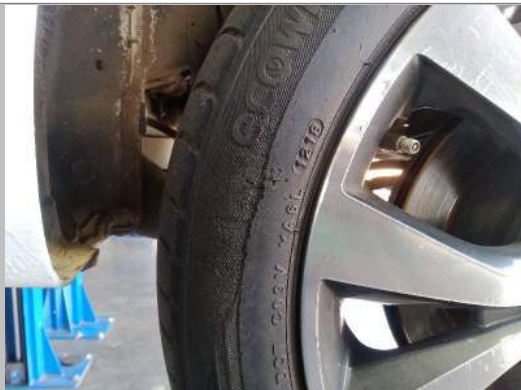
| Tyre Rear Left Damaged | Replace |

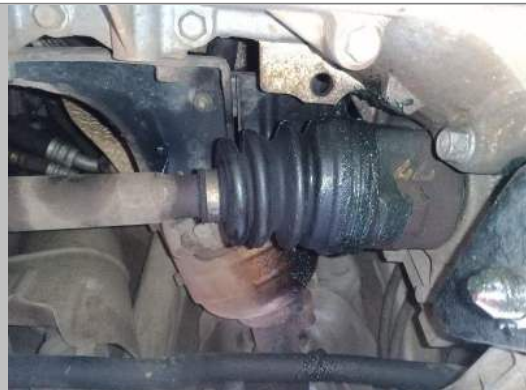
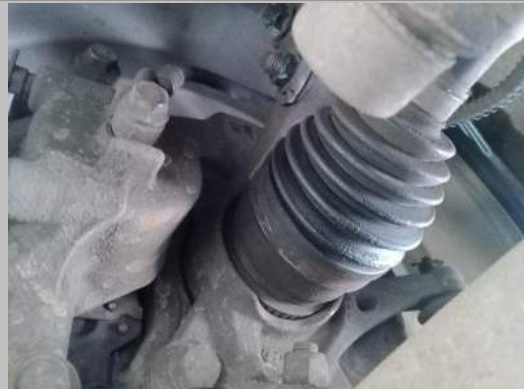
| CV Joint(s) Boot(s) Front Right (inner/outer) Damaged | Replace |

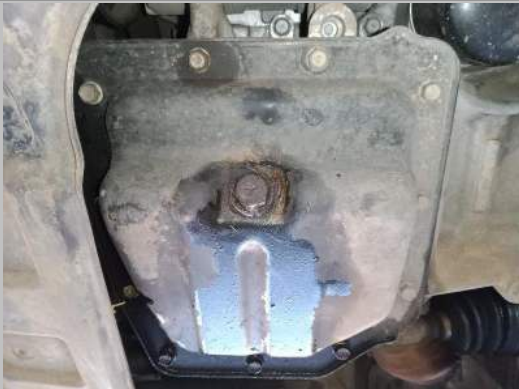
| Engine Oil Leak | Repair |

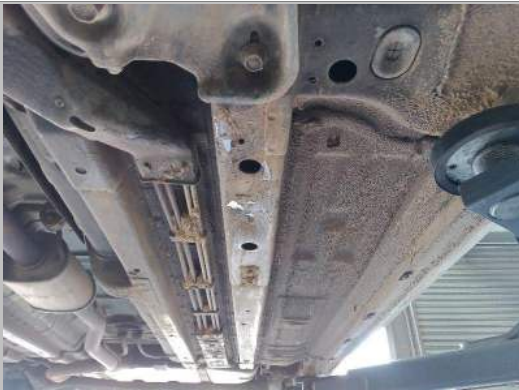
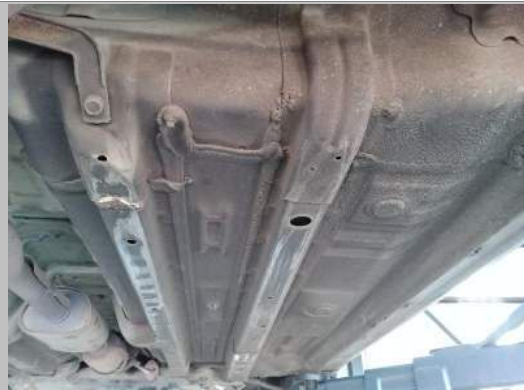
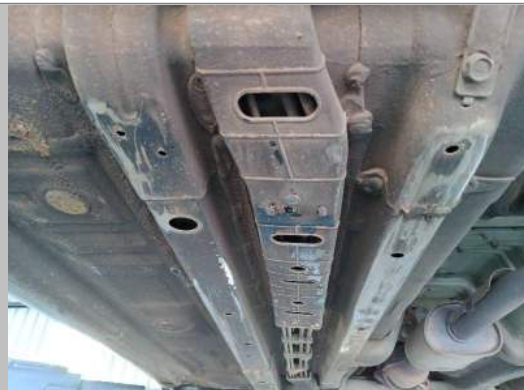
| Chassis Dented | Repair |

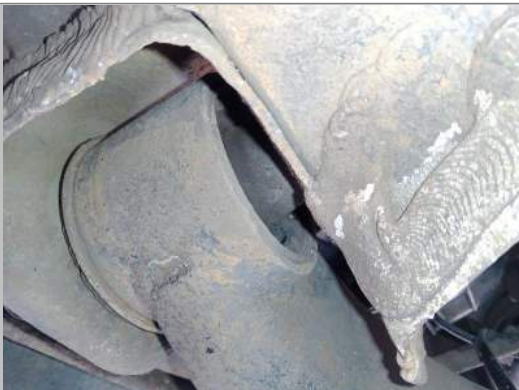
| Mounting Rubber(s) Rear Axle Left Cracked | Replace |

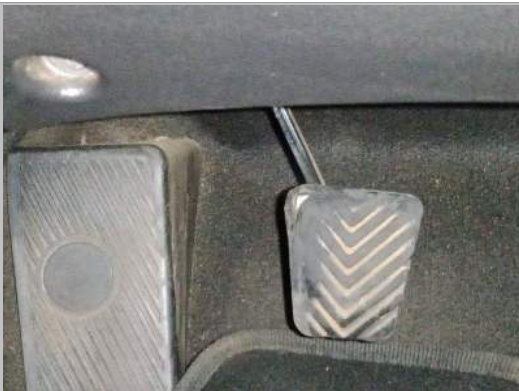
| Clutch Pedal Rubber Damaged | Replace |

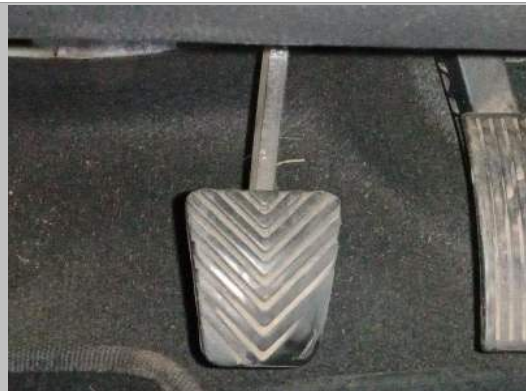
| Brake Pedal Rubber Torn / Cut | Replace |

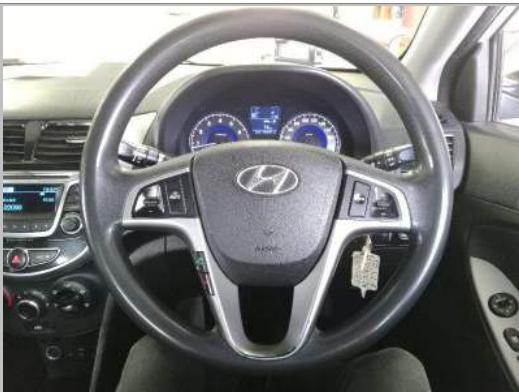
| Steering Wheel Trim Excessive Wear & Tear | Repair |

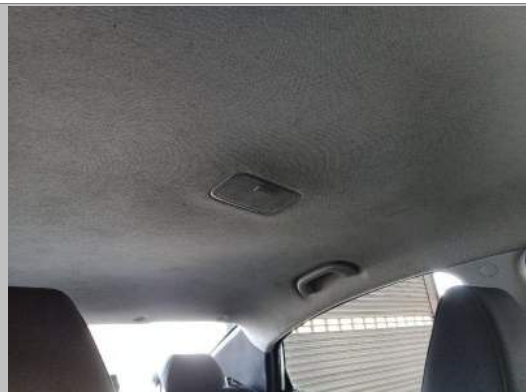
| Hood Lining Dirty | Repair |

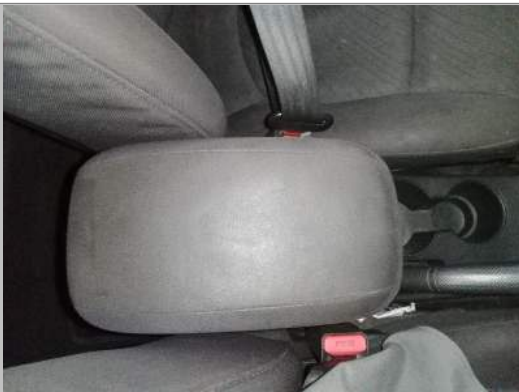
| Center Console / Cubbyhole + Lid Damaged | Repair |

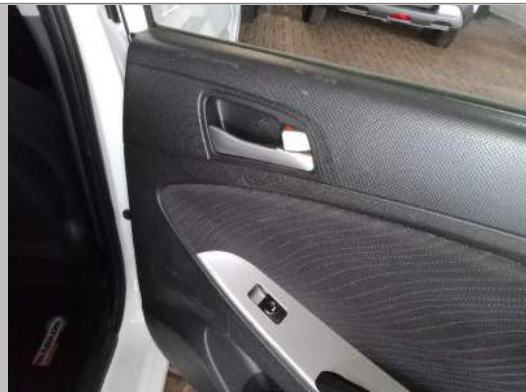
| Door Panel Rear Right Damaged | Repair |
