CONDITION REPORT

Report No: 2016488292

MFC Auction House  
M57 Pretoria Rd, Glenmarais, KEMPTON PARK  
Gauteng

| Manufacturer | HYUNDAI | Registration Number | FH64YBGP |

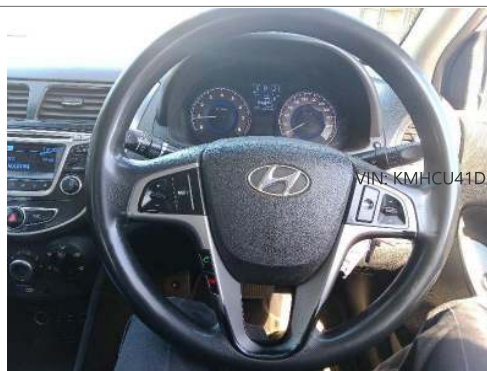
| Damage | Repair Way |
|---|---|
| Steering Wheel Trim Defective | Repair |

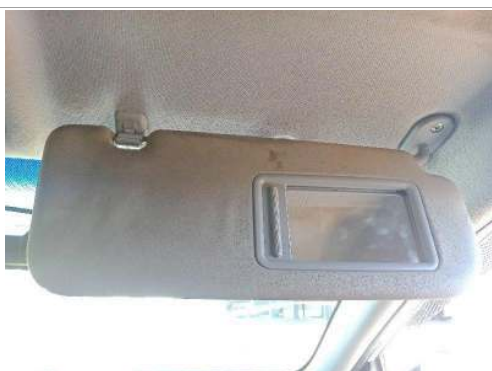
| Damage | Repair Way |
|---|---|
| Sun Visor Right Dirty | Repair |

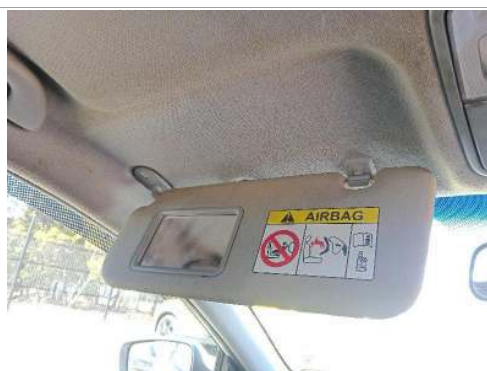
| Damage | Repair Way |
|---|---|
| Sun Visor Left Dirty | Repair |

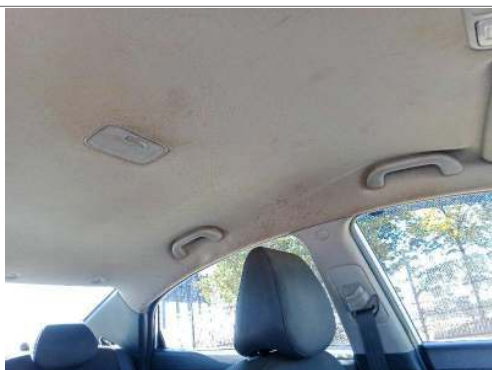
| Damage | Repair Way |
|---|---|
| Hood Lining Dirty | Repair |

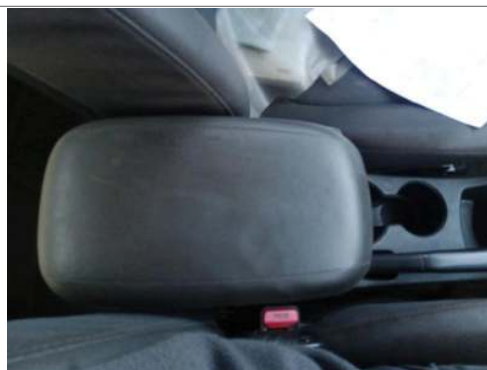
| Damage | Repair Way |
|---|---|
| Center Console / Cubbyhole + Lid Damaged | Repair |

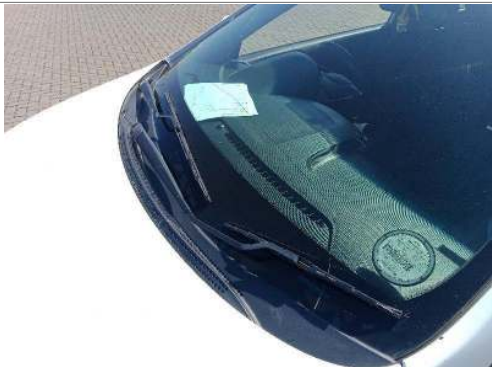
| Damage | Repair Way |
|---|---|
| Windscreen Wiper Damaged | Replace |

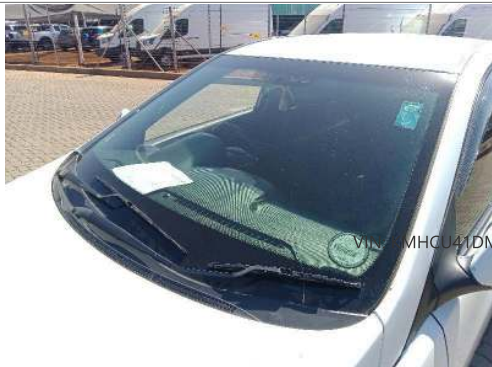
| Damage | Repair Way |
|---|---|
| Windscreen Cracked | Replace |

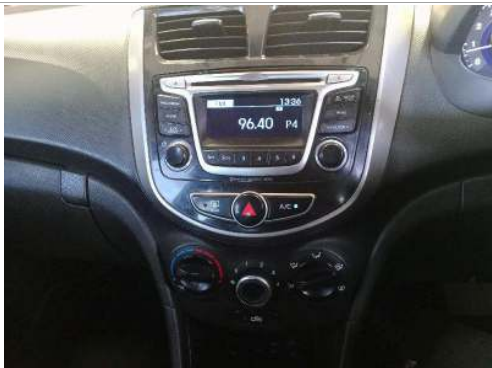
| Damage | Repair Way |
|---|---|
| Air Conditioner Insufficient | Replace |

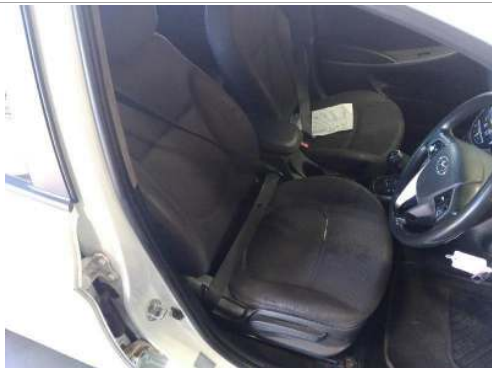
| Damage | Repair Way |
|---|---|
| Seat Front Right Damaged | Repair |

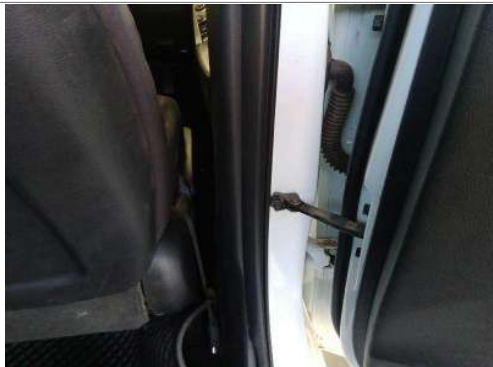
| Damage | Repair Way |
|---|---|
| Doorstopper Rear Right Defective | Replace |

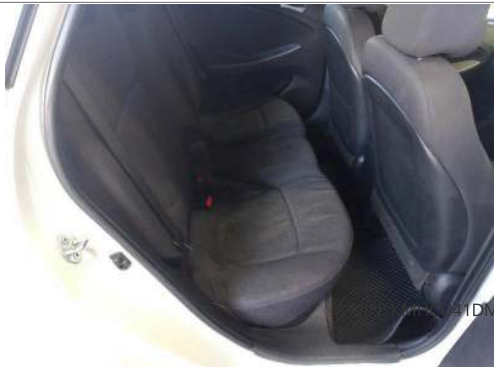
| Damage | Repair Way |
|---|---|
| Seat Rear Defective | Repair |

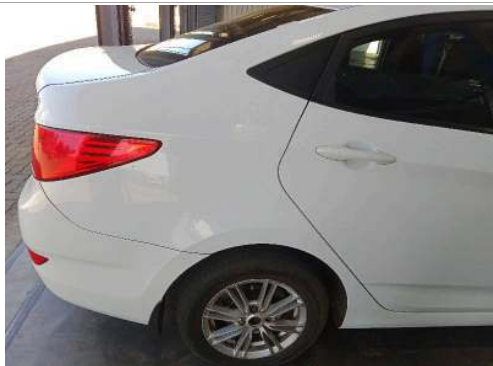
| Damage | Repair Way |
|---|---|
| Rear Fender Right Paintwork • Scratched | Repair |

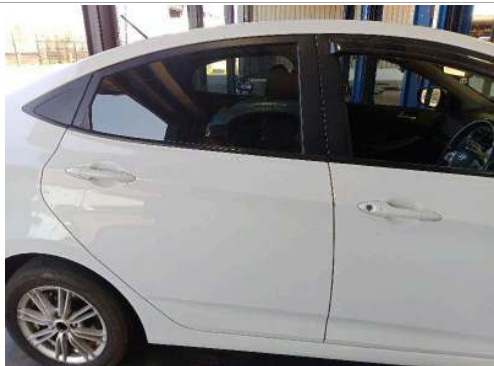
| Damage | Repair Way |
|---|---|
| Door Rear Right Dented | Repair |

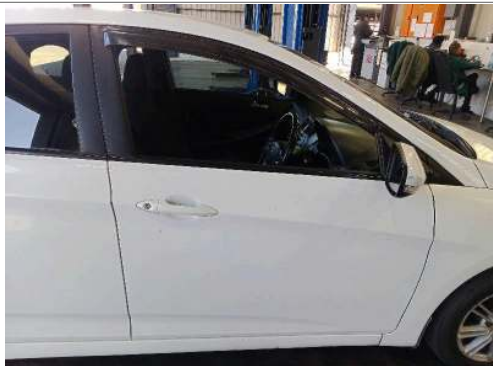
| Damage | Repair Way |
|---|---|
| Door Front Right Damaged | Repair |

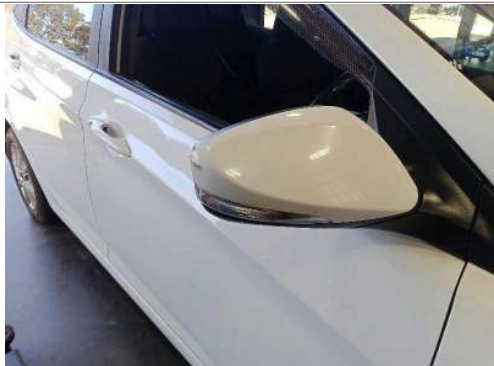
| Damage | Repair Way |
|---|---|
| Side Mirror Right Paintwork • Scratched | Repair |

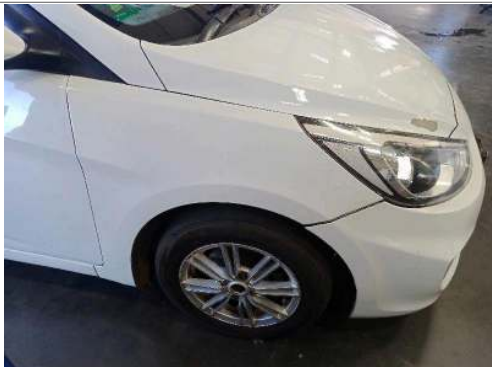
| Damage | Repair Way |
|---|---|
| Front Fender Right Residual Traces of Repair | Repair |

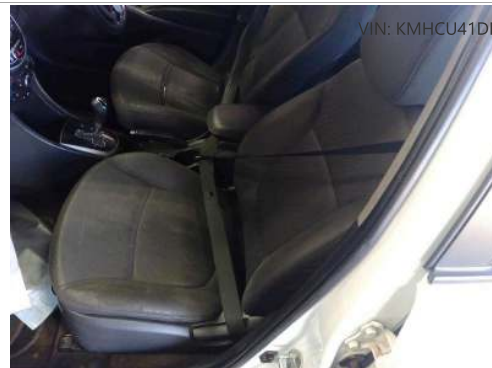
| Damage | Repair Way |
|---|---|
| Seat Front Left Dirty | Repair |

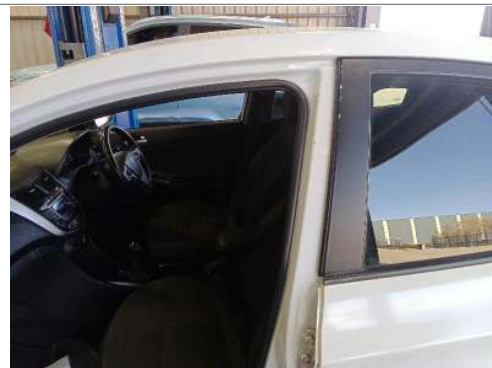
| Damage | Repair Way |
|---|---|
| B • Pillar Left Dented | Repair |

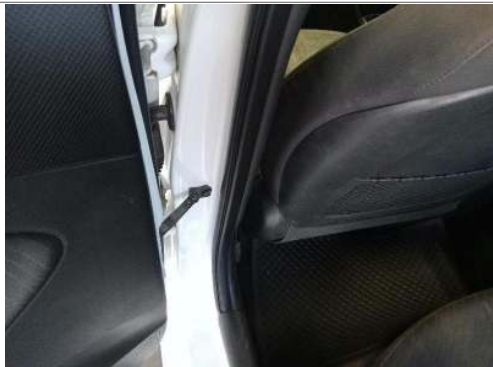
| Damage | Repair Way |
|---|---|
| Doorstopper Rear Left Defective | Replace |

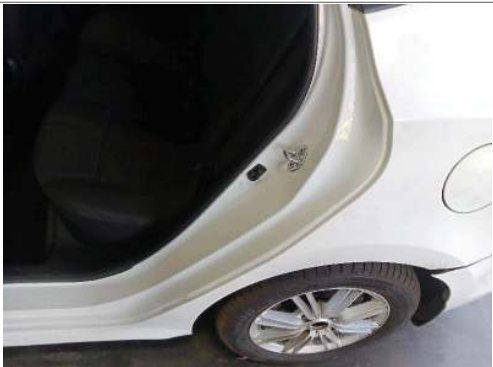
| Damage | Repair Way |
|---|---|
| C • Pillar Left Dented | Repair |

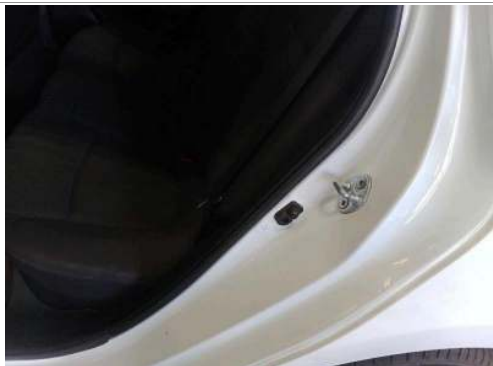
| Damage | Repair Way |
|---|---|
| Door Sealing Rubber Rear Left Torn / Cut | Replace |

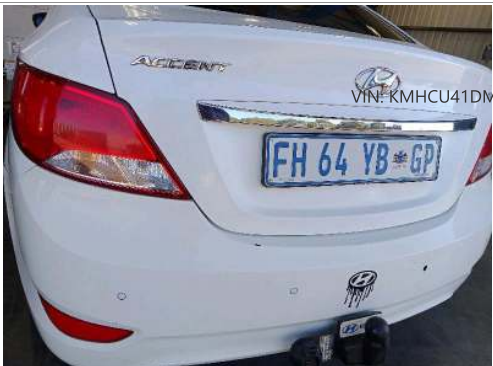
| Damage | Repair Way |
|---|---|
| Rear bumper Damaged | Repair |

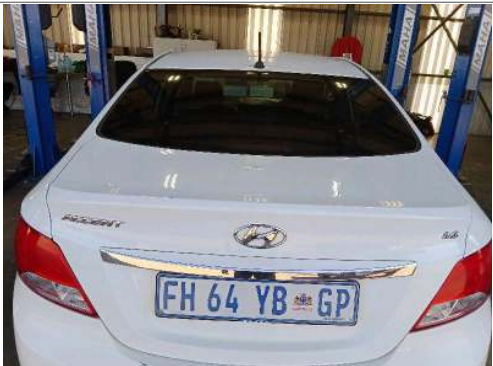
| Damage | Repair Way |
|---|---|
| Boot Lid / Hatch door Paintwork • Scratched | Repair |

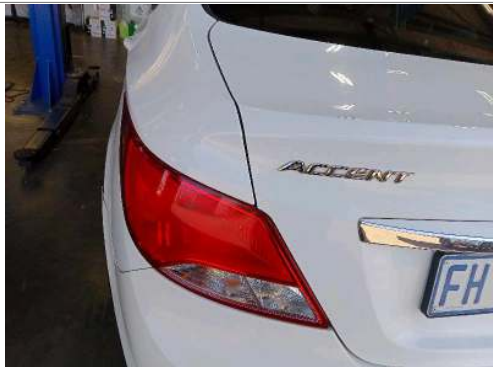
| Damage | Repair Way |
|---|---|
| Tail Light Left Damaged | Replace |

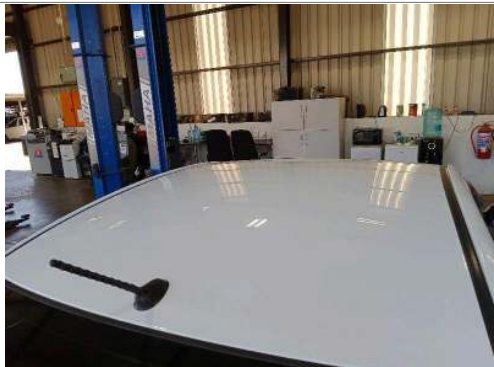
| Damage | Repair Way |
|---|---|
| Roof Dented | Repair |

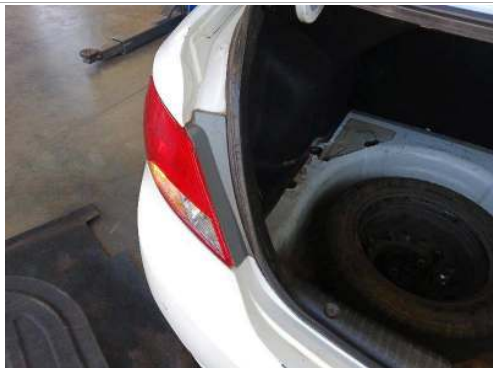
| Damage | Repair Way |
|---|---|
| Boot Lid / Hatch Door Rubbers Damaged | Replace |

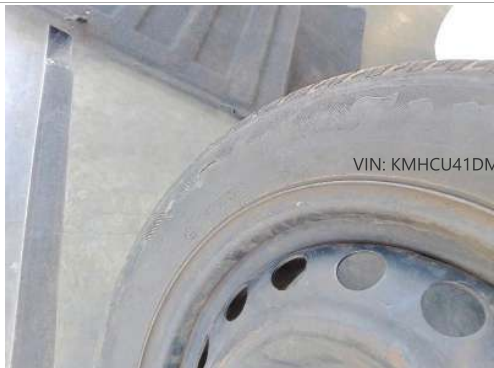
| Damage | Repair Way |
|---|---|
| Spare Tyre Torn / Cut | Replace |

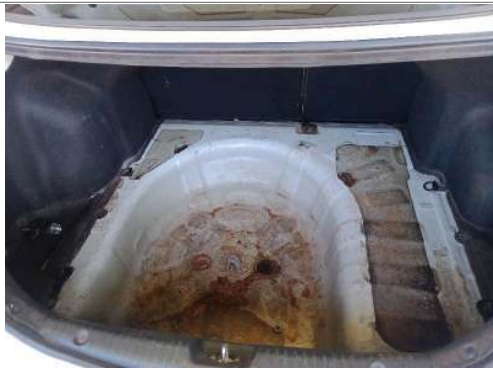
| Damage | Repair Way |
|---|---|
| Inner Boot Floor Pan and Spare Wheel Well Dented | Repair |

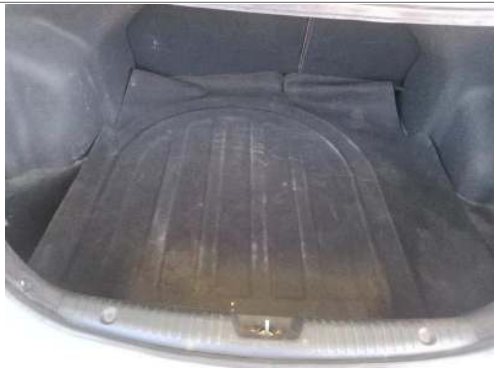
| Damage | Repair Way |
|---|---|
| Boot Carpet Damaged | Repair |

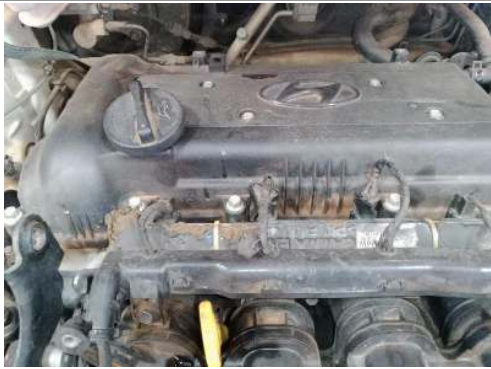
| Damage | Repair Way |
|---|---|
| Engine Wiring Defective | Replace |

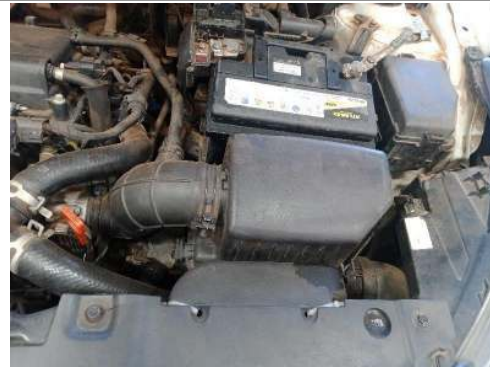
| Damage | Repair Way |
|---|---|
| Air cleaner Defective | Replace |

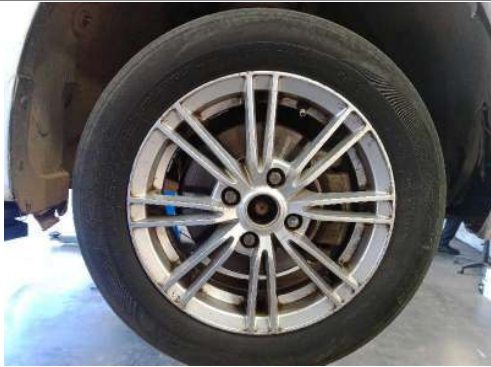
| Damage | Repair Way |
|---|---|
| Rim Front Right Scratched | Repair |

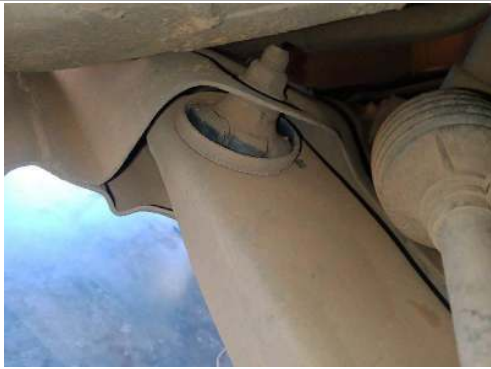
| Damage | Repair Way |
|---|---|
| Control Arm Bush(es) Front Axle Right Cracked | Replace |

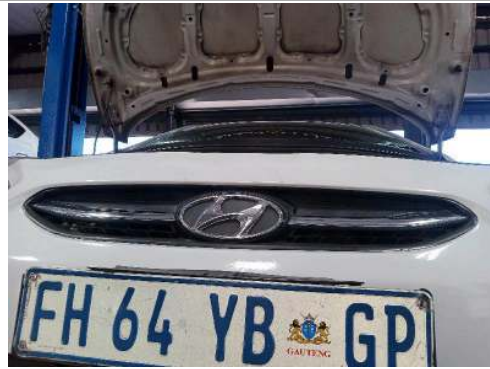
| Damage | Repair Way |
|---|---|
| Grill Cracked | Replace |

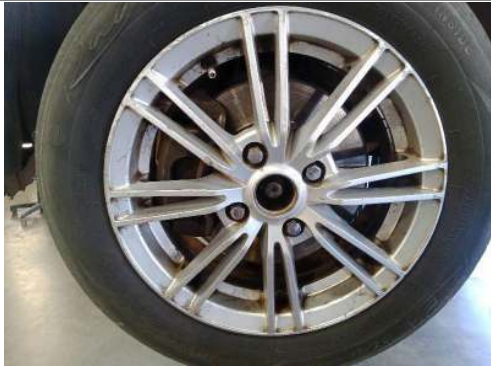
| Damage | Repair Way |
|---|---|
| Rim Front Left Damaged | Repair |

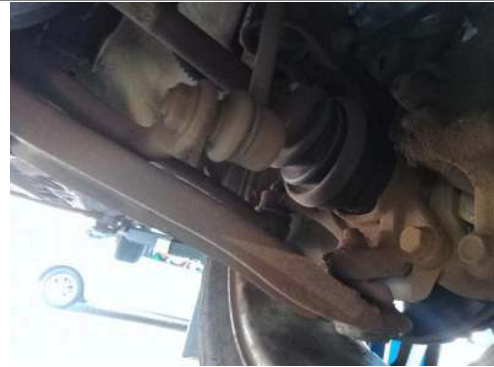
| Damage | Repair Way |
|---|---|
| Wheel bearing Front Left Loose / Excessive Play | Replace |

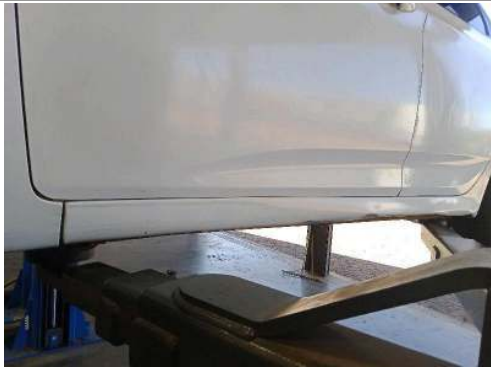
| Damage | Repair Way |
|---|---|
| Sill Panel Left Damaged | Repair |

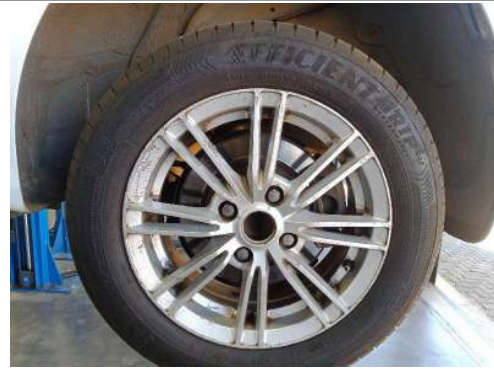
| Damage | Repair Way |
|---|---|
| Rim Rear Left Scratched | Repair |

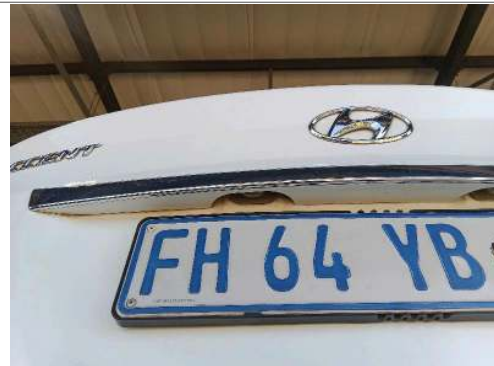
| Damage | Repair Way |
|---|---|
| Number Plate Light Left Defective | Replace |

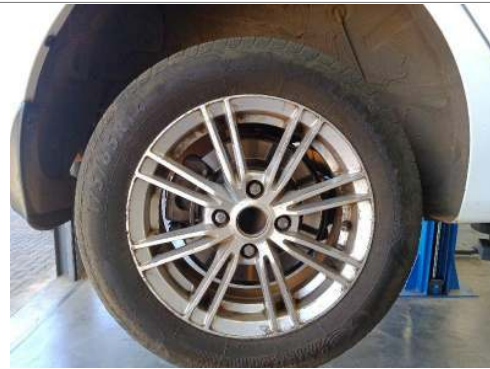
| Damage | Repair Way |
|---|---|
| Rim Rear Right Dented | Repair |

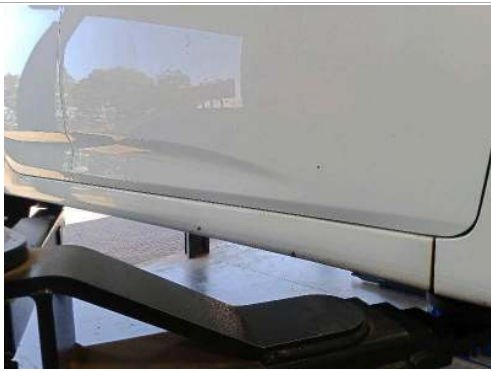
| Damage | Repair Way |
|---|---|
| Rocker Panel Right Dented | Repair |

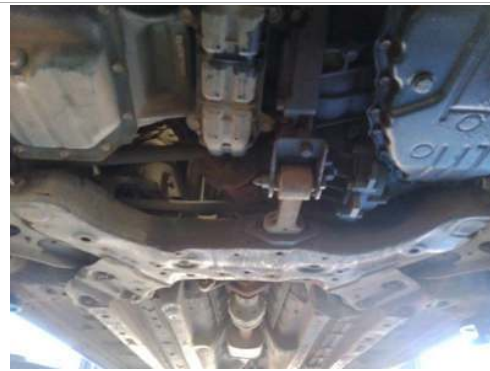
| Damage | Repair Way |
|---|---|
| Sub Frame Damaged | Repair |

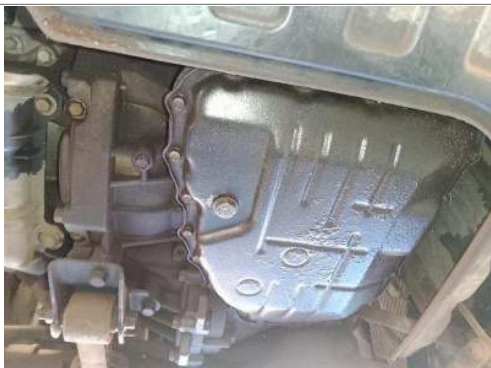
| Damage | Repair Way |
|---|---|
| Gearbox Oil Leak | Repair |

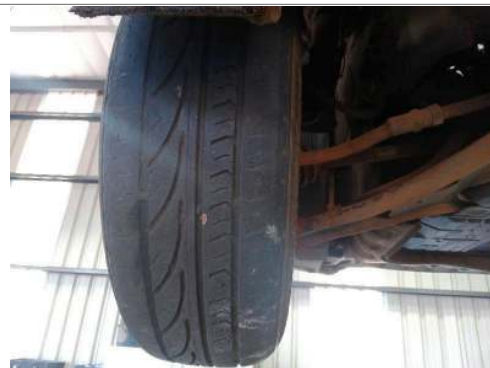
| Damage | Repair Way |
|---|---|
| Tyre Front Left Worn | Replace |

| | Size | Load/Speed Index | Manufacture | Model | Type* | Production Date | Tread Depth (mm) |
|---|---|---|---|---|---|---|---|
| Front Left | 175/65 R14 | 86H | Radar | RPX-800 | V | 2322 | 0 mm |

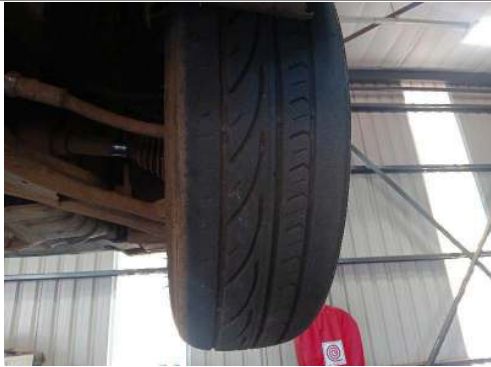
| Damage | Repair Way |
|---|---|
| Tyre Front Right Worn | Replace |

| | Size | Load/Speed Index | Manufacture | Model | Type* | Production Date | Tread Depth (mm) |
|---|---|---|---|---|---|---|---|
| Front Right | 175/65 R14 | 86H | Radar | RPX-800 | V | 3721 | 0 mm |

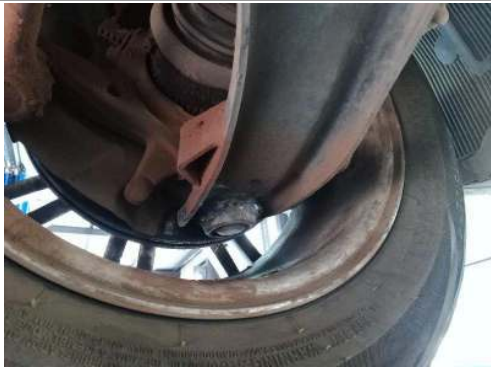
| Damage | Repair Way |
|---|---|
| Ball Joint(s) Front Axle Left Welded | Replace |

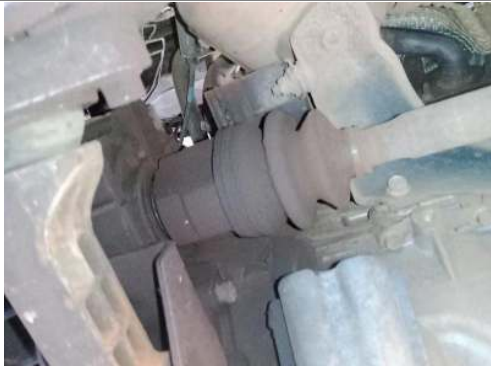
| Damage | Repair Way |
|---|---|
| CV Joint(s) Boot(s) Front Right (inner/outer) Damaged | Replace |

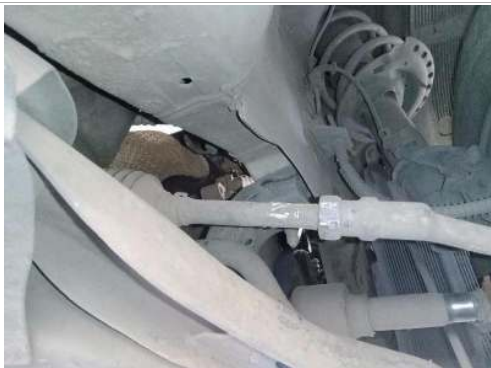
| Damage | Repair Way |
|---|---|
| Tie Rod right Defective | Replace |

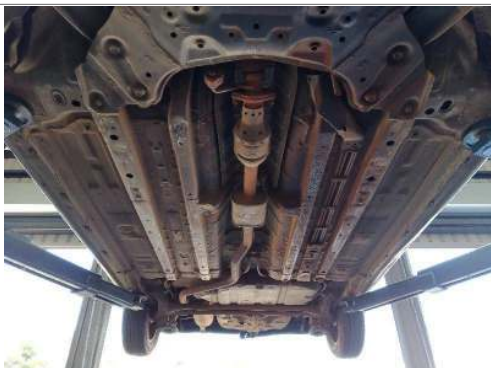
| Damage | Repair Way |
|---|---|
| Chassis Damaged | Repair |

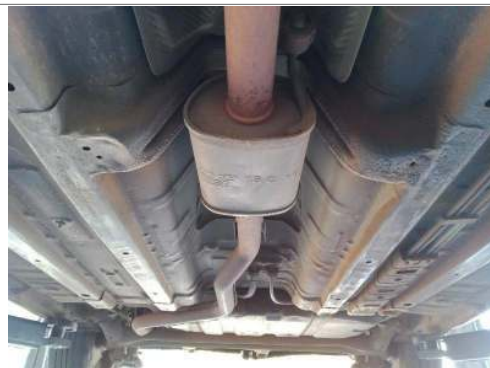
| Damage | Repair Way |
|---|---|
| Silencer Defective | Repair |

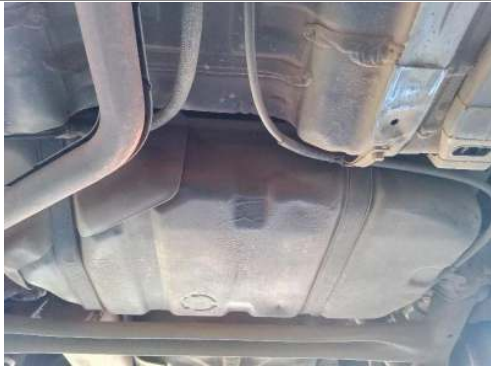
| Damage | Repair Way |
|---|---|
| Fuel Tank Dented | Repair |

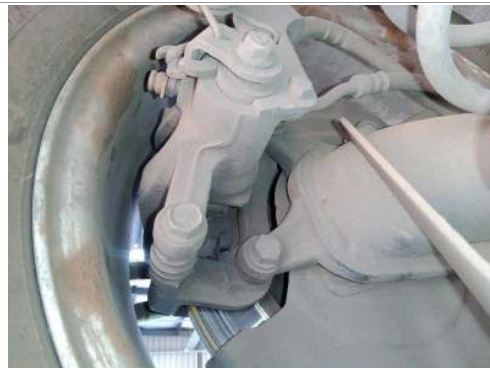
| Damage | Repair Way |
|---|---|
| Brake Pad/Shoe 2. Axle left Defective | Replace |

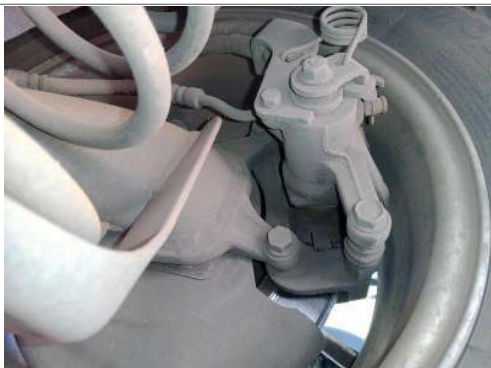
| Damage | Repair Way |
|---|---|
| Brake Pad/Shoe 2. Axle right Defective | Replace |

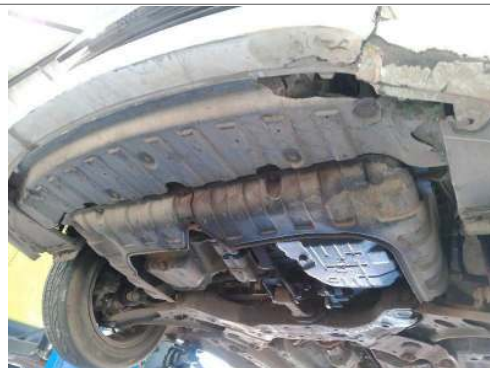
| Damage | Repair Way |
|---|---|
| Belly plates Damaged | Repair |
