MFC Auction House
M57 Pretoria Rd, Glenmarais, KEMPTON PARK
Gauteng

DEKRA MFC
M57 Pretoria Rd - 1619
KEMPTON PARK - GT
08610 33572

VEHICLE INSPECTION

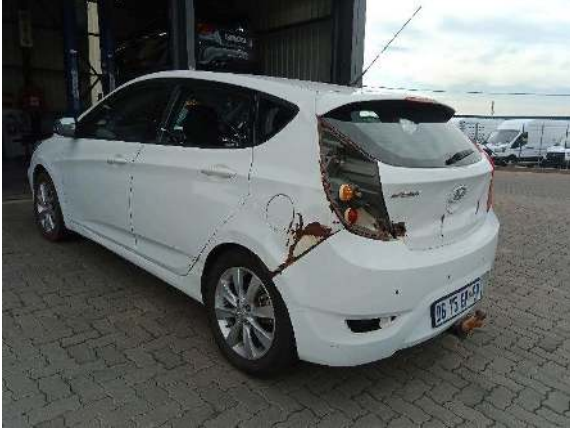
REAR LEFT CORNER

General Comments: SIGNS OF IMPACT DAMAGE TO LEFT REAR OF VEHICLE. SPRAY WORK ON SOME BODY PANELS. SOME BODY PANELS MISALIGNED. ACCORDING TO THE AGE AD MILEAGE OF THE VEHICLE, NORMAL WEAR AND TEAR MARKS ARE VISIBLE ON THE INTERIOR, EXTERIOR, ELECTRICAL AND MECHANICAL P

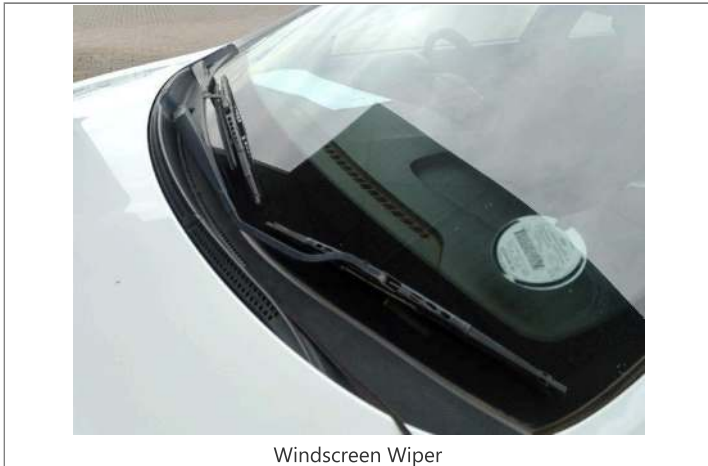
Damage	Repair Way
Engine Oil Leak	Repair
Engine Wiring Defective	Repair
Hoses Defective	Replace
Air cleaner Defective	Repair
Windscreen Wiper Damaged	Replace
Park Light Front Left Defective	Replace
Park Light Front Right Defective	Replace
Tail Light Left Damaged	Replace
Headlight Left Defective	Repair
Headlight Right Defective	Repair
Seat Front Left Dirty	Repair
Seat Front Right Dirty	Repair
Seat Rear Dirty	Repair
Sun Visor Left Dirty	Repair
Sun Visor Right Dirty	Repair
Hood Lining Dirty	Repair
Door Sealing Rubber Rear Right Defective	Repair
Boot Carpet Damaged	Repair
Steering Wheel Trim Defective	Repair
Side Mirror Left Damaged	Replace
Side Mirror Right Paintwork • Scratched	Repair
Front Bumper Damaged	Repair
Bonnet Paintwork • Chipmarks	Repair
Front Fender Left Paintwork • Scratched	Repair
Front Fender Right Paintwork • Scratched	Repair
Rear Fender Left Damaged	Repair
Rear Fender Right Dented	Repair
Front Fender Left / Inner Tray Damaged	Replace

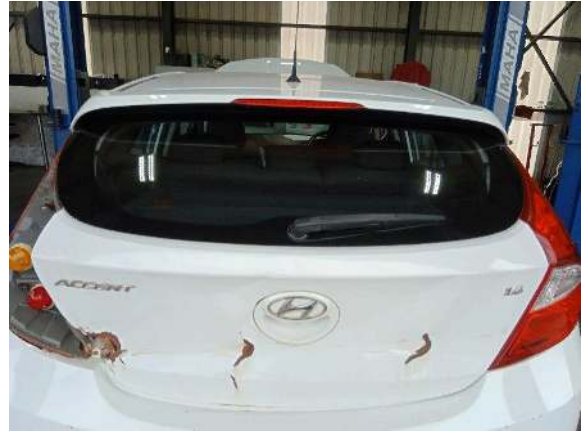
Boot Lid / Hatch door VIN: KMHCU51DLEU165933

Damage	Repair Way
Rear Fender Right / Inner Tray Defective	Repair
Door Front Left Dented	Repair
Door Front Right Paintwork • Scratched	Repair
Door Rear Left Dented	Repair
Door Rear Right Paintwork • Scratched	Repair
Boot Lid / Hatch door Damaged	Replace
Rear bumper Damaged	Repair
Inner Boot Floor Pan and Spare Wheel Well Damaged	Repair
Rocker Panel Left Damaged	Repair
Rocker Panel Right Damaged	Repair
Roof Paintwork • Chipmarks	Repair
Windscreen Cracked	Replace
Brake disc 1. Axle right Defective	Replace
Service Brake Performance Rear Axle Left / Right	Repair
Difference out of legal range	Repair
Control Arm Bush(es) Front Axle Left Cracked	Replace
Control Arm Bush(es) Front Axle Right Cracked	Replace
Mounting Rubber(s) Rear Axle Left Cracked	Replace
Mounting Rubber(s) Rear Axle Right Cracked	Replace
Tyre Front Left Worn	Replace
Tyre Rear Left Worn	Replace
Spare Tyre Damaged	Replace
Rim Front Left Scratched	Repair

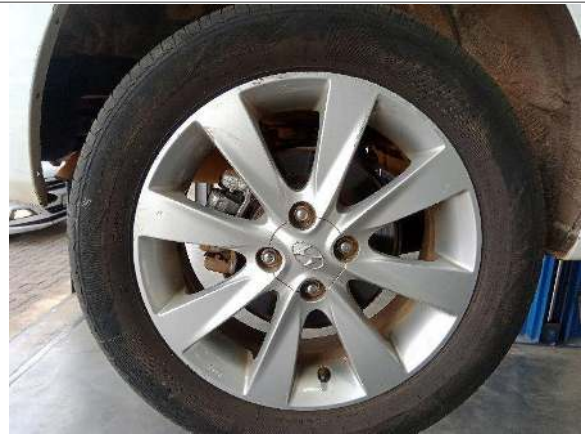
Rim Rear Right Scratched	Repair
Main Beam Left Damaged	Repair
Chassis Dented	Repair
Sub Frame Dented	Repair
Belly plates Damaged	Replace
Fuel Tank Dented	Repair
CV Joint(s) Boot(s) Front Left (inner/outer) Damaged	Replace
Engine Noise Excessive	Repair
Vehicle key fob casing defective	Replace
