MFC Auction House
M57 Pretoria Rd, Glenmarais, KEMPTON PARK
Gauteng

| Manufacturer | HYUNDAI | Registration Number | HY01KLGP |

CONDITION REPORT

Report No: 2016317760

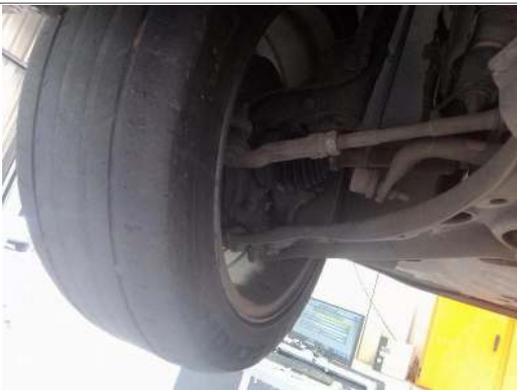
LF TYRE TREAD

| | Size | Load/Speed Index | Manufacture | Model | Type* | Production Date | Tread Depth (mm) |
|---|---|---|---|---|---|---|---|
| Front Left | 225/45R17 | 94Y | Tracmak | Privilo | V | 4520 | 0 mm |

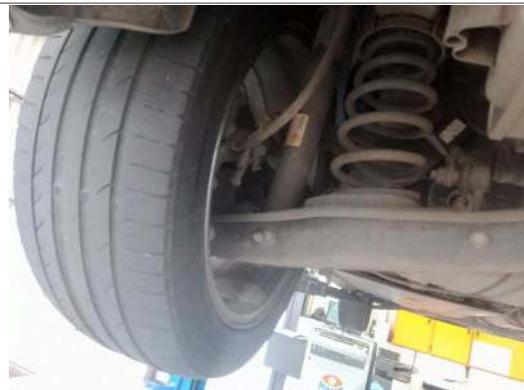
LR TYRE TREAD

| | Size | Load/Speed Index | Manufacture | Model | Type* | Production Date | Tread Depth (mm) |
|---|---|---|---|---|---|---|---|
| Rear Left | 225/45R17 | 94Y | Tracmak | Privilo | V | 4420 | 1 mm |

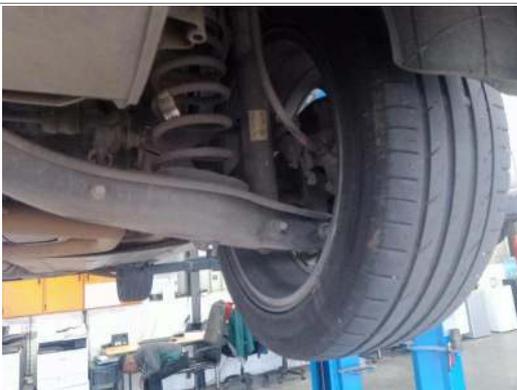
RR TYRE TREAD

| | Size | Load/Speed Index | Manufacture | Model | Type* | Production Date | Tread Depth (mm) |
|---|---|---|---|---|---|---|---|
| Rear Right | 225/45R17 | 94Y | Tracmak | Privilo | V | 4720 | 2 mm |

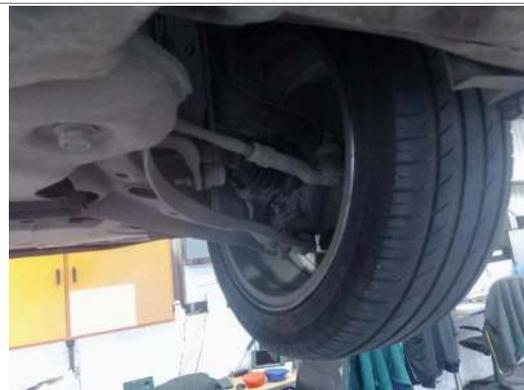
RF TYRE TREAD

| | Size | Load/Speed Index | Manufacture | Model | Type* | Production Date | Tread Depth (mm) |
|---|---|---|---|---|---|---|---|
| Front Right | 225/45R17 | 94W | Cachland | CH861 | V | 4621 | 2 mm |

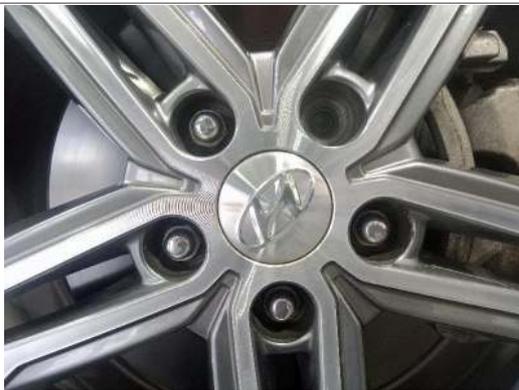
| Damage | Repair Way |
|--|---|
| Bolt(s) / Nut(s) Front Wheel Right Missing | Replace |

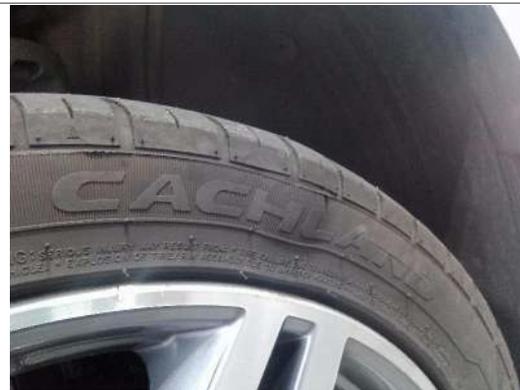
| Damage | Repair Way |
|--|---|
| Tyre Front Right Damaged | Replace |

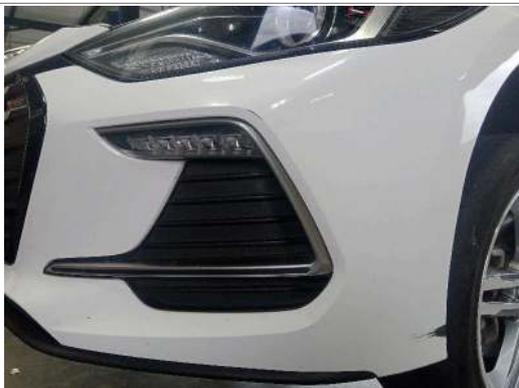
| Damage | Repair Way |
|--|---|
| Front Bumper Paintwork • Scratched | Repair |

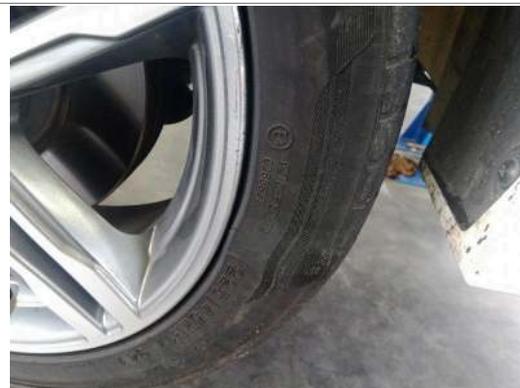
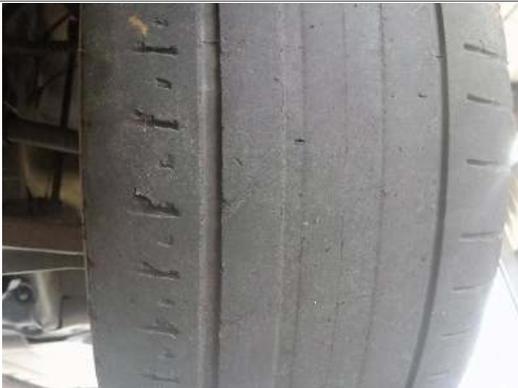
| Damage | Repair Way |
|--|---|
| Tyre Front Left Damaged | Replace |

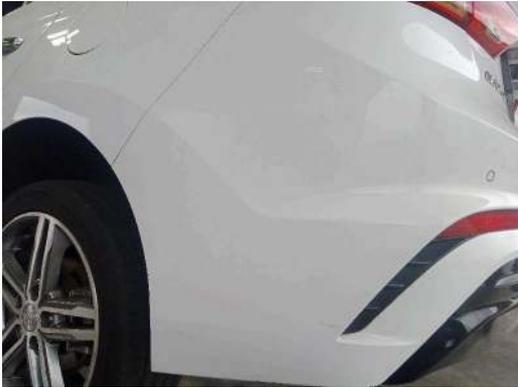
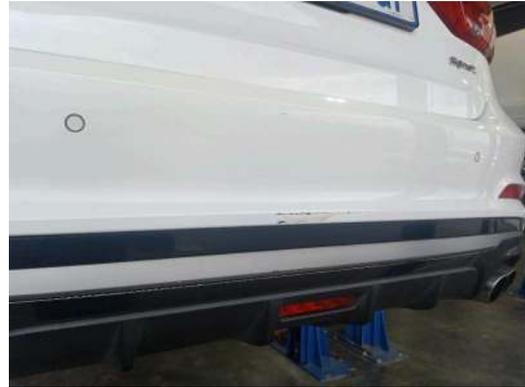
| Damage | Repair Way |
|--|---|
| Rear bumper Paintwork • Scratched | Repair |

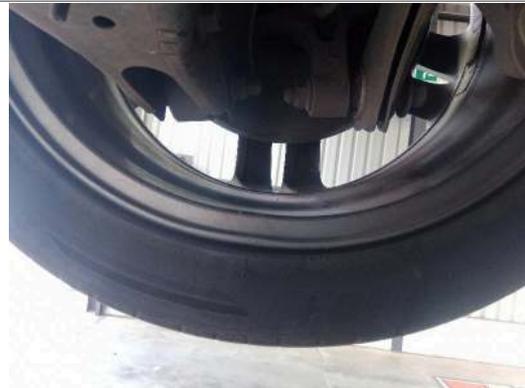
| Damage | Repair Way |
|--|---|
| Rim Rear Left Dented | Repair |
