MFC Auction House  
M57 Pretoria Rd, Glenmarais, KEMPTON PARK  
Gauteng

DEKRA MFC  
M57 Pretoria Rd - 1619  
KEMPTON PARK - GT  
08610 33572

| Manufacturer | HYUNDAI | Registration Number | KK85YGGP |
| Model | ELANTRA | Register Number | |

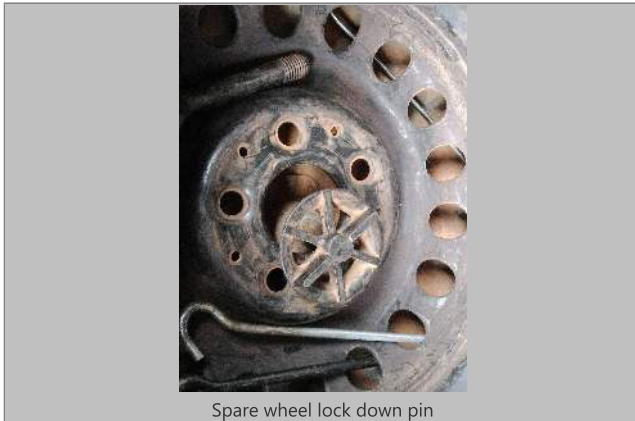
Spare wheel lock down pin

| Damage | Repair Way |
|---|---|
| Tyres and rims | Spare wheel lockdown pin damaged |

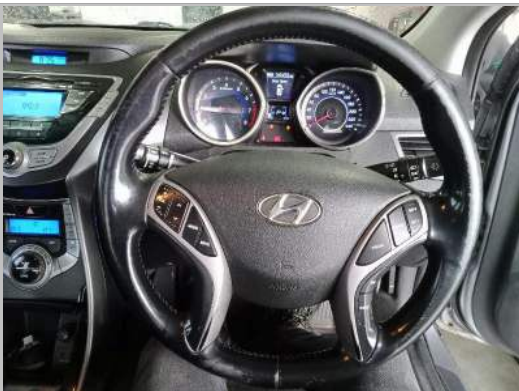
| Damage | Repair Way |
|---|---|
| Steering Wheel Trim Defective | Repair |

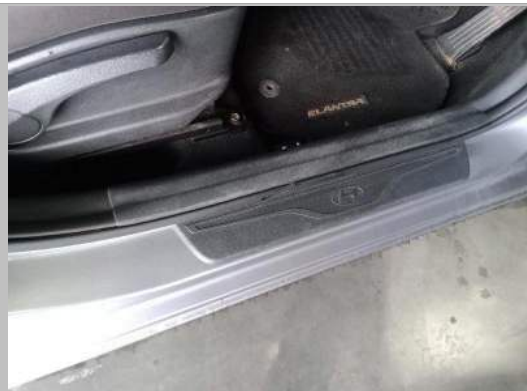
| Damage | Repair Way |
|---|---|
| Door Sealing Rubber Front Right Damaged | Replace |

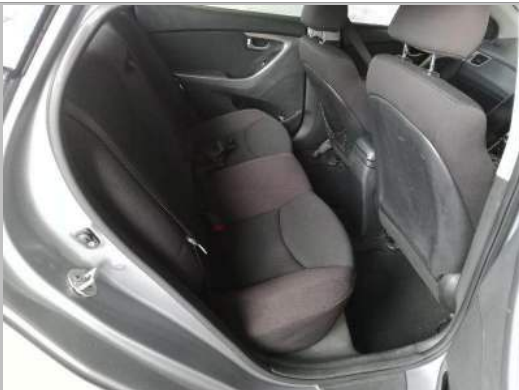
| Damage | Repair Way |
|---|---|
| Seat Rear Damaged | Repair |

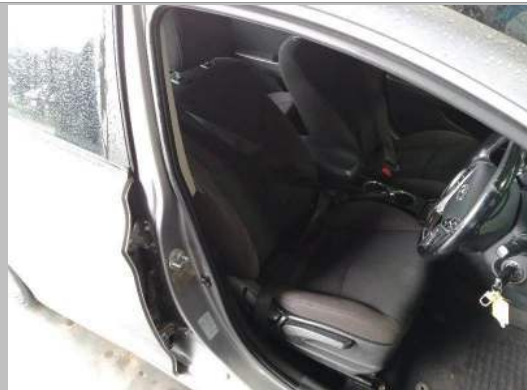
| Damage | Repair Way |
|---|---|
| Seat Front Right Damaged | Repair |

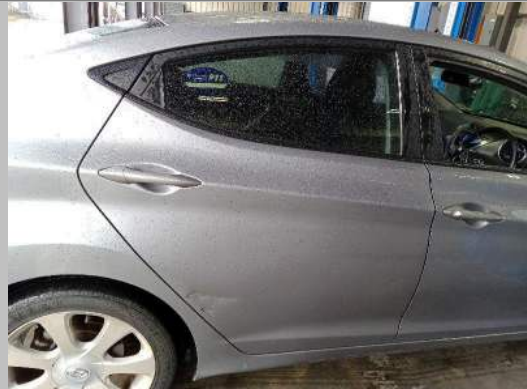
| Damage | Repair Way |
|---|---|
| Door Rear Right Damaged | Repair |

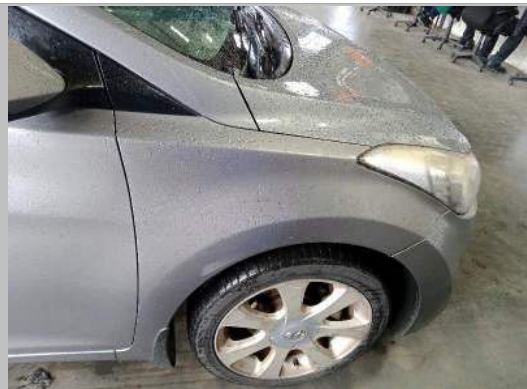
| Damage | Repair Way |
|---|---|
| Front Fender Right Damaged | Repair |

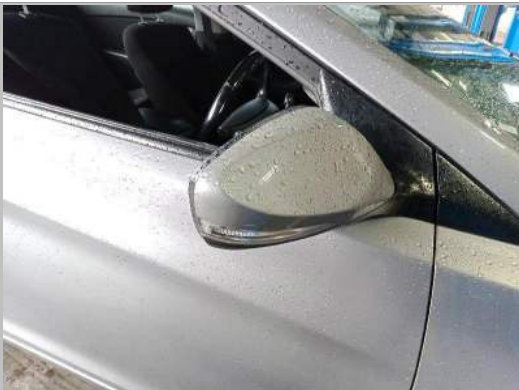
| Damage | Repair Way |
|---|---|
| Side Mirror Right Paintwork • Scratched | Repair |

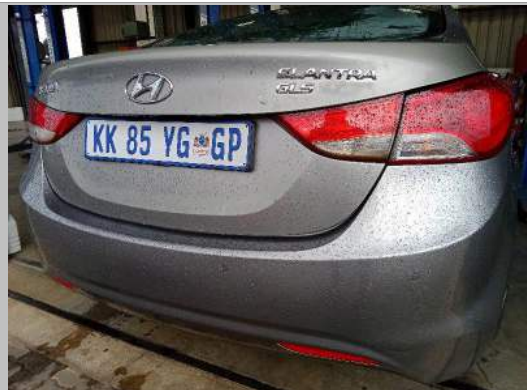
| Damage | Repair Way |
|---|---|
| Rear bumper Damaged | Repair |

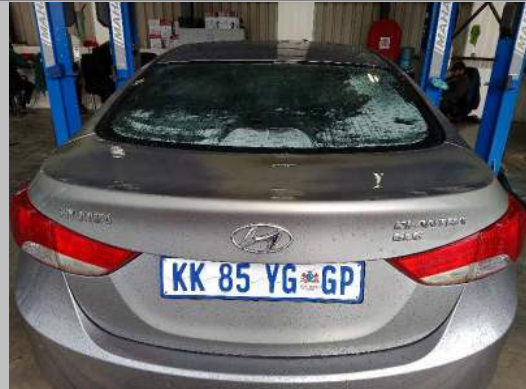
| Damage | Repair Way |
|---|---|
| Boot Lid / Hatch door Damaged | Repair |

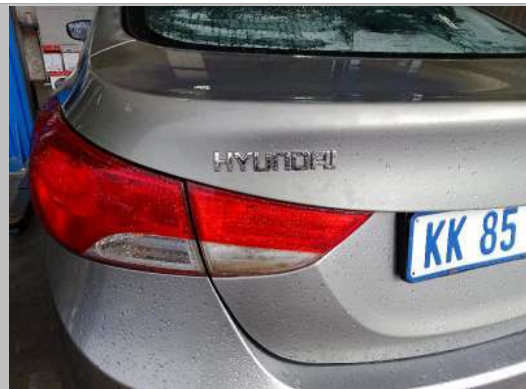
| Damage | Repair Way |
|---|---|
| Tail Light Left Damaged | Replace |

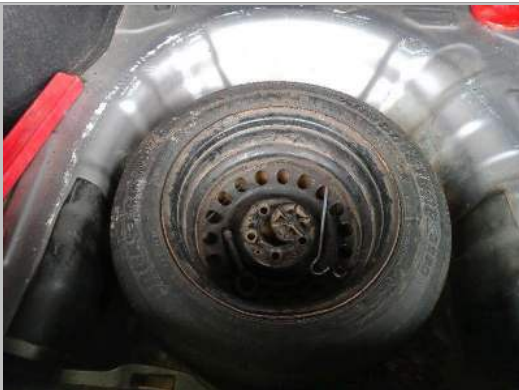
| Damage | Repair Way |
|---|---|
| Rim Spare Wheel Dented | Repair |

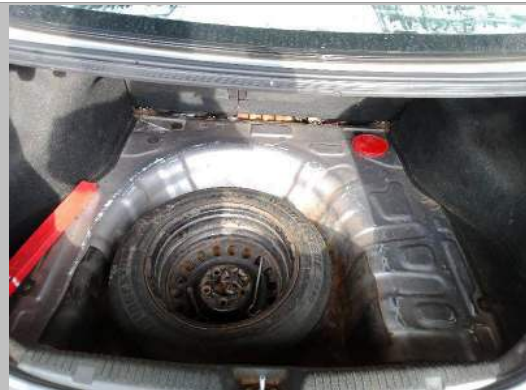
| Damage | Repair Way |
|---|---|
| Inner Boot Floor Pan and Spare Wheel Well Damaged | Repair |

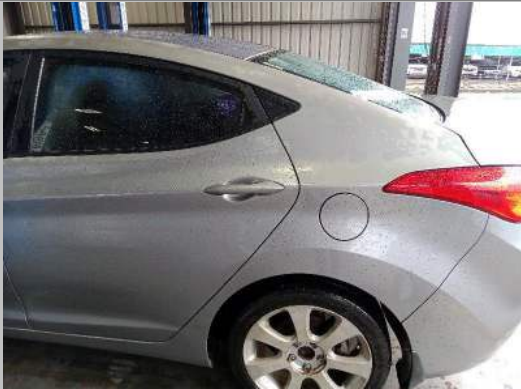
| Damage | Repair Way |
|---|---|
| Rear Fender Left Paintwork • Discoloured | Repair |

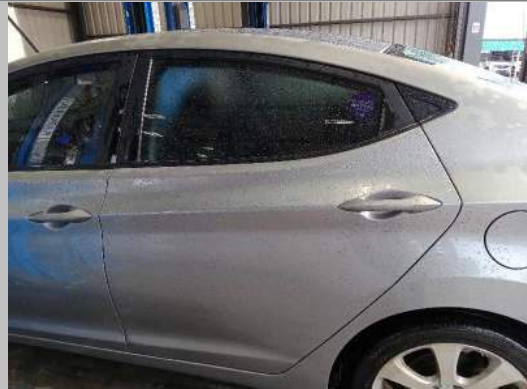
| Damage | Repair Way |
|---|---|
| Door Rear Left Paintwork • Discoloured | Repair |

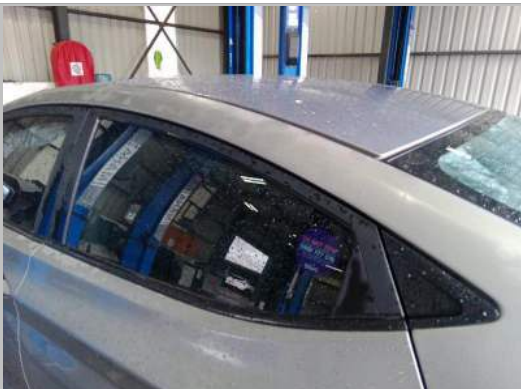
| Damage | Repair Way |
|---|---|
| C • Pillar Left Paintwork • Discoloured | Repair |

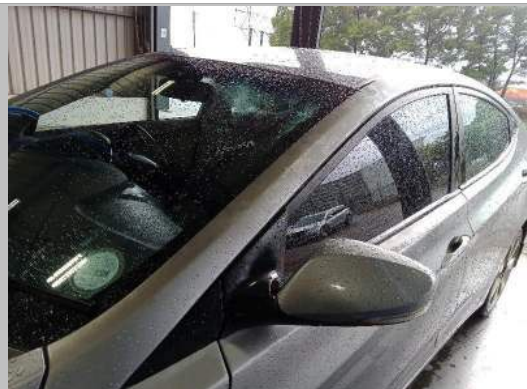
| Damage | Repair Way |
|---|---|
| A • Pillar Left Paintwork • Discoloured | Repair |

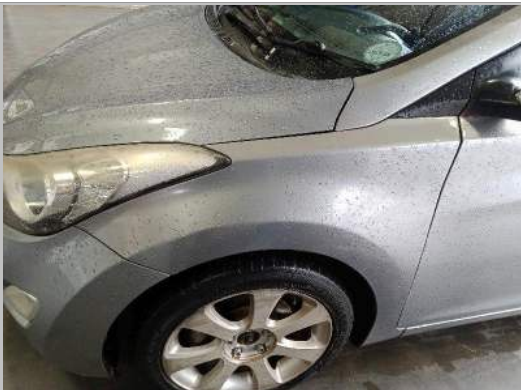
| Damage | Repair Way |
|---|---|
| Front Fender Left Damaged | Repair |

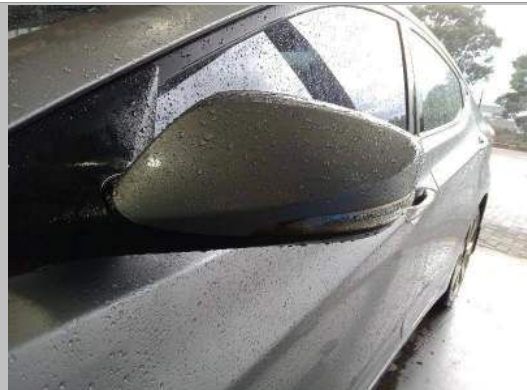
| Damage | Repair Way |
|---|---|
| Indicator Light Front Left Damaged | Replace |

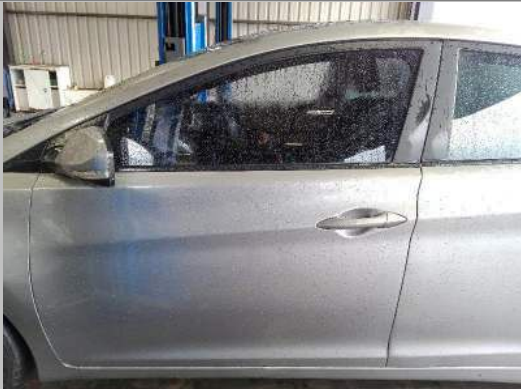
| Damage | Repair Way |
|---|---|
| Door Front Left Damaged | Repair |

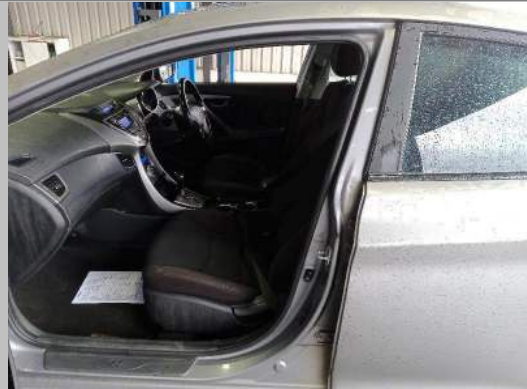
| Damage | Repair Way |
|---|---|
| B • Pillar Left Damaged | Repair |

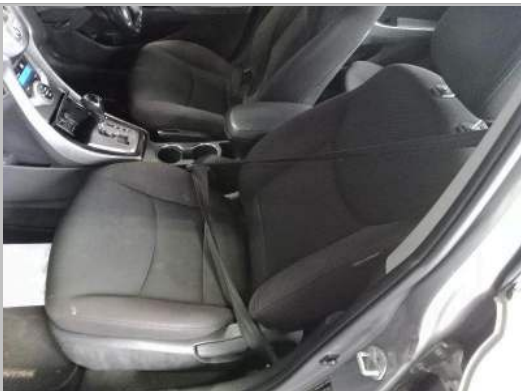
| Damage | Repair Way |
|---|---|
| Seat Front Left Defective | Repair |

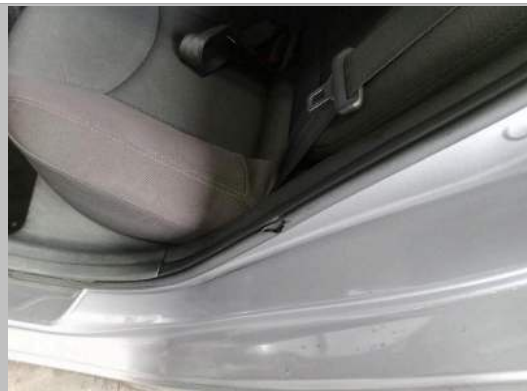
| Damage | Repair Way |
|---|---|
| Door Sealing Rubber Rear Left Torn / Cut | Replace |

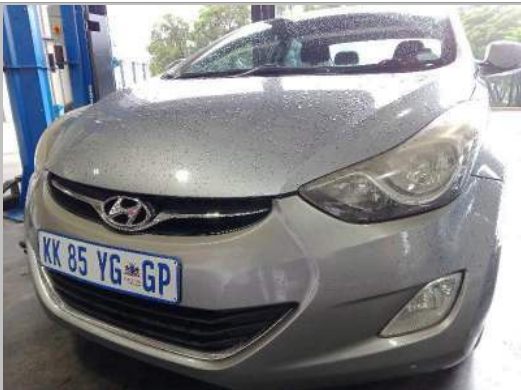
| Damage | Repair Way |
|---|---|
| Front Bumper Damaged | Repair |

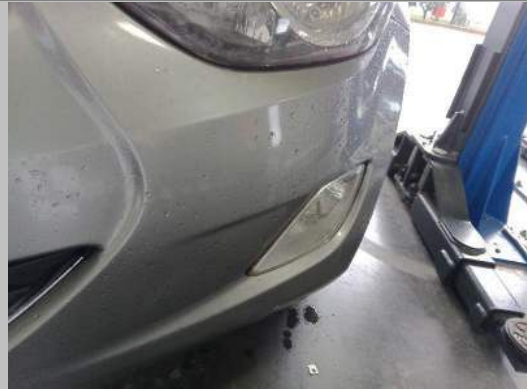
| Damage | Repair Way |
|---|---|
| Fog Light Front Left Defective | Repair |

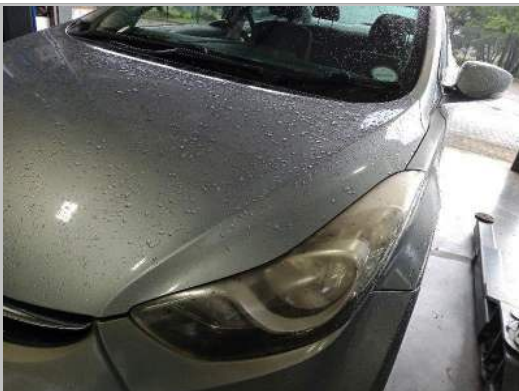
| Damage | Repair Way |
|---|---|
| Headlight Left Defective | Repair |

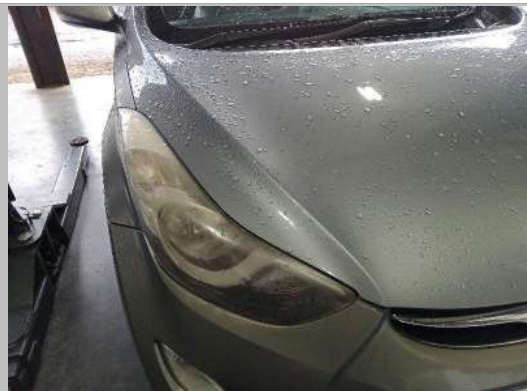
| Damage | Repair Way |
|---|---|
| Headlight Right Defective | Repair |

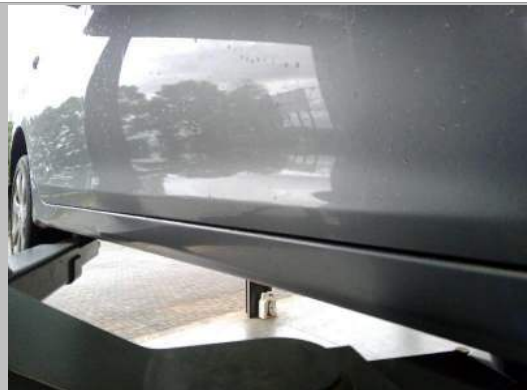
| Damage | Repair Way |
|---|---|
| Sill Panel Right Damaged | Repair |

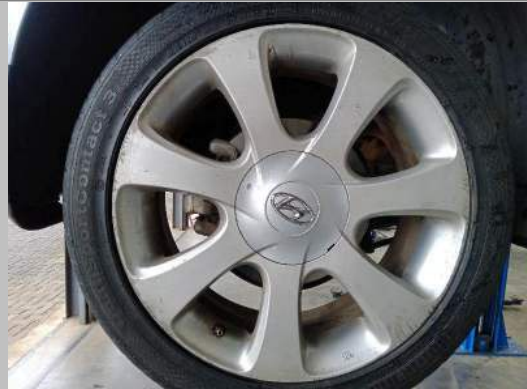
| Damage | Repair Way |
|---|---|
| Rim Rear Right Scratched | Repair |

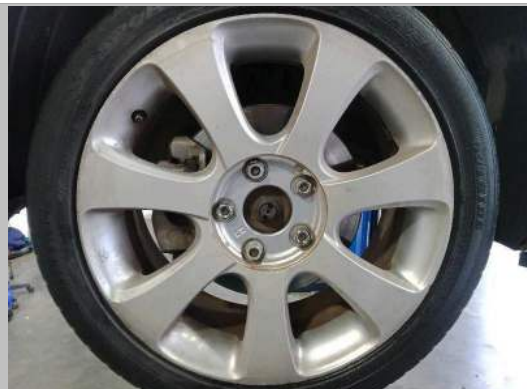
| Damage | Repair Way |
|---|---|
| Rim Front Left Scratched | Repair |

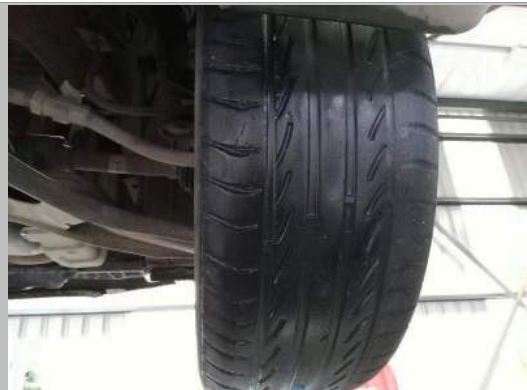
| Damage | Repair Way |
|---|---|
| Tyre Front Right Damaged | Replace |

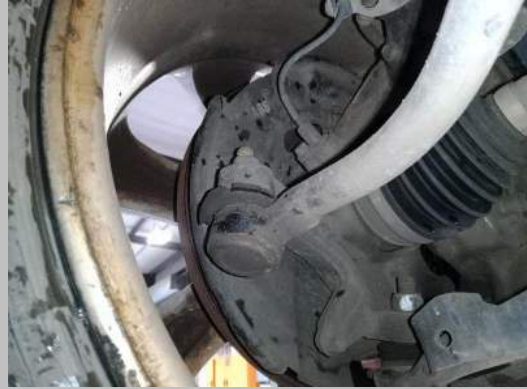
| Damage | Repair Way |
|---|---|
| Tie Rod End left Damaged | Replace |

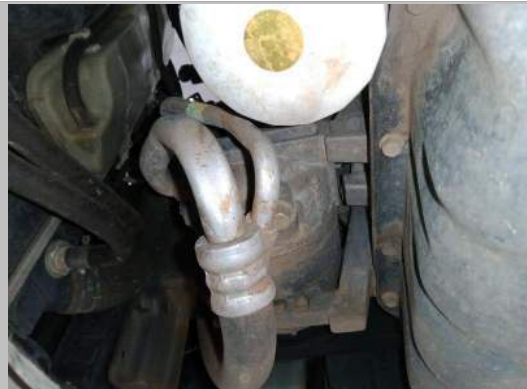
| Damage | Repair Way |
|---|---|
| Air conditioner pipes Defective | Repair |

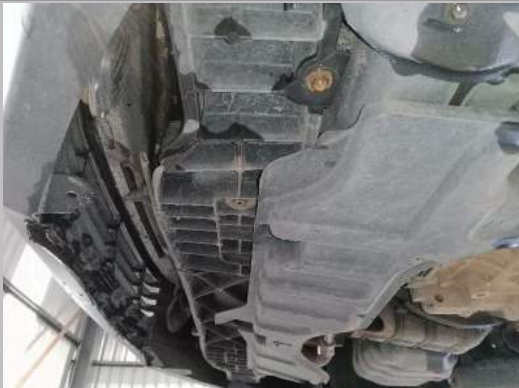
| Damage | Repair Way |
|---|---|
| Radiator Cradle Damaged | Replace |

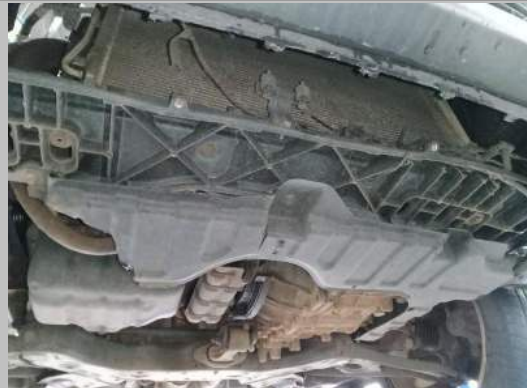
| Damage | Repair Way |
|---|---|
| Belly plates Damaged | Replace |

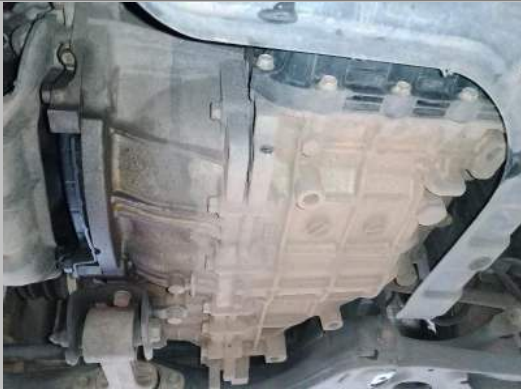
| Damage | Repair Way |
|---|---|
| Gearbox Oil Sweat | Repair |

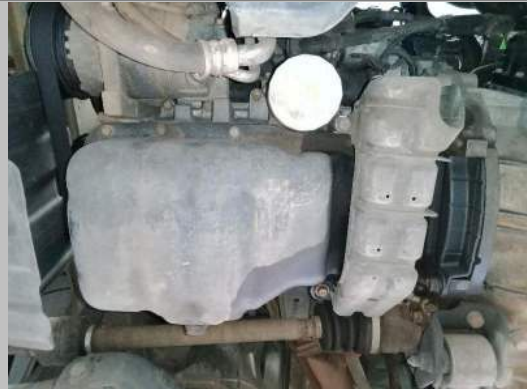
| Damage | Repair Way |
|---|---|
| Engine Oil Leak | Repair |

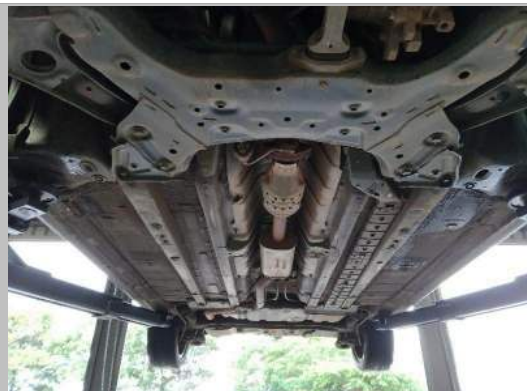
| Damage | Repair Way |
|---|---|
| Chassis Damaged | Repair |

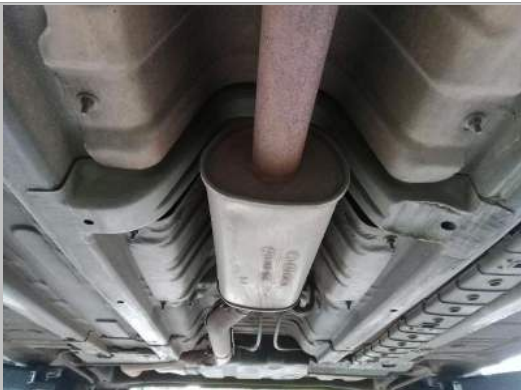
| Damage | Repair Way |
|---|---|
| Silencer Damaged | Replace |

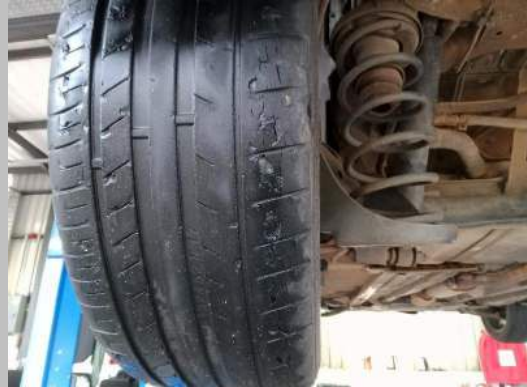
| Damage | Repair Way |
|---|---|
| Tyre Rear Left Damaged | Replace |

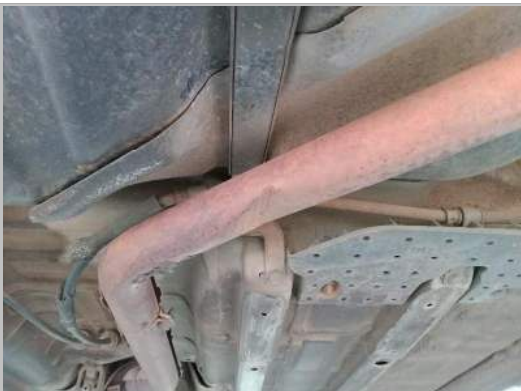
| Damage | Repair Way |
|---|---|
| Engine to silencer pipe Damaged | Repair |

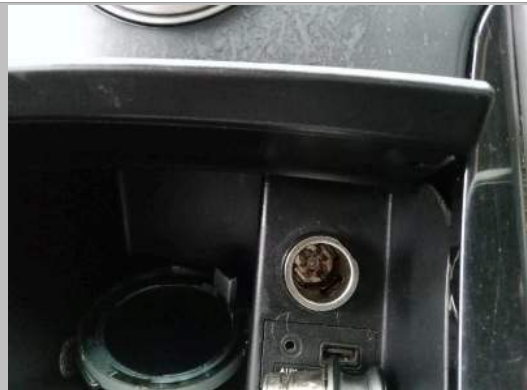
| Damage | Repair Way |
|---|---|
| Cigarette Lighter Defective | Repair |

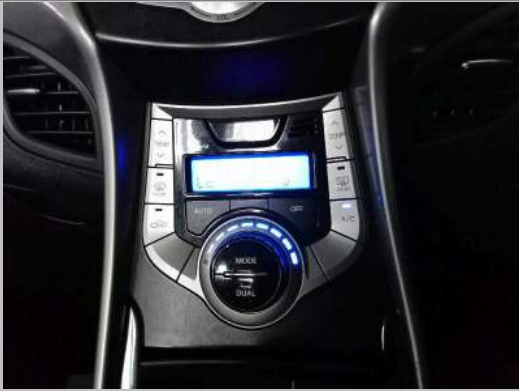
| Damage | Repair Way |
|---|---|
| Air Conditioner Insufficient | Replace |
