MFC Auction House  
M57 Pretoria Rd, Glenmarais, KEMPTON PARK  
Gauteng

DEKRA MFC  
M57 Pretoria Rd - 1619  
KEMPTON PARK - GT  
08610 33572

## Assignment

## VEHICLE INSPECTION

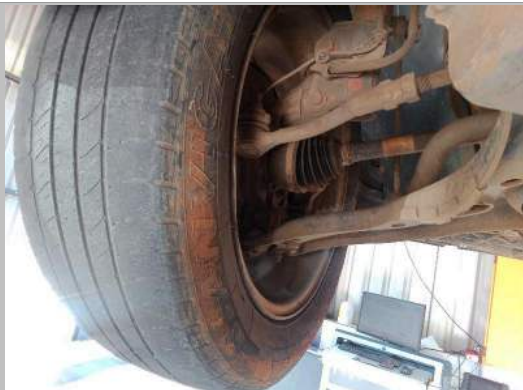
LF TYRE TREAD

| Damage | Repair Way |
|---|---|
| Tyre Front Left Smooth | Replace |

| | Size | Load/Speed Index | Manufacture | Model | Type* | Production Date | Tread Depth (mm) |
|---|---|---|---|---|---|---|---|
| Front Left | 215/60R17 | 96H | Lanvigator | Performance | V | 0221 | 0 mm |

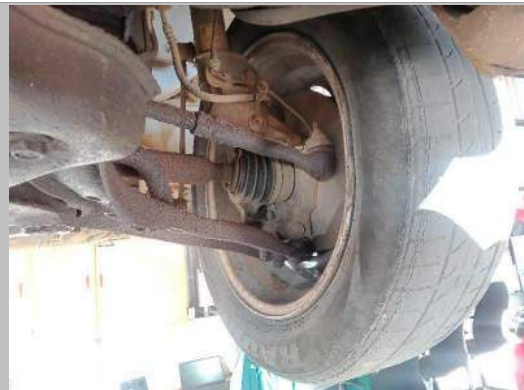
RF TYRE TREAD

| Damage | Repair Way |
|---|---|
| Tyre Front Right Smooth | Replace |

| | Size | Load/Speed Index | Manufacture | Model | Type* | Production Date | Tread Depth (mm) |
|---|---|---|---|---|---|---|---|
| Front Right | 215/60R17 | 100H | Radar | RPax | V | 3221 | 0 mm |

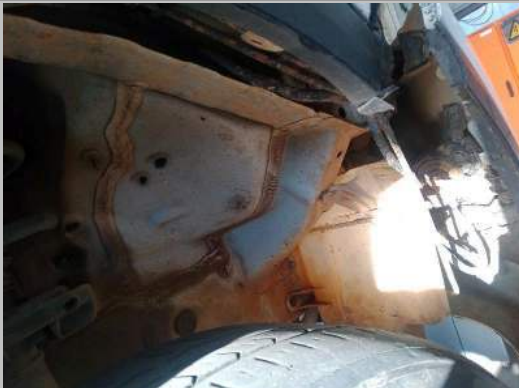
R/F fender liner missing

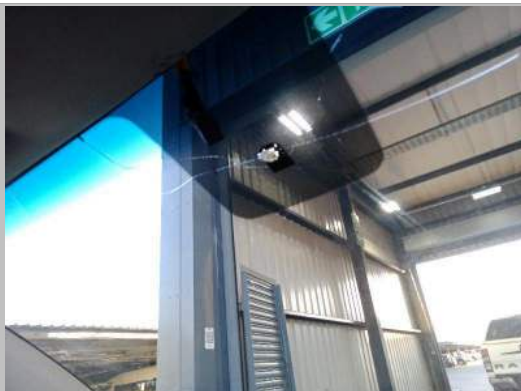
| Damage | Repair Way |
|---|---|
| Interior Mirror Missing | Replace |

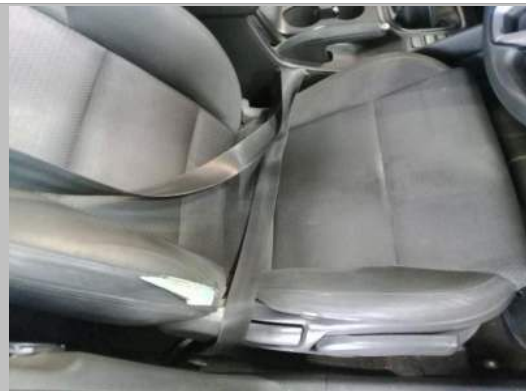
| Damage | Repair Way |
|---|---|
| Seat Front Right Torn / Cut | Repair |

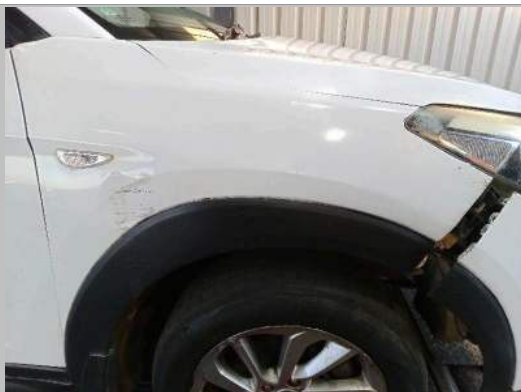
| Damage | Repair Way |
|---|---|
| Front Fender Right Damaged | Repair |

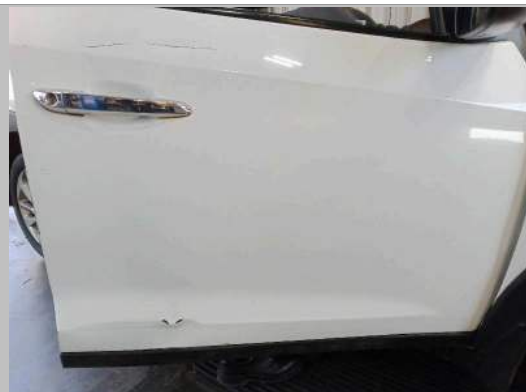
| Damage | Repair Way |
|---|---|
| Door Front Right Damaged | Repair |

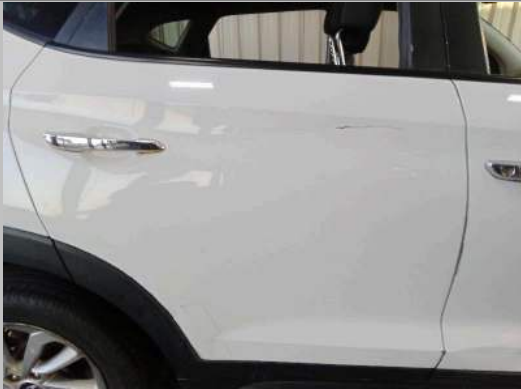
| Damage | Repair Way |
|---|---|
| Door Rear Right Damaged | Repair |

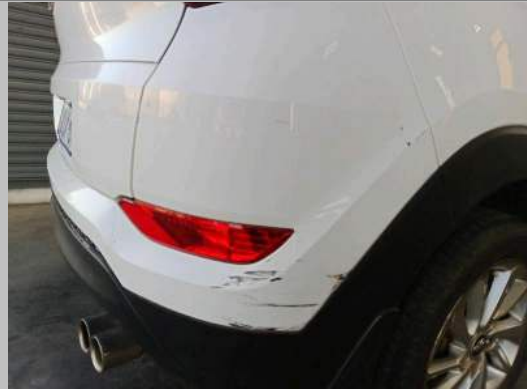
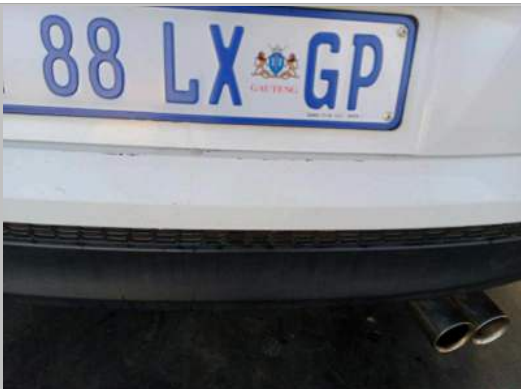
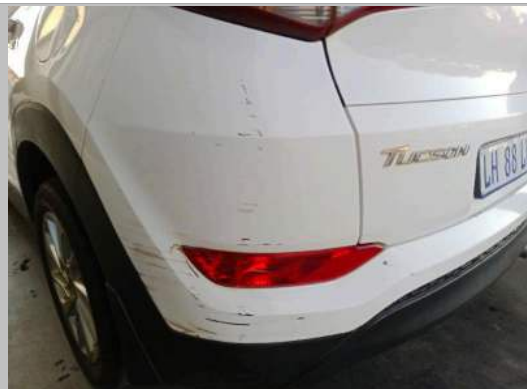
| Damage | Repair Way |
|---|---|
| Rear bumper Damaged | Repair |

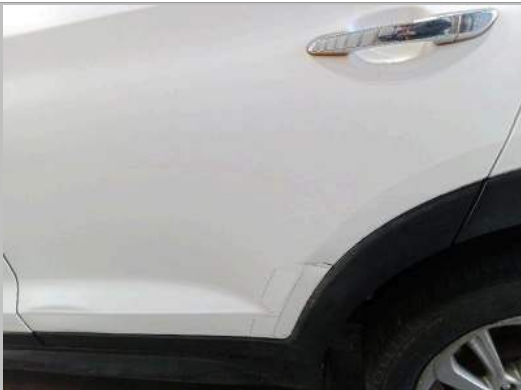
| Damage | Repair Way |
|---|---|
| Door Rear Left Damaged | Repair |

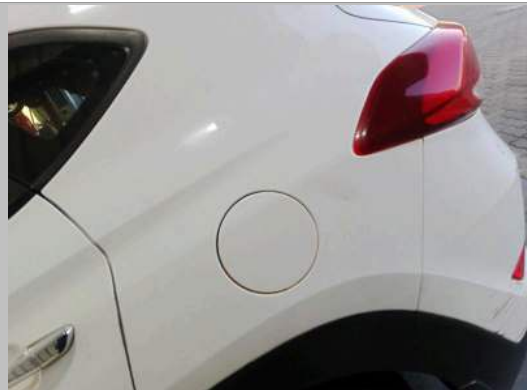
| Damage | Repair Way |
|---|---|
| Rear Fender Left Dented | Repair |

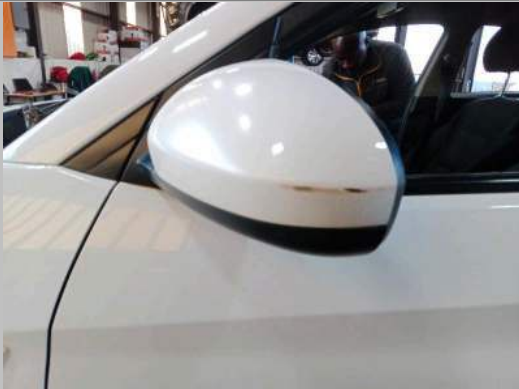
| Damage | Repair Way |
|---|---|
| Side Mirror Left Paintwork • Scratched | Repair |

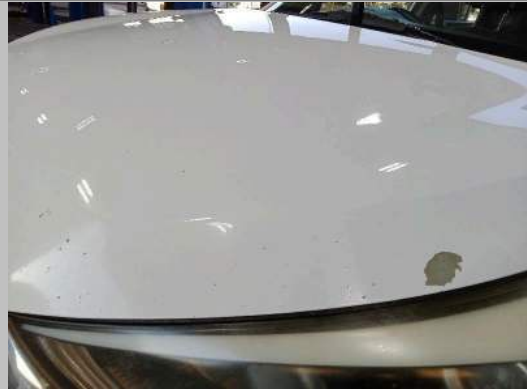
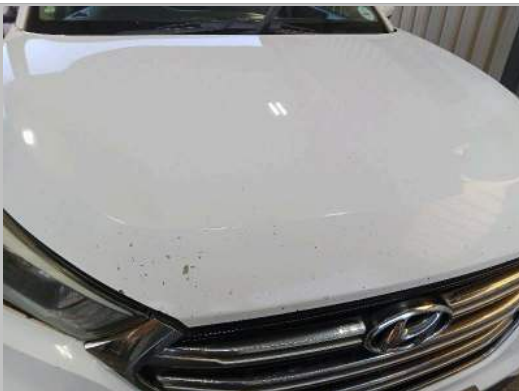
| Damage | Repair Way |
|---|---|
| Bonnet Paintwork • Flaking | Repair |

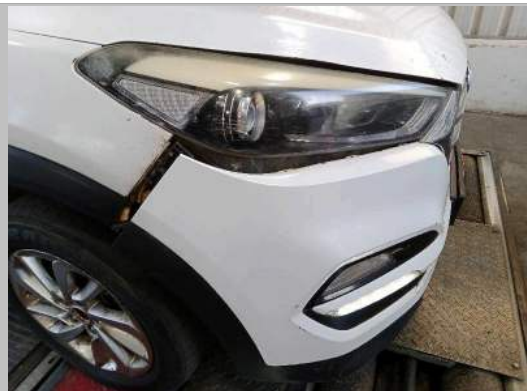
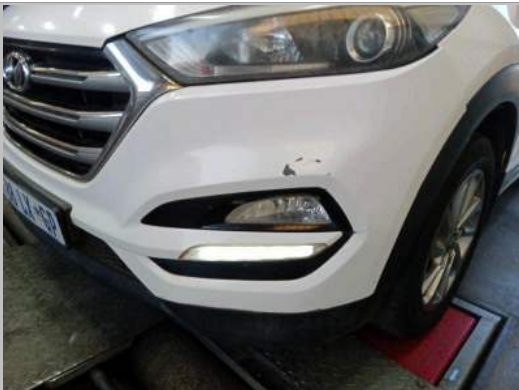
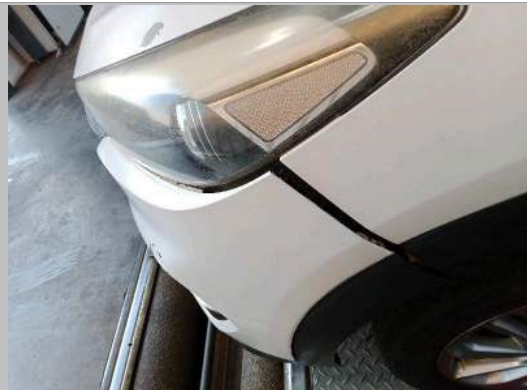
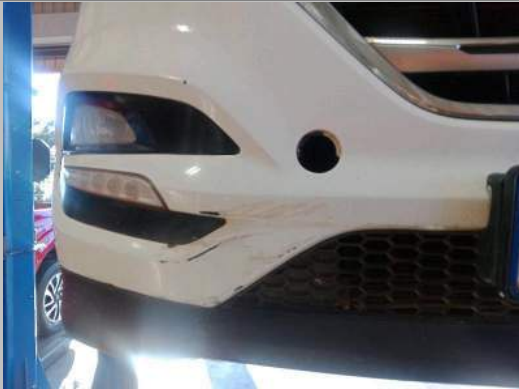
| Damage | Repair Way |
|---|---|
| Front Bumper Damaged | Repair |

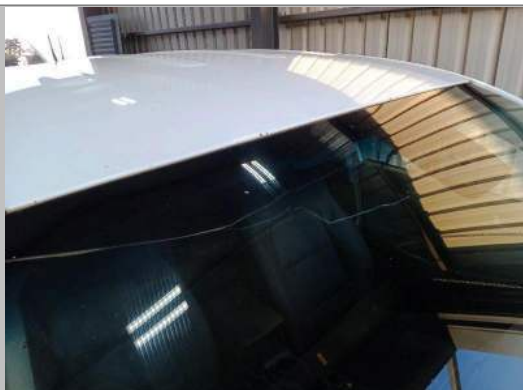
| Damage | Repair Way |
|---|---|
| Windscreen Cracked | Replace |

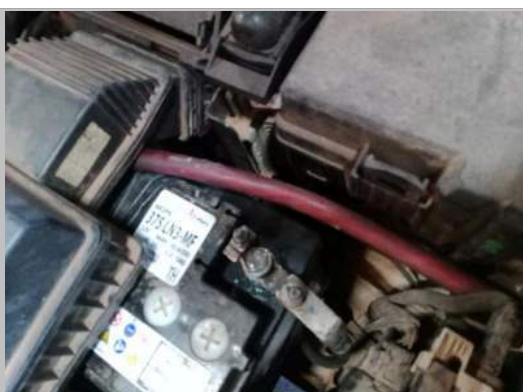
| Damage | Repair Way |
|---|---|
| Engine Wiring Defective | Repair |

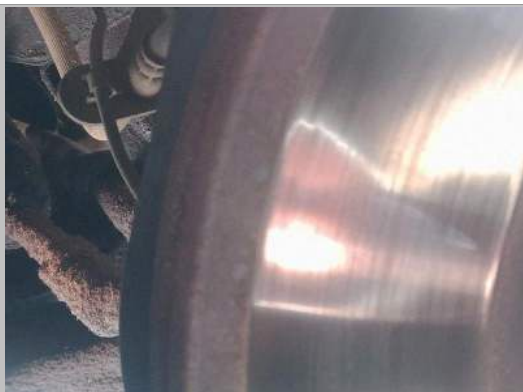
| Damage | Repair Way |
|---|---|
| Brake disc 1. Axle right Worn | Replace |

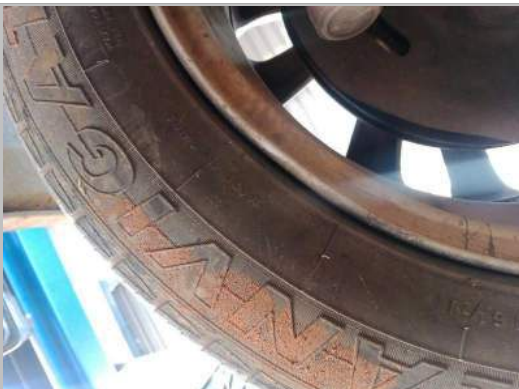
| Damage | Repair Way |
|---|---|
| Rim Front Left Dented | Repair |

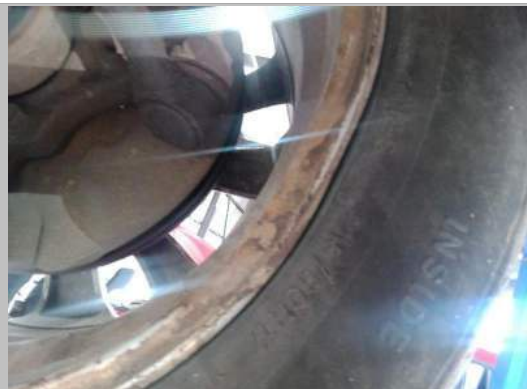
| Damage | Repair Way |
|---|---|
| Rim Front Right Dented | Repair |

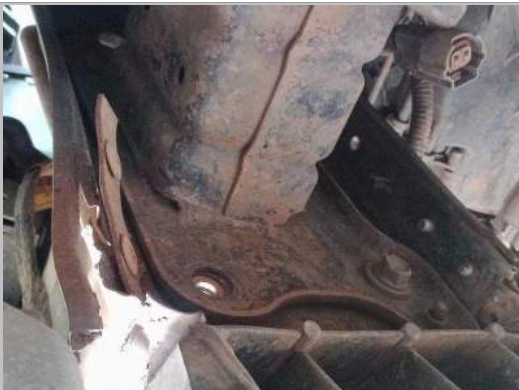
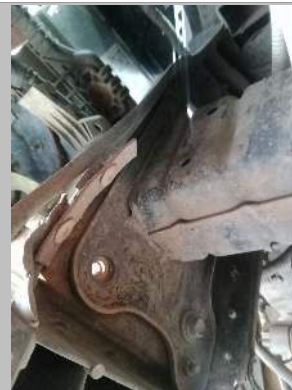
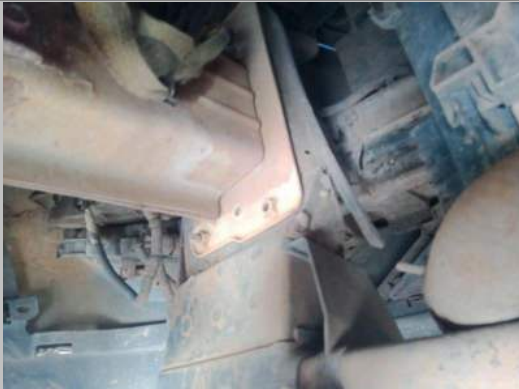
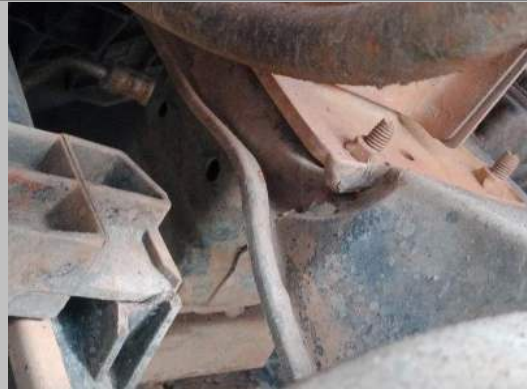
| Damage | Repair Way |
|---|---|
| Radiator Cradle Damaged | Replace |

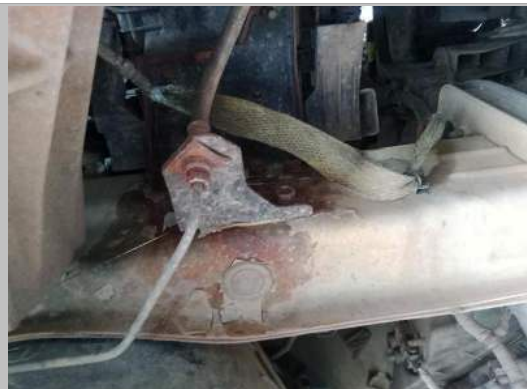
| Damage | Repair Way |
|---|---|
| Main Beam Left Damaged | Repair |

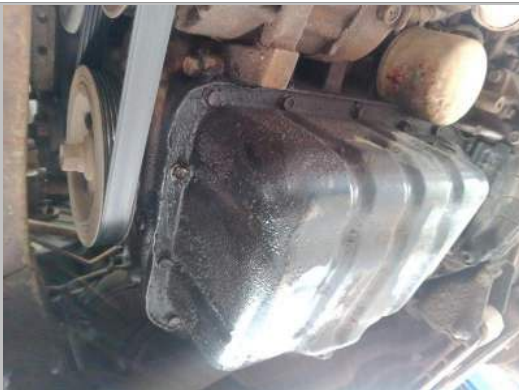
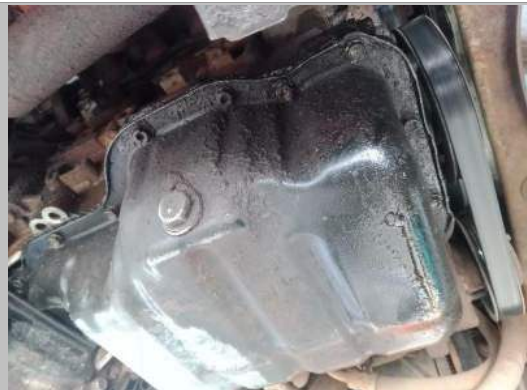
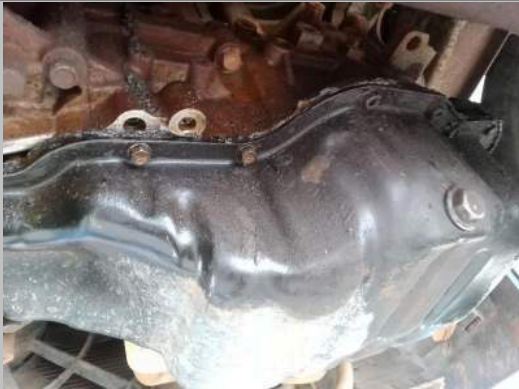
| Damage | Repair Way |
|---|---|
| Engine Oil Leak | Repair |

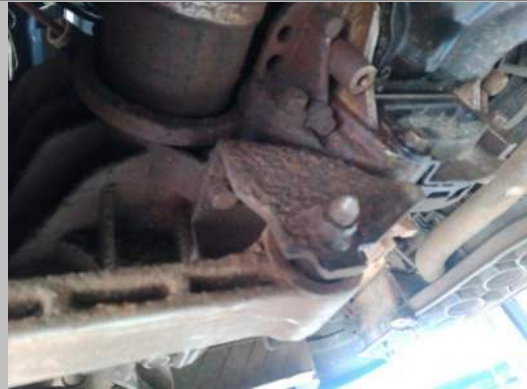
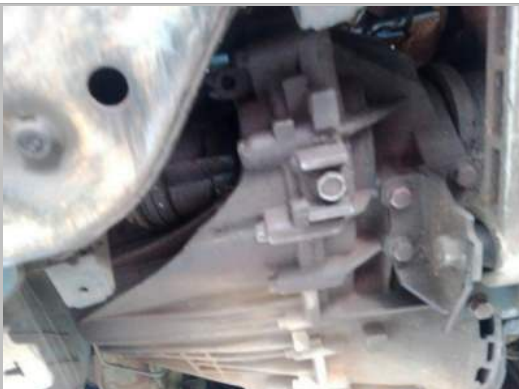
| Damage | Repair Way |
|---|---|
| Gearbox Oil Leak | Repair |

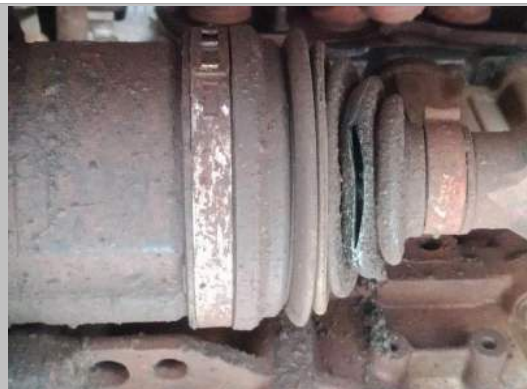
| Damage | Repair Way |
|---|---|
| CV Joint(s) Boot(s) Front Right (inner/outer) Damaged | Replace |

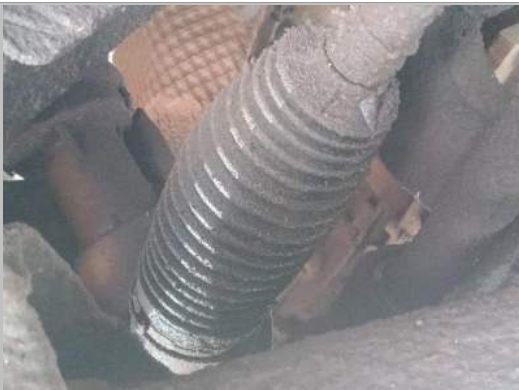
| Damage | Repair Way |
|---|---|
| Steering Rack Boot Right Leak | Replace |

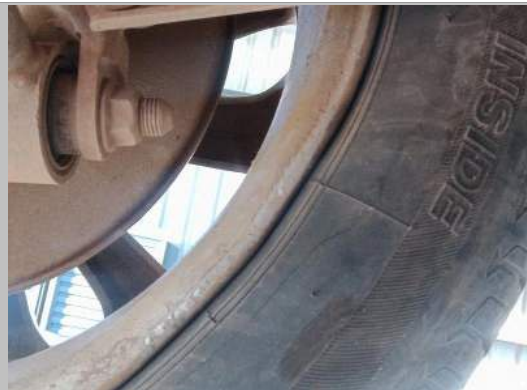
| Damage | Repair Way |
|---|---|
| Rim Rear Left Dented | Repair |

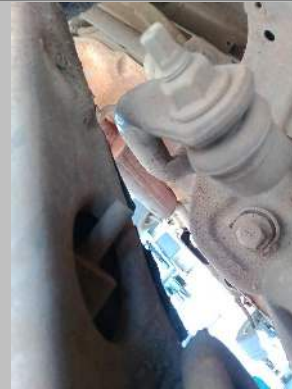
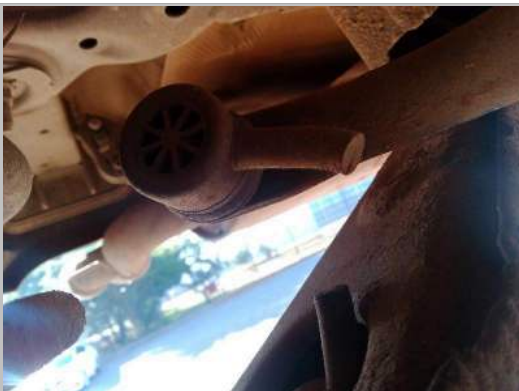
| Damage | Repair Way |
|---|---|
| Stabilizer Mounting Rear Right Damaged | Replace |

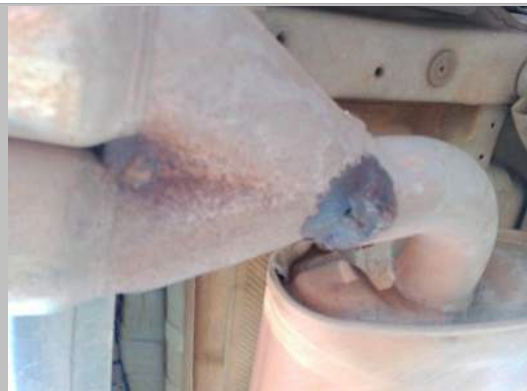
| Damage | Repair Way |
|---|---|
| Engine to silencer pipe Leak | Replace |

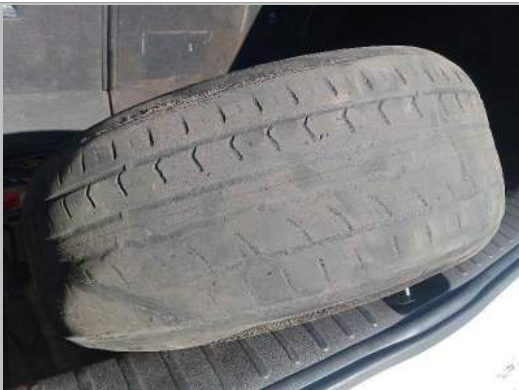
| Damage | Repair Way |
|---|---|
| Spare Tyre Smooth | Replace |

| | Size | Load/Speed Index | Manufacture | Model | Type* | Production Date | Tread Depth (mm) |
|---|---|---|---|---|---|---|---|
| Spare | 215/60R17 | 100H | Radar | RPX | V | /////// | 0 mm |

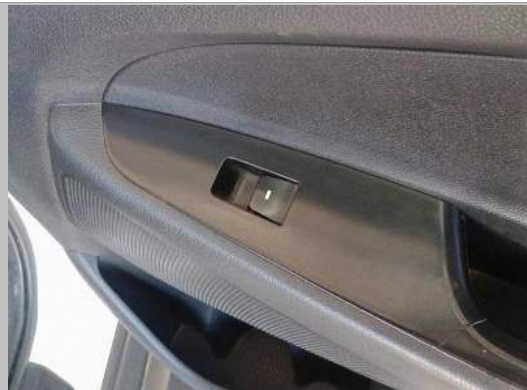
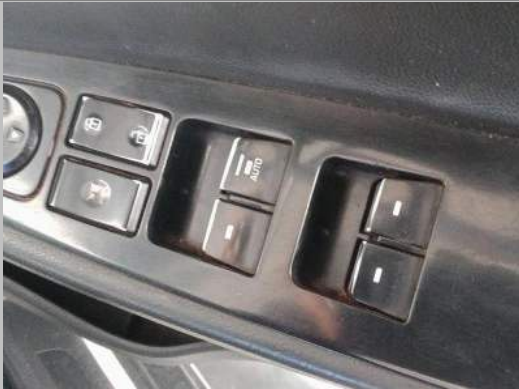
| Damage | Repair Way |
|---|---|
| Switch Electrical Window Winder rear right Defective | Repair |
