MFC Auction House
M57 Pretoria Rd, Glenmarais, KEMPTON PARK
Gauteng

DEKRA MFC
M57 Pretoria Rd - 1619
KEMPTON PARK - GT
08610 33572

VEHICLE INSPECTION

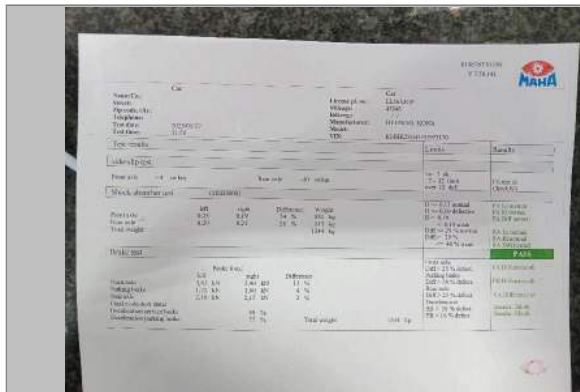
Shock and brake report

Left	Right		
	Braking Force [KN]	Braking Force [KN]	Axle Weight [KG]	Deceleration [m/s ²]
Front	3.8	3.4	-	
Rear	2.1	2.1	-	
Emergency / Parking	1.7	1.8	-

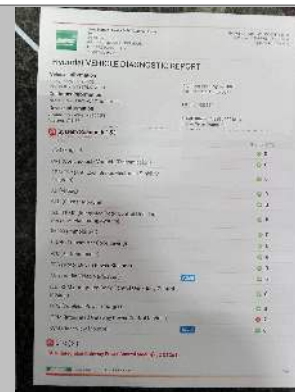
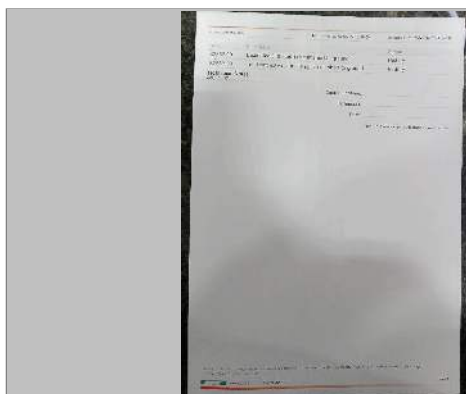
Diagnostic test

No	System	Code	Description	Status
1	IGPM	B2352:00	DEDICATED DRL LEFT CIRCUIT SHORT TO GROUND

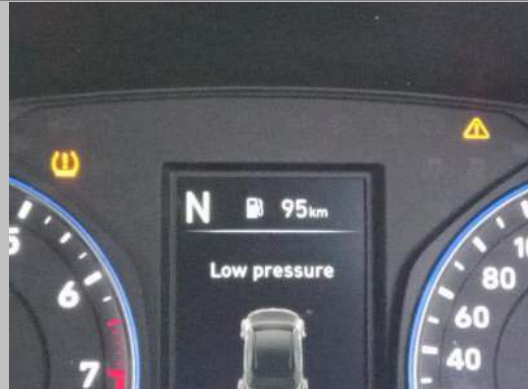
Warning lights illuminated

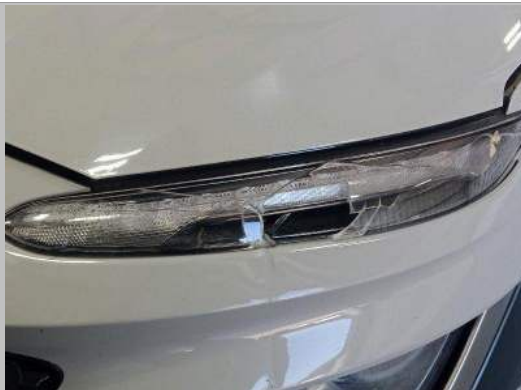
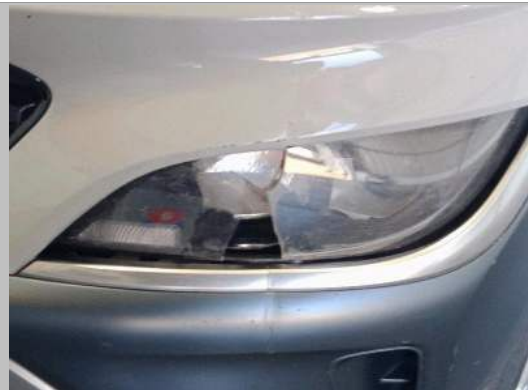
Headlight Left Damaged
Tyre Front Left Torn / Cut
Tyre Front Right Excessive Wear & Tear
Some body panels misaligned
Warning lights illuminated

Headlight Left

Repair
Replace
Replace
Repair
Repair

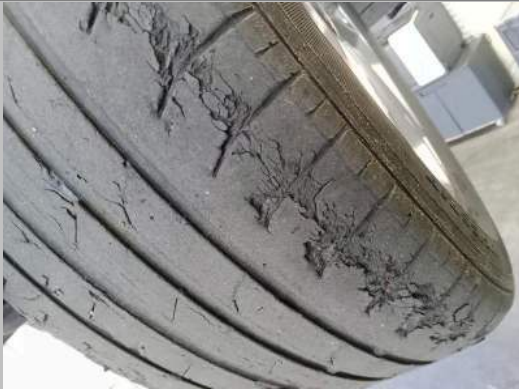
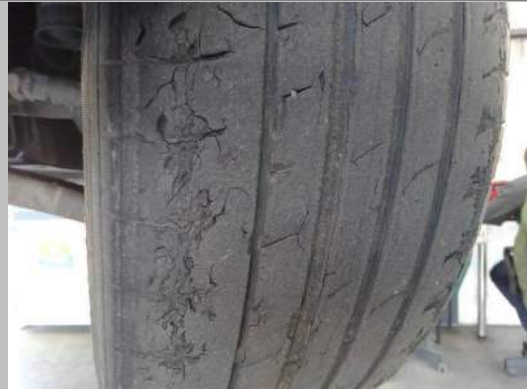
Tyre Front Right

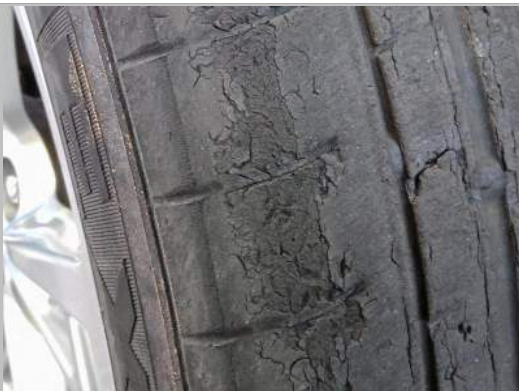
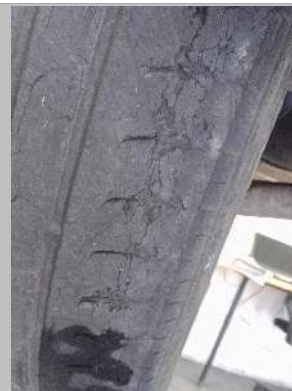
Tyre Front Left
