MFC Auction House  
M57 Pretoria Rd, Glenmarais, KEMPTON PARK  
Gauteng

| Vehicle Type | MINI BUS | Registered Owner | MFC |

## CONDITION REPORT

Report No: 201623809

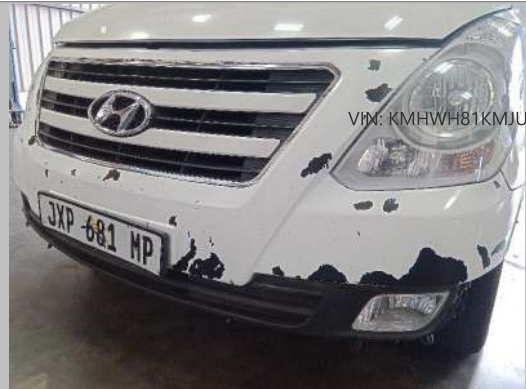
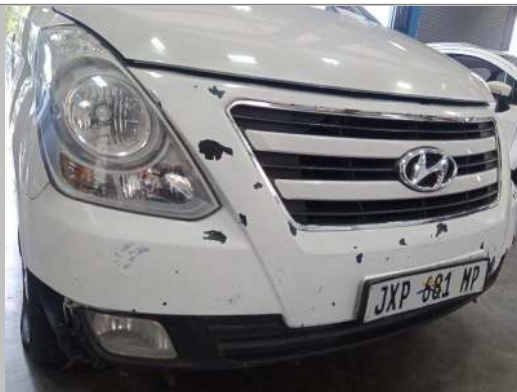
| | Damage | Repair Way |
|---|---|---|
| | Front Bumper Damaged | Replace |

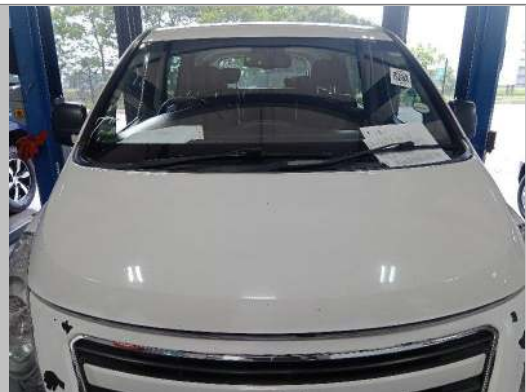
| | Damage | Repair Way |
|---|---|---|
| | Bonnet Paintwork • Chipmarks | Repair |

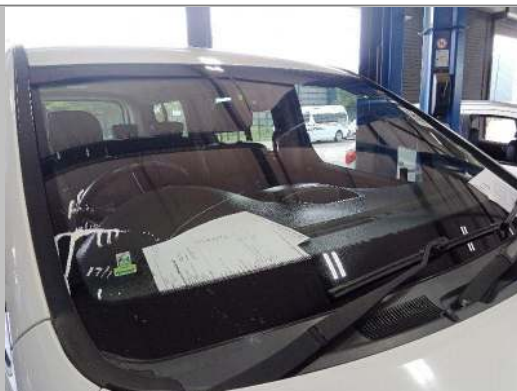
| Damage | Repair Way |
|---|---|
| Windscreen Cracked | Replace |

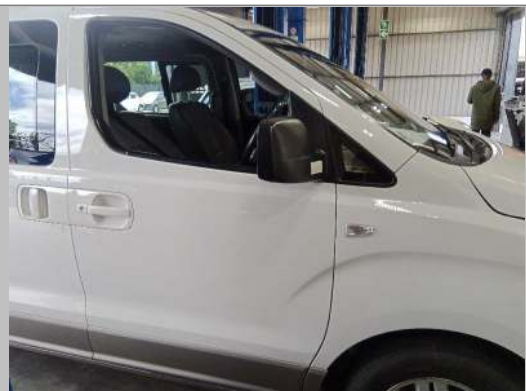
| | Damage | Repair Way |
|---|---|---|
| | Door Front Right Paintwork • Scratched | Repair |

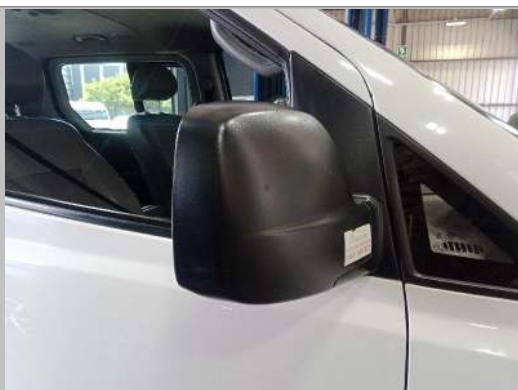
| | Damage | Repair Way |
|---|---|---|
| | Side Mirror Right Paintwork • Scratched | Repair |

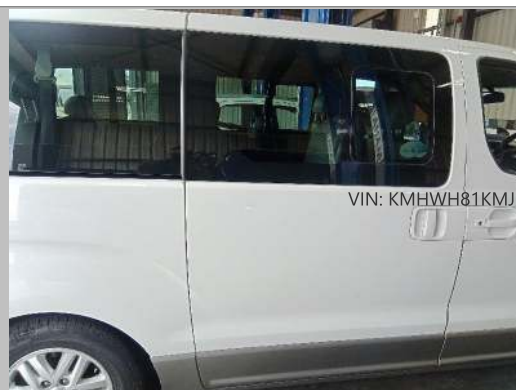
| | Damage | Repair Way |
|---|---|---|
| | Door Rear Right Dented | Repair |

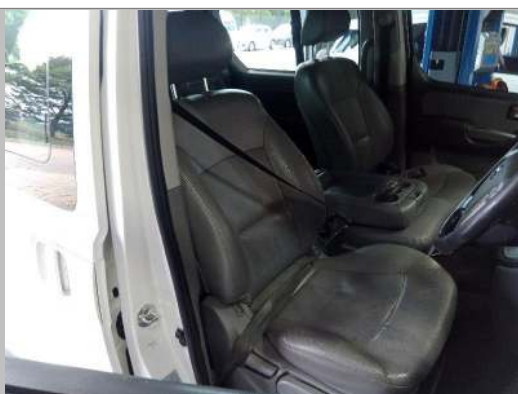
| | Damage | Repair Way |
|---|---|---|
| | Seat Front Right Damaged | Repair |

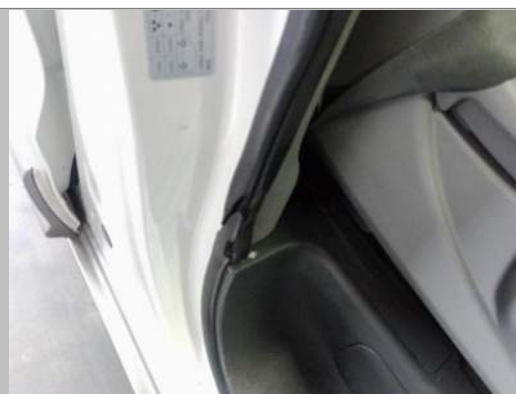
| | Damage | Repair Way |
|---|---|---|
| | Door Sealing Rubber Front Right Damaged | Replace |

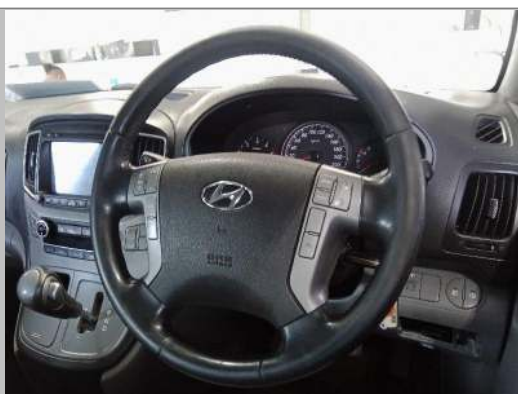
| | Damage | Repair Way |
|---|---|---|
| | Steering Wheel Trim Defective | Repair |

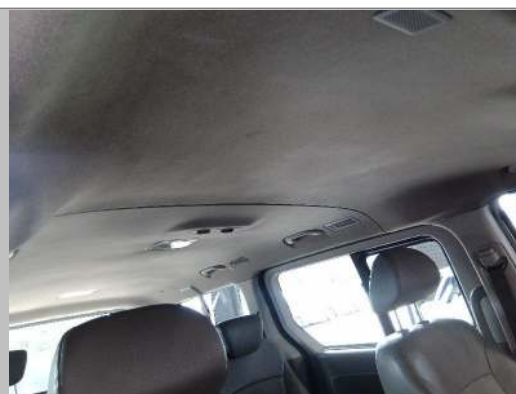
| | Damage | Repair Way |
|---|---|---|
| | Hood Lining Defective | Repair |

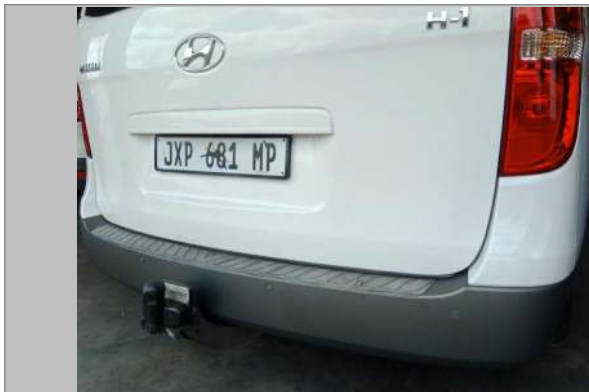
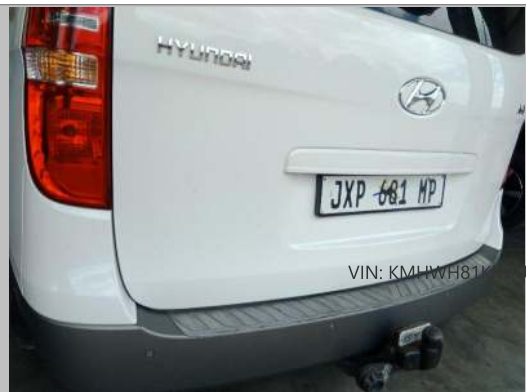
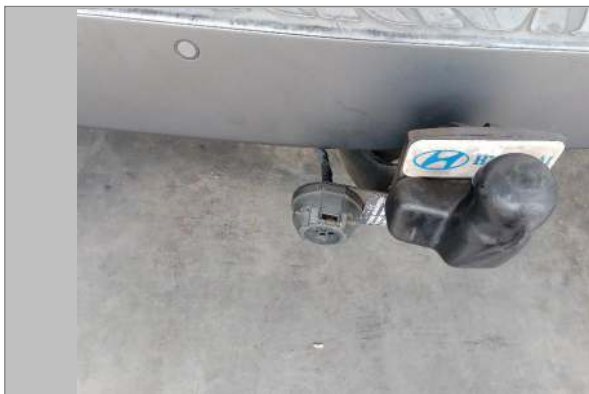
| | Damage | Repair Way |
|---|---|---|
| | Rear bumper Paintwork • Scratched | Repair |

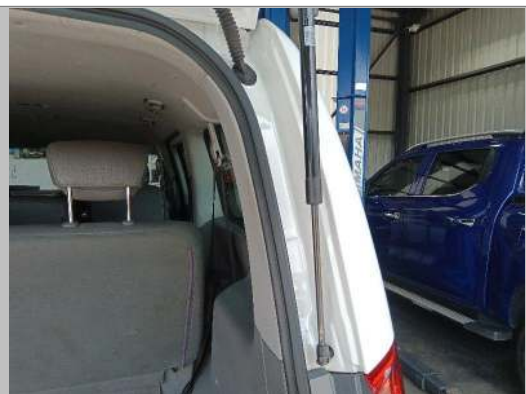
| | Damage | Repair Way |
|---|---|---|
| | C • Pillar Right Residual Traces of Repair | Repair |

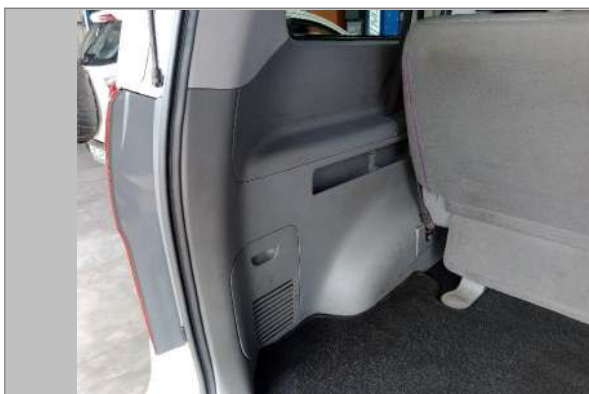
| | Damage | Repair Way |
|---|---|---|
| | Boot Panel Left Defective | Repair |

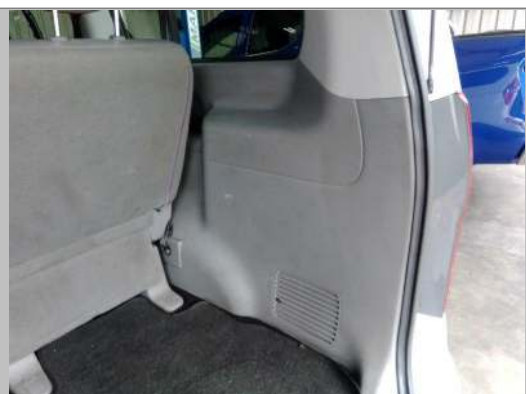
| | Damage | Repair Way |
|---|---|---|
| | Boot Panel Right Defective | Repair |

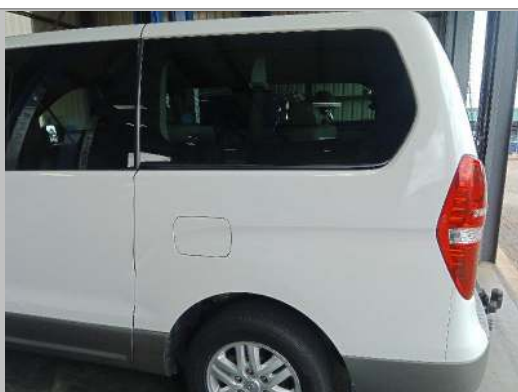
| | Damage | Repair Way |
|---|---|---|
| | Rear Fender Left Residual Traces of Repair | Repair |

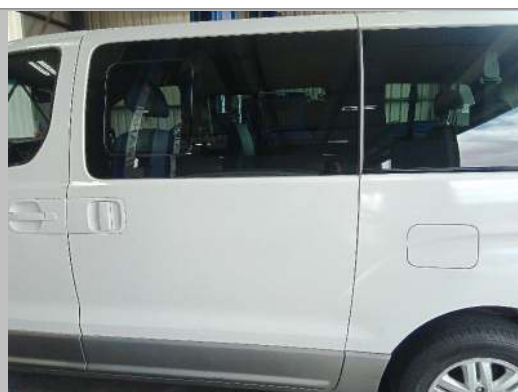
| | Damage | Repair Way |
|---|---|---|
| | Door Rear Left Residual Traces of Repair | Repair |

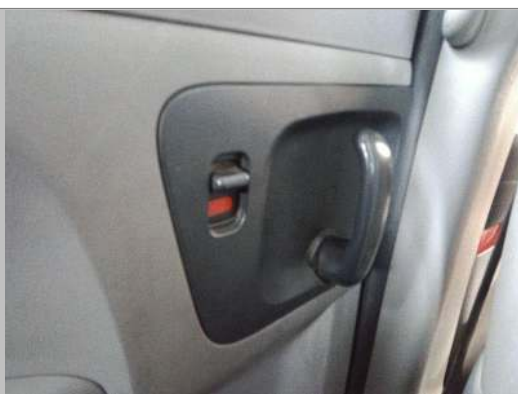
| | Damage | Repair Way |
|---|---|---|
| | Door Handle Rear Left Damaged | Replace |

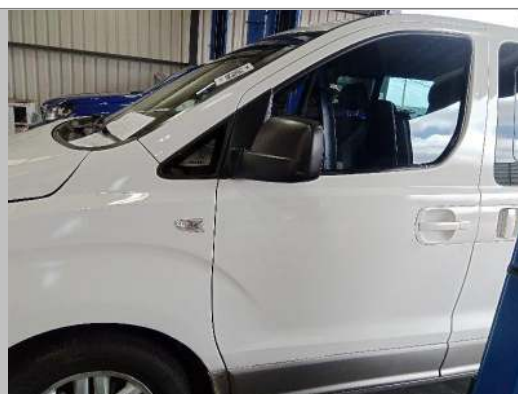
| | Damage | Repair Way |
|---|---|---|
| | Door Front Left Residual Traces of Repair | Repair |

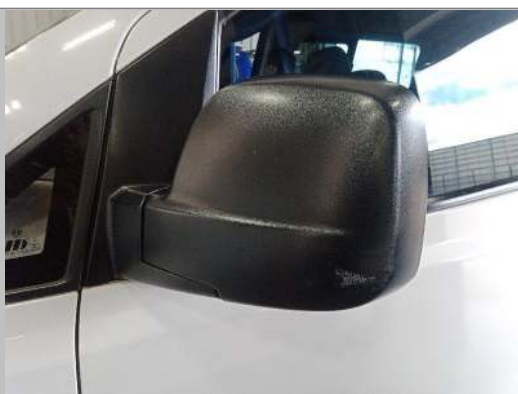
| | Damage | Repair Way |
|---|---|---|
| | Side Mirror Left Paintwork • Scratched | Repair |

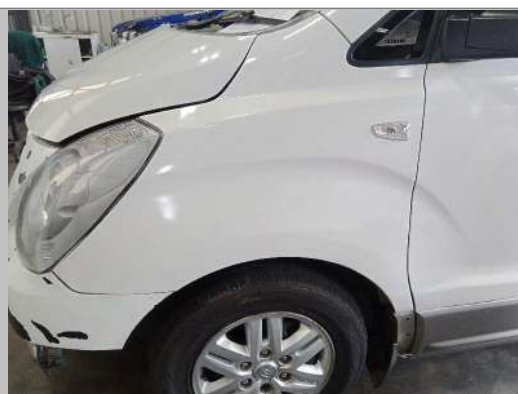
| | Damage | Repair Way |
|---|---|---|
| | Front Fender Left Damaged | Repair |

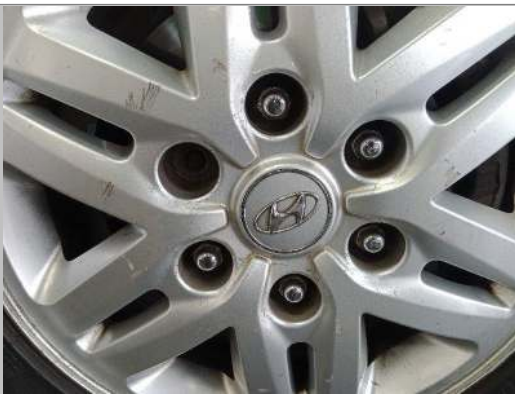
| Damage | Repair Way |
|---|---|
| Bolt(s) / Nut(s) Front Wheel Left Missing | Replace |

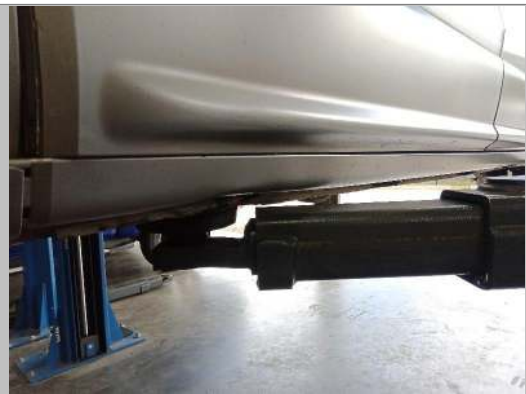
| | Damage | Repair Way |
|---|---|---|
| | Rocker Panel Left Dented | Repair |

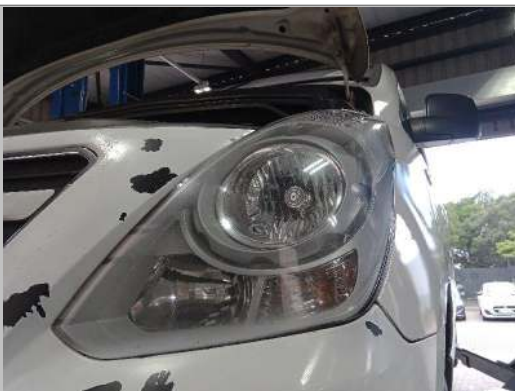
| | Damage | Repair Way |
|---|---|---|
| | Headlight Left Defective | Replace |

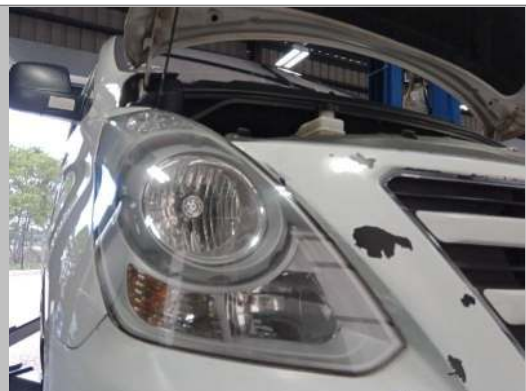
| | Damage | Repair Way |
|---|---|---|
| | Headlight Right Defective | Repair |

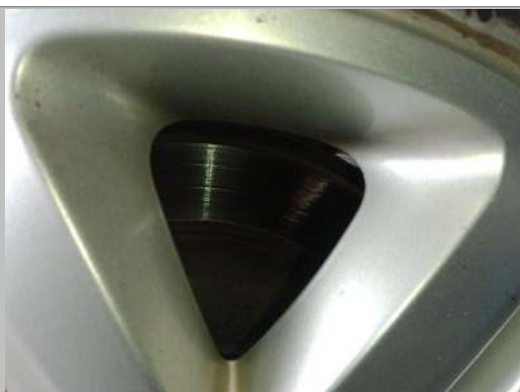
| Damage | Repair Way |
|---|---|
| Brake disc 2. Axle right Defective | Replace |

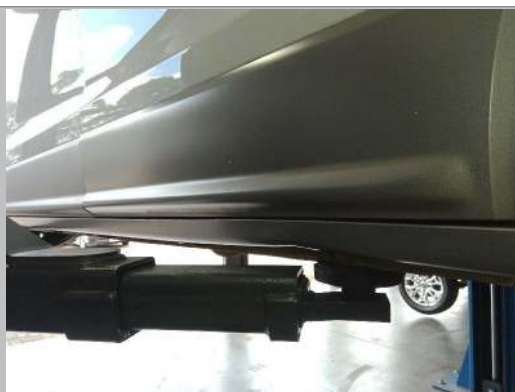
| | Damage | Repair Way |
|---|---|---|
| | Rocker Panel Right Dented | Repair |

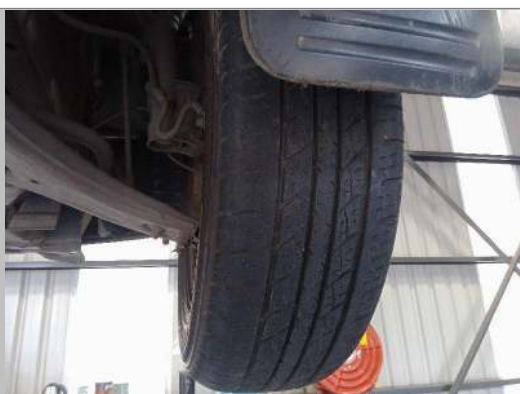
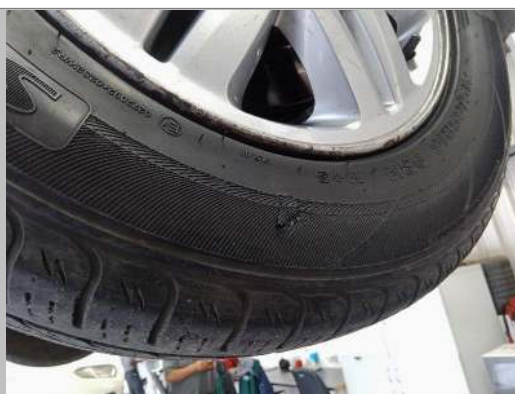
| Damage | Repair Way |
|---|---|
| Tyre Front Right Worn | Replace |

| | Size | Load/Speed Index | Manufacture | Model | Type* | Production Date | Tread Depth (mm) |
|---|---|---|---|---|---|---|---|
| Front Right | 215/65 R16 | 98H | Westlake | SU318 | V | 3521 | 0 mm |

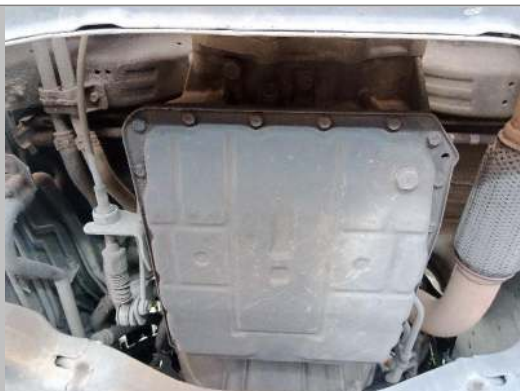
| Damage | Repair Way |
|---|---|
| Gearbox Oil Sweat | Repair |

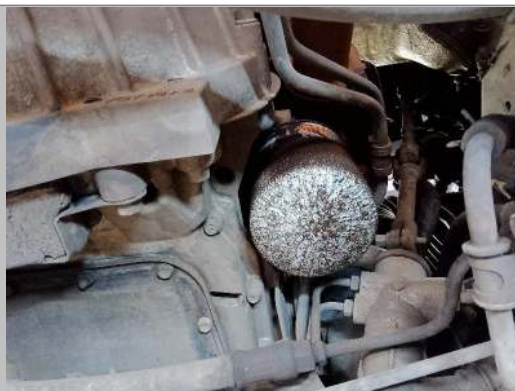
| | Damage | Repair Way |
|---|---|---|
| | Engine Oil Sweat | Repair |

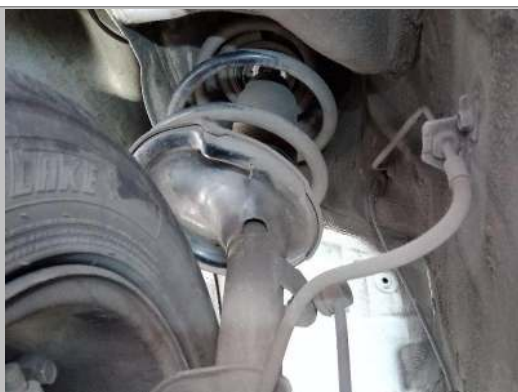
| Damage | Repair Way |
|---|---|
| Shock Absorber Front Left Sweat | Replace |

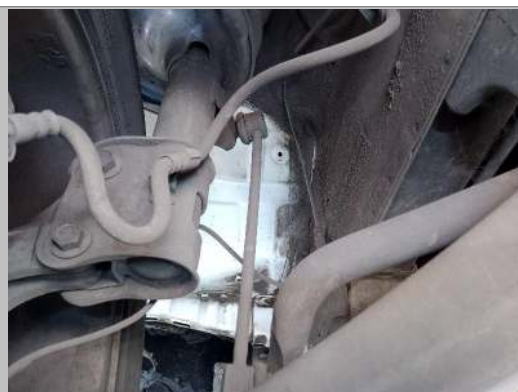
| Damage | Repair Way |
|---|---|
| Stabilizer Mounting Front Left Defective | Replace |

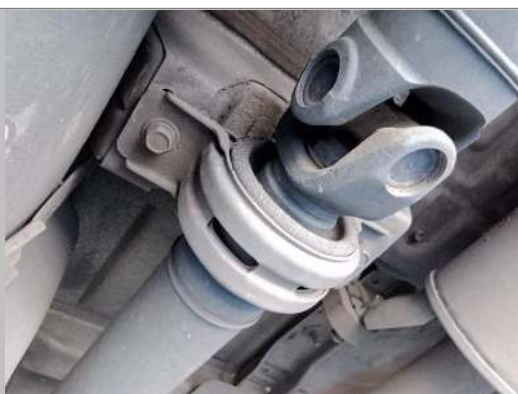
| Damage | Repair Way |
|---|---|
| Center Prop Shaft Rubber(s) Cracked | Replace |

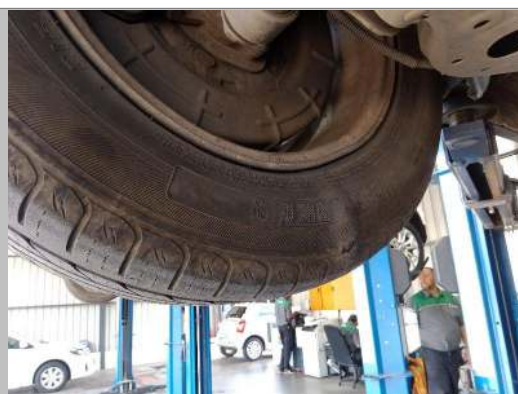
| Damage | Repair Way |
|---|---|
| Tyre Rear Left Damaged | Replace |

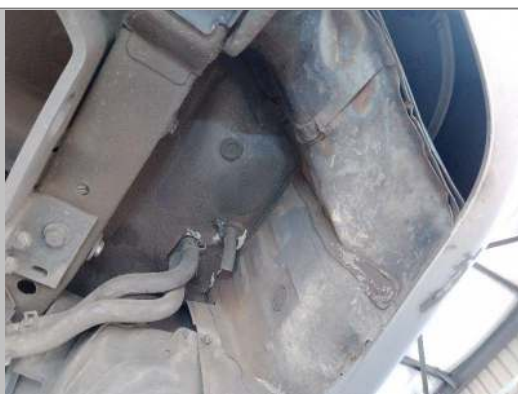
| | Damage | Repair Way |
|---|---|---|
| | Rear Fender Right / Inner Tray Dented | Repair |

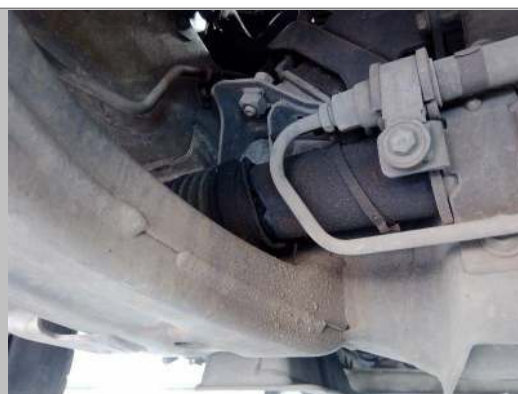
| Damage | Repair Way |
|---|---|
| Steering Rack Boot Left Damaged | Replace |

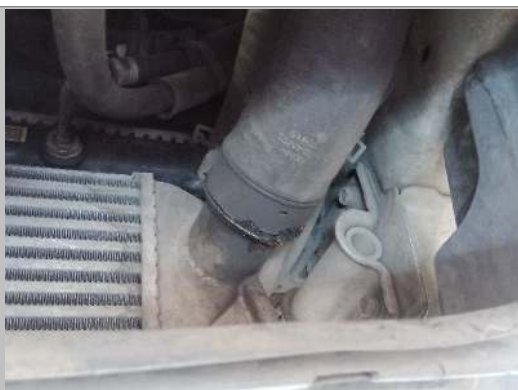
| | Damage | Repair Way |
|---|---|---|
| | Hoses Oil Leak | Repair |

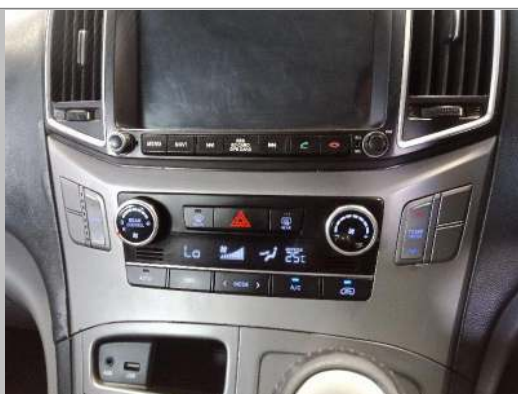
| | Damage | Repair Way |
|---|---|---|
| | Air Conditioner Insufficient | Replace |

| No | System | Code | Description | Status |
|---|---|---|---|---|
| 1 | ENG(ENGINE) | P0532 | A/C REFRIGERATOR PRESSURE SENSOR'A' CIRCUIT INPUT | |

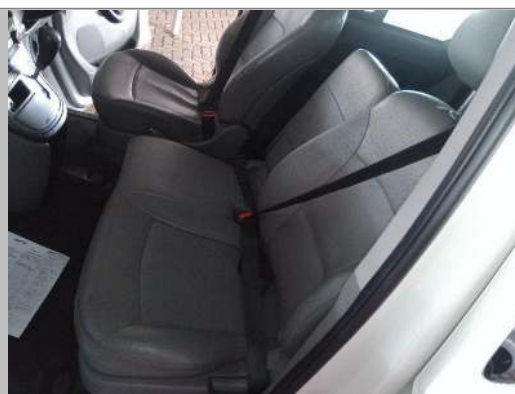
| | Damage | Repair Way |
|---|---|---|
| | Seat Front Left Defective | Repair |

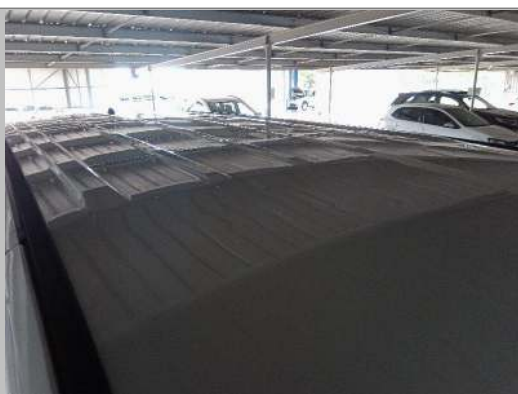
| Damage | Repair Way |
|---|---|
| Roof Dented | Repair |
