## CONDITION REPORT

Report No: 2016828308

| Manufacturer | HYUNDAI | Registration Number | KDJ061MP |
| Model | H-1 2.4 GLS 9-S BUS [2009-2016] | Register Number | |

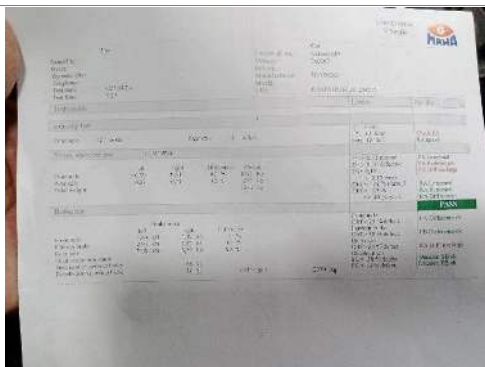
Brake test

| Damage | Repair Way |
|---|---|
| Service Brake Performance Rear Axle Left / Right | Repair |
| Difference out of legal range | |

| | Left | Right | | |
|---|---|---|---|---|
| Rear | 0.05 | 5.79 | - | |

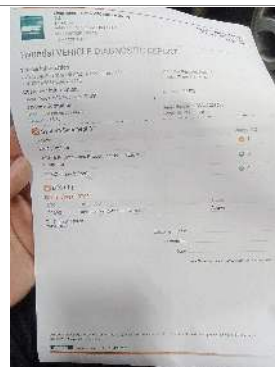
Diagnostics

| No | System | Code | Description | Status |
|---|---|---|---|---|
| 1 | ENG | P1693 | IN MOBILIZER TRANSPONDER ERROR | |

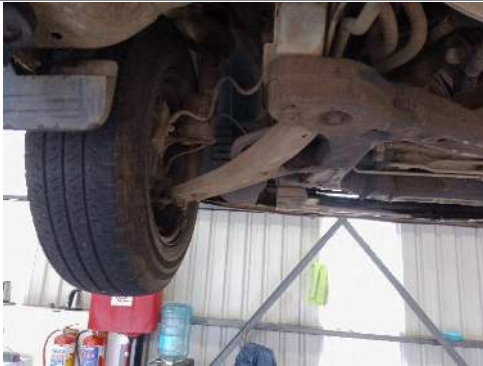
LF TYRE TREAD

| | Size | Load/Speed Index | Manufacture | Model | Type* | Production Date | Tread Depth (mm) |
|---|---|---|---|---|---|---|---|
| Front Left | 195/75R16 | 108R | Dunlop | Sp | V | 4723 | 2 mm |

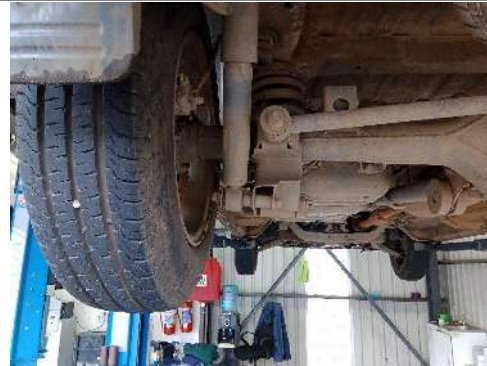
LR TYRE TREAD

| | Size | Load/Speed Index | Manufacture | Model | Type* | Production Date | Tread Depth (mm) |
|---|---|---|---|---|---|---|---|
| Rear Left | 195/75R16 | 105R | Rapid | Radial | V | 1024 | 4 mm |

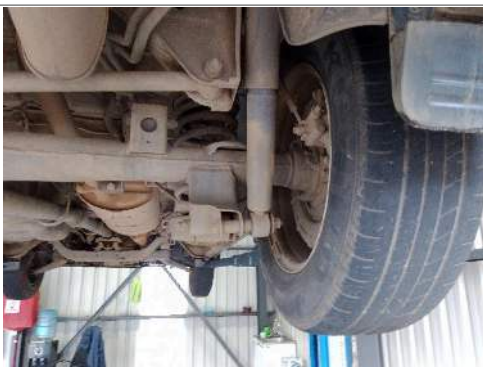
RR TYRE TREAD

| Damage | Repair Way |
|---|---|
| Rear tyres size differs | Replace |

| | Size | Load/Speed Index | Manufacture | Model | Type* | Production Date | Tread Depth (mm) |
|---|---|---|---|---|---|---|---|
| Rear Right | 215/65R16 | 98H | Kumho | Radial | V | 1709 | 1 mm |

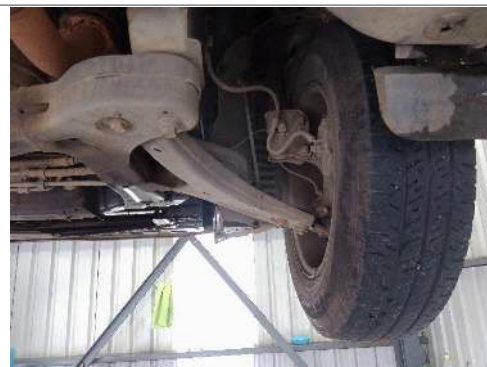
RF TYRE TREAD

| | Size | Load/Speed Index | Manufacture | Model | Type* | Production Date | Tread Depth (mm) |
|---|---|---|---|---|---|---|---|
| Front Right | 195/75R16 | 108R | Dunlop | Radial | V | 4723 | 3 mm |

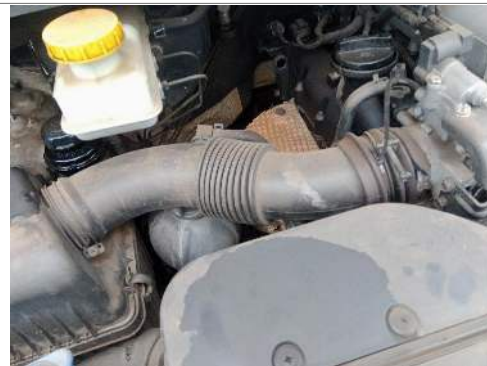
| Damage | Repair Way |
|---|---|
| Hoses Damaged | Repair |

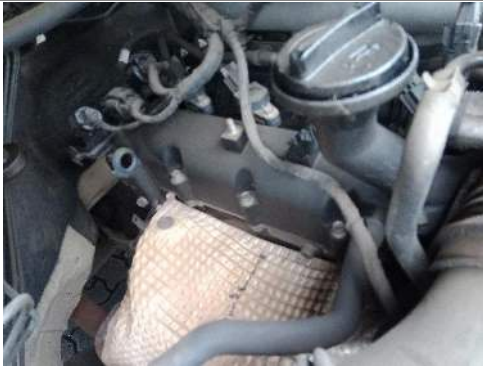
| Damage | Repair Way |
|---|---|
| Engine Oil Leak | Repair |

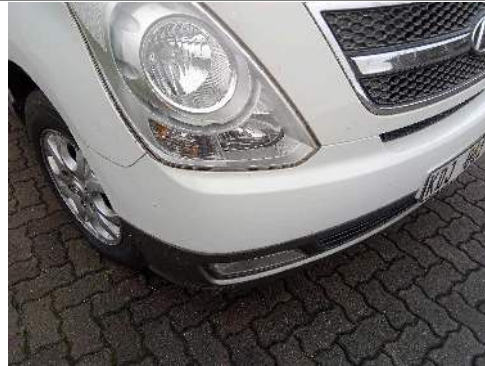
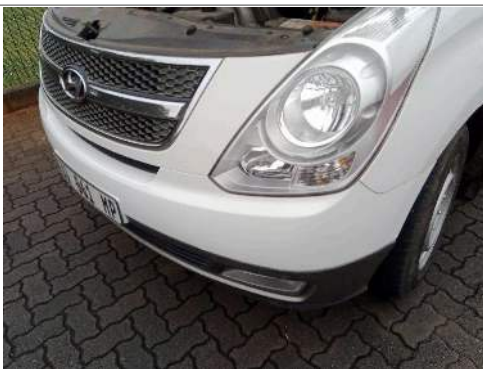
| Damage | Repair Way |
|---|---|
| Front Bumper Damaged | Repair |

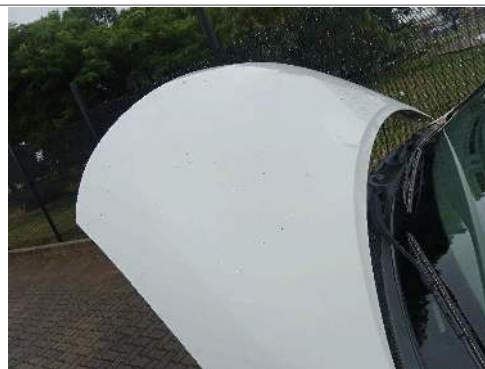
| Damage | Repair Way |
|---|---|
| Bonnet Damaged | Repair |

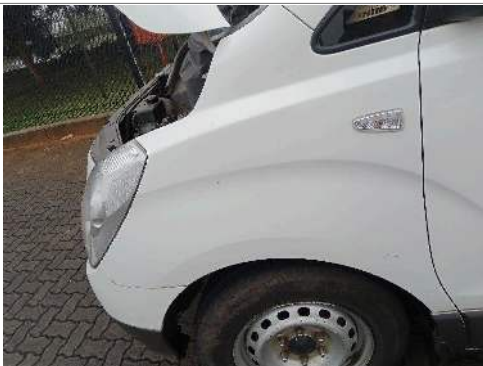
| Damage | Repair Way |
|---|---|
| Front Fender Left Damaged | Repair |

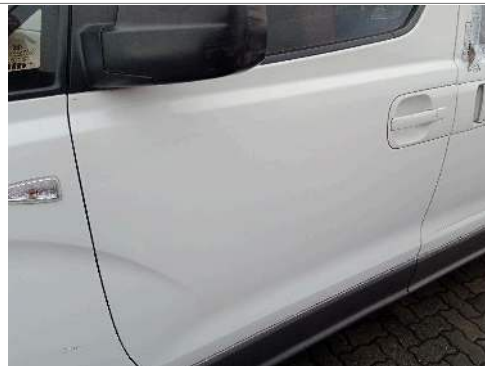
| Damage | Repair Way |
|---|---|
| Door Front Left Damaged | Repair |

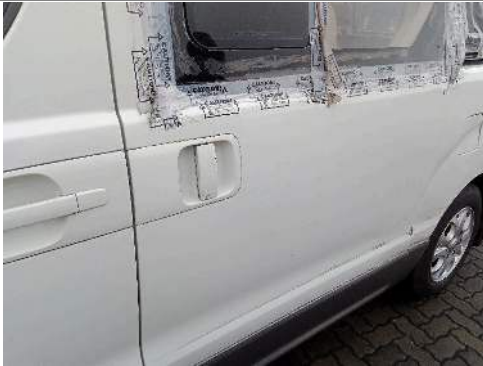
| Damage | Repair Way |
|---|---|
| Door Rear Left Damaged | Repair |

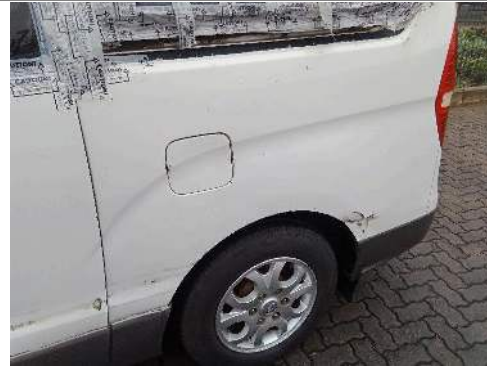
| Damage | Repair Way |
|---|---|
| Rear Fender Left Damaged | Repair |

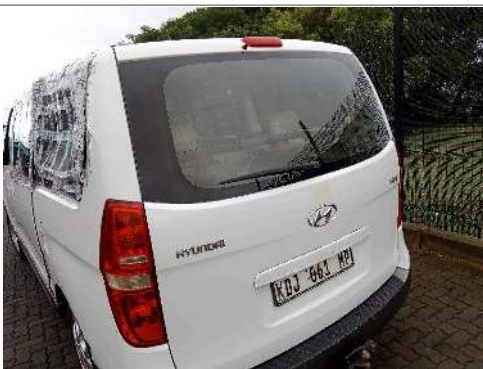
| Damage | Repair Way |
|---|---|
| Boot Lid / Hatch door Damaged | Repair |

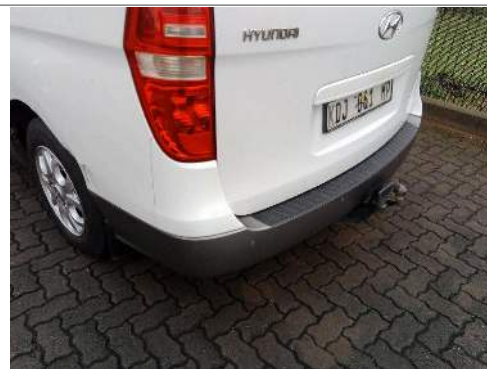
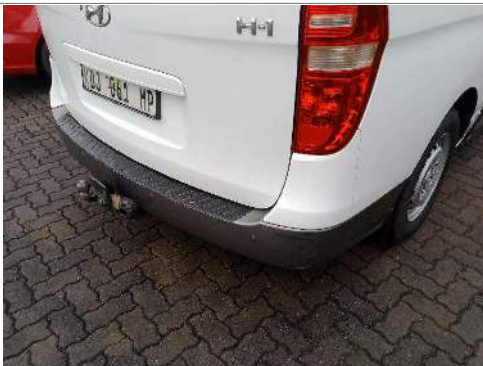
| Damage | Repair Way |
|---|---|
| Rear bumper Damaged | Repair |

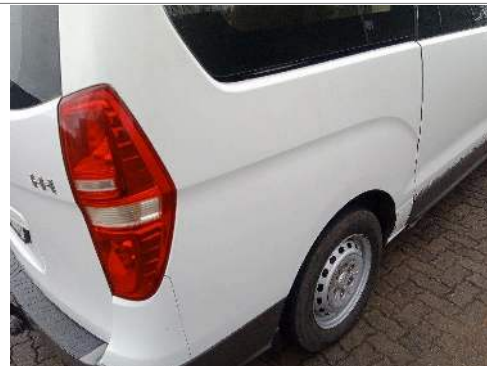
| Damage | Repair Way |
|---|---|
| Rear Fender Right Damaged | Repair |

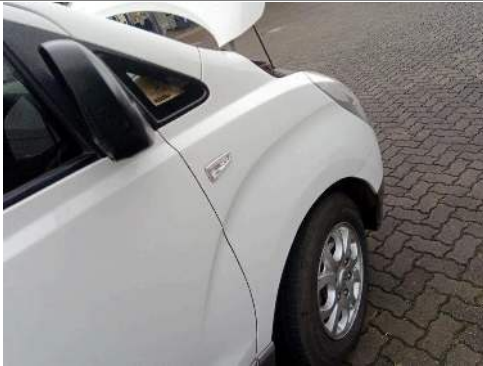
| Damage | Repair Way |
|---|---|
| Front Fender Right Damaged | Repair |

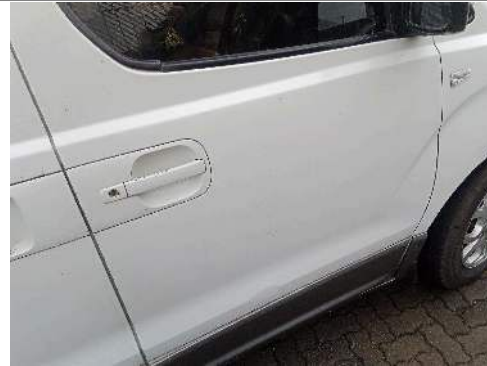
| Damage | Repair Way |
|---|---|
| Door Front Right Damaged | Repair |

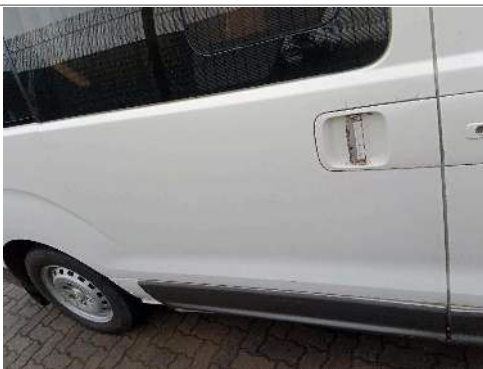
| Damage | Repair Way |
|---|---|
| Door Rear Right Damaged | Repair |

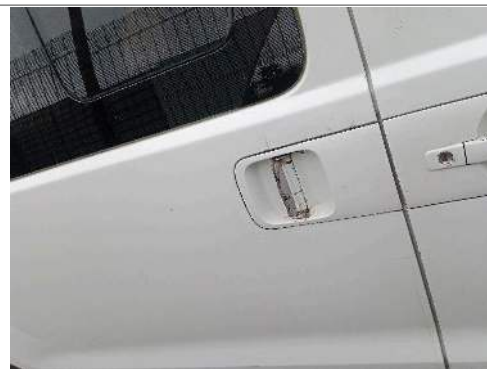
| Damage | Repair Way |
|---|---|
| Door Handle Rear Right Damaged | Replace |

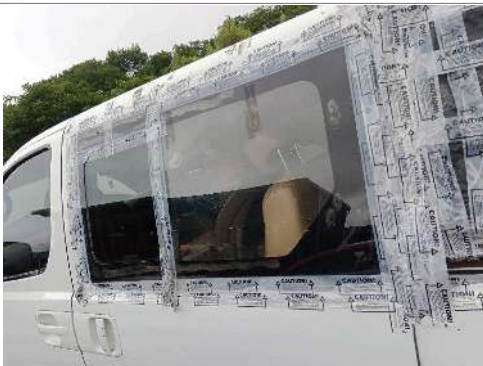
| Damage | Repair Way |
|---|---|
| Window Rear Door Left Damaged | Replace |

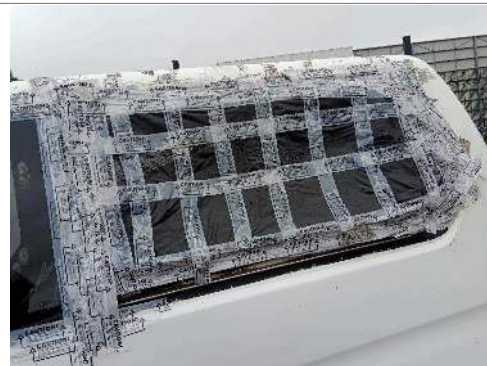
| Damage | Repair Way |
|---|---|
| Sealing Window Rear Door Left Damaged | Replace |

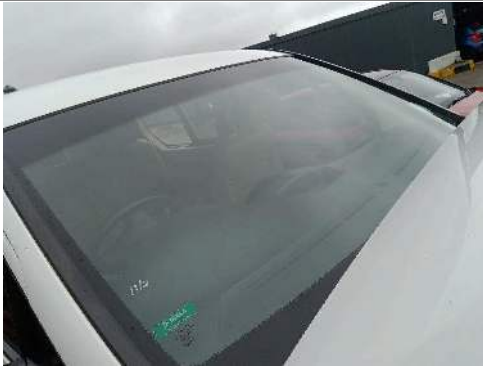
| Damage | Repair Way |
|---|---|
| Windscreen Damaged | Replace |

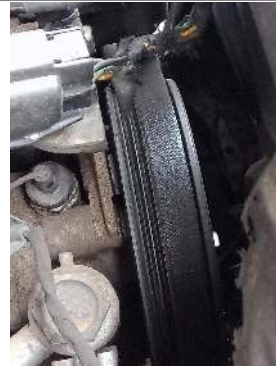
| Damage | Repair Way |
|---|---|
| Fan Belt Damaged | Replace |

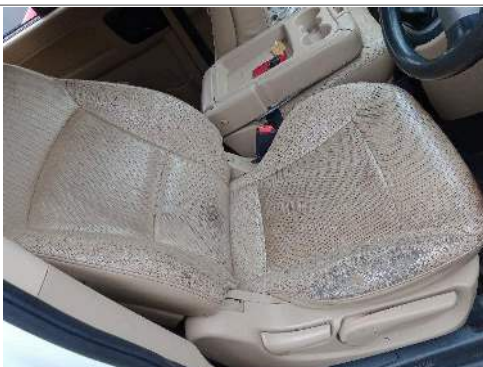
| Damage | Repair Way |
|---|---|
| Seat Front Right Worn | Repair |

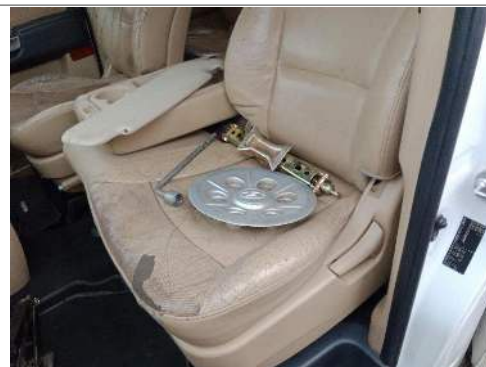
| Damage | Repair Way |
|---|---|
| Seat Front Left Worn | Repair |

Interior: driver side seat loose. vehicle interior in poor condition.

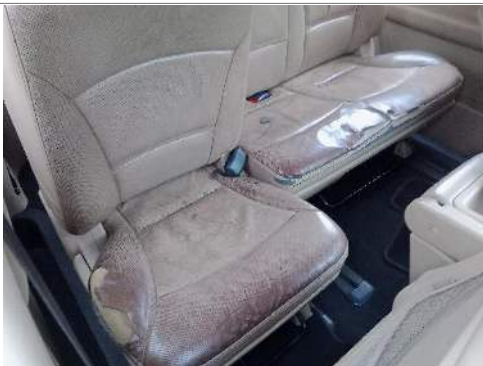
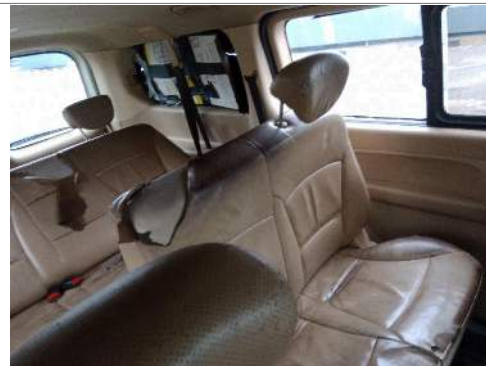
| Damage | Repair Way |
|---|---|
| Seat Rear Damaged | Repair |

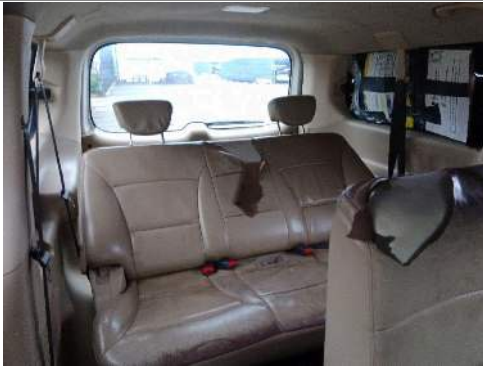
| Damage | Repair Way |
|---|---|
| Seat Rear ( 2. Row) Damaged | Repair |

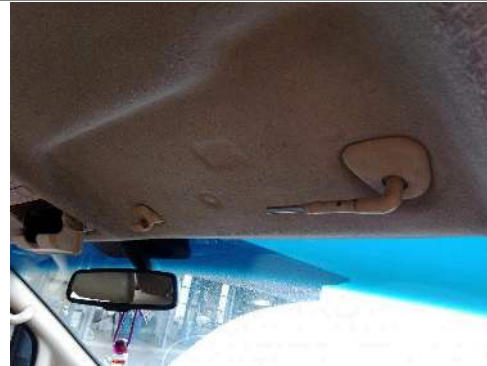
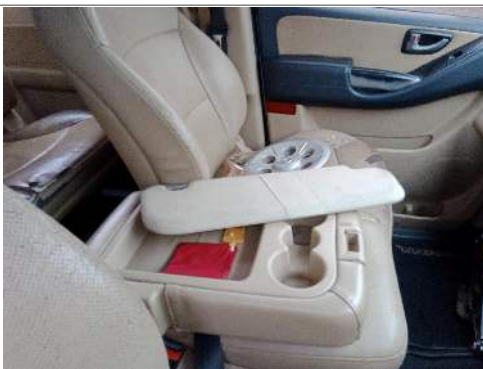
| Damage | Repair Way |
|---|---|
| Sun Visor Right Damaged | Replace |

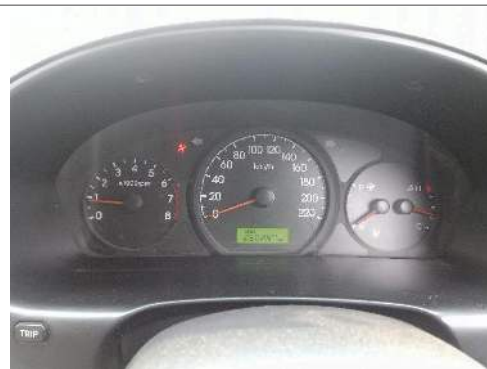
| Damage | Repair Way |
|---|---|
| Engine Management Lights Set | Repair |

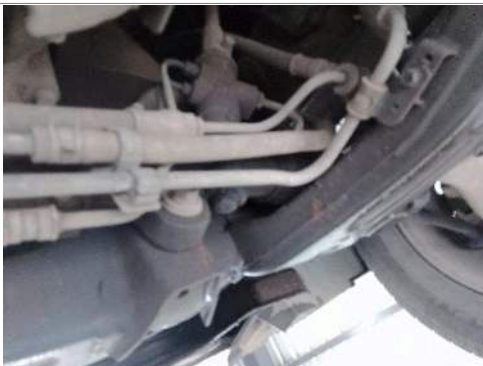
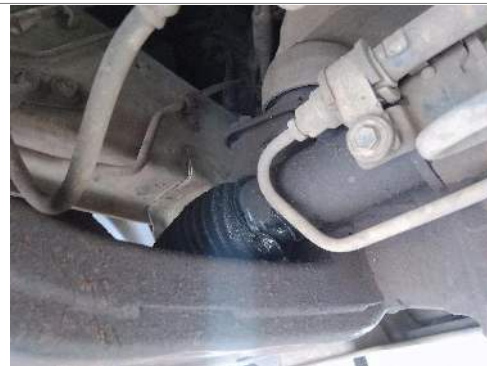
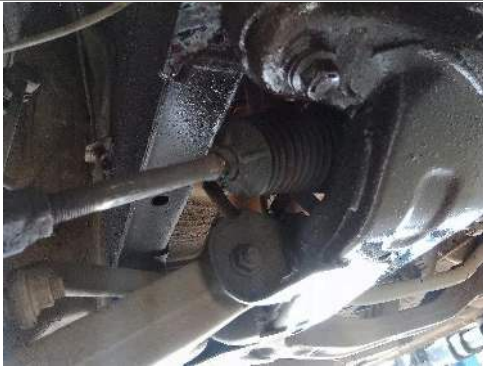
| Damage | Repair Way |
|---|---|
| Steering box Leak | Repair |
| Steering Insufficient | Repair |

Road Test: vehicle has no power steering. manual gearbox struggles to select gear.

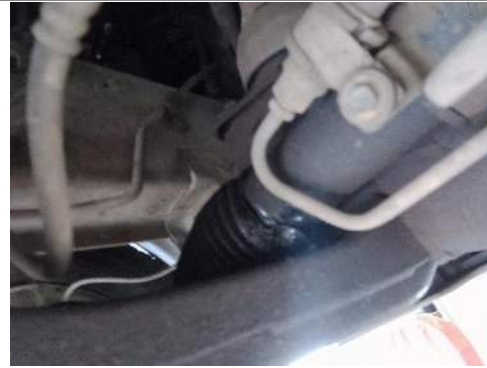
| Damage | Repair Way |
|---|---|
| Steering Rack Boot Left Damaged | Replace |

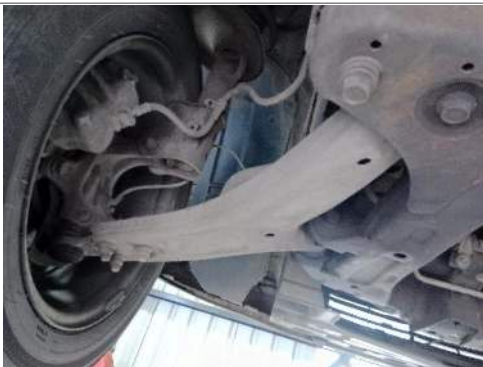
| Damage | Repair Way |
|---|---|
| Control Arm Bush(es) Front Axle Left Worn | Replace |

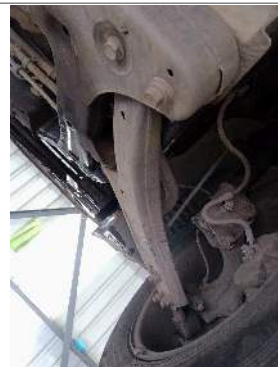
| Damage | Repair Way |
|---|---|
| Control Arm Bush(es) Front Axle Right Worn | Replace |

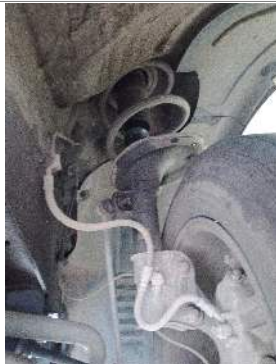
| Damage | Repair Way |
|---|---|
| Shock Absorber Front Right Worn | Replace |

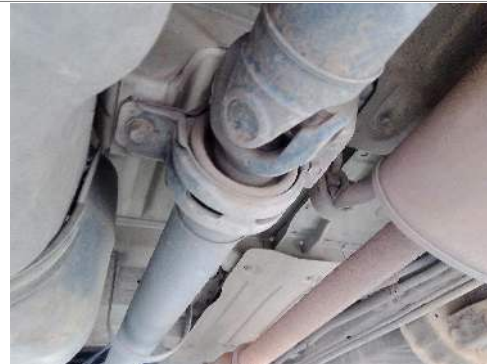
| Damage | Repair Way |
|---|---|
| Center Prop Shaft Rubber(s) Damaged | Replace |

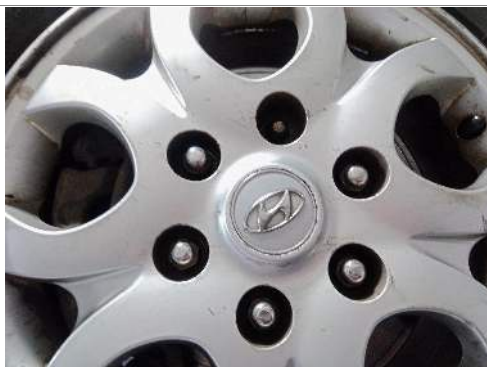
| Damage | Repair Way |
|---|---|
| Bolt(s) / Nut(s) Front Wheel Right Missing | Replace |

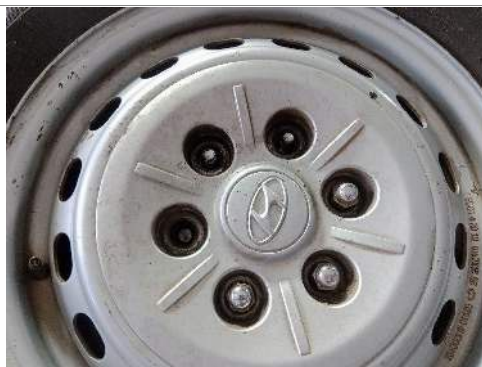
| Damage | Repair Way |
|---|---|
| Bolt(s) / Nut(s) Rear Wheel Right Missing | Replace |

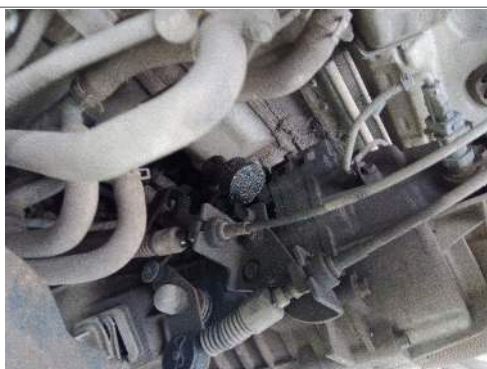
| Damage | Repair Way |
|---|---|
| Gearbox Oil Leak | Repair |
| Gear Selections Insufficient | Repair |

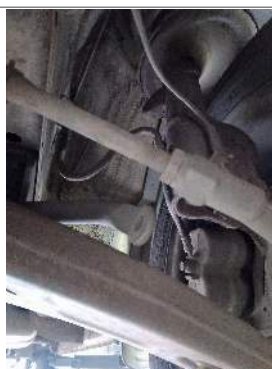
| Damage | Repair Way |
|---|---|
| Stabilizer Mounting Front Left Damaged | Replace |
