## CONDITION REPORT

Report No:  
2017302491  
DATE  
23/09/2026

| Manufacturer | KIA | Registration Number | JWH057MP |
| VIN | KNAB2511MKT365271 | Date Of First Licensing | |

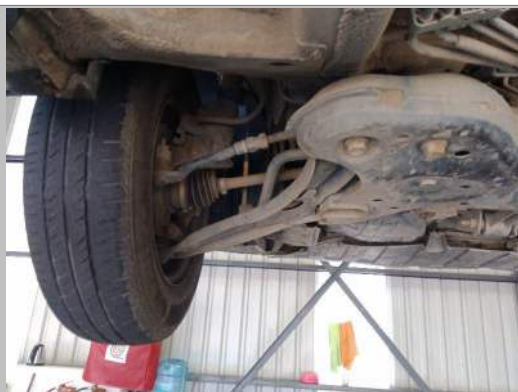
LF TYRE TREAD

| | Size | Load/Speed Index | Manufacture | Model | Type* | Production Date | Tread Depth (mm) |
|---|---|---|---|---|---|---|---|
| Front Left | 155/80R13 | 79T | Sailun | Radial | V | 3824 | 1 mm |

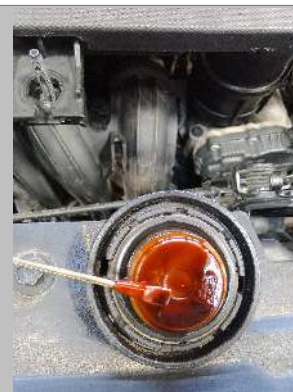
General Comments: ACCORDING TO THE AGE AND MILEAGE OF THE VEHICLE, NORMAL WEAR AND TEAR MARKS ARE VISIBLE ON THE INTERIOR, EXTERIOR, ELECTRICAL AND MECHANICAL PARTS. Engine Compartment: dipstick damaged. oil level could not be checked correctly. battery loose.

Oil cap and dipstick.

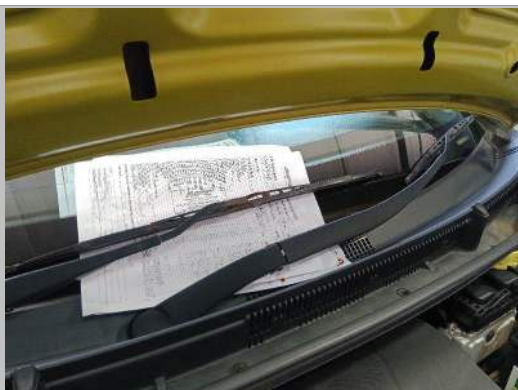
Engine Management Lights Set  
 Windscreen Wiper Damaged  
 Tail Light Left Damaged  
 Headlight Left Damaged  
 Headlight Right Damaged  
 Front Bumper Damaged  
 Bonnet Damaged  
 Front Fender Left Damaged  
 Front Fender Right Damaged  
 Rear Fender Left Damaged  
 Rear Fender Right Damaged  
 Door Front Left Damaged  
 Door Front Right Damaged  
 Door Rear Left Damaged  
 Door Rear Right Damaged  
 Boot Lid / Hatch door Damaged  
 Rear bumper Defective  
 Roof Damaged  
 Windscreen Damaged  
 Radiator Cradle Damaged

Repair  
 Replace  
 Replace  
 Replace  
 Replace  
 Repair  
 Repair  
 Repair  
 Repair  
 Repair  
 Repair  
 Repair  
 Repair  
 Repair  
 Repair  
 Repair  
 Replace  
 Replace
