## CONDITION REPORT

Report No: 2016886862

| Manufacturer | KIA | Registration Number | JHY232MP |
| Model | PICANTO | Register Number | |

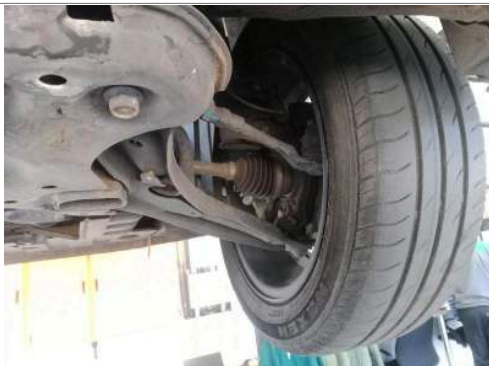
RF TYRE TREAD

| | Size | Load/Speed Index | Manufacture | Model | Type* | Production Date | Tread Depth (mm) |
|---|---|---|---|---|---|---|---|
| Front Right | 185/55R15 | 86H | Nexen | Nblue | V | 2617 | 3 mm |

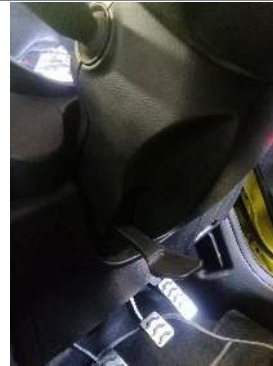
Steering adjustable lever dama

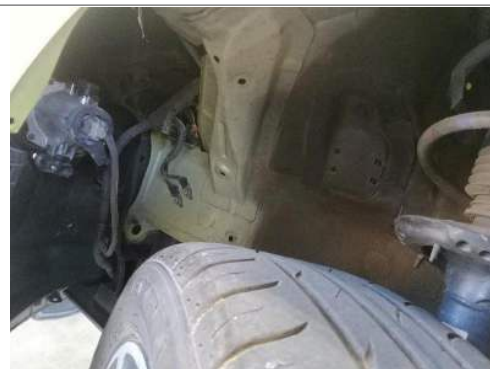
L/F fender liner missing
