## CONDITION REPORT

Report No: 2016867939

MFC Auction House  
M57 Pretoria Rd, Glenmarais, KEMPTON PARK  
Gauteng

Vehicle Type	PASSENGER VEHICLE	Registered Owner	
Manufacturer	KIA	Registration Number	DW40JJGP
Model	PICANTO	Register Number	
VIN	KNABE511LGT097544	Date Of First Licensing	
Engine Number		Last COR	
Doors	5	License Expiry Date	31/07/2025
Color	GREY	Power / Displacement	
Year Model		Paint Finish	M - METALLIC
Km Reading	216,675 KM	Fuel	PETROL
Cab / Body Type	HATCHBACK	Transmission	MANUAL

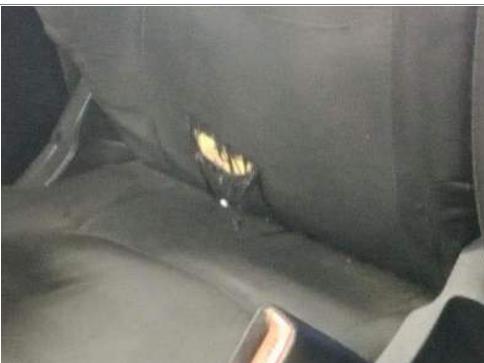
Damage	Repair Way
Seat Front Right Torn / Cut	Repair
Side Mirror Left Paintwork • Scratched	Repair
Side Mirror Right Paintwork • Scratched	Repair
Front Bumper Paintwork • Scratched	Repair
Front Fender Left Dented	Repair
Front Fender Right Dented	Repair
Rear Fender Left Dented	Repair
Rear Fender Right Dented	Repair
Door Front Left Paintwork • Scratched	Repair
Door Front Right Dented	Repair
Door Rear Left Dented	Repair
Door Rear Right Paintwork • Scratched	Repair
Boot Lid / Hatch door Dented	Repair
Rear bumper Paintwork • Scratched	Repair
Windscreen Cracked	Replace
Tyre Front Left Smooth	Replace
Tyre Front Right Smooth	Replace
Tyre Rear Right Smooth	Replace
Bolt(s) / Nut(s) Rear Wheel Right Defective	Repair
Boot not opening	Repair

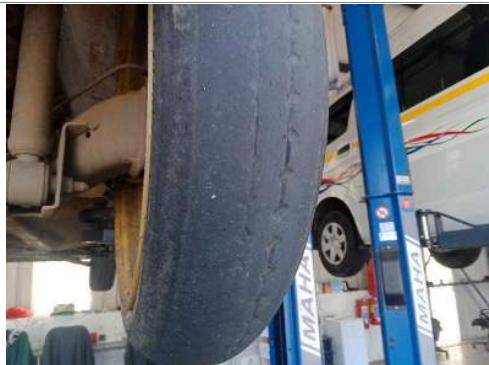
Tyre Rear Right

Size	Load/Speed Index	Manufacture	Model	Type*	Production Date	Tread Depth (mm)
Front Left	165/65R14	79T	Kumho	Ecowing	V	2618	0 mm
Front Right	155/65R14	75T	Goodyear	Efficient gr	V	1422	0 mm
Rear Left	155/80R13	79T	Good ride	Radial Rp28	V	0619	2 mm
Rear Right	T115/70D14	88M	Bridgestone	Temporary	V	3807	0 mm
Spare	175/65R14	82H	Goodyear	Efficient gr	V	0000	2 mm

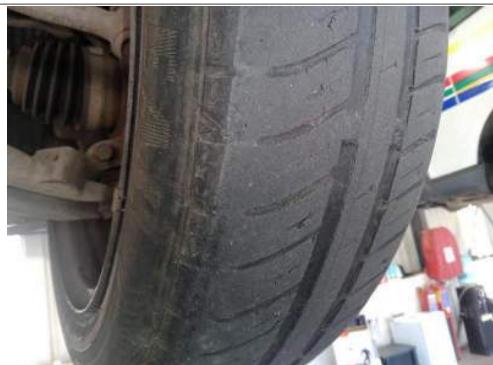
Tyre Front Right

Damage	Repair Way
Antenna missing	Replace
Both front fog lights malfunction	Repair
Rear and Front tyres size differs	Replace
