CONDITION REPORT

Report No: 2016845858

DATE
16/04/2025

Vehicle Type	PASSENGER VEHICLE	Registered Owner	
Manufacturer	KIA	Registration Number	DX25NDGP
Model	PICANTO	Register Number	
VIN	KNABE511LGT136196	Date Of First Licensing	
Engine Number		Last COR	
Doors	5	License Expiry Date	31/10/2025
Color	WHITE	Power / Displacement	
Year Model		Paint Finish	TWO COAT UNI
Km Reading	157,416 KM	Fuel	PETROL
Cab / Body Type	HATCHBACK	Transmission	MANUAL

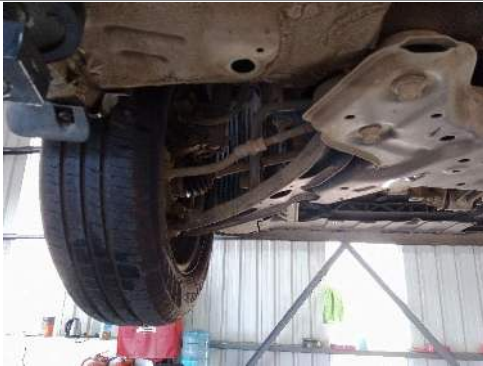
LF TYRE TREAD

Size	Load/Speed Index	Manufacture	Model	Type*	Production Date	Tread Depth (mm)
Front Left	175/65R14	82H	Arivo	Radial	V	4024	3 mm
Front Right	175/65R14	82H	Arivo	Radial	V	4024	3 mm
Rear Left	175/65R14	82H	Tracmax	Radial	V	1122	2 mm
Rear Right	175/65R14	82H	Tracmax	Radial	V	1122	2 mm

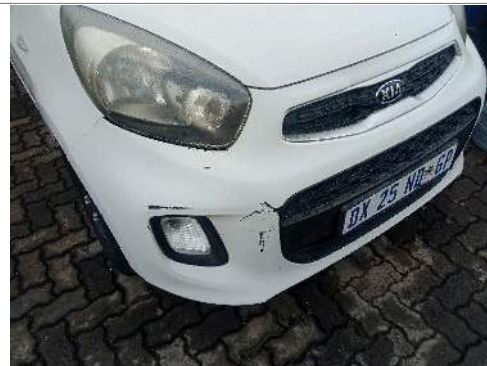
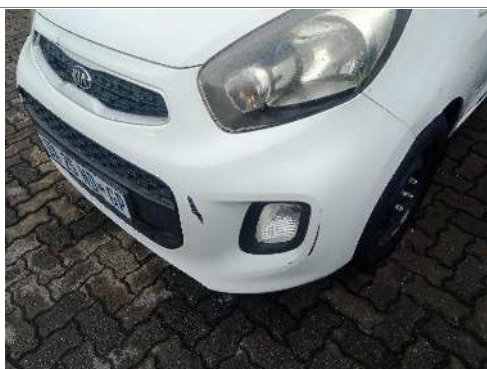
Damage	Repair Way
Front Bumper Damaged	Repair
Bonnet Damaged	Repair
Front Fender Left Damaged	Repair
Rear Fender Left Damaged	Repair
Rear Fender Right Damaged	Repair
Door Front Left Damaged	Repair
Door Front Right Damaged	Repair
Door Rear Left Damaged	Repair
Door Rear Right Damaged	Repair
Boot Lid / Hatch door Damaged	Repair
Rear bumper Damaged	Repair
Parking Brake Performance Left / Right Difference out of legal range	Repair
Clutch Operation Insufficient	Repair

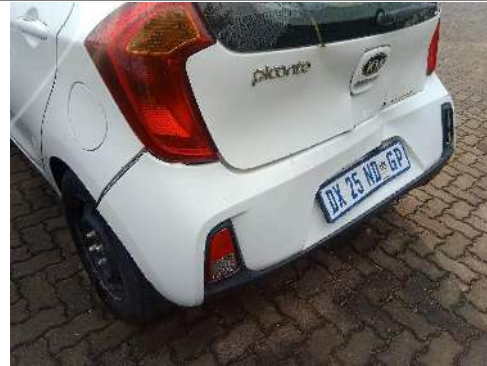
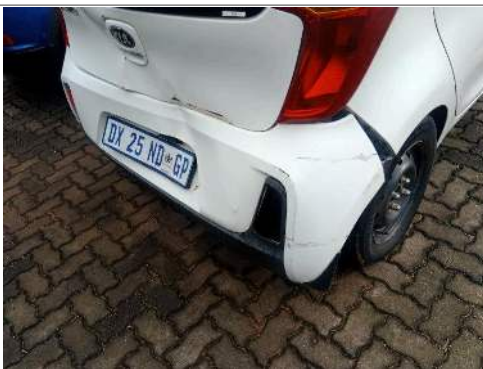
Rear bumper

General Comments: ACCORDING TO THE AGE AND MILEAGE OF THE VEHICLE, NORMAL WEAR AND TEAR MARKS ARE VISIBLE ON THE INTERIOR, EXTERIOR, ELECTRICAL AND MECHANICAL PARTS. Body • Exterior: Minor dents and scratches to some body panels. Signs of stone chips to some body panels. Signs of repair work done to some body panels. Poor alignment to some body panels. Signs of impact damage to rear of vehicle. Repair work done to vehicle below standard. Vehicle body in poor condition.
