MFC Auction House  
M57 Pretoria Rd, Glenmarais, KEMPTON PARK  
Gauteng

| Manufacturer | KIA | Registration Number | KN04MWGP |
| Model | PICANTO 1.0 LS 5-DR [2015-2018] | Register Number | |

## VEHICLE INSPECTION

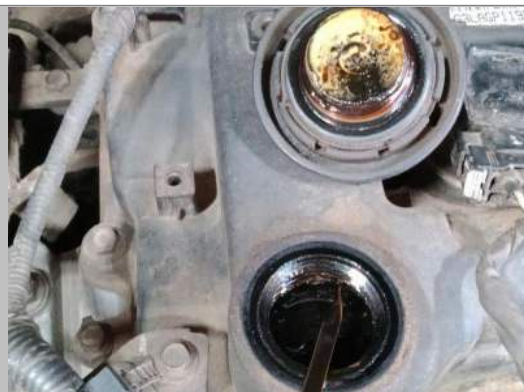
Oil cap and dipstick

| Damage | Repair Way |
|---|---|
| foreign substance on oil caps | Repair |

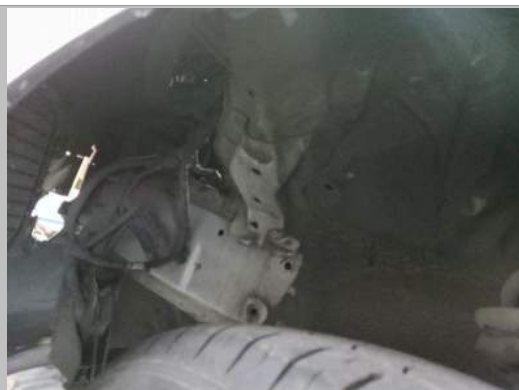
L/F fender liner missing

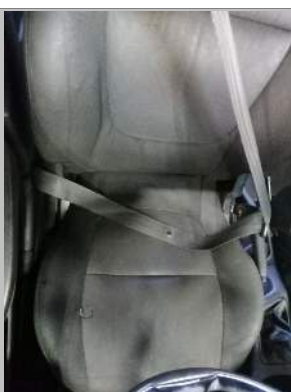
| Damage | Repair Way |
|---|---|
| Seat Front Right Torn / Cut | Repair |

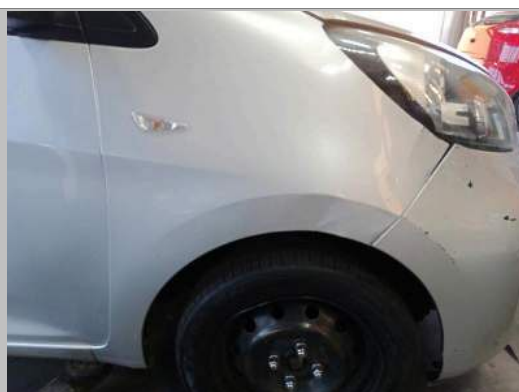
| Damage | Repair Way |
|---|---|
| Front Fender Right Dented | Repair |

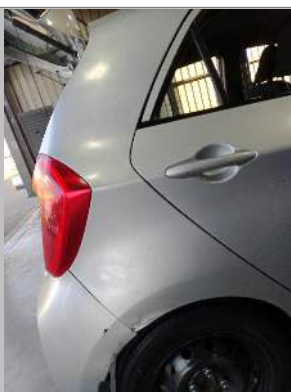
| Damage | Repair Way |
|---|---|
| Rear Fender Right Residual Traces of Repair | Repair |

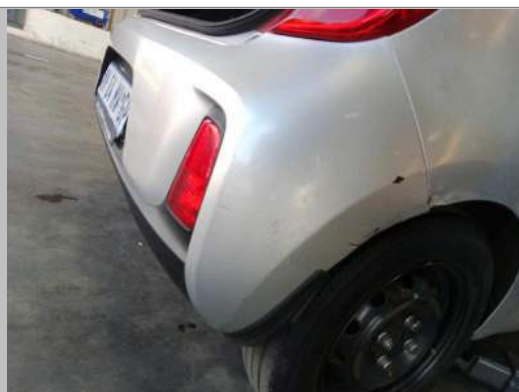
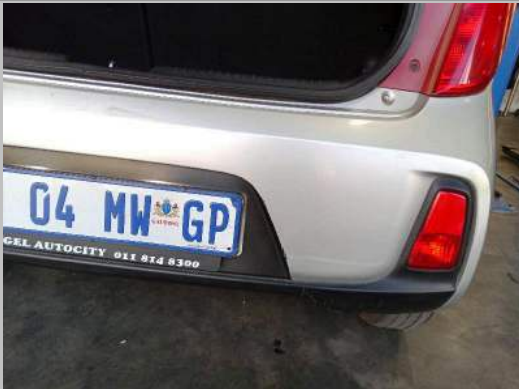
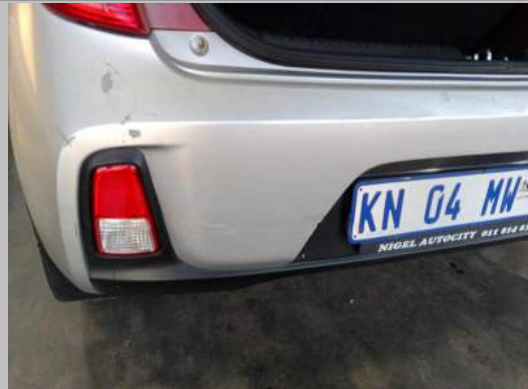
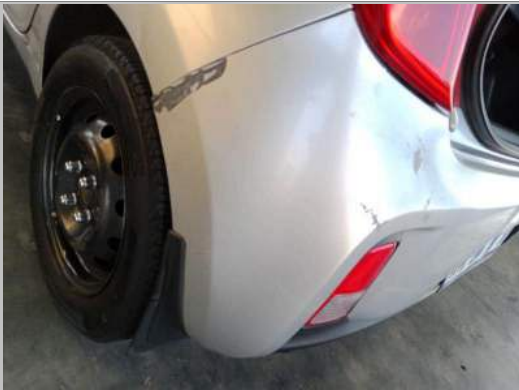
| Damage | Repair Way |
|---|---|
| Rear bumper Residual Traces of Repair | Repair |

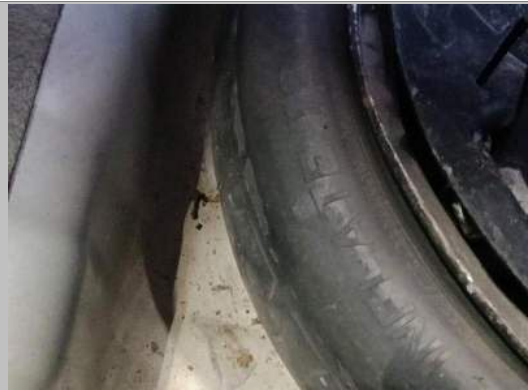
| Damage | Repair Way |
|---|---|
| Spare Tyre Smooth | Replace |

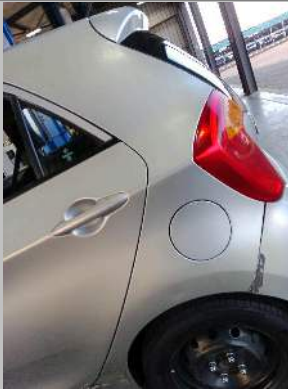
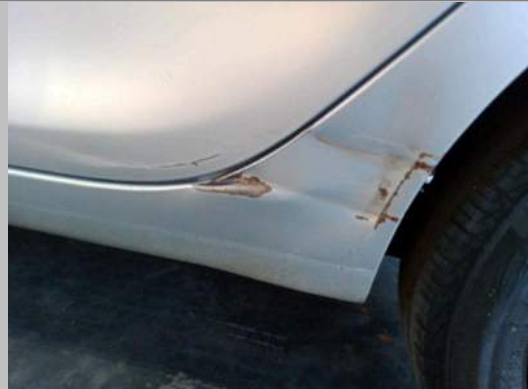
| Damage | Repair Way |
|---|---|
| Rear Fender Left Residual Traces of Repair | Repair |

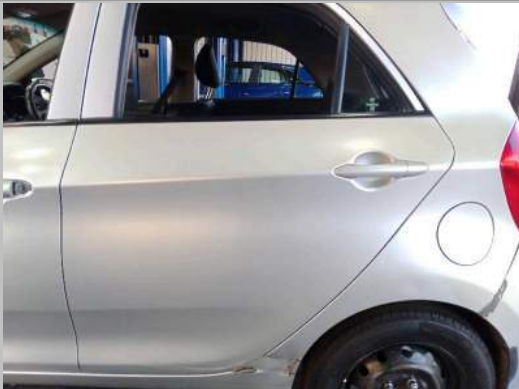
| Damage | Repair Way |
|---|---|
| Door Rear Left Residual Traces of Repair | Repair |

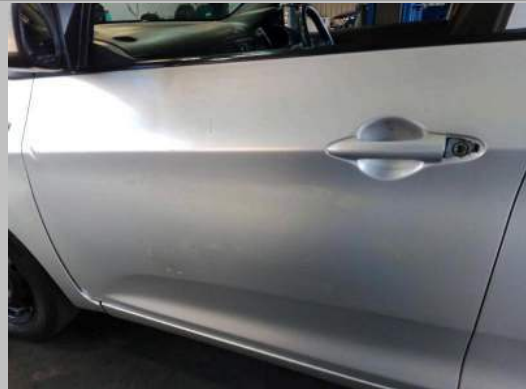
| Damage | Repair Way |
|---|---|
| Door Front Left Residual Traces of Repair | Repair |

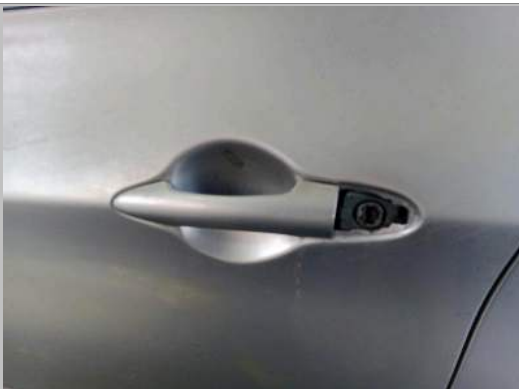
| Damage | Repair Way |
|---|---|
| Door Handle Front Left Damaged | Replace |

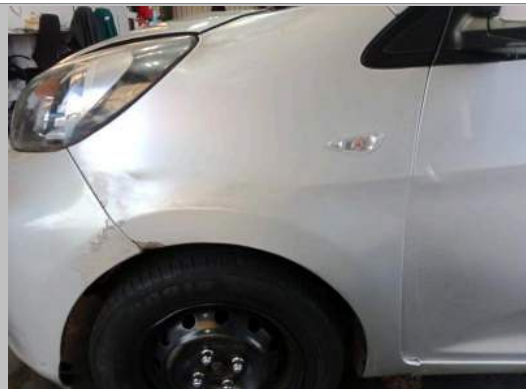
| Damage | Repair Way |
|---|---|
| Front Fender Left Residual Traces of Repair | Repair |

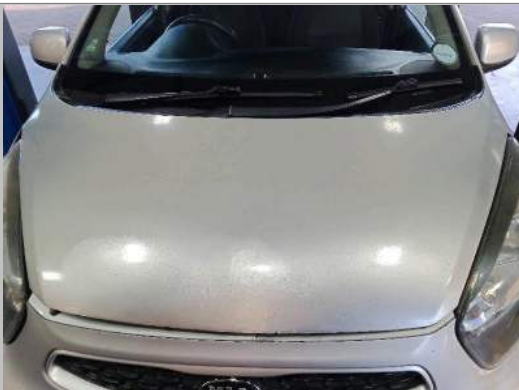
| Damage | Repair Way |
|---|---|
| Bonnet Residual Traces of Repair | Repair |

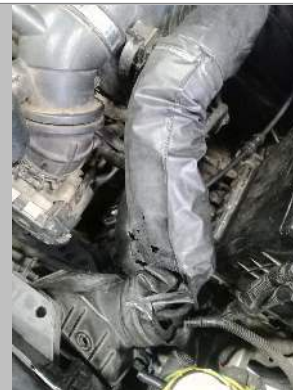
| Damage | Repair Way |
|---|---|
| Air cleaner Damaged | Repair |

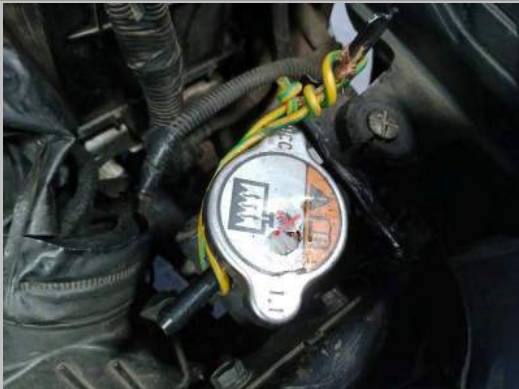
| Damage | Repair Way |
|---|---|
| Caps Damaged | Replace |

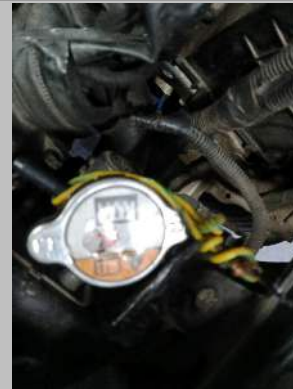
| Damage | Repair Way |
|---|---|
| Engine Wiring Defective | Repair |

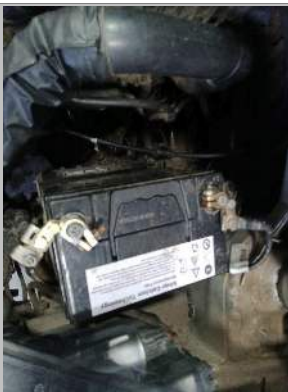
| Damage | Repair Way |
|---|---|
| Battery clamps Defective | Replace |

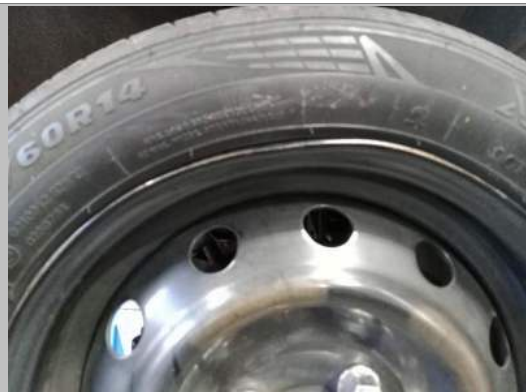
| Damage | Repair Way |
|---|---|
| Rim Front Right Dented | Repair |

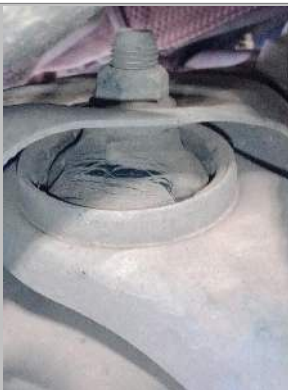
| Damage | Repair Way |
|---|---|
| Control Arm Bush(es) Front Axle Right Cracked | Replace |

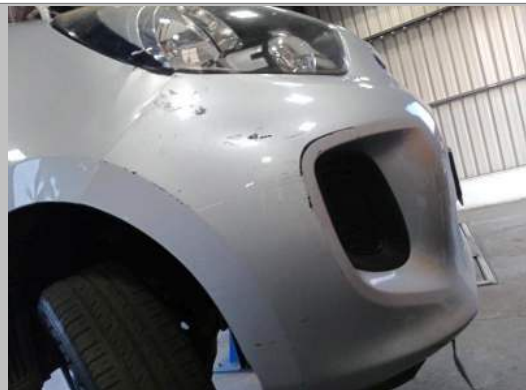
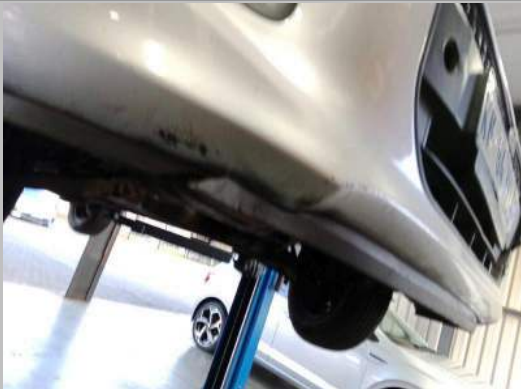
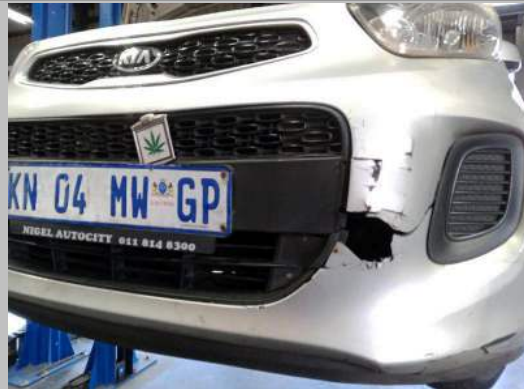
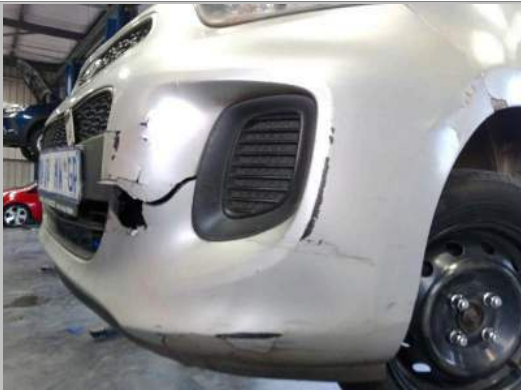
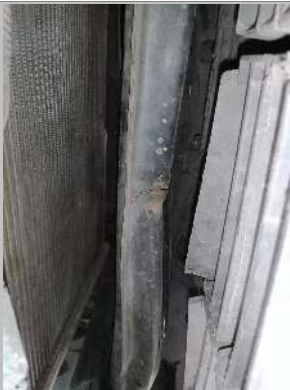
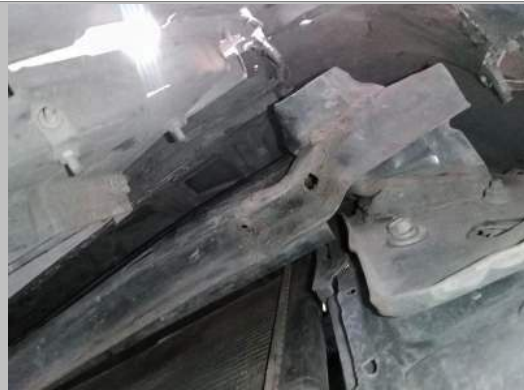
| Damage | Repair Way |
|---|---|
| Front Bumper Paintwork • Scratched | Repair |

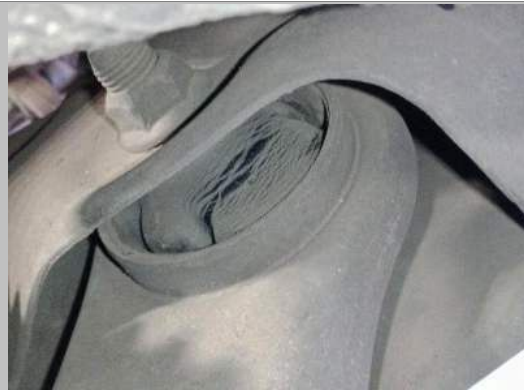
| Damage | Repair Way |
|---|---|
| Control Arm Bush(es) Front Axle Left Cracked | Replace |

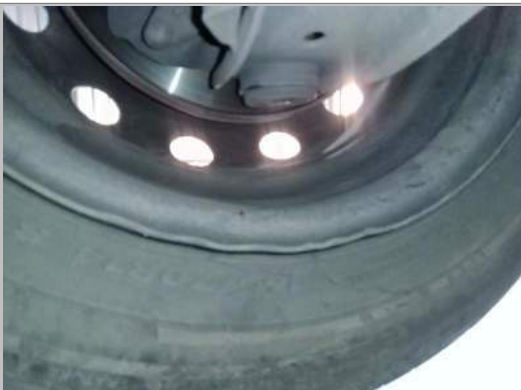
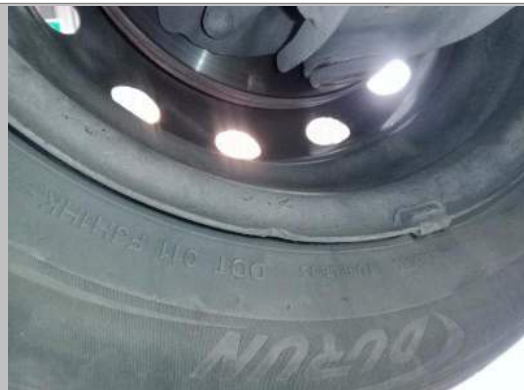
| Damage | Repair Way |
|---|---|
| Rim Front Left Dented | Repair |

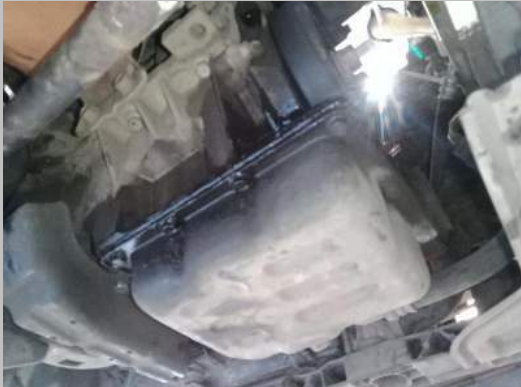
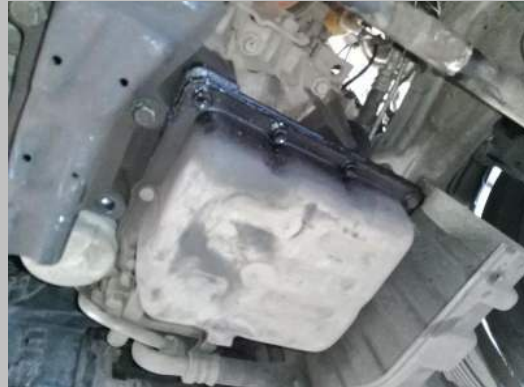
| Damage | Repair Way |
|---|---|
| Engine Oil Leak | Repair |

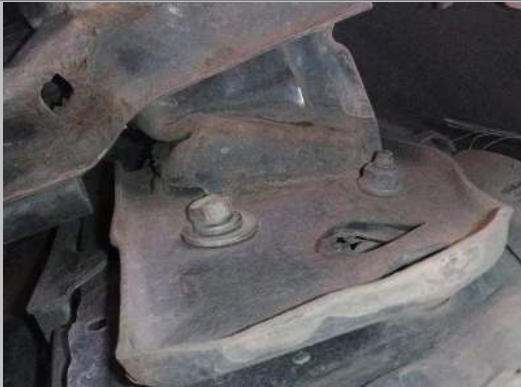
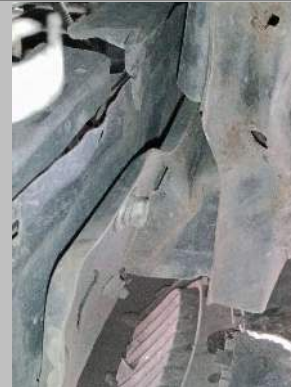
| Damage | Repair Way |
|---|---|
| Main Beam Left Damaged | Replace |

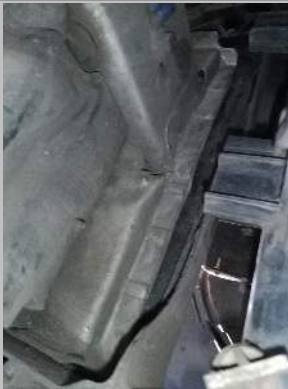
| Damage | Repair Way |
|---|---|
| Radiator Cradle Damaged | Replace |

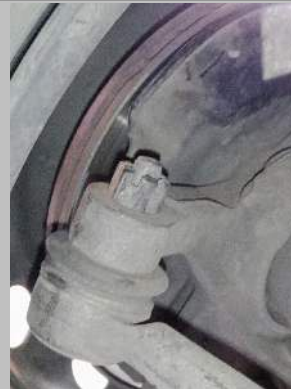
| Damage | Repair Way |
|---|---|
| Split Pin Left Missing | Replace |

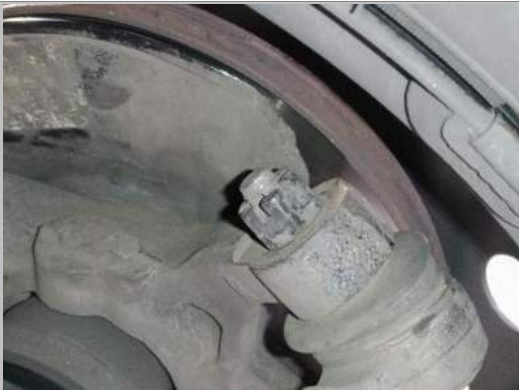
| Damage | Repair Way |
|---|---|
| Split Pin Right Missing | Replace |

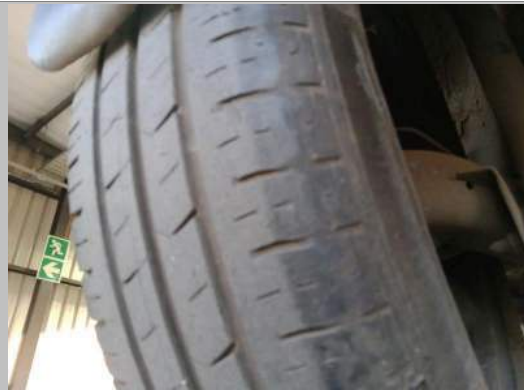
| Damage | Repair Way |
|---|---|
| Tyre Rear Left Smooth | Replace |

| | Size | Load/Speed Index | Manufacture | Model | Type* | Production Date | Tread Depth (mm) |
|---|---|---|---|---|---|---|---|
| Rear Left | 175/65R14 | 82H | Powertrac | Adams | V | 3124 | 0 mm |

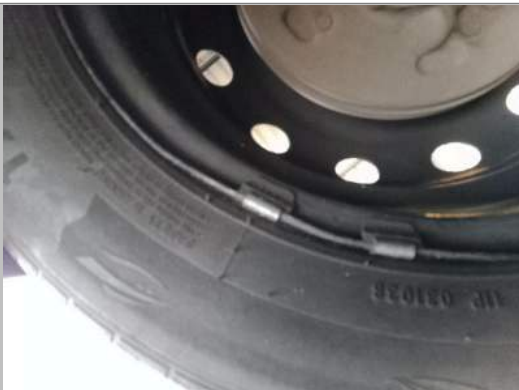
| Damage | Repair Way |
|---|---|
| Rim Rear Left Dented | Repair |

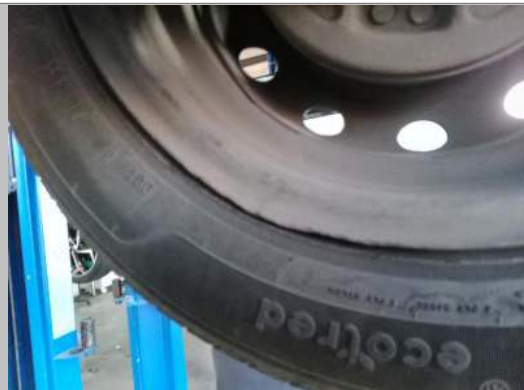
| Damage | Repair Way |
|---|---|
| Rim Rear Right Dented | Repair |

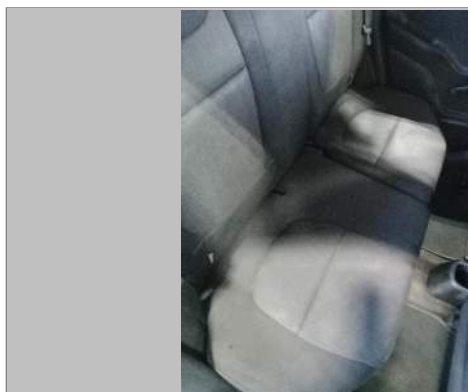
| Damage | Repair Way |
|---|---|
| Seat Rear Torn / Cut | Repair |
