MFC Auction House  
M57 Pretoria Rd, Glenmarais, KEMPTON PARK  
Gauteng

Vehicle Type	PASSENGER VEHICLE	Registered Owner	MFC AUCTION HOUSE
Manufacturer	KIA	Registration Number	JC61SXGP
Model	RIO	Register Number	
VIN	KNADB512LK6324007	Date Of First Licensing	
Engine Number		Last COR	
Doors	5	License Expiry Date	31/08/2024
Color	RED	Power / Displacement	
Year Model		Paint Finish	M - METALLIC
Km Reading	152,795 KM	Fuel	PETROL
Cab / Body Type	HATCHBACK	Transmission	MANUAL

## CONDITION REPORT

Report No: 2016265337

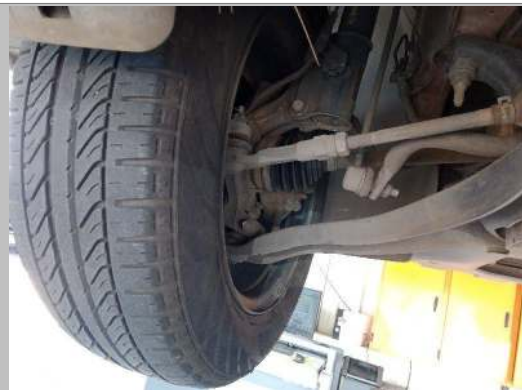
LF TYRE TREAD

Size	Load/Speed Index	Manufacture	Model	Type*	Production Date	Tread Depth (mm)
Front Left	185/65R15	92H	Dunlop	Sport	V	3321	3 mm
Front Right	185/65R15	92H	Dunlop	Sport	V	3321	5 mm
Rear Left	185/65R15	88H	Nexen	Nblue	V	1619	5 mm
Rear Right	185/65R15	88H	Nexen	Nblue	V	1619	6 mm
Spare	185/65R15	88T	Goodyear	GT3	V	0000	5 mm

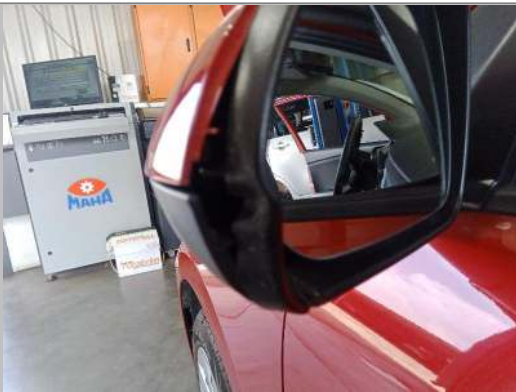
Damage	Repair Way
Side Mirror Left Damaged	Replace
Windscreen Cracked	Replace
