## CONDITION REPORT

2017304207

| Manufacturer | KIA | Registration Number | BF62DDZN |
| Model | RIO | Register Number | |

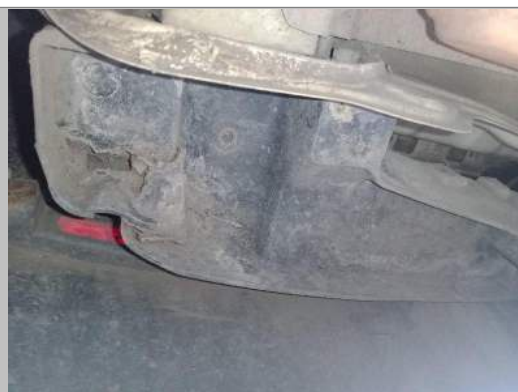
| Damage | Repair Way |
|---|---|
| Rear bumper stiffener damaged | Replace |

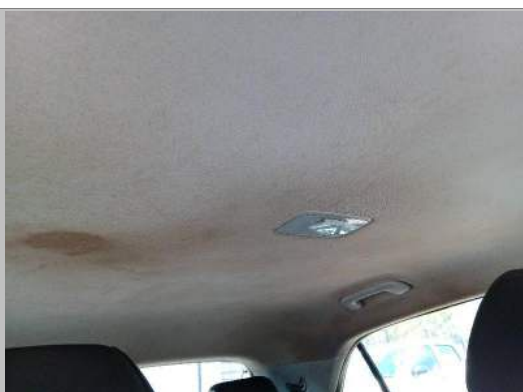
| Damage | Repair Way |
|---|---|
| Hood Lining Dirty | Repair |

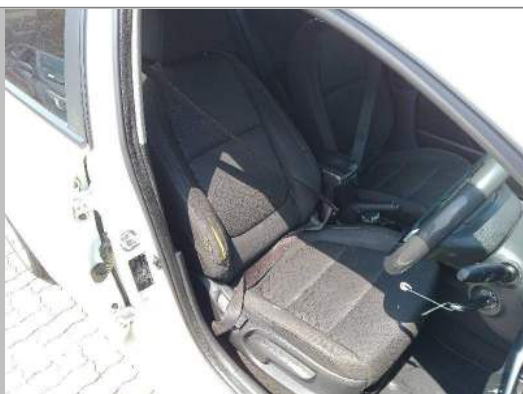
| Damage | Repair Way |
|---|---|
| Seat Front Right Damaged | |

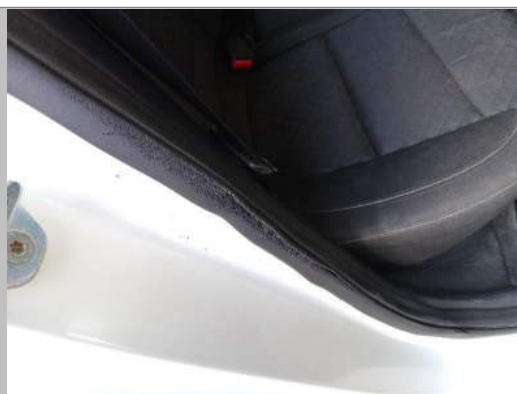
| Damage | Repair Way |
|---|---|
| Door Sealing Rubber Rear Right Damaged | Replace |

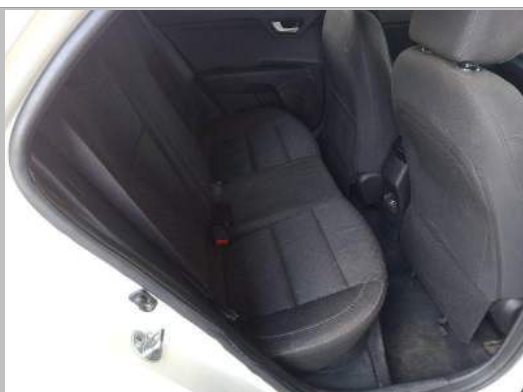
| Damage | Repair Way |
|---|---|
| Seat Rear Dirty | Repair |

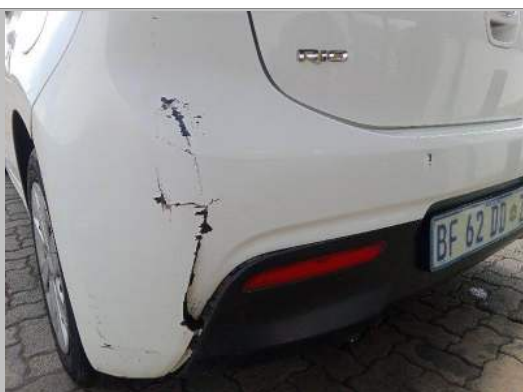
| Damage | Repair Way |
|---|---|
| Rear bumper Damaged | Replace |

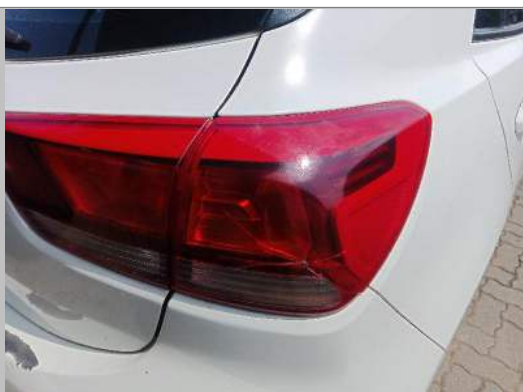
| Damage | Repair Way |
|---|---|
| Tail Light Right Cracked | Replace |

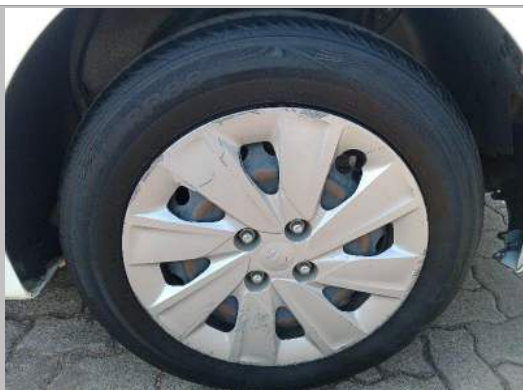
| Damage | Repair Way |
|---|---|
| Tyre Rear Left Damaged | Replace |

| | Size | Load/Speed Index | Manufacture | Model | Type* | Production Date | Tread Depth (mm) |
|---|---|---|---|---|---|---|---|
| Rear Left | 185/65 R15 | 88H | Goodride | Radial | V | 2823 | 0 mm |

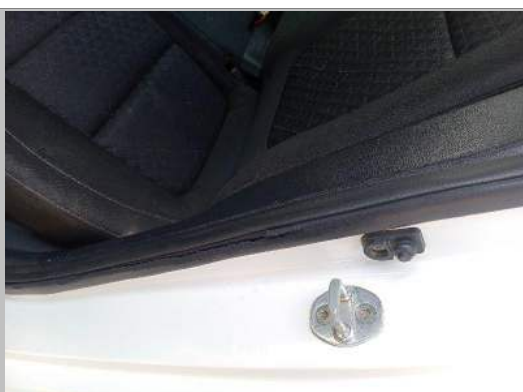
| Damage | Repair Way |
|---|---|
| Door Sealing Rubber Rear Left Damaged | Replace |

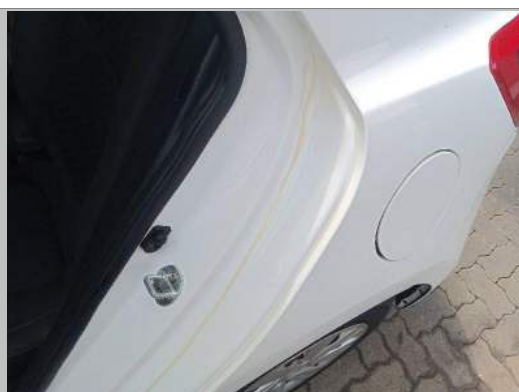
| Damage | Repair Way |
|---|---|
| C • Pillar Left Defective | Repair |

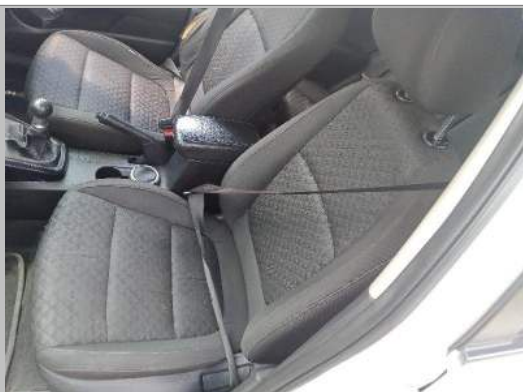
| Damage | Repair Way |
|---|---|
| Seat Front Left Dirty | Repair |

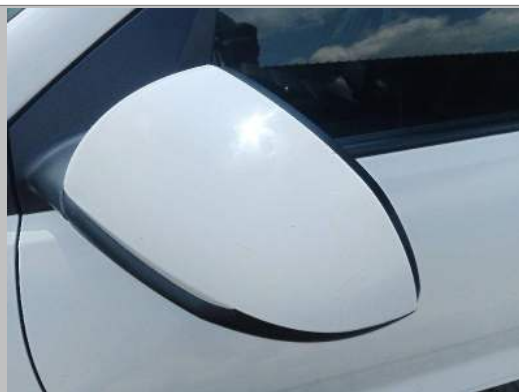
| Damage | Repair Way |
|---|---|
| Side Mirror Left Paintwork • Scratched | Repair |

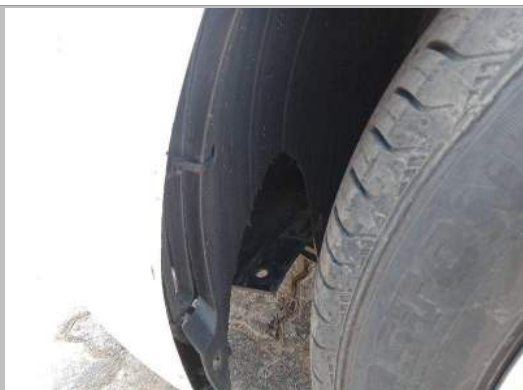
| Damage | Repair Way |
|---|---|
| Front Fender Left / Inner Tray Damaged | Replace |

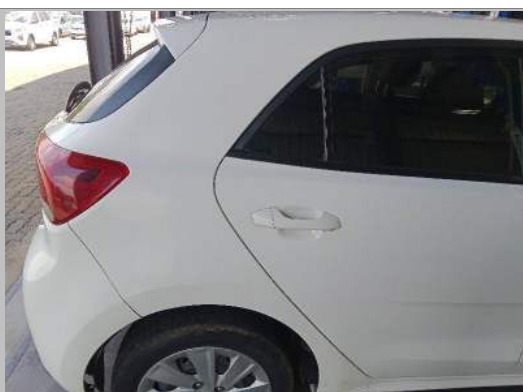
| Damage | Repair Way |
|---|---|
| Rear Fender Right Paintwork • Dull | Repair |

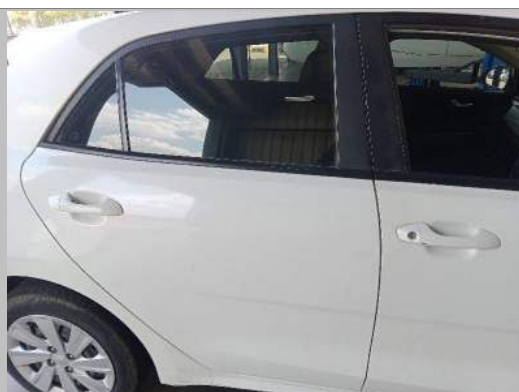
| Damage | Repair Way |
|---|---|
| Door Rear Right Damaged | Repair |

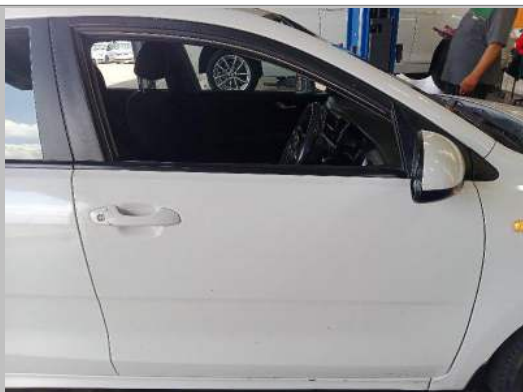
| Damage | Repair Way |
|---|---|
| Door Front Right Damaged | Repair |

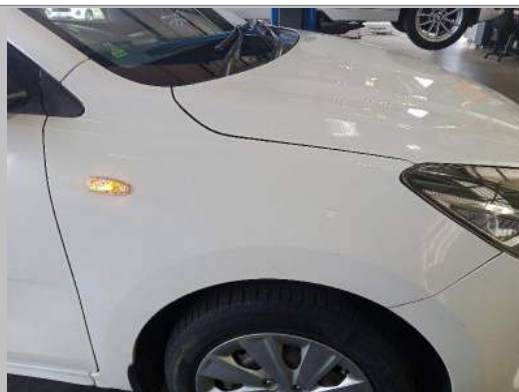
| Damage | Repair Way |
|---|---|
| Front Fender Right Damaged | Repair |

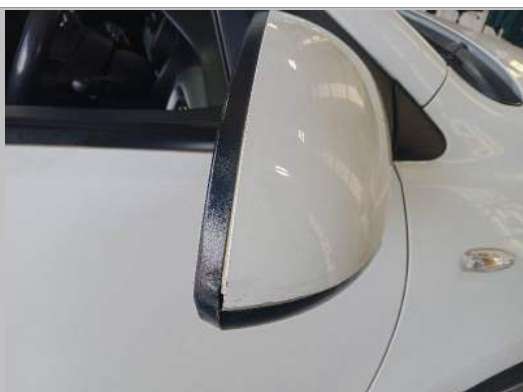
| Damage | Repair Way |
|---|---|
| Side Mirror Right Damaged | Repair |

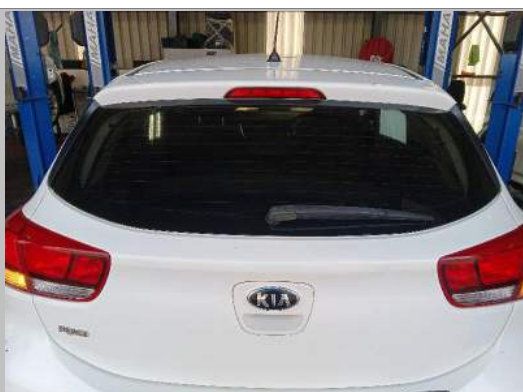
| Damage | Repair Way |
|---|---|
| Boot Lid / Hatch door Dented | Repair |

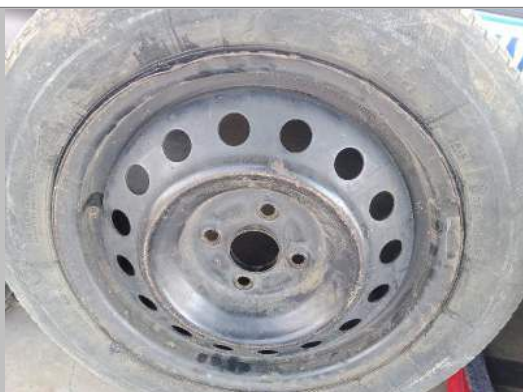
| Damage | Repair Way |
|---|---|
| Rim Spare Wheel Dented | Repair |

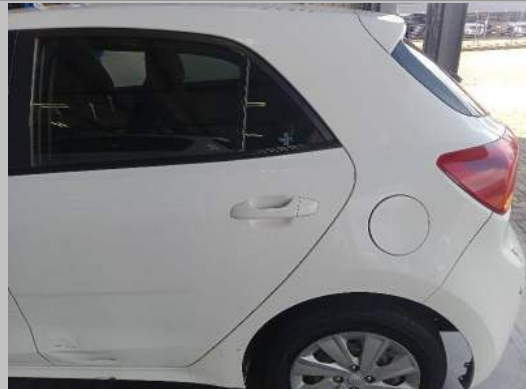
| Damage | Repair Way |
|---|---|
| Rear Fender Left Damaged | Repair |

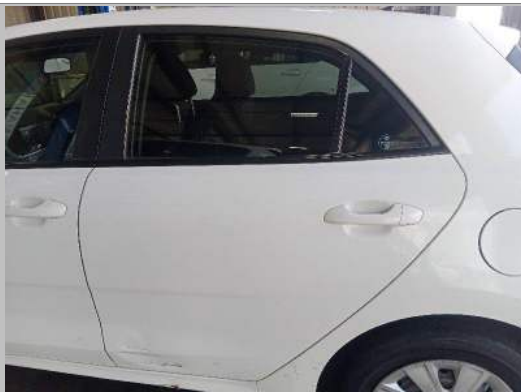
| Damage | Repair Way |
|---|---|
| Door Rear Left Damaged | Repair |

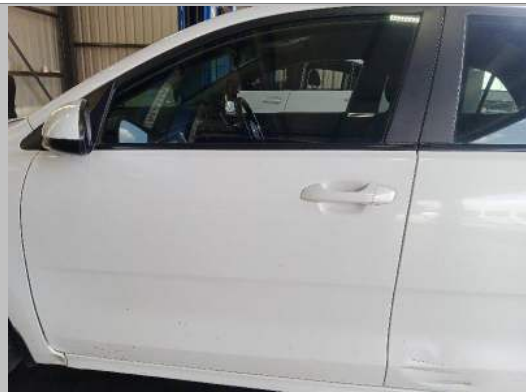
| Damage | Repair Way |
|---|---|
| Door Front Left Damaged | Repair |

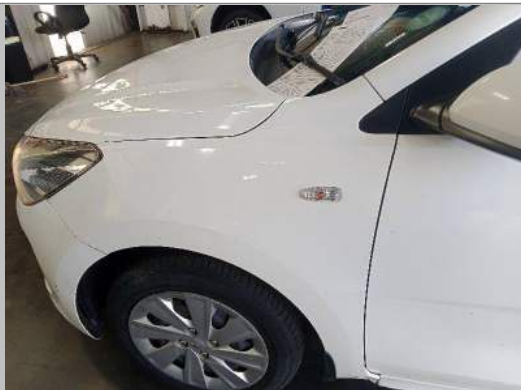
| Damage | Repair Way |
|---|---|
| Front Fender Left Damaged | Repair |

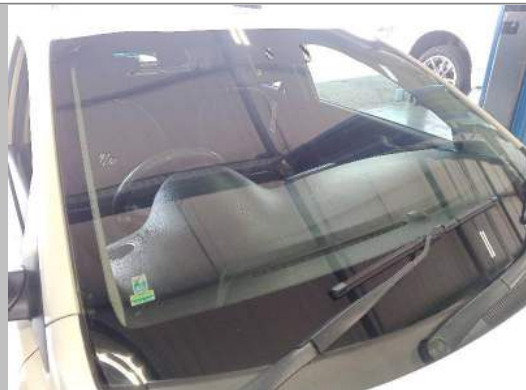
| Damage | Repair Way |
|---|---|
| Windscreen Chipped | Repair |

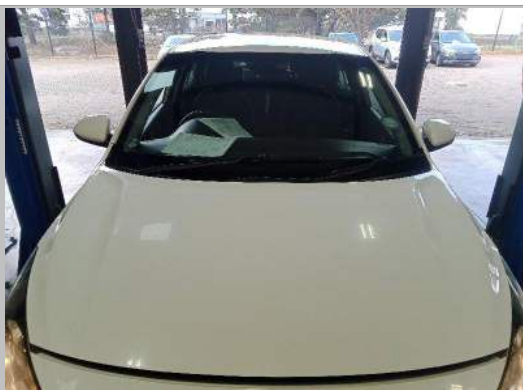
| Damage | Repair Way |
|---|---|
| Bonnet Dented | Repair |

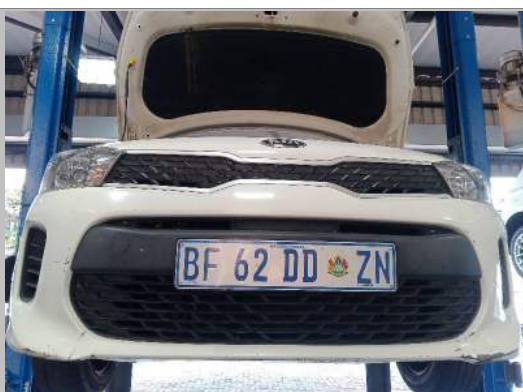
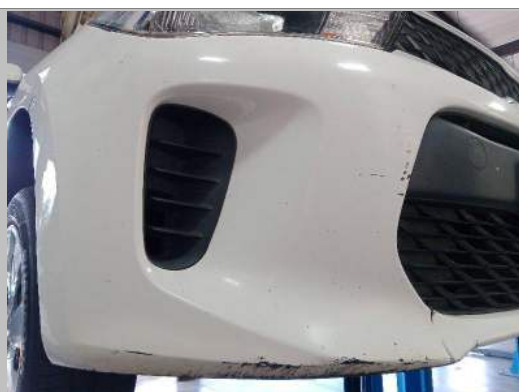
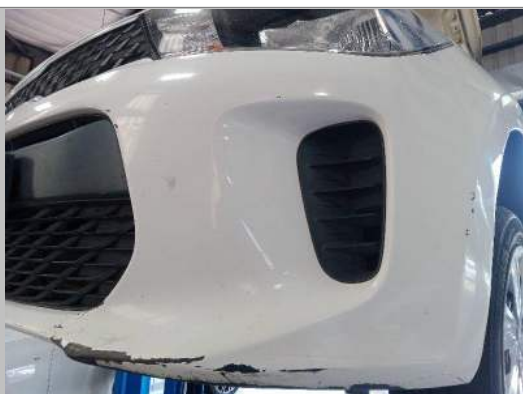
| Damage | Repair Way |
|---|---|
| Front Bumper Damaged | Repair |

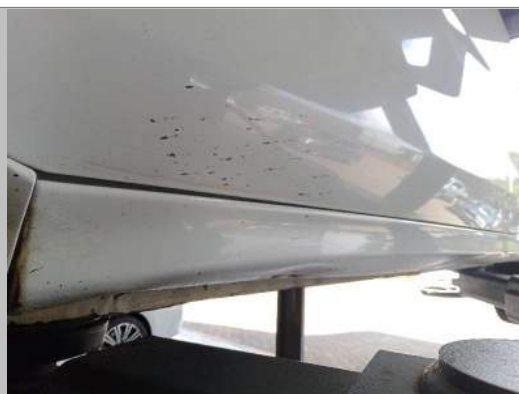
| Damage | Repair Way |
|---|---|
| Sill Panel Left Damaged | Repair |

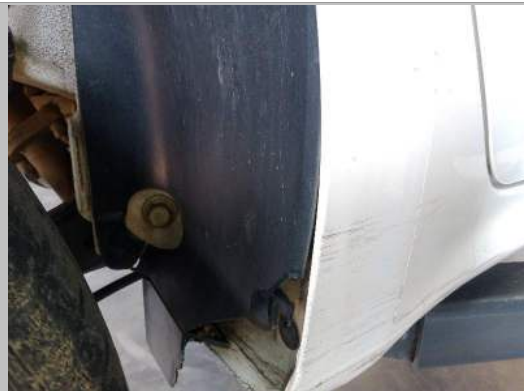
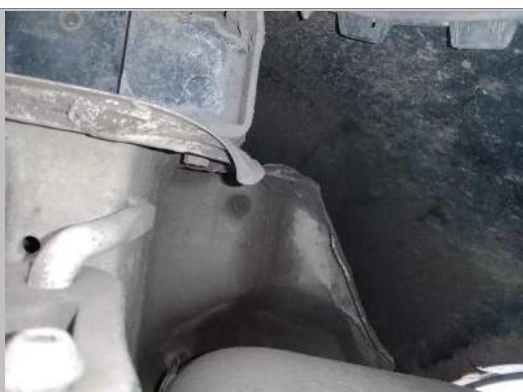
| Damage | Repair Way |
|---|---|
| Rear Fender Right / Inner Tray Damaged | Replace |

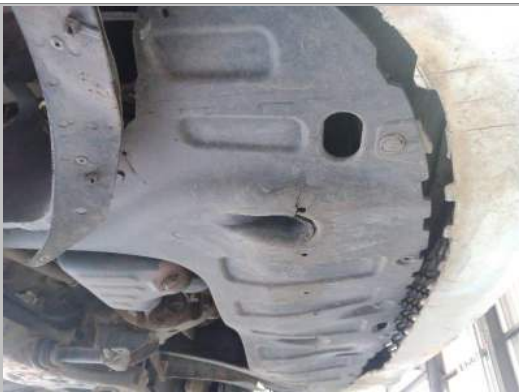
| Damage | Repair Way |
|---|---|
| Belly plates Damaged | Replace |

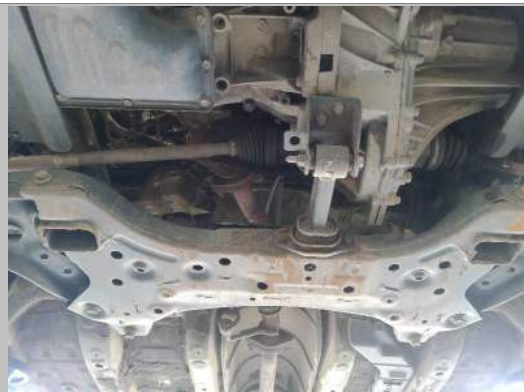
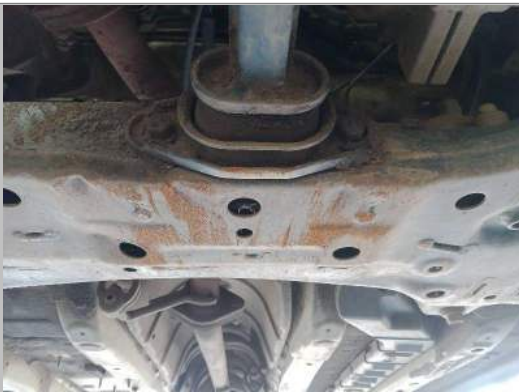
| Damage | Repair Way |
|---|---|
| Sub Frame Damaged | Replace |

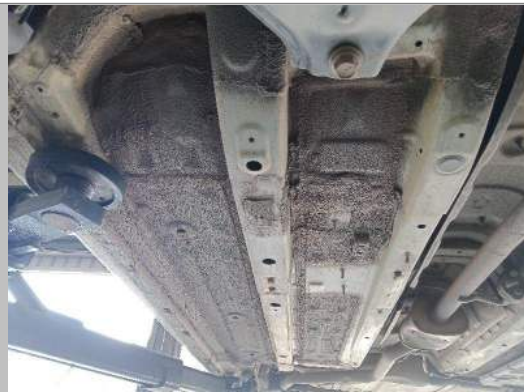
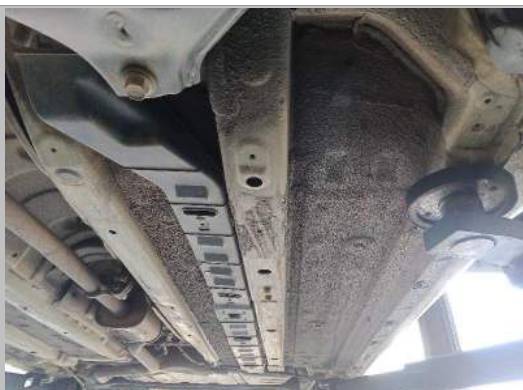
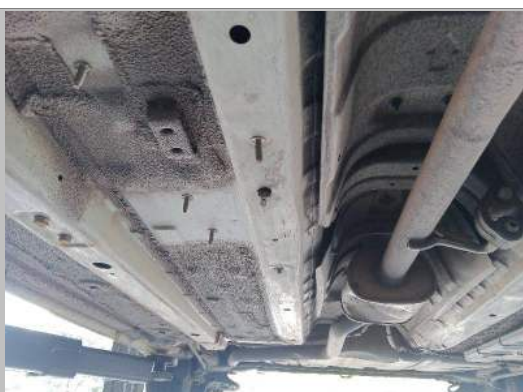
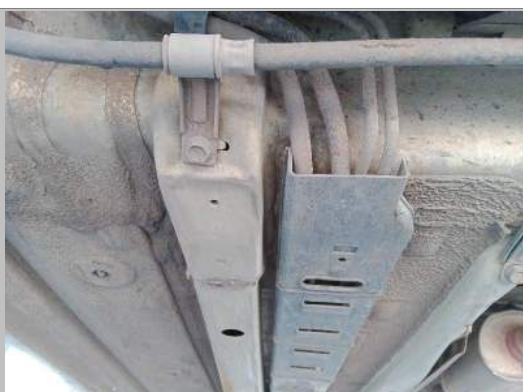
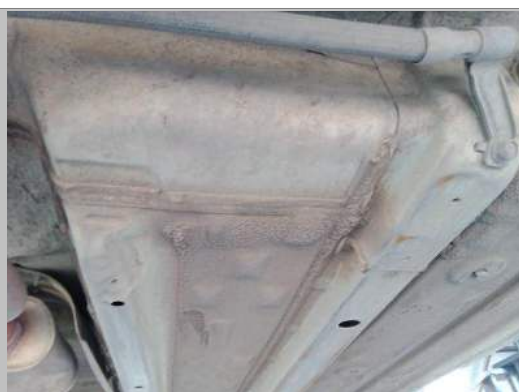
| Damage | Repair Way |
|---|---|
| Chassis Damaged | Repair |

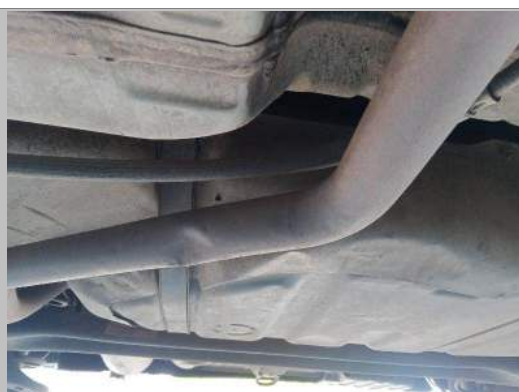
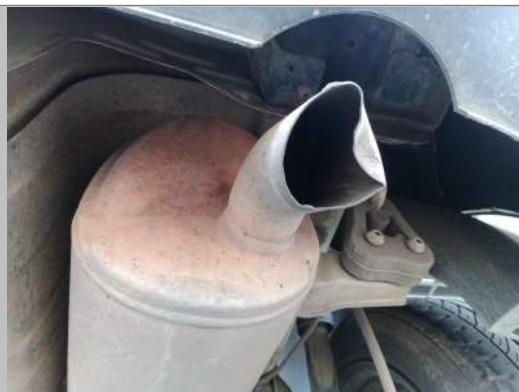
| Damage | Repair Way |
|---|---|
| Engine to silencer pipe Damaged | Repair |

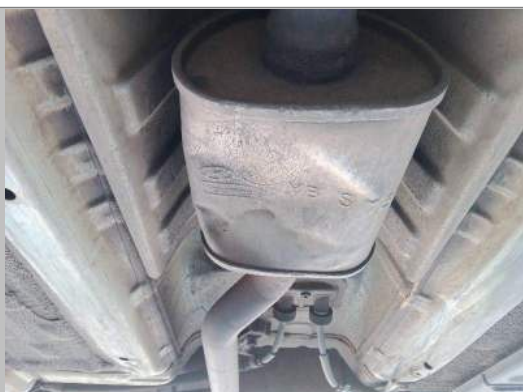
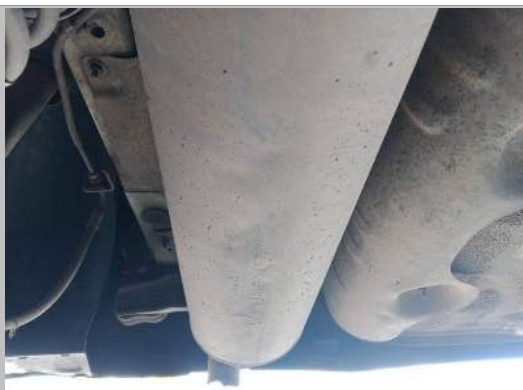
| Damage | Repair Way |
|---|---|
| Silencer Damaged | Replace |

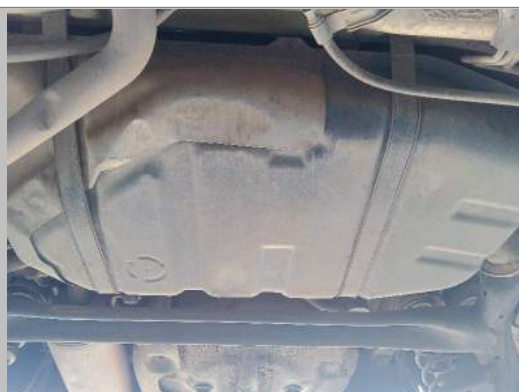
| Damage | Repair Way |
|---|---|
| Fuel Tank Damaged | Repair |

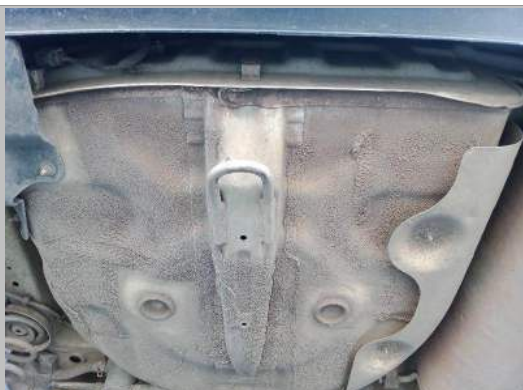
| Damage | Repair Way |
|---|---|
| Inner Boot Floor Pan and Spare Wheel Well Dented | Repair |

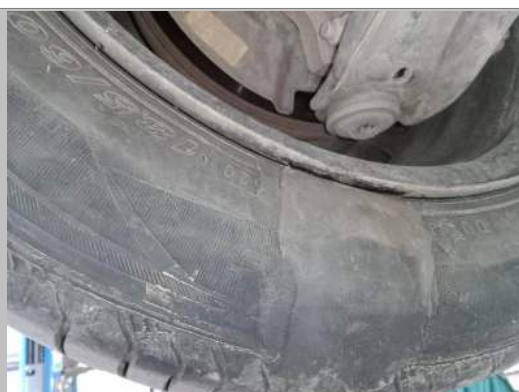
| Damage | Repair Way |
|---|---|
| Tyre Front Left Damaged | Replace |

| | Size | Load/Speed Index | Manufacture | Model | Type* | Production Date | Tread Depth (mm) |
|---|---|---|---|---|---|---|---|
| Front Left | 185/60 R15 | 88H | Roadstone | Eurovis | V | 0000 | 3 mm |

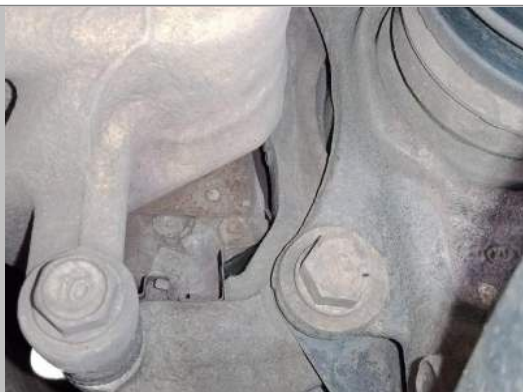
| Damage | Repair Way |
|---|---|
| Brake Pad 1. Axle right Worn | Replace |

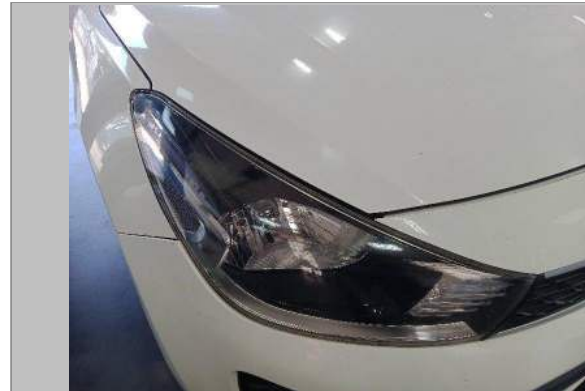
| Damage | Repair Way |
|---|---|
| Headlight Right Defective | Repair |

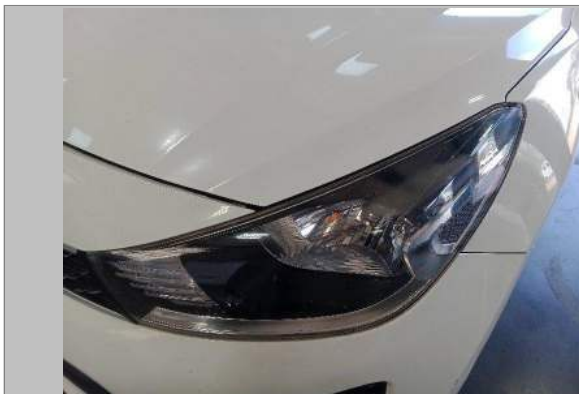
| Damage | Repair Way |
|---|---|
| Headlight Left Defective | Repair |
