## CONDITION REPORT

Report No: 2016878508

| Manufacturer | KIA | Registration Number | KTF717NW |
| Model | RIO | Register Number | |

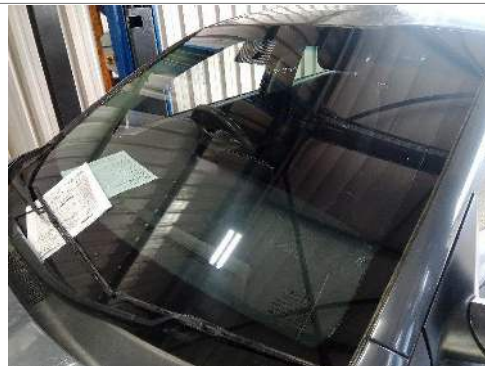
No license disc

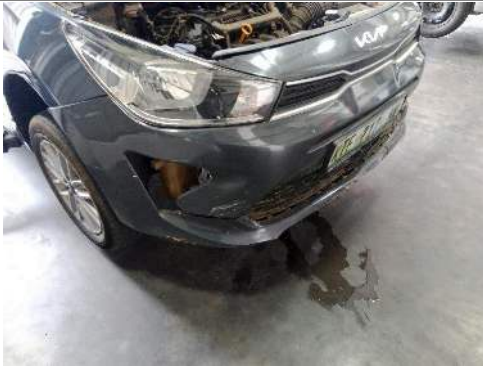
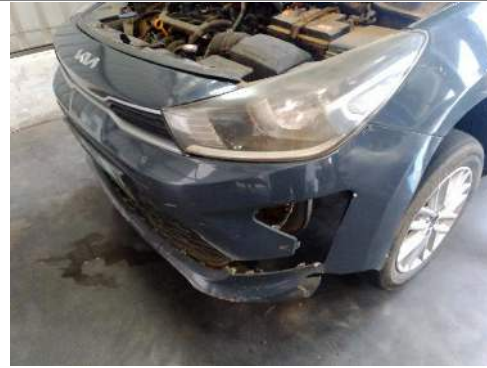
| Damage | Repair Way |
|---|---|
| Front Bumper Damaged | Repair |

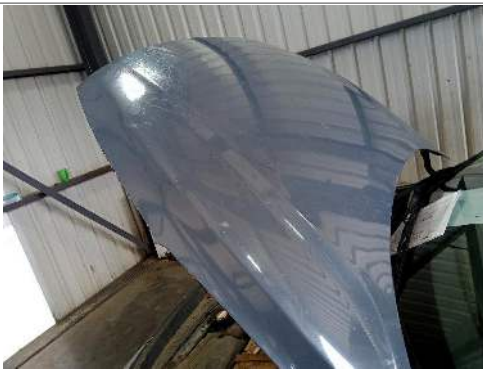
| Damage | Repair Way |
|---|---|
| Bonnet Damaged | Repair |

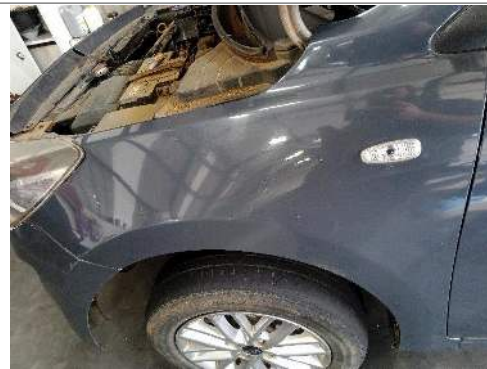
| Damage | Repair Way |
|---|---|
| Front Fender Left Damaged | Repair |

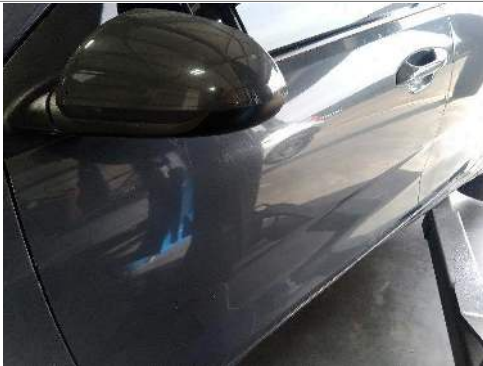
| Damage | Repair Way |
|---|---|
| Door Front Left Damaged | Repair |

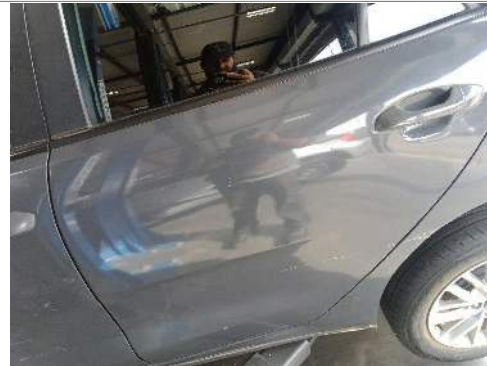
| Damage | Repair Way |
|---|---|
| Door Rear Left Damaged | Repair |

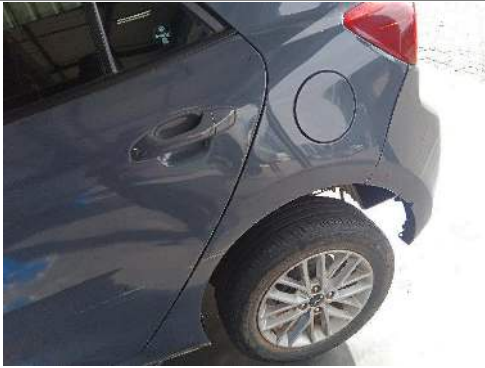
| Damage | Repair Way |
|---|---|
| Rear Fender Left Damaged | Repair |

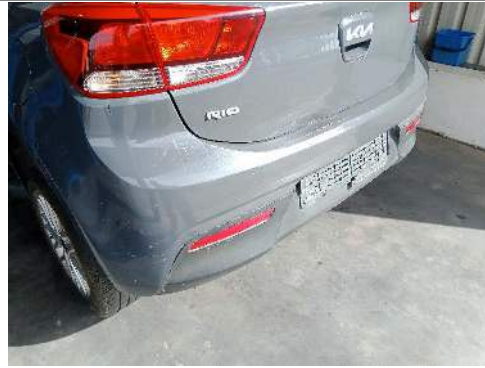
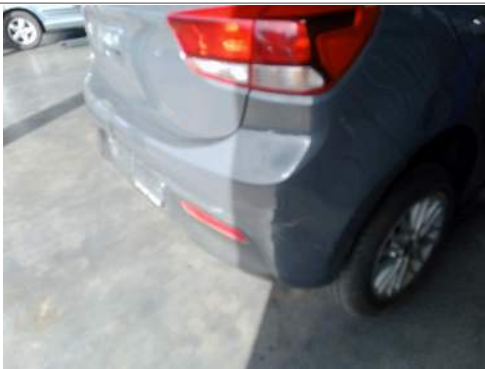
| Damage | Repair Way |
|---|---|
| Rear bumper Damaged | Repair |

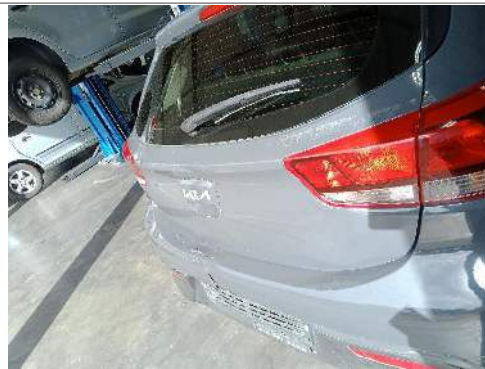
| Damage | Repair Way |
|---|---|
| Boot Lid / Hatch door Damaged | Repair |

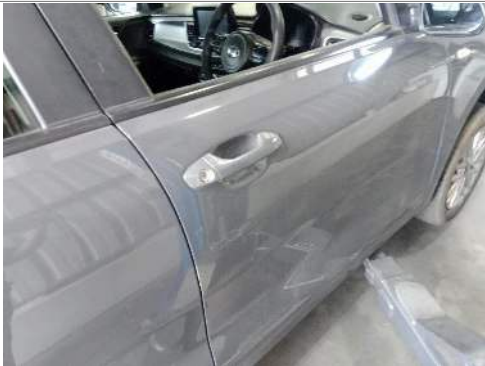
| Damage | Repair Way |
|---|---|
| Door Front Right Damaged | Repair |

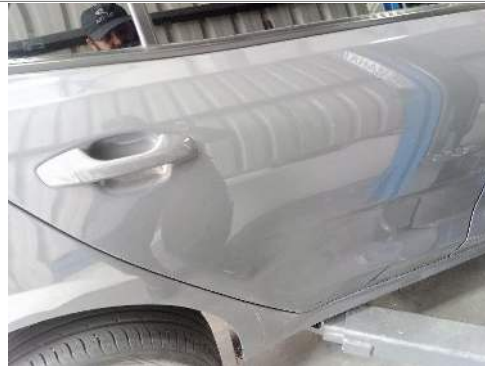
| Damage | Repair Way |
|---|---|
| Door Rear Right Damaged | Repair |

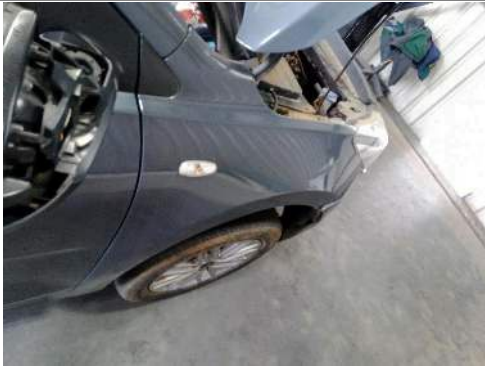
| Damage | Repair Way |
|---|---|
| Front Fender Right Damaged | Repair |

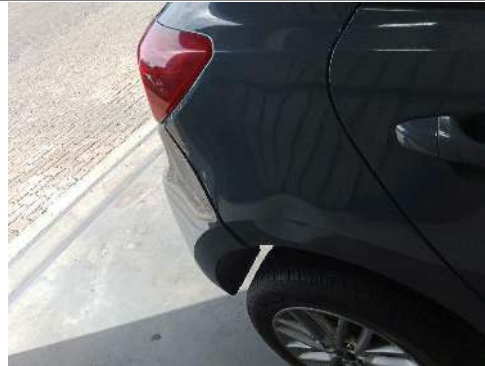
| Damage | Repair Way |
|---|---|
| Rear Fender Right Damaged | Repair |

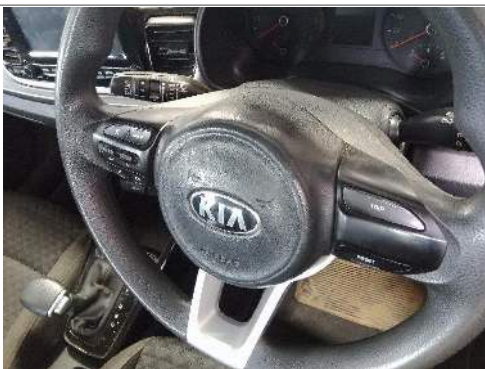
| Damage | Repair Way |
|---|---|
| Steering Wheel Trim Damaged | Replace |

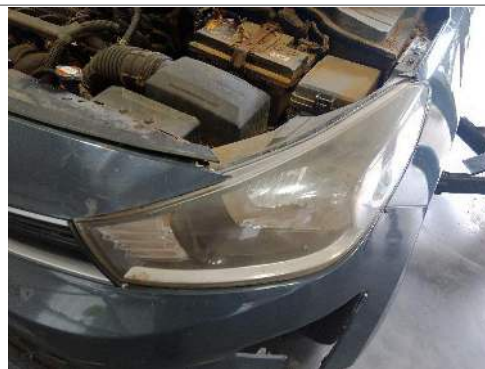
| Damage | Repair Way |
|---|---|
| Headlight Left Defective | Repair |

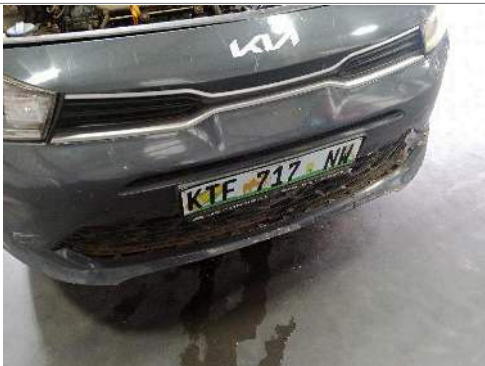
| Damage | Repair Way |
|---|---|
| Grill Damaged | Repair |

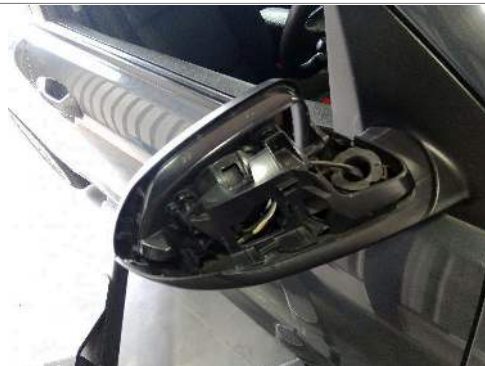
| Damage | Repair Way |
|---|---|
| Side Mirror Right Damaged | Replace |

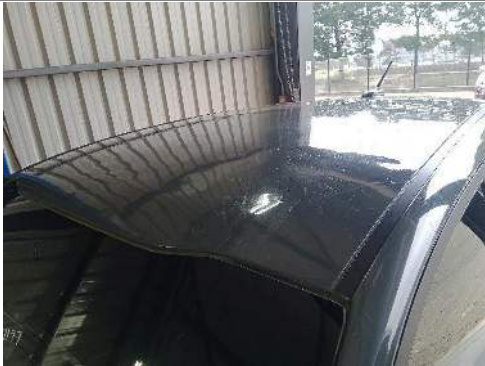
| Damage | Repair Way |
|---|---|
| Roof Damaged | Repair |

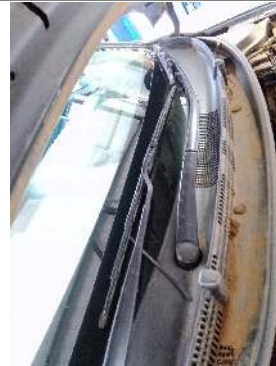
| Damage | Repair Way |
|---|---|
| Windscreen Wiper Damaged | Replace |

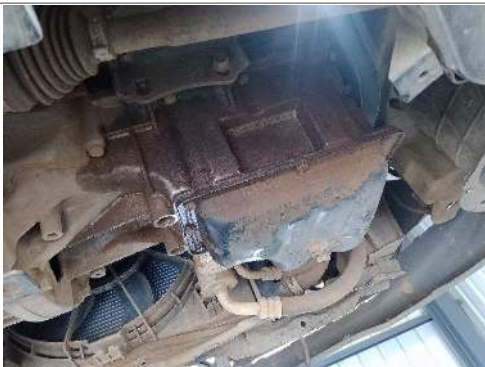
| Damage | Repair Way |
|---|---|
| Engine Oil Leak | Repair |

| Damage | Repair Way |
|---|---|
| Engine Performance Insufficient | Repair |
| Engine Noise Excessive | Repair |

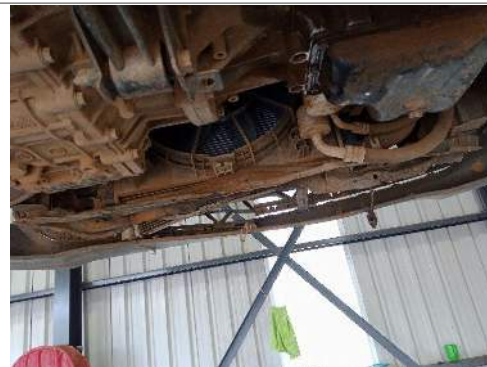
| Damage | Repair Way |
|---|---|
| Radiator Cradle Damaged | Replace |

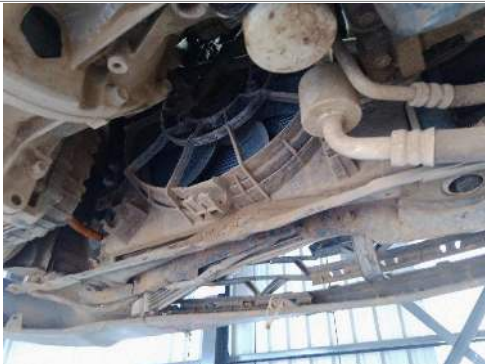
| Damage | Repair Way |
|---|---|
| Radiator Damaged | Repair |

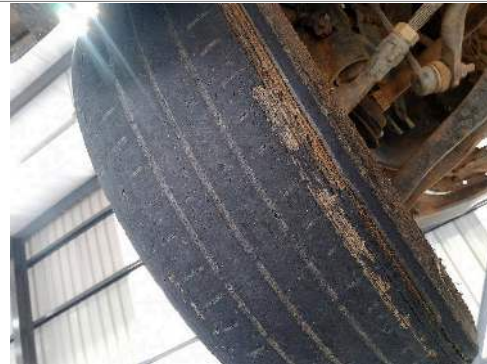
| Damage | Repair Way |
|---|---|
| Tyre Front Left Worn | Replace |

| | Size | Load/Speed Index | Manufacture | Model | Type* | Production Date | Tread Depth (mm) |
|---|---|---|---|---|---|---|---|
| Front Left | 185/65R15 | 88H | Bridgestone | Radial | V | 4519 | 0 mm |

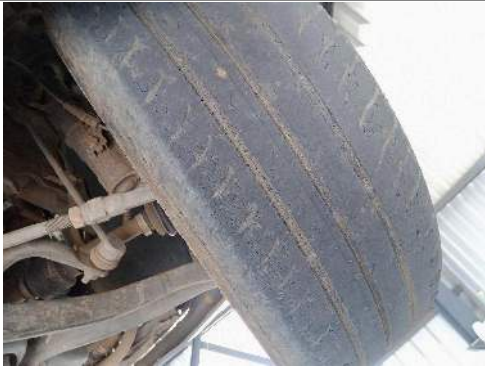
| Damage | Repair Way |
|---|---|
| Tyre Front Right Worn | Replace |

| | Size | Load/Speed Index | Manufacture | Model | Type* | Production Date | Tread Depth (mm) |
|---|---|---|---|---|---|---|---|
| Front Right | 185/65R15 | 88H | Nexen | Radial | V | 1921 | 0 mm |

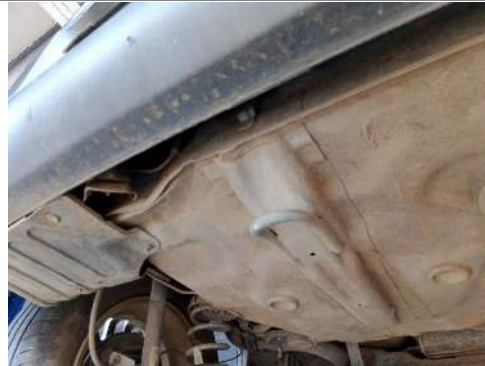
| Damage | Repair Way |
|---|---|
| Inner Boot Floor Pan and Spare Wheel Well Damaged | Repair |

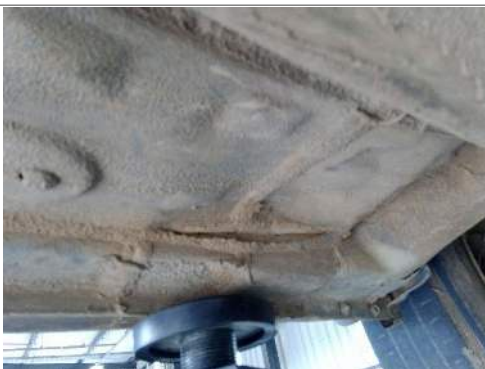
| Damage | Repair Way |
|---|---|
| Chassis Damaged | Replace |
